# HESS CORPORATION

## PHILLIPS "H" CULP BATTERY #19 LEA COUNTY, NEW MEXICO

### SITE CLOSURE REPORT

## Phillips "H" Culp Battery #19

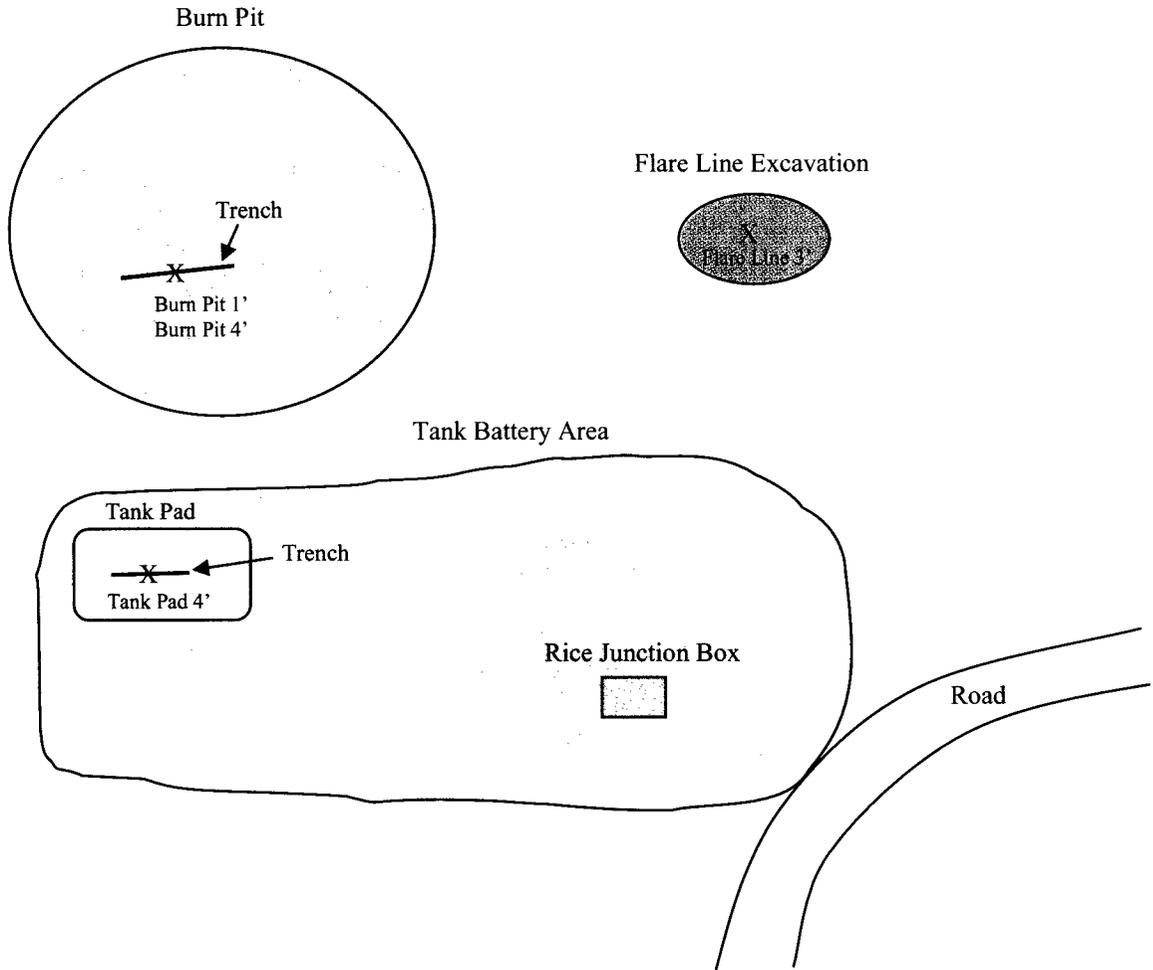
# HESS CORPORATION PHILLIPS "H" CULP BATTERY #19

On June 26, 2006, BBC collected four (4) soil samples from test holes excavated with a trackhoe. The samples were tested for total petroleum hydrocarbons (TPH) – gasoline range organics (GRO)/diesel range organics (DRO), chloride, and benzene-toluene-ethylbenzene-xylene (BTEX). All samples were non-detect for BTEX. The Flare Line 3' sample was collected from the bottom of the flare line excavation on the northeast side of the site at three (3) feet below ground surface (bgs). The sample was non-detect for GRO, and had 52.0 parts per million (ppm) DRO and 32 ppm chloride. Two (2) samples were collected from a trench in the burn pit located on the northwest side of the site. Both of these samples were non-detect for GRO. The Burn Pit 1' sample at one (1) foot bgs had 101 ppm DRO and 16 ppm chloride. The Burn Pit 4' sample at four (4) feet bgs had 18.0 ppm DRO and 16 ppm chloride. The Tank Pad 4' sample was collected from a trench in the tank pad of the battery area located on the south end of the site at four (4) feet bgs. The sample was non-detect for GRO and DRO and chloride content was 176 ppm. All site diagrams depicting sample

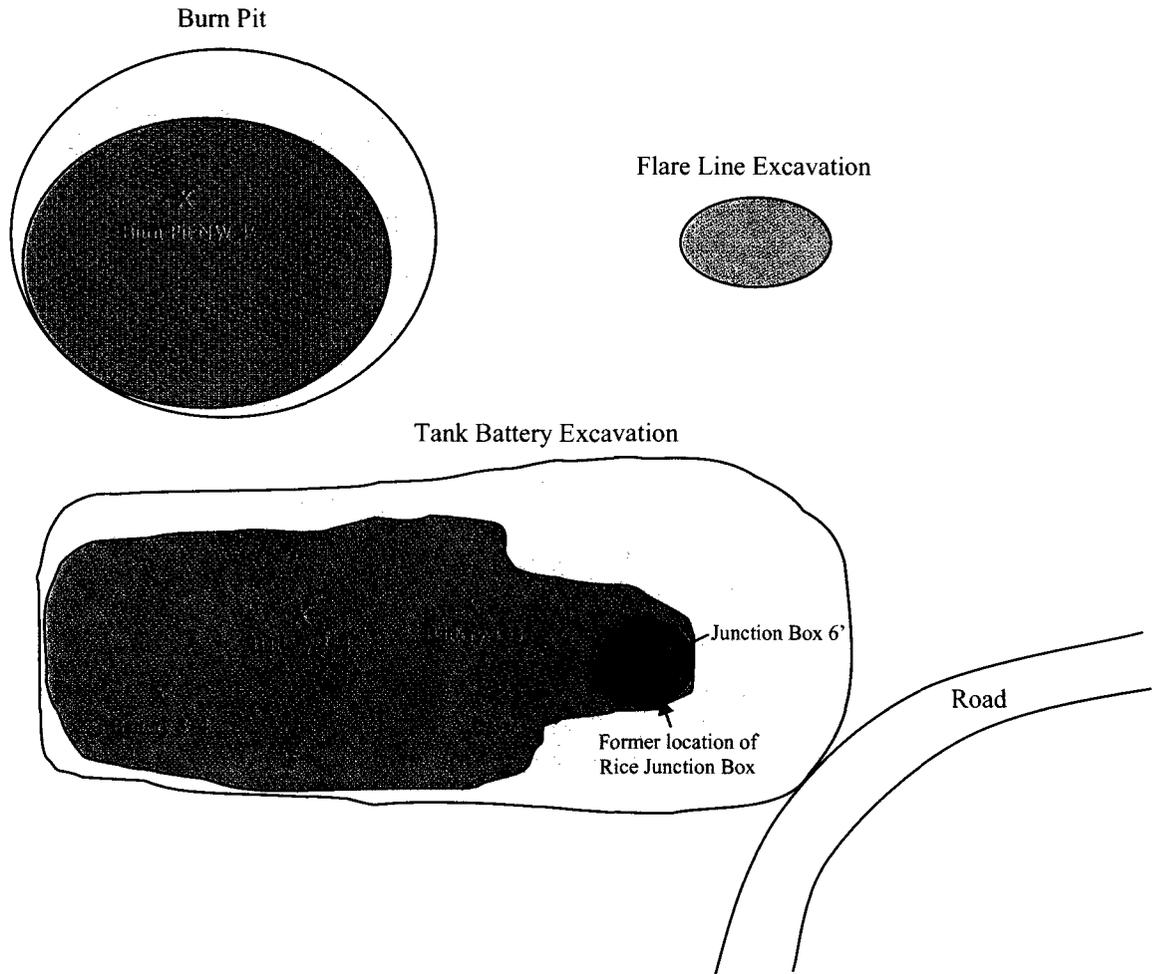
# HESS CORPORATION PHILLIPS "H" CULP BATTERY #19

Samples were collected on July 6, 2006 from the battery area and burn pit. The Junction Box 6' sample was taken from the southeast corner of the tank battery area at six (6) feet bgs in the former location of a junction box. The sample had 46.7 ppm GRO, 968 ppm DRO, and was non-detect for chloride and BTEX. The Battery 1 3' sample from the northeast side of the battery excavation at three (3) feet bgs was non-detect for GRO and BTEX, and had 24.3 ppm DRO and 32 ppm chloride. The Battery 2 4' sample from the center of the battery excavation at four (4) feet bgs was non-detect for GRO and BTEX, and had 67.7 ppm DRO and 16 ppm chloride. The Battery 3 4' sample from the southwest corner of the battery excavation at four (4) feet bgs was non-detect for GRO, DRO, and BTEX, and had 32 ppm chloride. The Burn Pit NW 4' sample from the center of the burn pit at four (4) feet bgs had 236 ppm GRO and 1,370 ppm DRO, and was non-detect for chloride and BTEX.

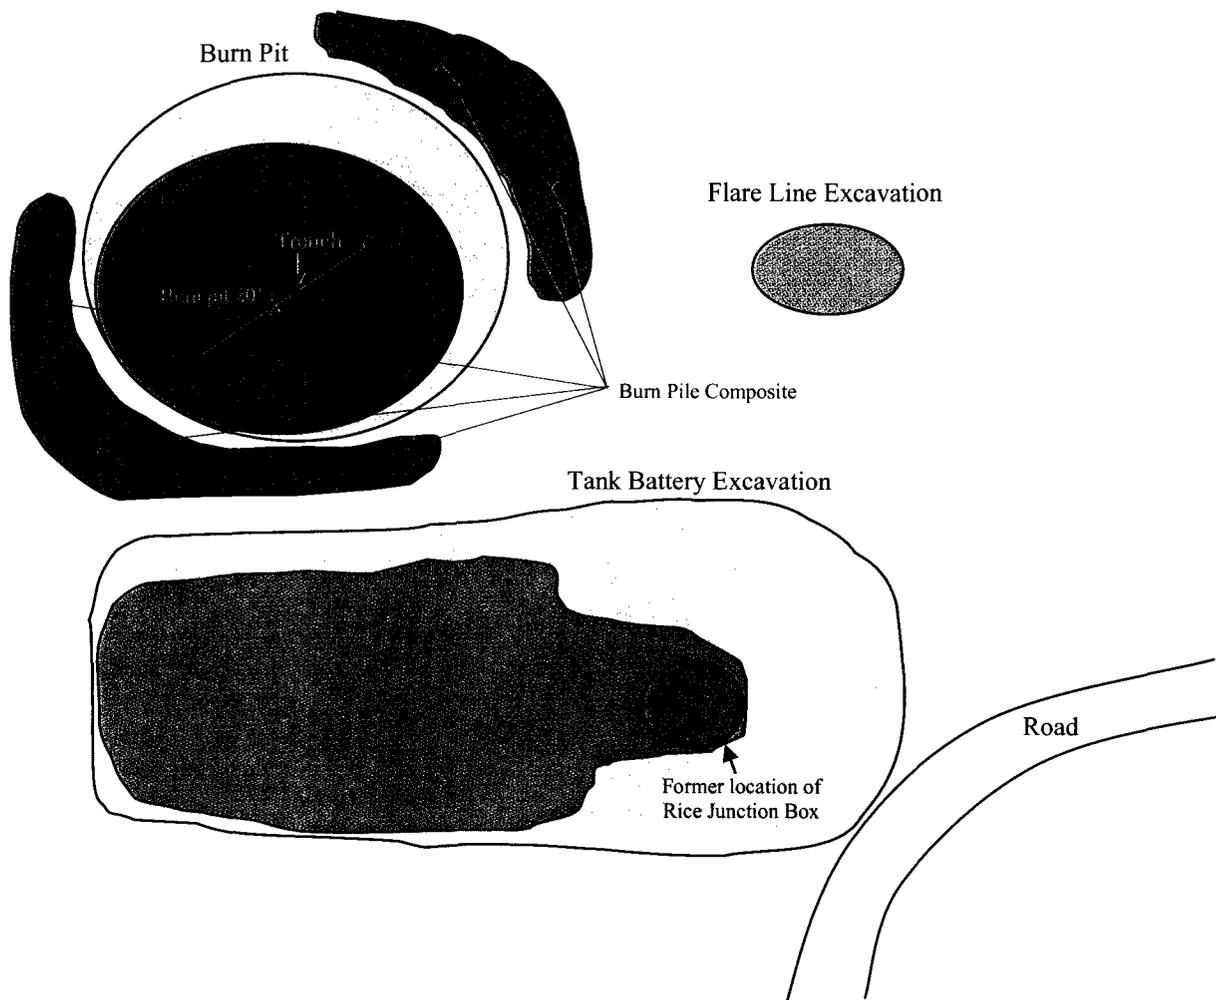
# HESS CORPORATION PHILLIPS "H" CULP BATTERY #19

On July 7, 2006, BBC collected samples from the burn pit spoils pile and the bottom of a trench excavated in the center of the burn pit. The Burn Pile Composite sample was non-detect for GRO and BTEX, and had 106 ppm DRO and 16 ppm chloride. The Burn Pit 20' sample from the trench excavated to twenty (20) feet bgs in the burn pit contained 789 ppm GRO, 4,070 ppm DRO, 144 ppm chloride, 0.010 ppm ethylbenzene, and 0.227 ppm total xylenes.

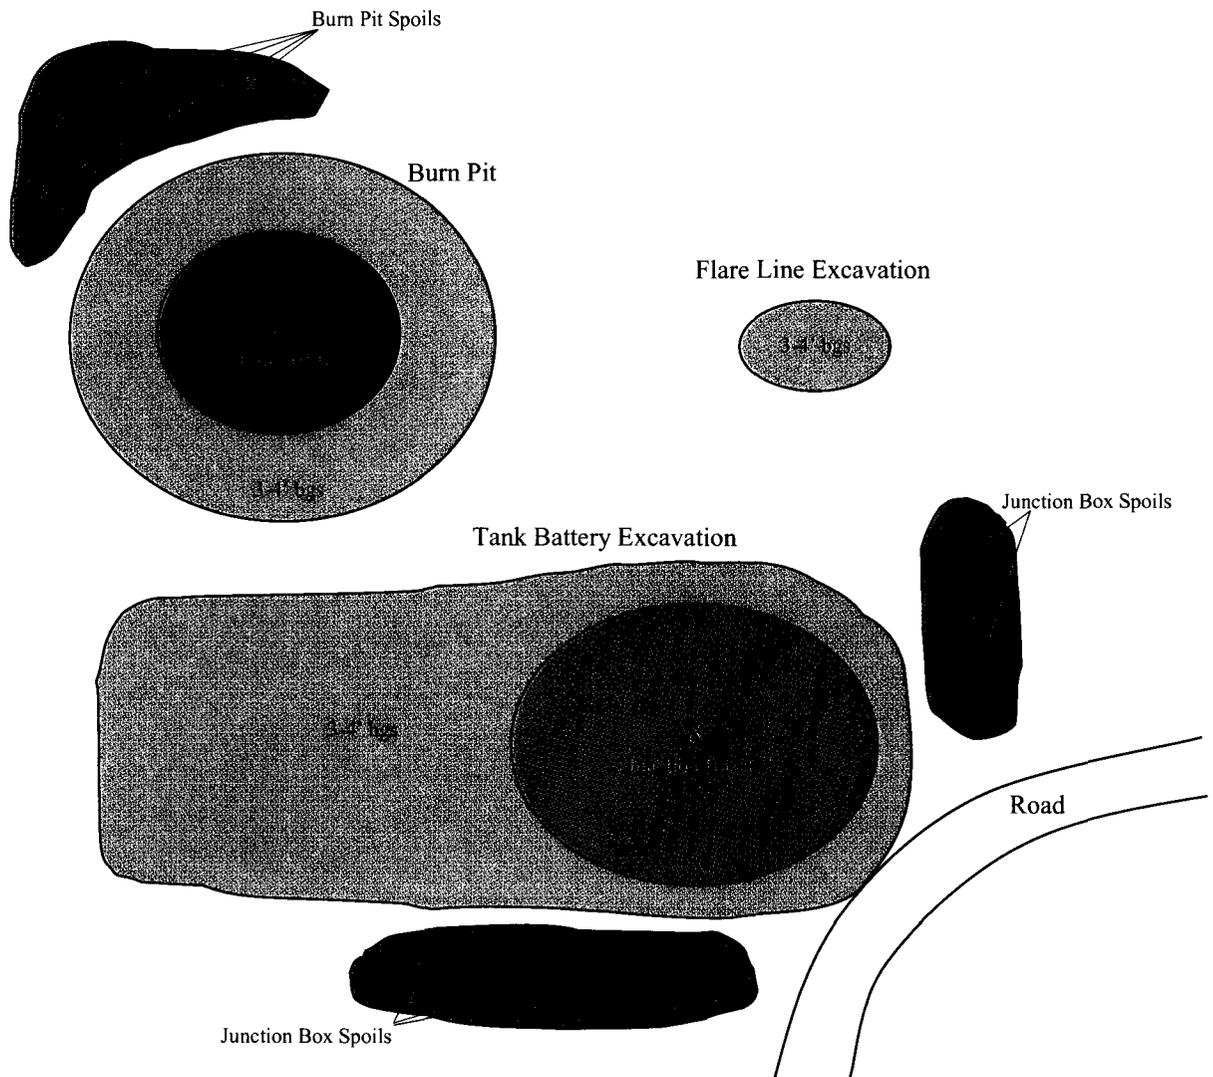
# HESS CORPORATION PHILLIPS "H" CULP BATTERY #19

BBC drilled two (2) boreholes on July 11, 2006 in the burn pit to collect soil samples. Two (2) soil samples were submitted to a laboratory from the first soil boring, SB1. The SB1-3' sample at three (3) feet bgs was non-detect for GRO, DRO, and BTEX, and had 32 ppm chloride. The SB1-30' sample at thirty (30) feet bgs was non-detect for GRO, DRO, and BTEX, and had 208 ppm chlorides. At the second soil boring, SB2, three samples were collected. The SB2-3' sample at three (3) feet bgs had 318 ppm GRO, 1,600 ppm DRO, 32 ppm chloride, 0.139 ppm ethylbenzene, and 0.331 ppm total xylenes. The SB2-5' sample at five (5) feet bgs contained 56.4 ppm GRO, 1,350 ppm DRO, 48 ppm chloride, 0.036 ppm ethylbenzene, and 0.095 ppm total xylenes. The SB2-20' sample at twenty (20) feet bgs was non-detect for GRO, DRO, and BTEX, and had 176 ppm chloride.

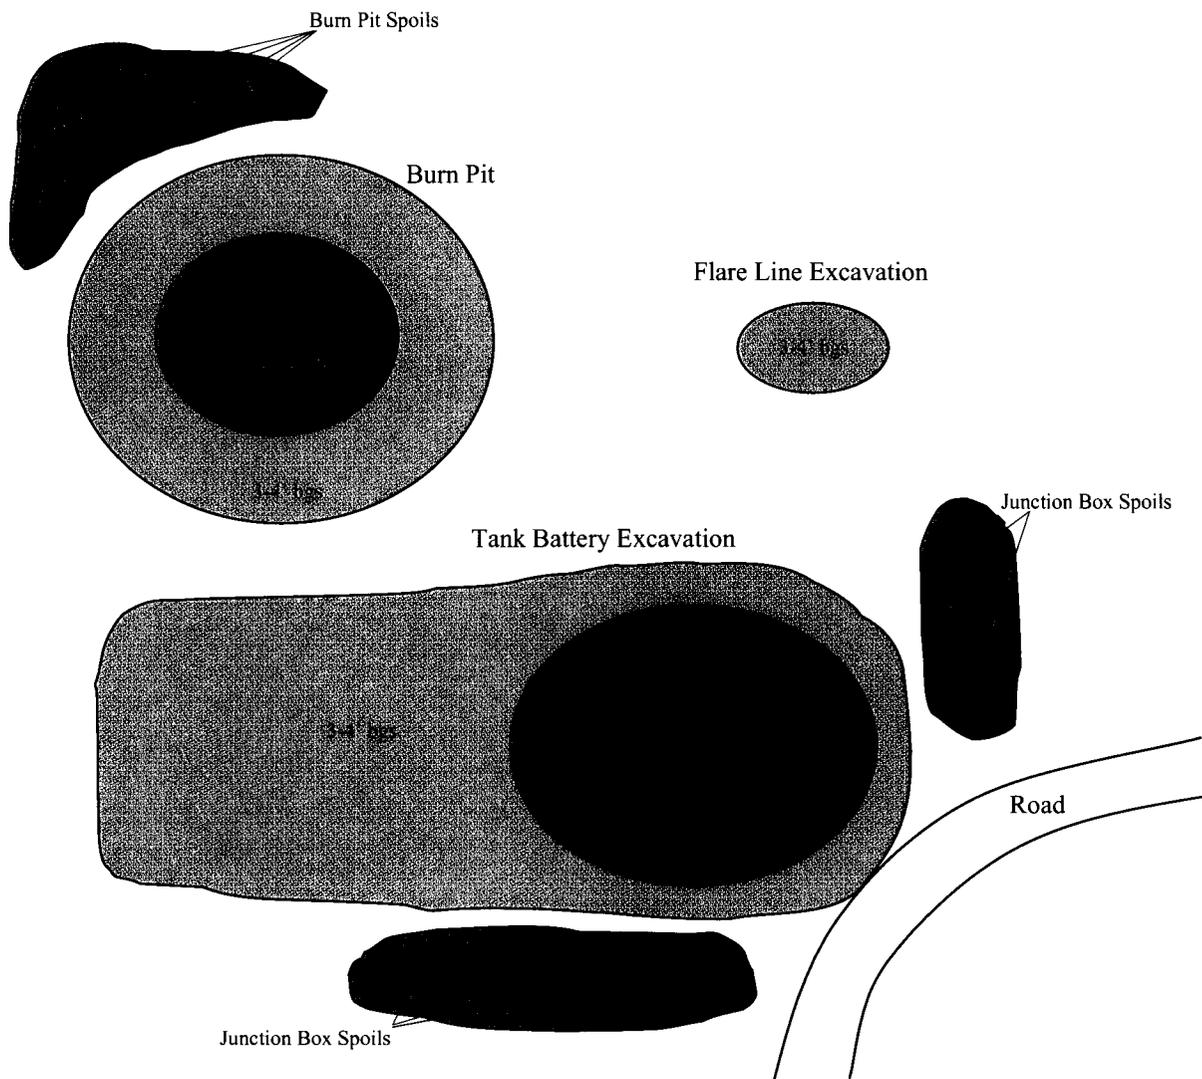
# HESS CORPORATION PHILLIPS "H" CULP BATTERY #19

After the site was fully excavated, BBC collected samples on July 25, 2006 from the former location of the junction box in the tank battery excavation, the bottom of the burn pit, and the spoils piles for each of these excavations. The Junction Box 18' sample at eighteen (18) feet bgs was non-detect for GRO and BTEX, and had 651 ppm DRO and 160 ppm chloride. The Burn Pit 20' sample had 20.3 ppm GRO, 1,830 ppm DRO, 128 ppm chloride, 0.048 ppm ethylbenzene, and 0.114 ppm total xylenes. The composite Burn Pit Spoils sample was non-detect for GRO, and contained 1,350 ppm DRO, 32 ppm chloride, and 0.018 total

xylenes. The composite Junction Box Spoils sample was non-detect for GRO and BTEX, and contained 1,030 ppm DRO and 192 ppm chloride.

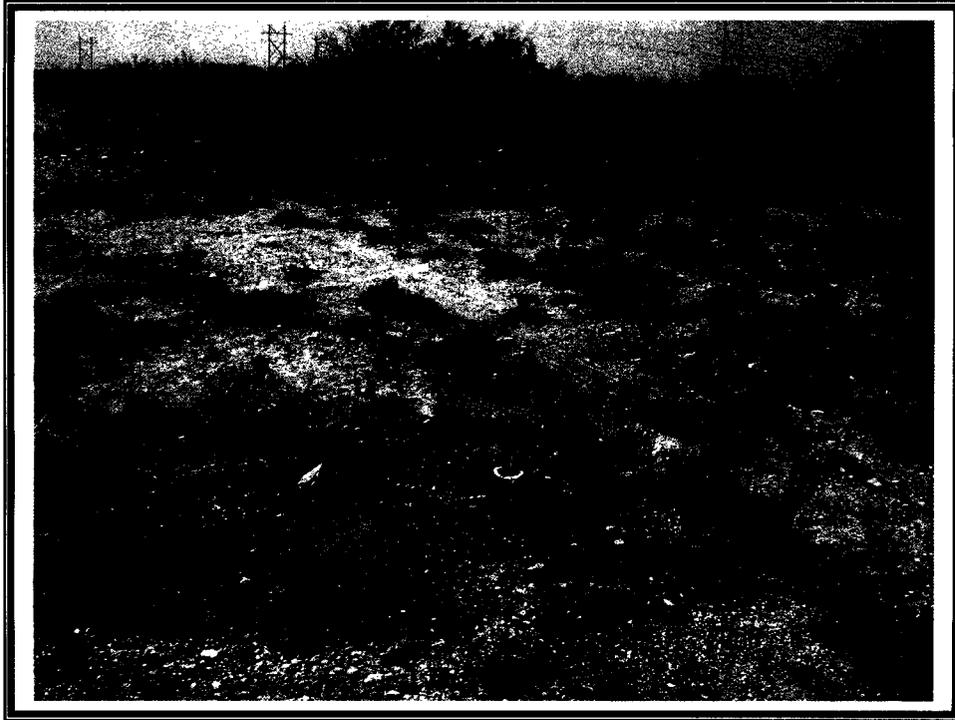
View to the northwest from Phillips H Culp tank battery area to the burn pit in background

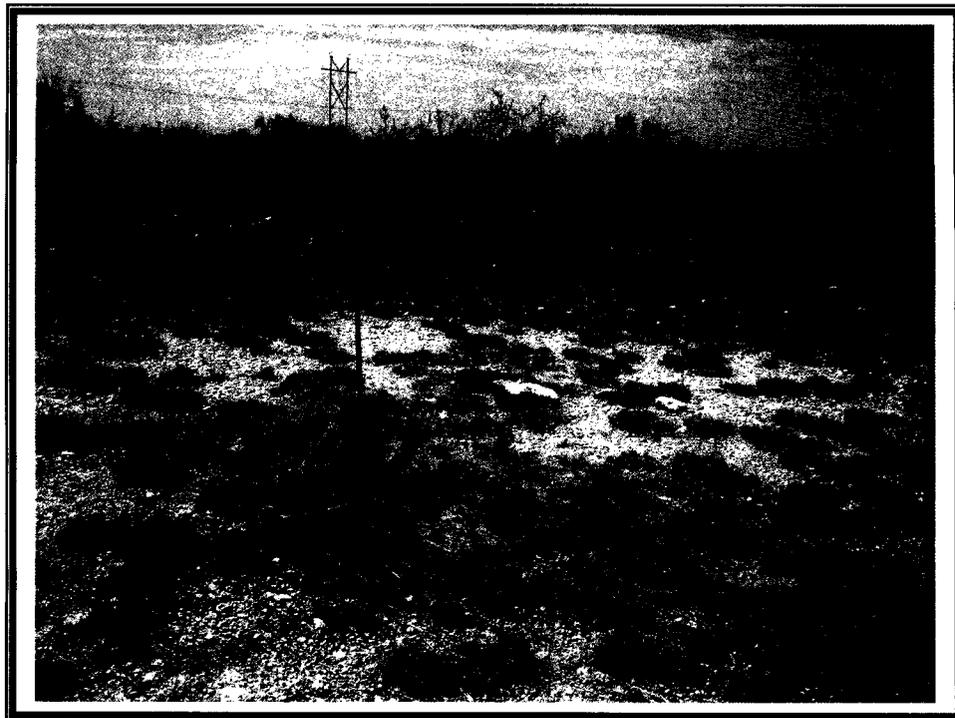
View from Phillips H Culp tank battery area to the burn pit in background

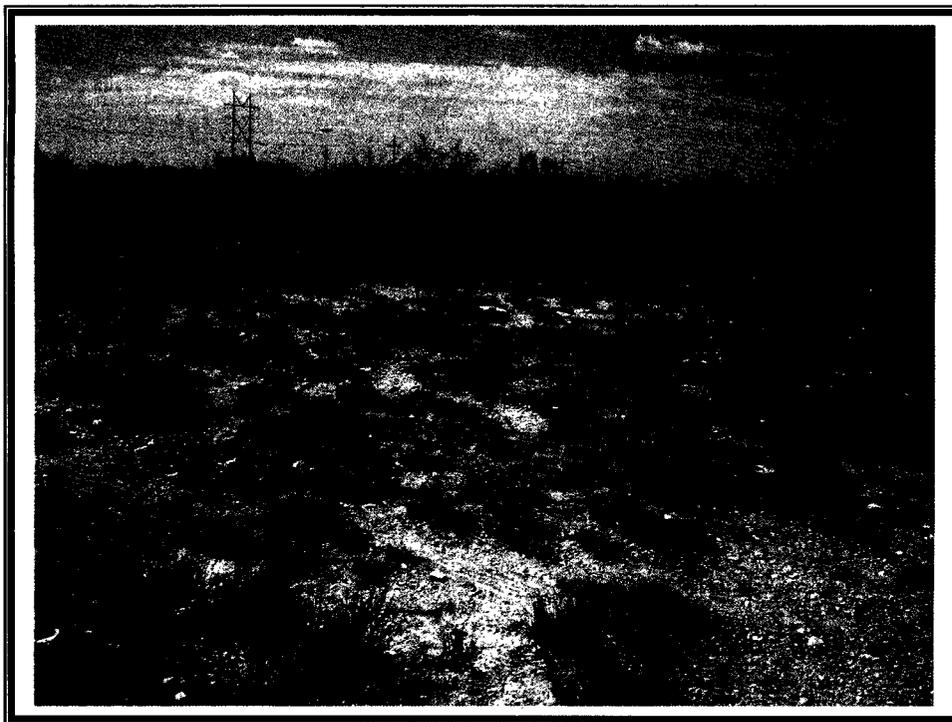
View from Phillips H Culp tank battery area to the burn pit on the left and the flare line area to the right

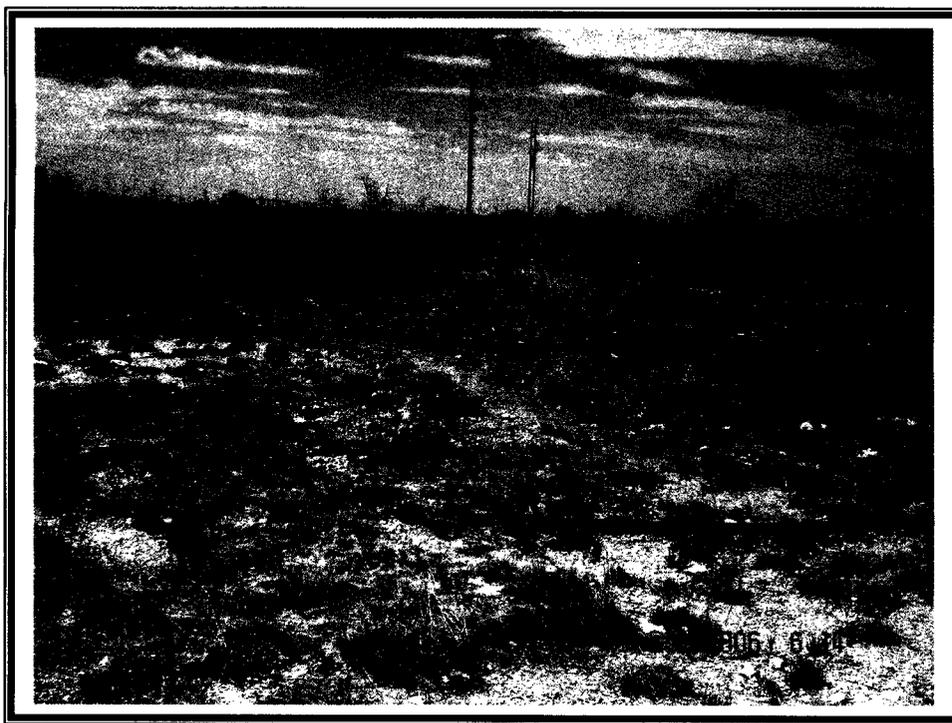
View from Phillips H Culp tank battery area north to the flare line area

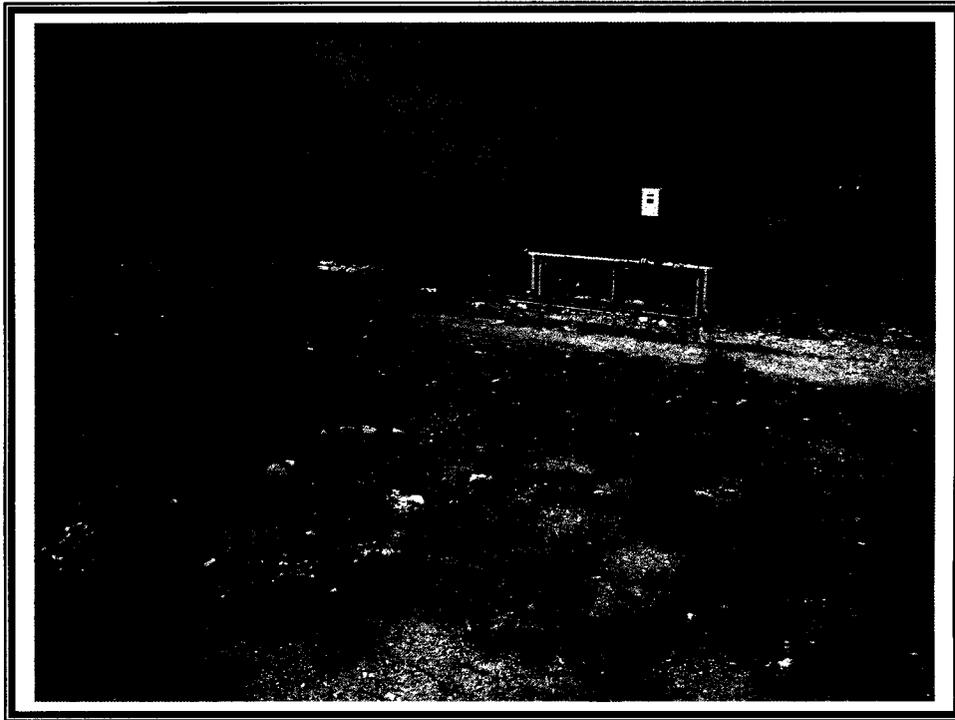
Southeast end of the flare line area

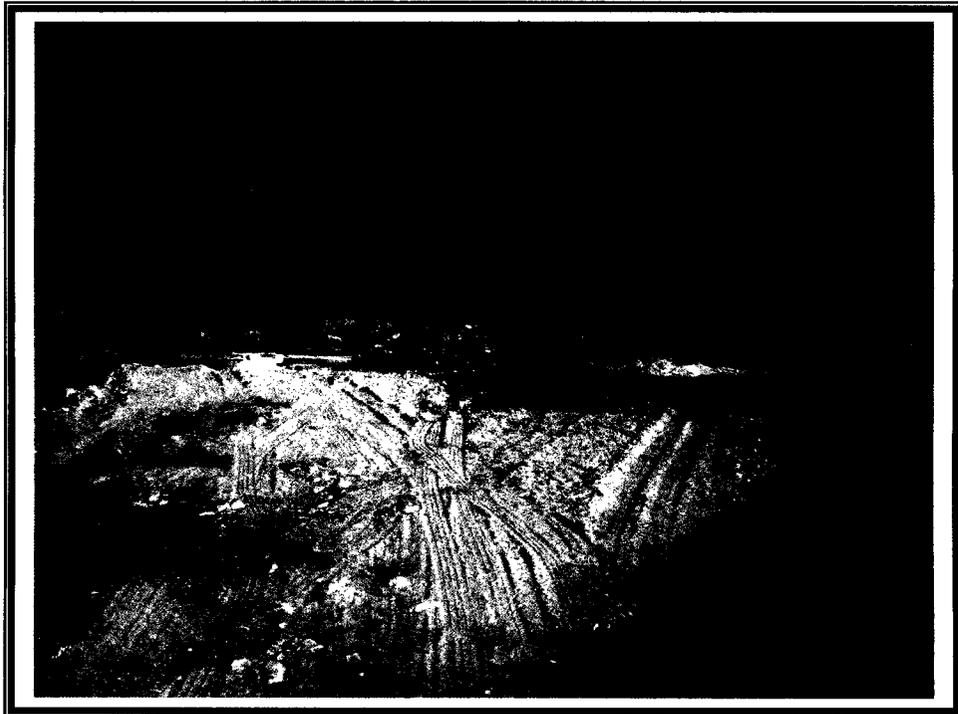
Burn pit – Locations of 2 soil borings within the pit

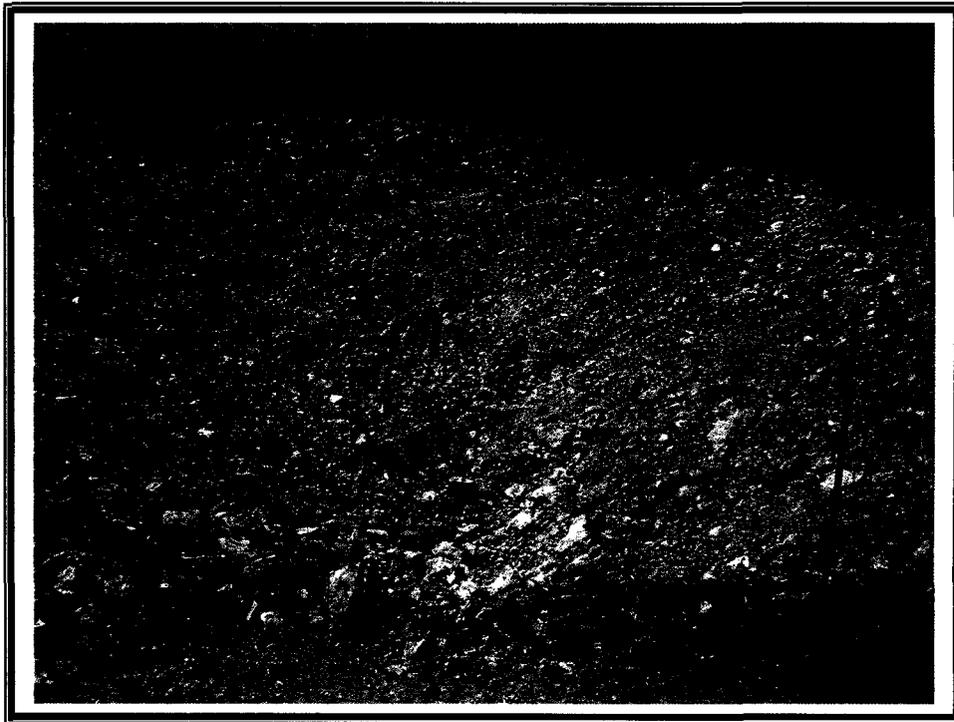
Tank battery area after excavation of soil in former location of Rice Junction Box in foreground – View location of burn pit at top right

Per our conversation this morning, Hess will close the Phillips H Culp Battery 19 which consists of two excavation sites. These are the burn pit and the Rice junction box. Per our agreement these two sites will be backfilled with caliche, capped with a clay liner, and finished with 3' of topsoil.

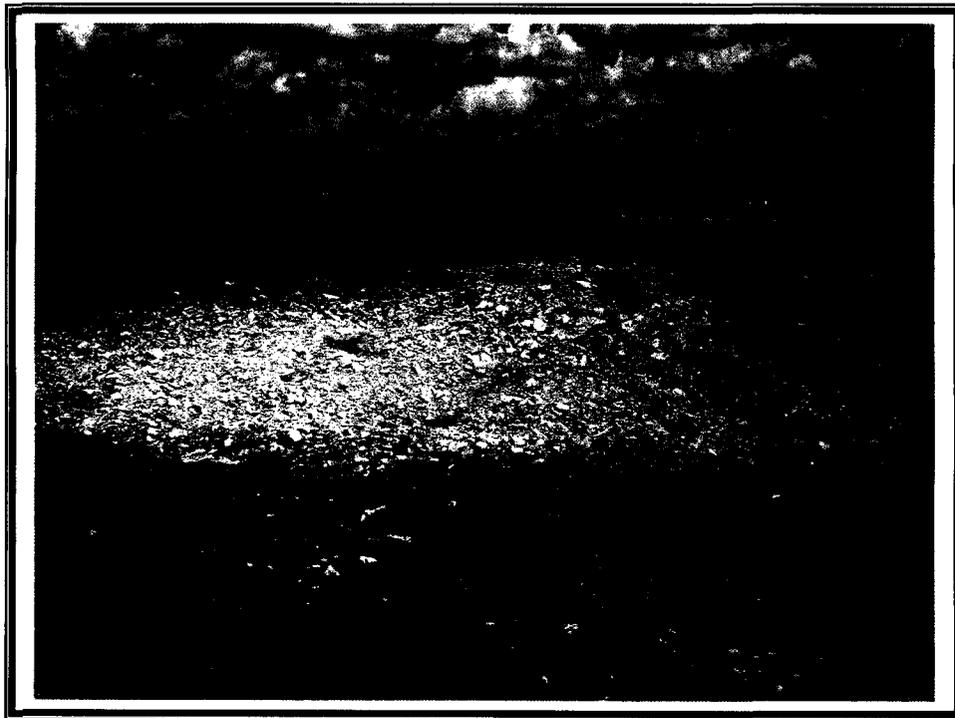
Flare line area excavation

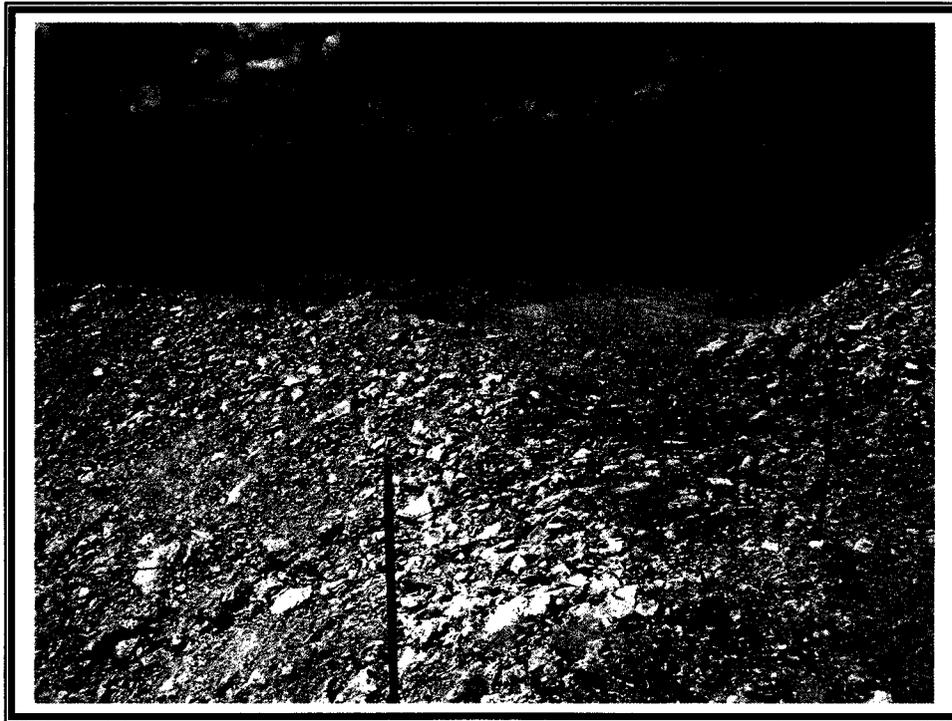
Tank battery excavation at front left, burn pit at top left, and flare line excavation at top right
