HESS CORPORATION

CHEVRON BV CULP BATTERY #17 LEA COUNTY, NEW MEXICO

SITE CLOSURE REPORT

February 15, 2007

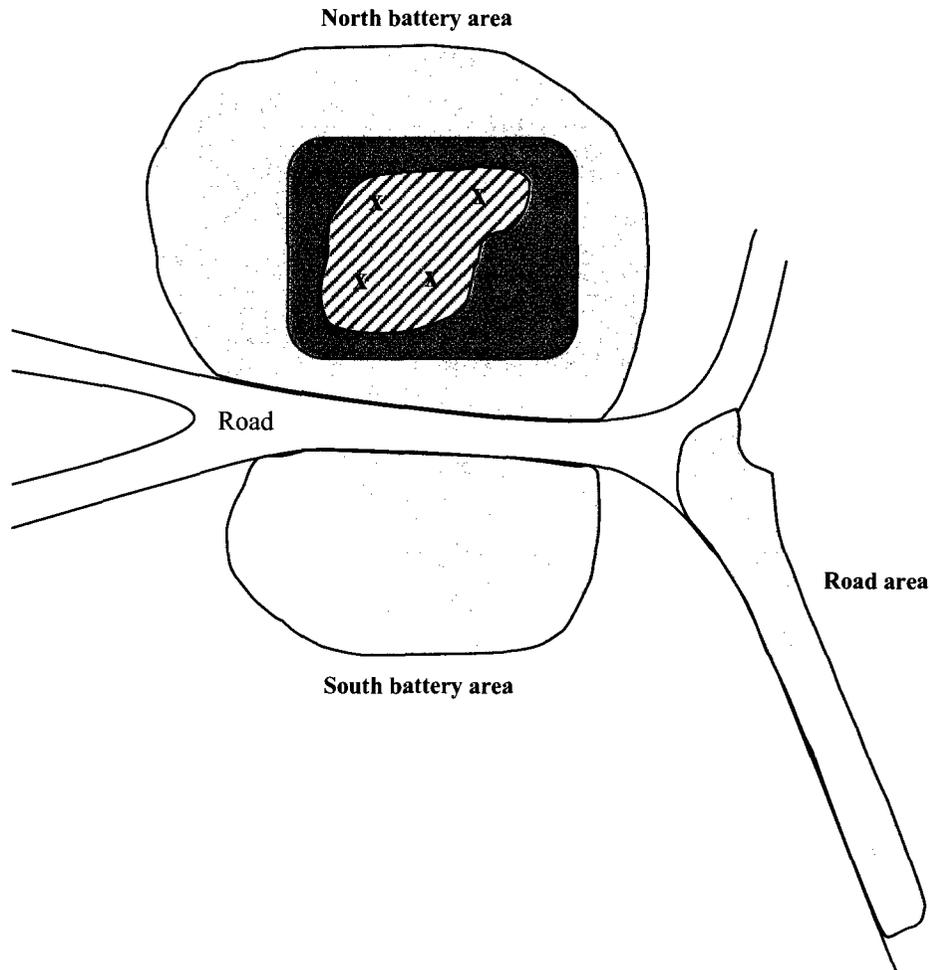
Excavation began at the north area of the site on November 13, 2006. On November 15, 2006, BBC collected a composite sample of the spoils pile on the north excavation. The samples were sent to a laboratory and analyzed for total petroleum hydrocarbons (TPH) – gasoline range organics (GRO)/diesel range organics (DRO), chloride, and benzene-toluene-ethylbenzene-xylene (BTEX). The sample was non-detect for GRO and had 171 parts per million (ppm) DRO, 16 ppm chloride, 0.015 ppm benzene, 0.012 ppm toluene, 0.034 ppm ethylbenzene, and 0.066 ppm total xylenes. All site diagrams depicting sample points can be found in **Appendix I**, laboratory analyticals can be found in **Appendix II**, and site photographs can be viewed in **Appendix III**.

Sampling Event November 15, 2006

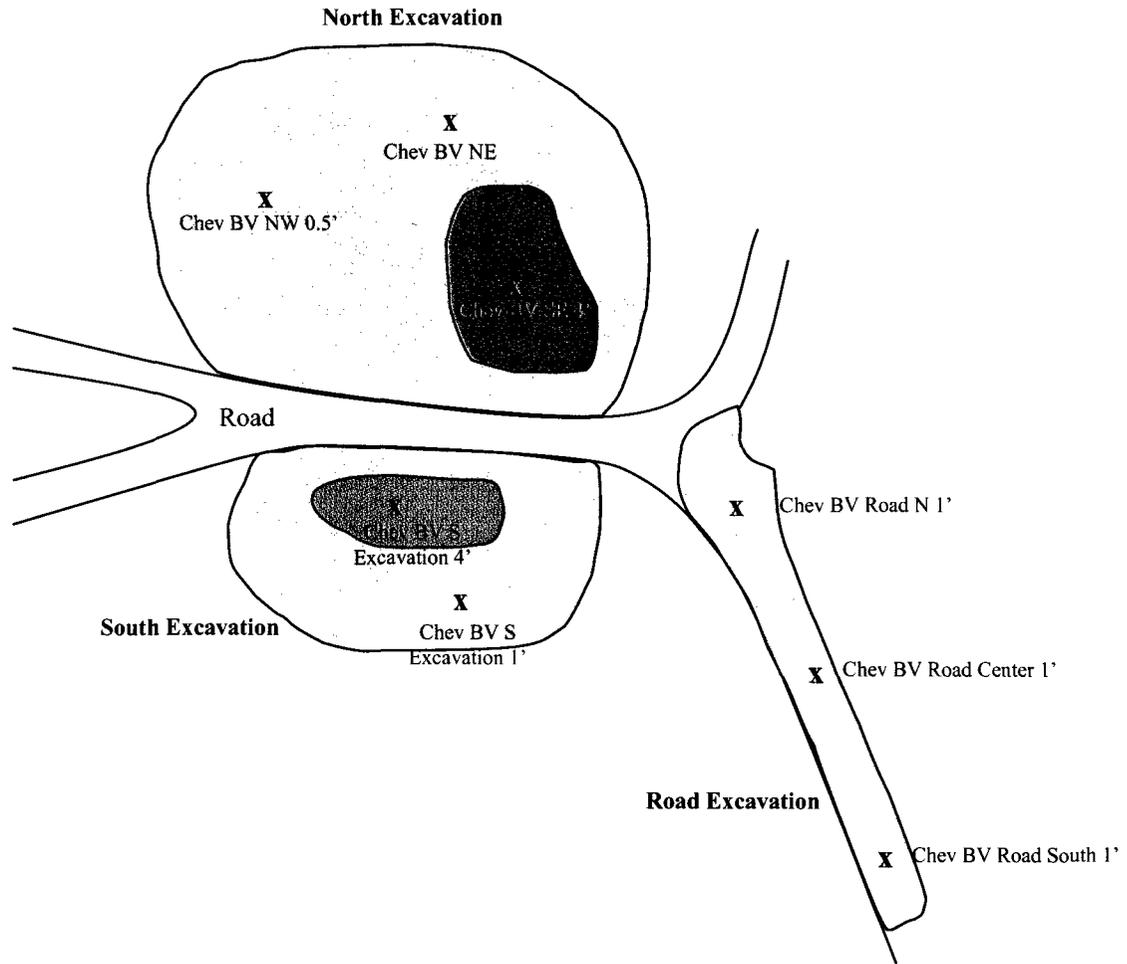
On December 27, 2006, BBC collected a total of eight (8) samples from the site. Three (3) of the eight (8) samples were taken from the north excavation. The Chev BV NW 0.5' sample was collected from the northwest corner of the excavation at 0.5 feet below ground surface (bgs). The sample was non-detect for GRO, benzene, ethylbenzene, and total xylenes, and contained 91.6 ppm DRO, 16 ppm chloride, and 0.006 ppm toluene. The Chev BV NE sample was taken from the northeast corner of the site at 0.5 feet bgs. The sample was non-detect for GRO, DRO, benzene, ethylbenzene, and total xylenes and had 144 ppm chloride and 0.009 ppm toluene. The Chev BV SE 4' sample was taken from the southeast corner of the excavation at four (4) feet bgs. The sample was non-detect for GRO, DRO, and BTEX and contained less than 16 ppm chloride. Two (2) samples were taken from the south excavation. The Chev BV S Excavation 4' sample was taken from the north half of the excavation at four (4) feet bgs. The sample was non-detect for GRO, DRO, and BTEX and contained 304 ppm chloride. The Chev BV S Excavation 1' was taken from the south side of the excavation. The sample was non-detect for GRO and BTEX and contained 120 ppm DRO and less than 16 ppm chloride. Three (3) samples were collected from the road excavation. The Chev BV Road N 1' was taken from the north end of the excavation at one (1) foot bgs. The sample was non-detect for GRO and BTEX and contained 305 ppm DRO and 48 ppm chloride. The Chev BV Road Center 1' was taken from the center of the excavation at one (1) foot bgs. The sample was non-detect for GRO, benzene, ethylbenzene, and total xylenes and contained 224 ppm DRO, less than 16 ppm chloride, and 0.005 ppm toluene. The Chev BV Road South 1' was taken from the south end of the excavation at one (1) foot bgs. The sample was non-detect for GRO and BTEX and contained 33.0 ppm DRO and 16 ppm chlorides.

Sampling Event December 27, 2006

The north half of the south excavation was deepened from four (4) feet bgs to six (6) feet bgs. Field screens were performed to confirm that remaining chloride was reduced from 304 ppm to less than 250 ppm. The north and center parts of the road excavation were further graded to remove excess hydrocarbon content from the surface.

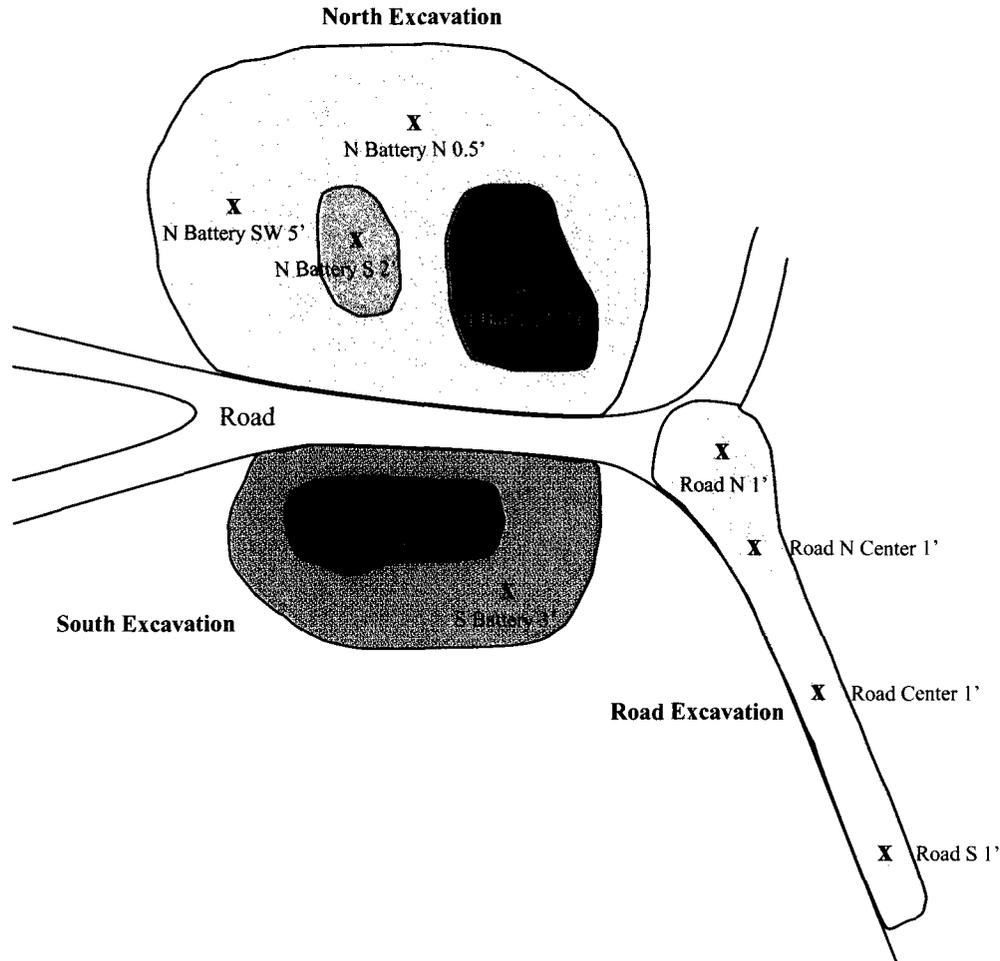
On January 17, 2007, Hess notified NMOCD of closing samples to be collected on January 19, 2007. Ten (10) closing samples were collected on January 22, 2006 due to inclement weather conditions. Four (4) samples were taken from the north excavation, two (2) samples were taken from the south excavation, and four (4) samples were taken from the road excavation. All samples were non-detect for GRO and BTEX, ranged from non-detect to 26.4 ppm DRO, and contained less than 16 ppm to 32 ppm chloride.

Sampling Event January 22, 2007

Backfilling and contouring of the site was completed on February 7, 2007 with a total of 4,620 cubic yards of clean soil. The excavation was backfilled with 1,824 cubic yards of caliche to three (3) feet bgs. The remaining volume was completed with 2,796 cubic yards of topsoil and contoured to grade. The site will be reseeded in the spring of 2007.

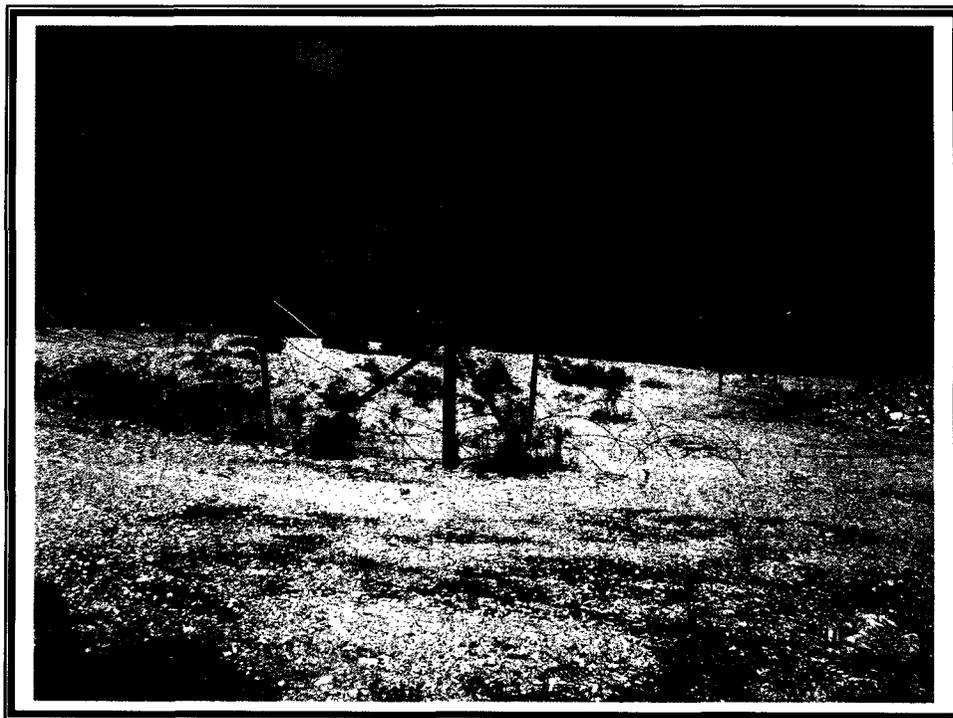
Southeastern corner of north battery site and a portion of the road

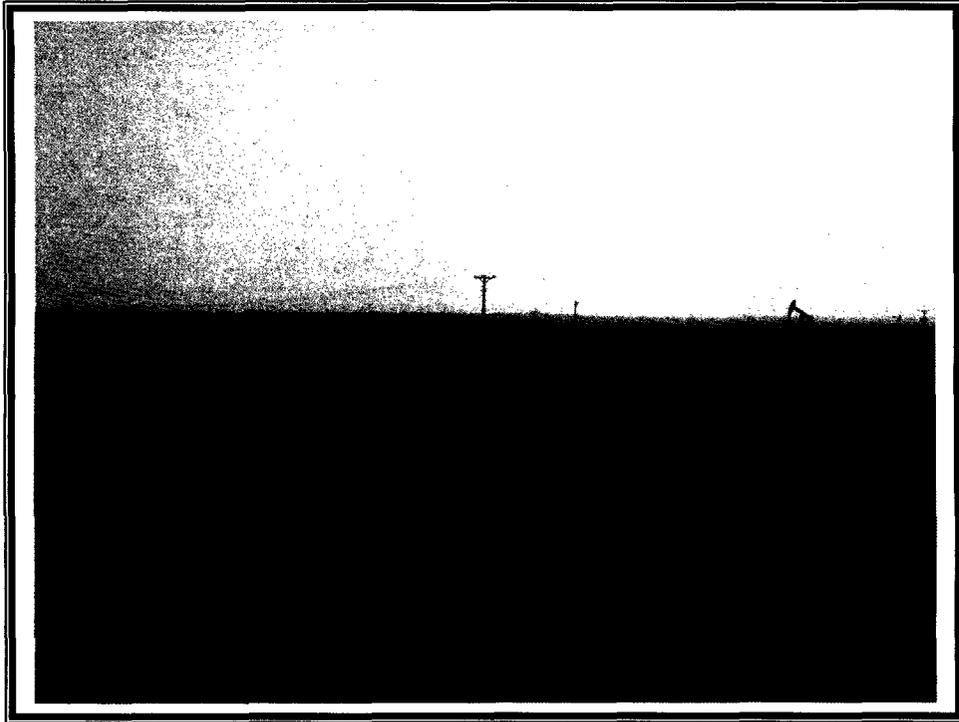
South battery area after backfill and installation of road
