# REMEDIATION PROPOSAL

**G-28-14 EXT. 3**

**NMOCD 1RP#1029**

**Duke Energy  
Field Services**

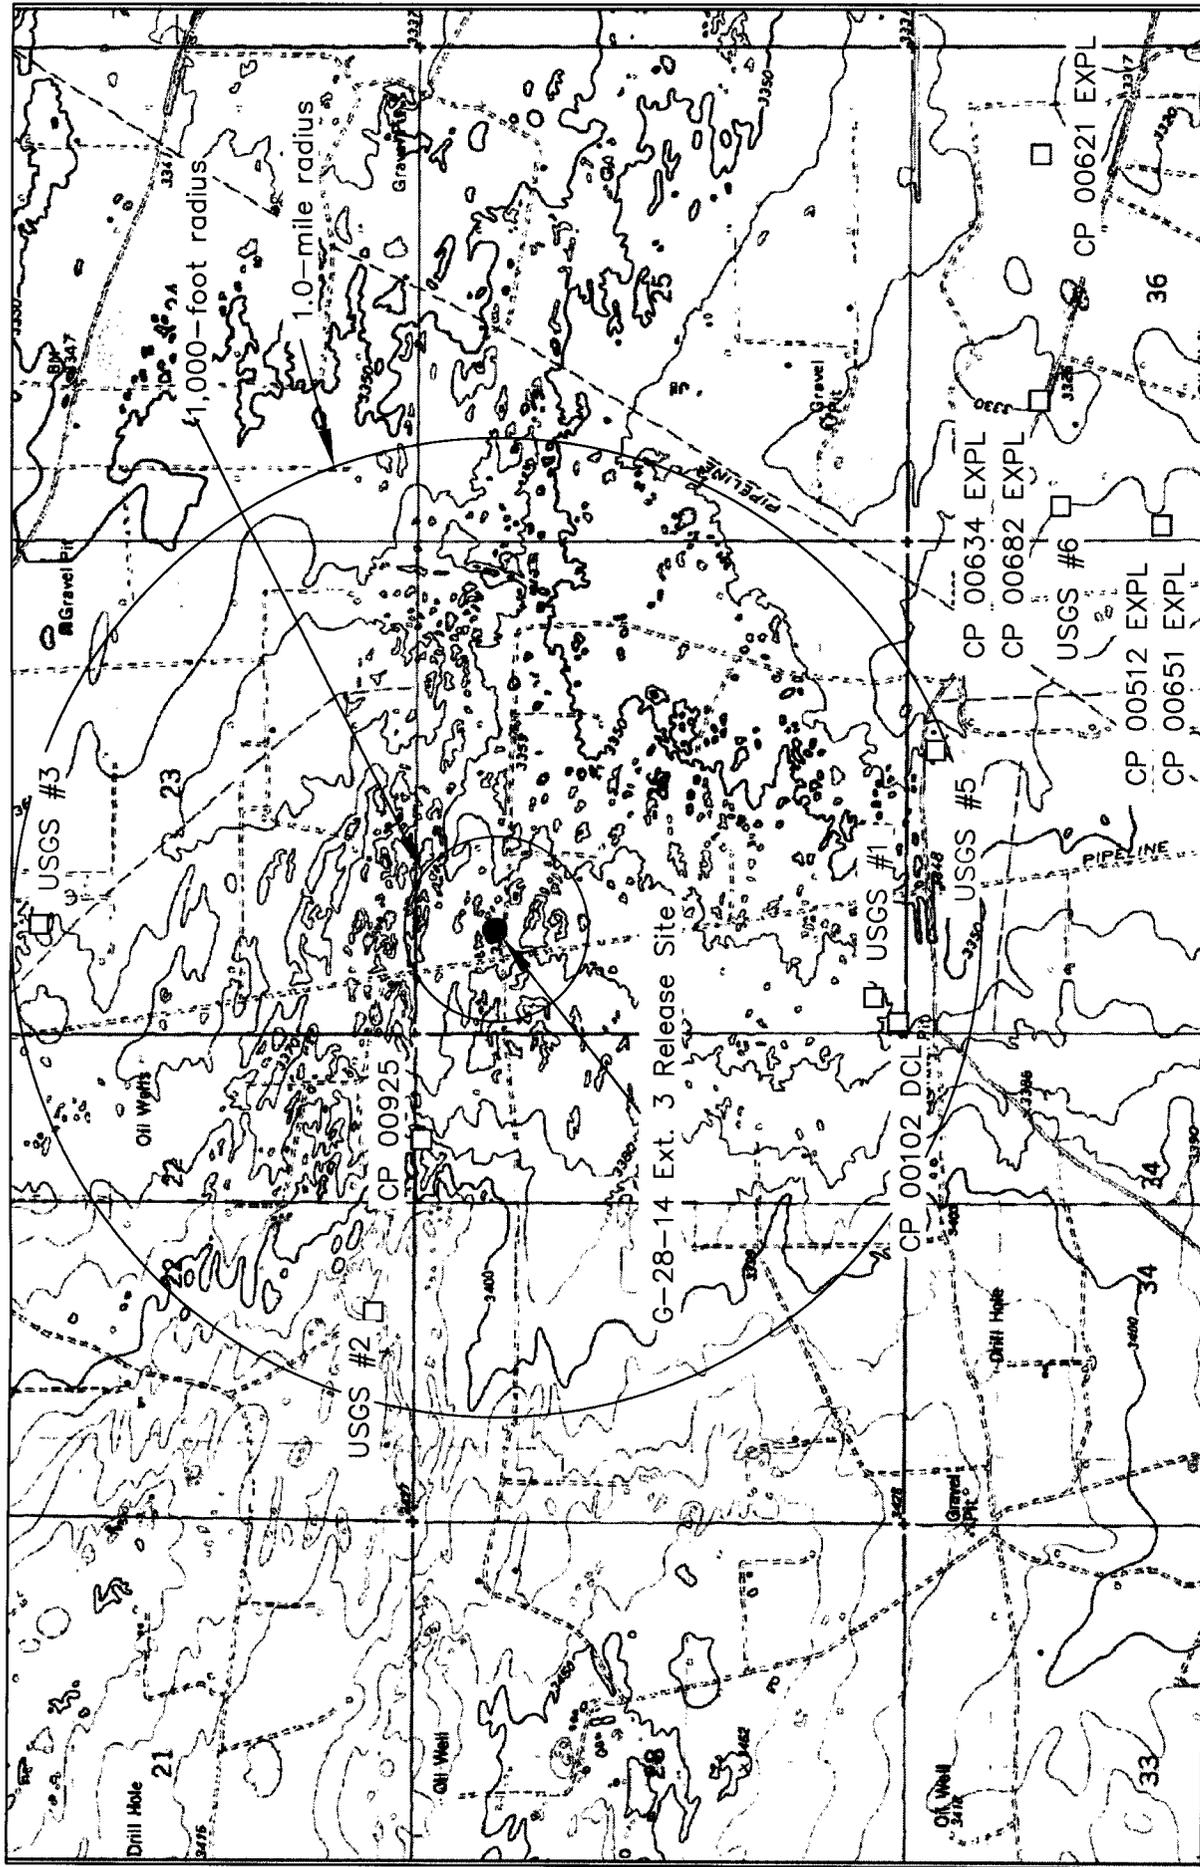
Figure 2  
 Site and Well Location Map  
 Duke Energy Field Services  
 G-28-14 Ext. 3

There are no wells within a 1,000-foot radius of the site (reference *Table 1* and *Figure 2*).

There are no surface water features within a 1,000-foot radius of the site (reference *Figure 2*).

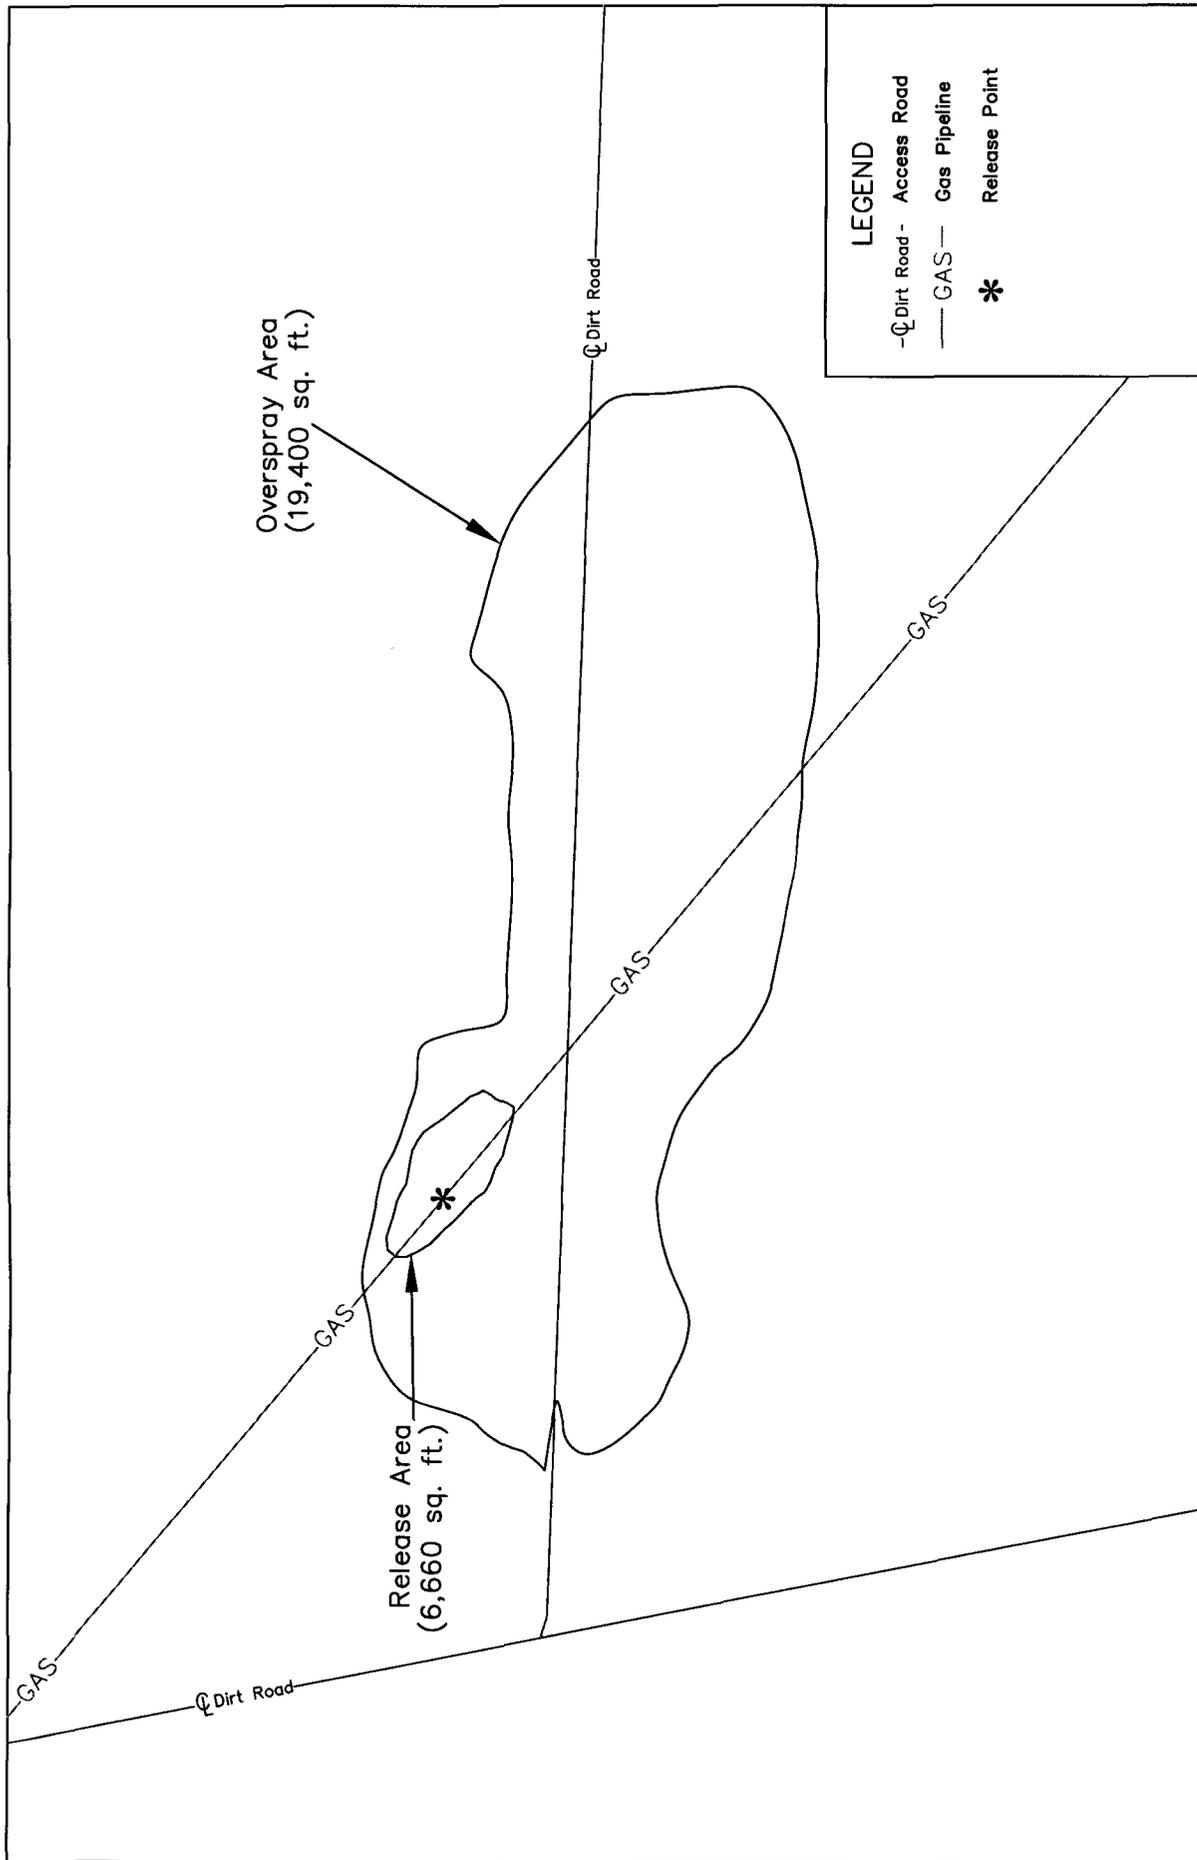
Figure 3  
Site Map  
Duke Energy Field Services  
G-28-14 Ext. 3

Soil impacted by the NGL release remains *in situ* (reference *Figure 3*).

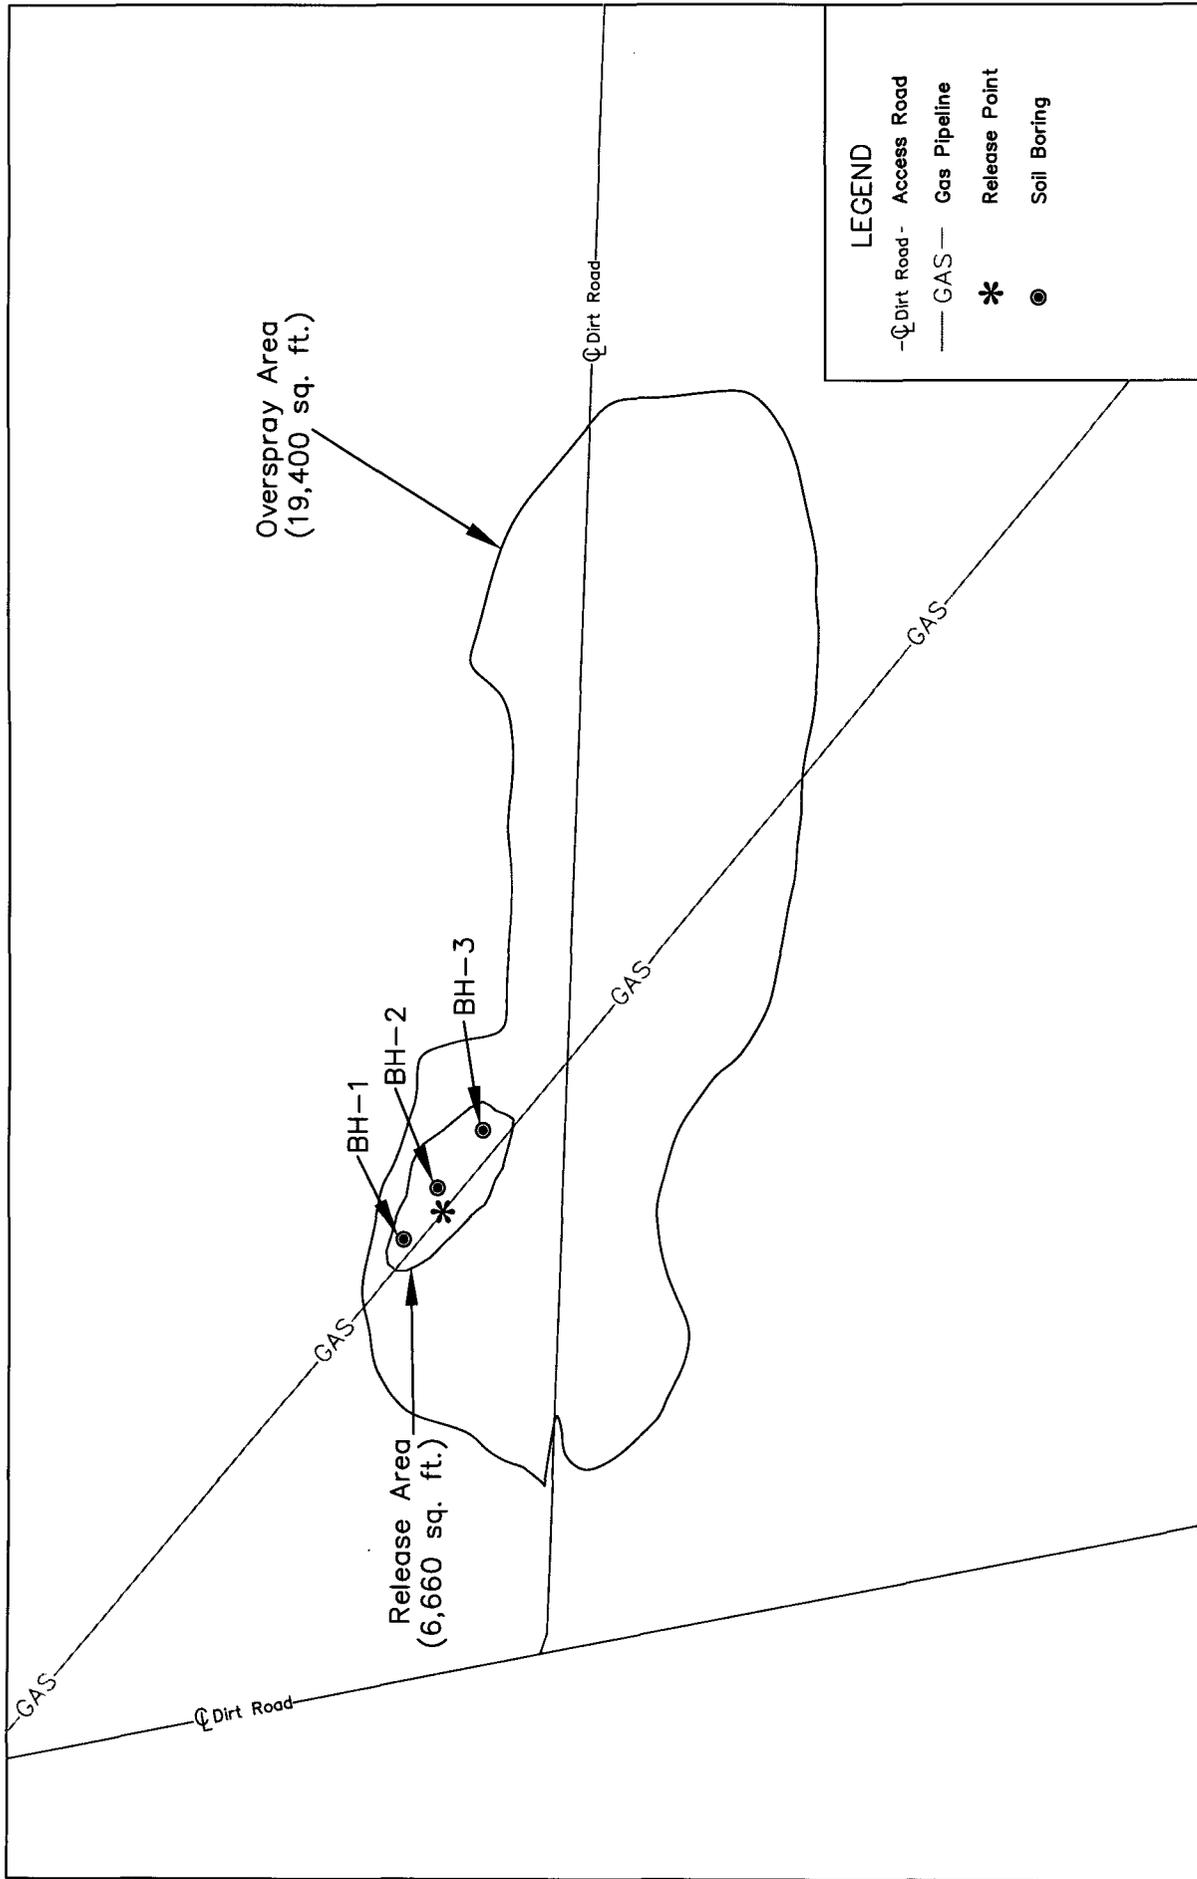
Figure 4  
Soil Boring Location Map  
Duke Energy Field Services  
G-28-14 Ext. 3

On August 1, 2005, a series of three soil borings (BH-1, BH-2 and BH-3) were advanced within the release area. Soil boring BH-1 was advanced to approximately 20-feet bgs north of the point of release. Soil boring BH-2 was advanced to approximately 15-feet bgs adjacent to the point of release. Soil boring BH-3 was advanced to approximately 15-feet bgs south of the point of release. Soil samples were collected from the soil borings initially at 5-foot bgs and then 5-foot intervals thereafter. Soil boring locations within the release area were chosen to provide the best representative sample to delineate the vertical extent of hydrocarbon impacted soil, if any (reference *Figure 4*).

Laboratory analyses of the soil samples collected on August 1, 2005 from soil borings BH-1, BH-2 and BH-3 indicated TPH and BTEX constituent concentrations were non-detectable at or above laboratory method detection limits. The exception was soil sample BH-2 (10') which indicated BTEX constituent concentrations were 0.0575 mg/Kg, below the NMOCD remedial threshold of 50 mg/Kg. Chloride concentrations ranged from 17.5 to 83.4 mg/Kg (reference *Table 2* and *Figure 4*).

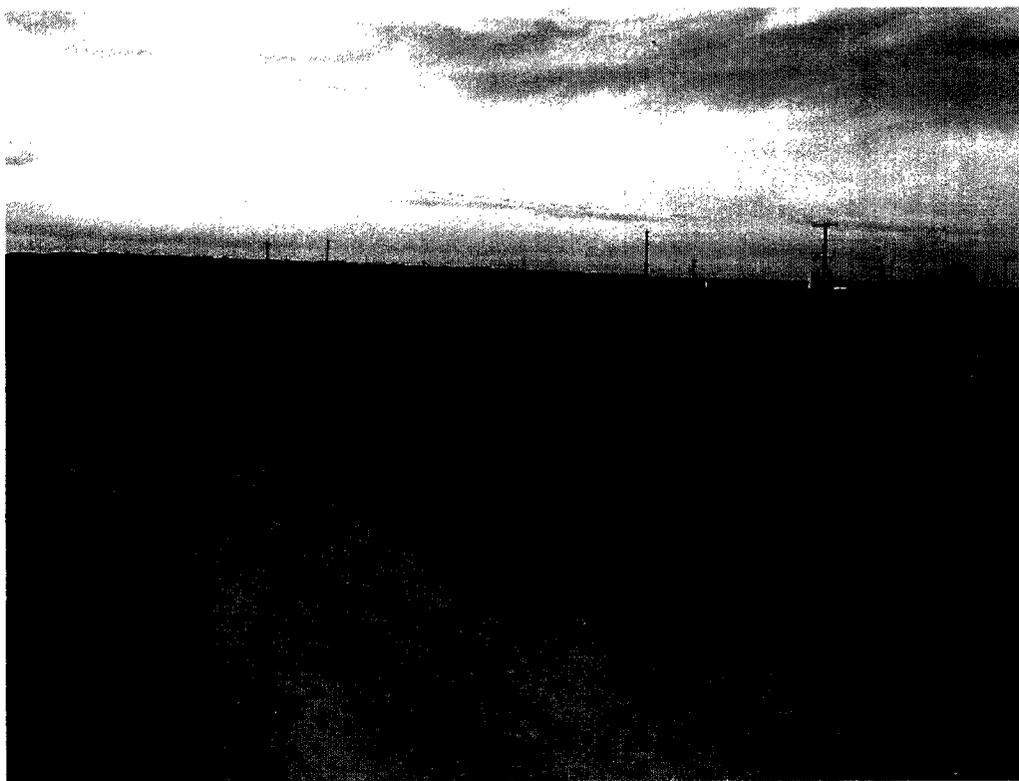
*Photo #1:* Looking westerly at overspray and release area. Dark stained soil indicates NGL contamination.

- 1) Excavate stained soil within the initial release area to approximately 5-feet bgs;
- 2) Collect soil samples from the excavation floor and sidewalls to verify NMOCD remedial thresholds achieved; and
- 3) Transport impacted soil to the Environmental Plus, Inc. Landfarm for treatment; and
- 4) Backfill excavation with clean native soil; and
- 5) Seed the area with a blend approved by the landowner.

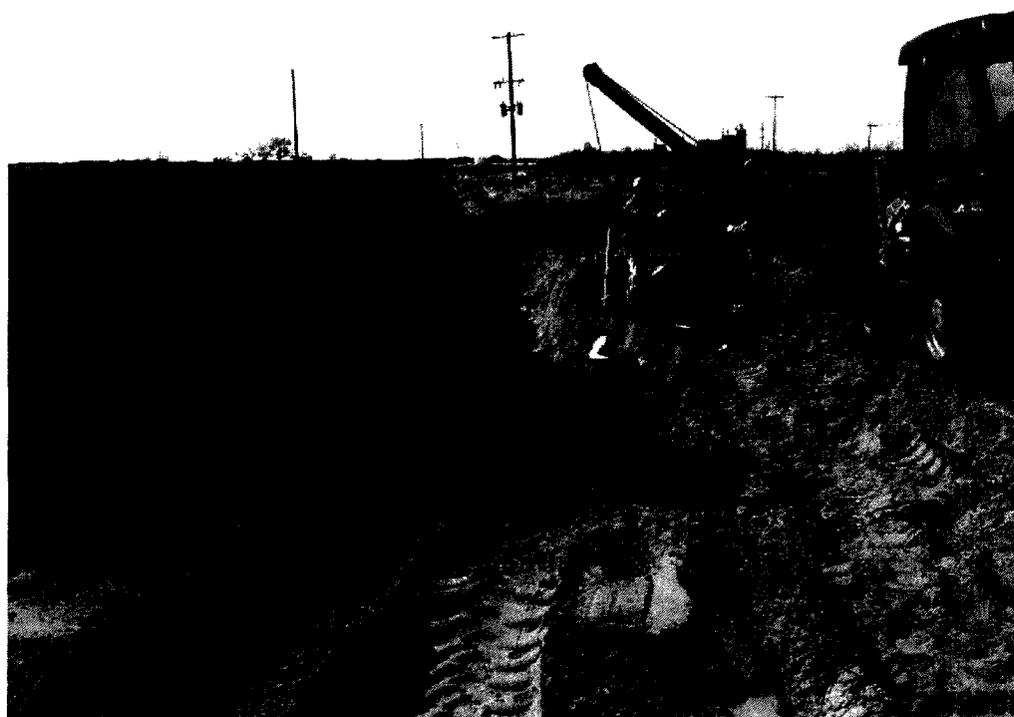
Weld failure on 6-inch Marlex natural gas pipeline.

*Photo #2:* Looking northwesterly at point of release, failed section of line is being replaced.

**Describe Cause of Problem and Remedial Action Taken.\***  
6" Marlex line began leaking, due to a weld failure. A line clamp was installed and the section replaced.

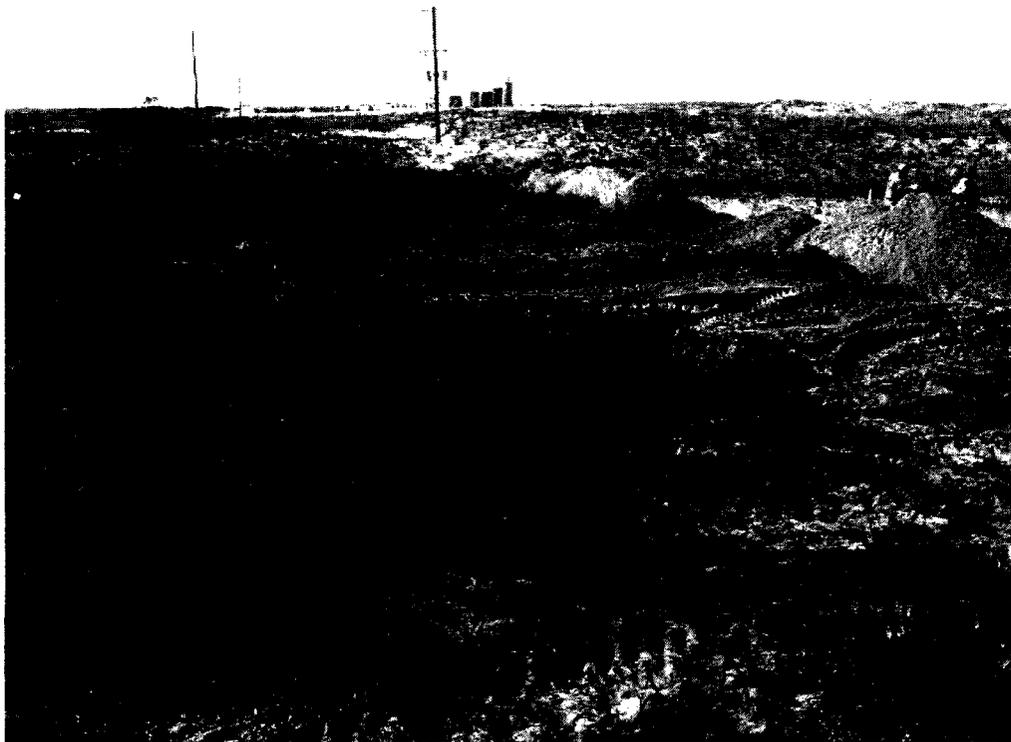
*Photo #3:* Looking northwesterly at overspray and release area.
