RE: **ENV – STUDIES, SURVEYS & REPORTS**  
Site Remediation  
NMGSAU Battery No. 85  
Closure Report

# **CLOSURE REPORT**

**NORTH MONUMENT GRAYBURG SAN ANDRES UNIT  
ABANDONED BATTERY SITE NO. 85  
AHC HUMBLE LAUGHLIN 2 & 3**

**NW ¼, SE ¼, SECTION 4, TOWNSHIP 20 SOUTH, RANGE 37 EAST  
LEA COUNTY, NEW MEXICO**

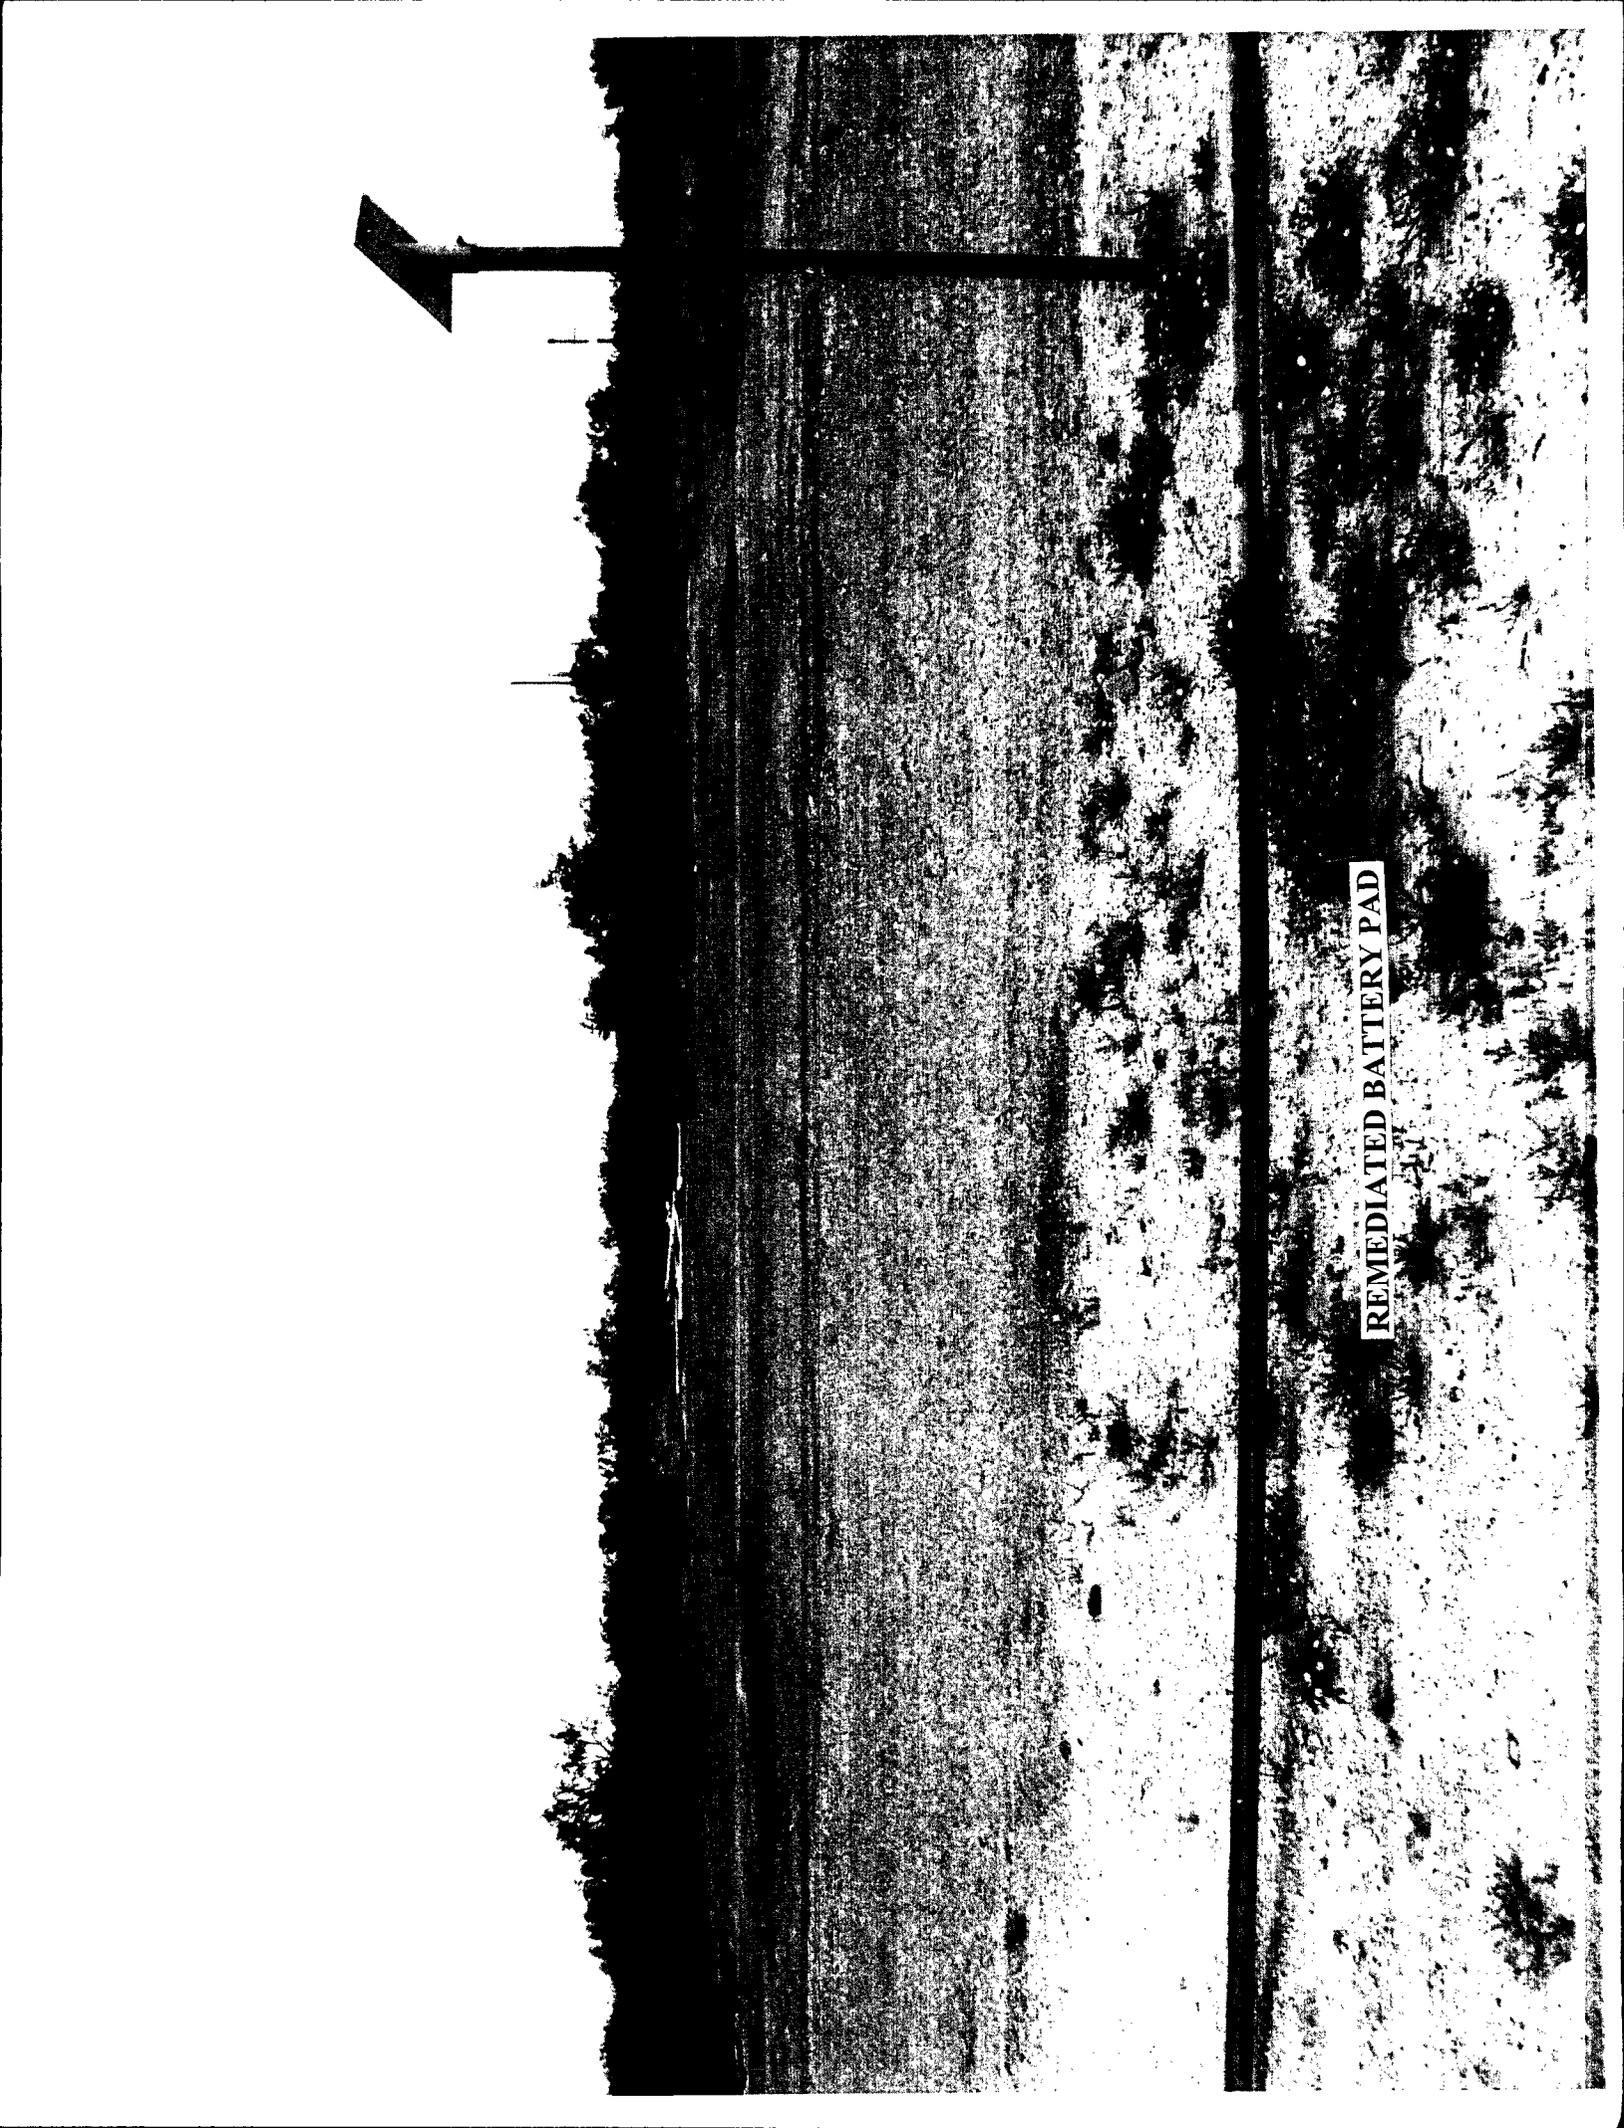
REMEDIATED BATTERY PAD

Surface material from the battery pad area was removed to a depth of approximately one foot below grade. A composite sample collected from the pad area indicated a DRO concentration slightly above the OCD guideline threshold; all other hydrocarbon and chloride concentrations were below the guidelines. The surface material was blended with clean material acquired from the landowner and was used to fill the pit excavation. Clean material was then applied to the entire site. The site was seeded with native vegetation.

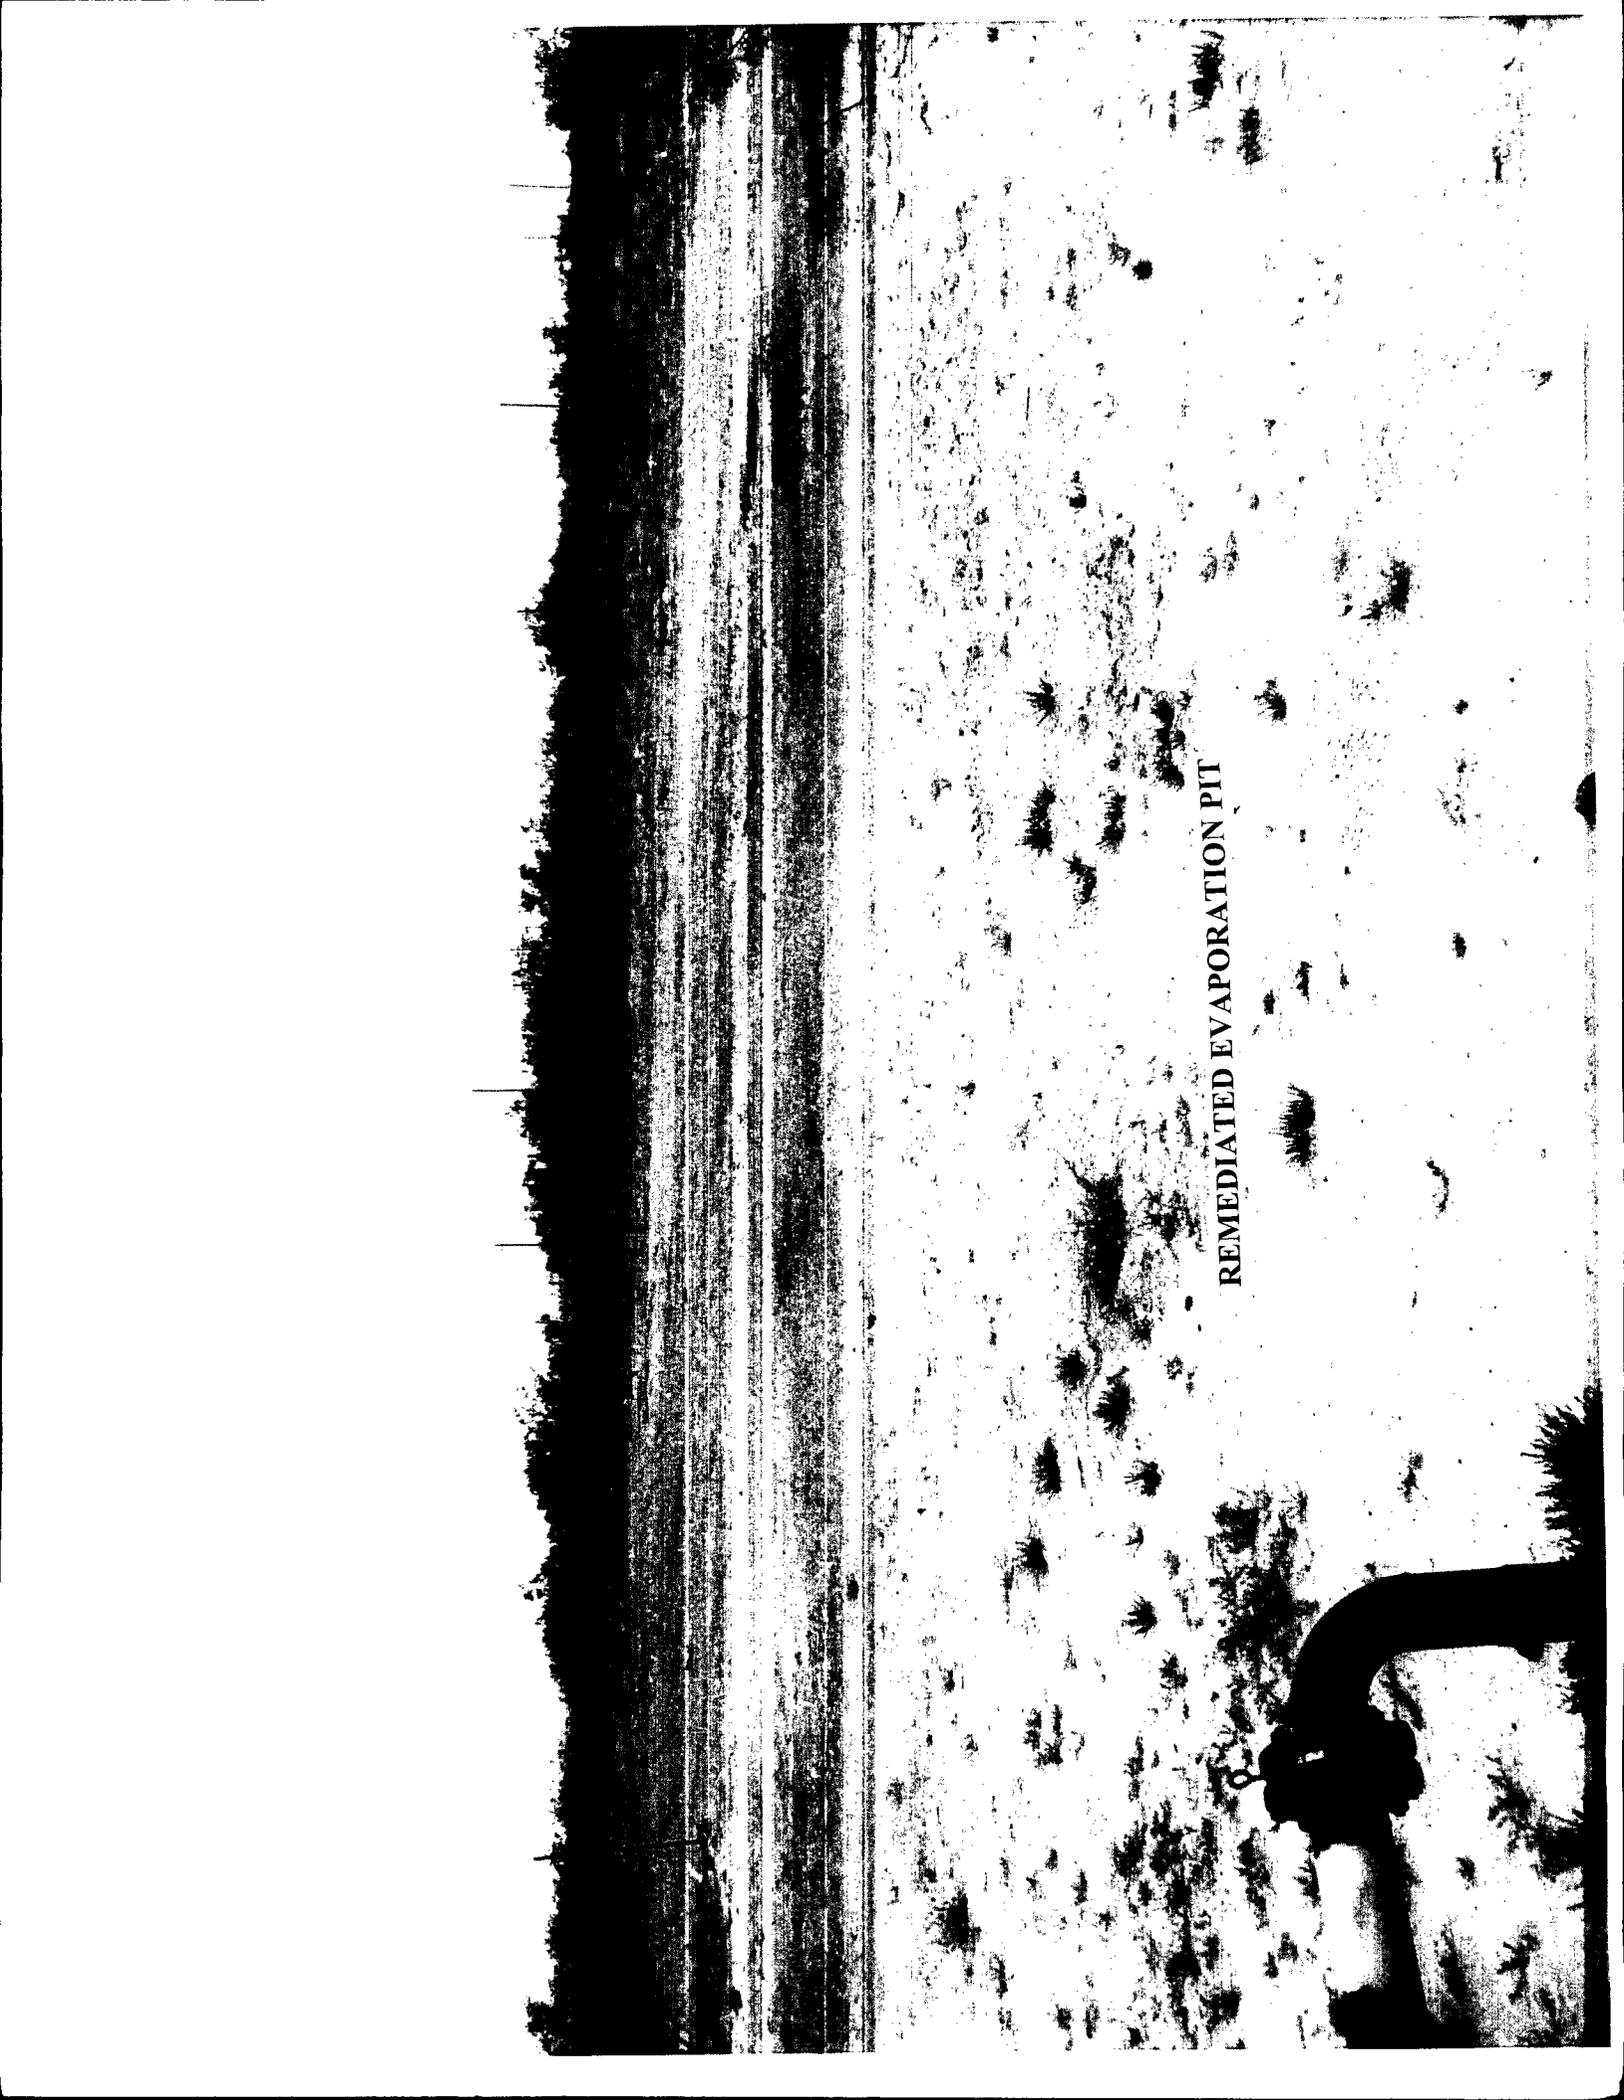
REMEDIATED EVAPORATION PIT

A composite sample of material from the pit area, collected off the bottom of the excavation at a maximum depth of 3 feet, was analyzed for hydrocarbon and chloride impacts. The analyses indicated that the hydrocarbon and chloride concentrations were below the OCD guideline thresholds.
