# CLOSURE REPORT

**CIGUENA STATE #1**

**EPI REF: #160048**

**NMOCD: 1RP#806**

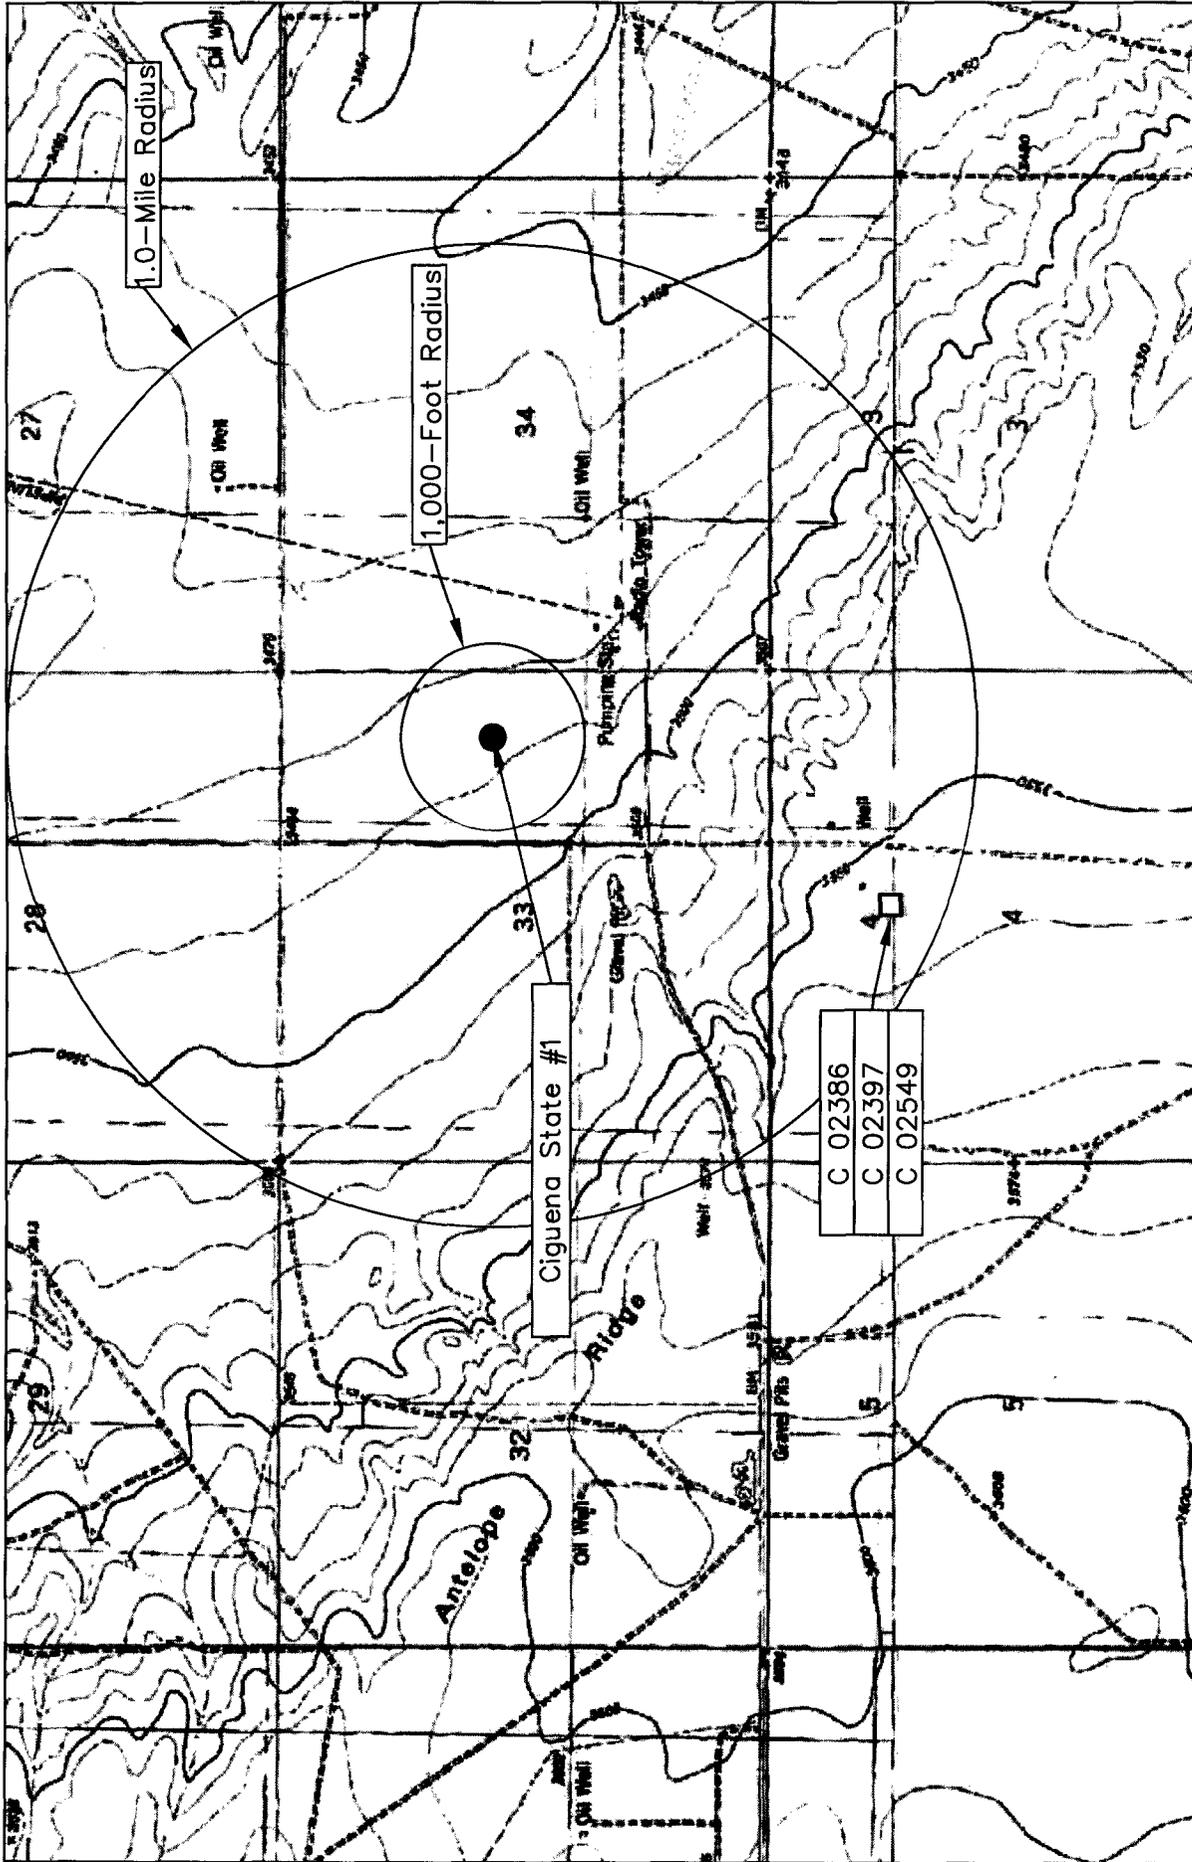
Figure 2  
 Site Location Map  
 Chesapeake Energy  
 Ciguena State #1

No water supply wells exist within 1,000 feet of the release site (reference *Figure 2* and *Table 1*)

No surface water features exist within 1,000 feet of the release site (reference *Figure 2*)

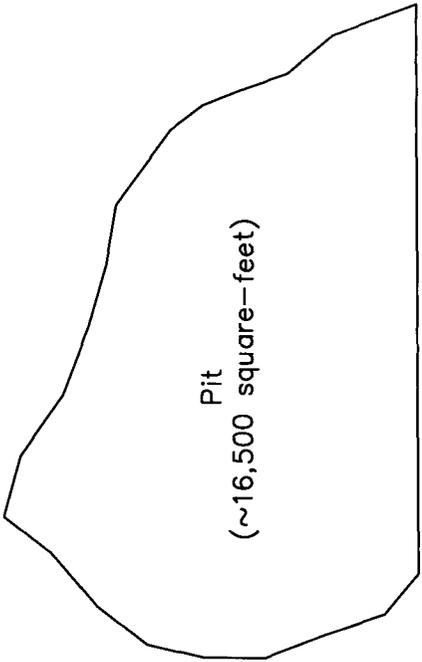
Figure 3  
Site Map  
Chesapeake Energy  
Ciguena State #1

Laboratory analytical data for the samples collected from SB-1, SB-2 and SB-3 indicated TPH constituent concentrations ranged from ND to 5,600 mg/Kg (SB-1, SB-2 and SB-3 @ 2-ft bgs). BTEX constituent concentrations ranged from ND to 0.0485 mg/Kg (SB-1, SB-2 and SB-3 @ 2-ft bgs). Chloride concentrations ranged from 58.4 mg/Kg to 4,360 mg/Kg (SB-3 @ 30-ft bgs and SB-2 @ 5-ft) and sulfate concentrations ranged from 34.3 mg/Kg to 1,040 mg/Kg (SB-1 @ 5-ft bgs and SB-3 @ 5-ft) (reference *Table 2* and *Figure 3*).

Laboratory analytical data for the soil samples collected May 15 through May 30, 2006 indicated TPH and BTEX constituent concentrations were ND at or above laboratory analytical Method Detection Limits (MDL). Chloride concentrations ranged from ND to 25,000 mg/Kg (E1 BH-4 @ 6-ft bgs and EW SW-4 @ 3-ft) Sulfate concentrations ranged from ND to 11,000 mg/Kg (E1 BH-9 @ 6-ft bgs and E2 BH-2 @ 4-ft) (reference *Table 2* and *Figure 3*).

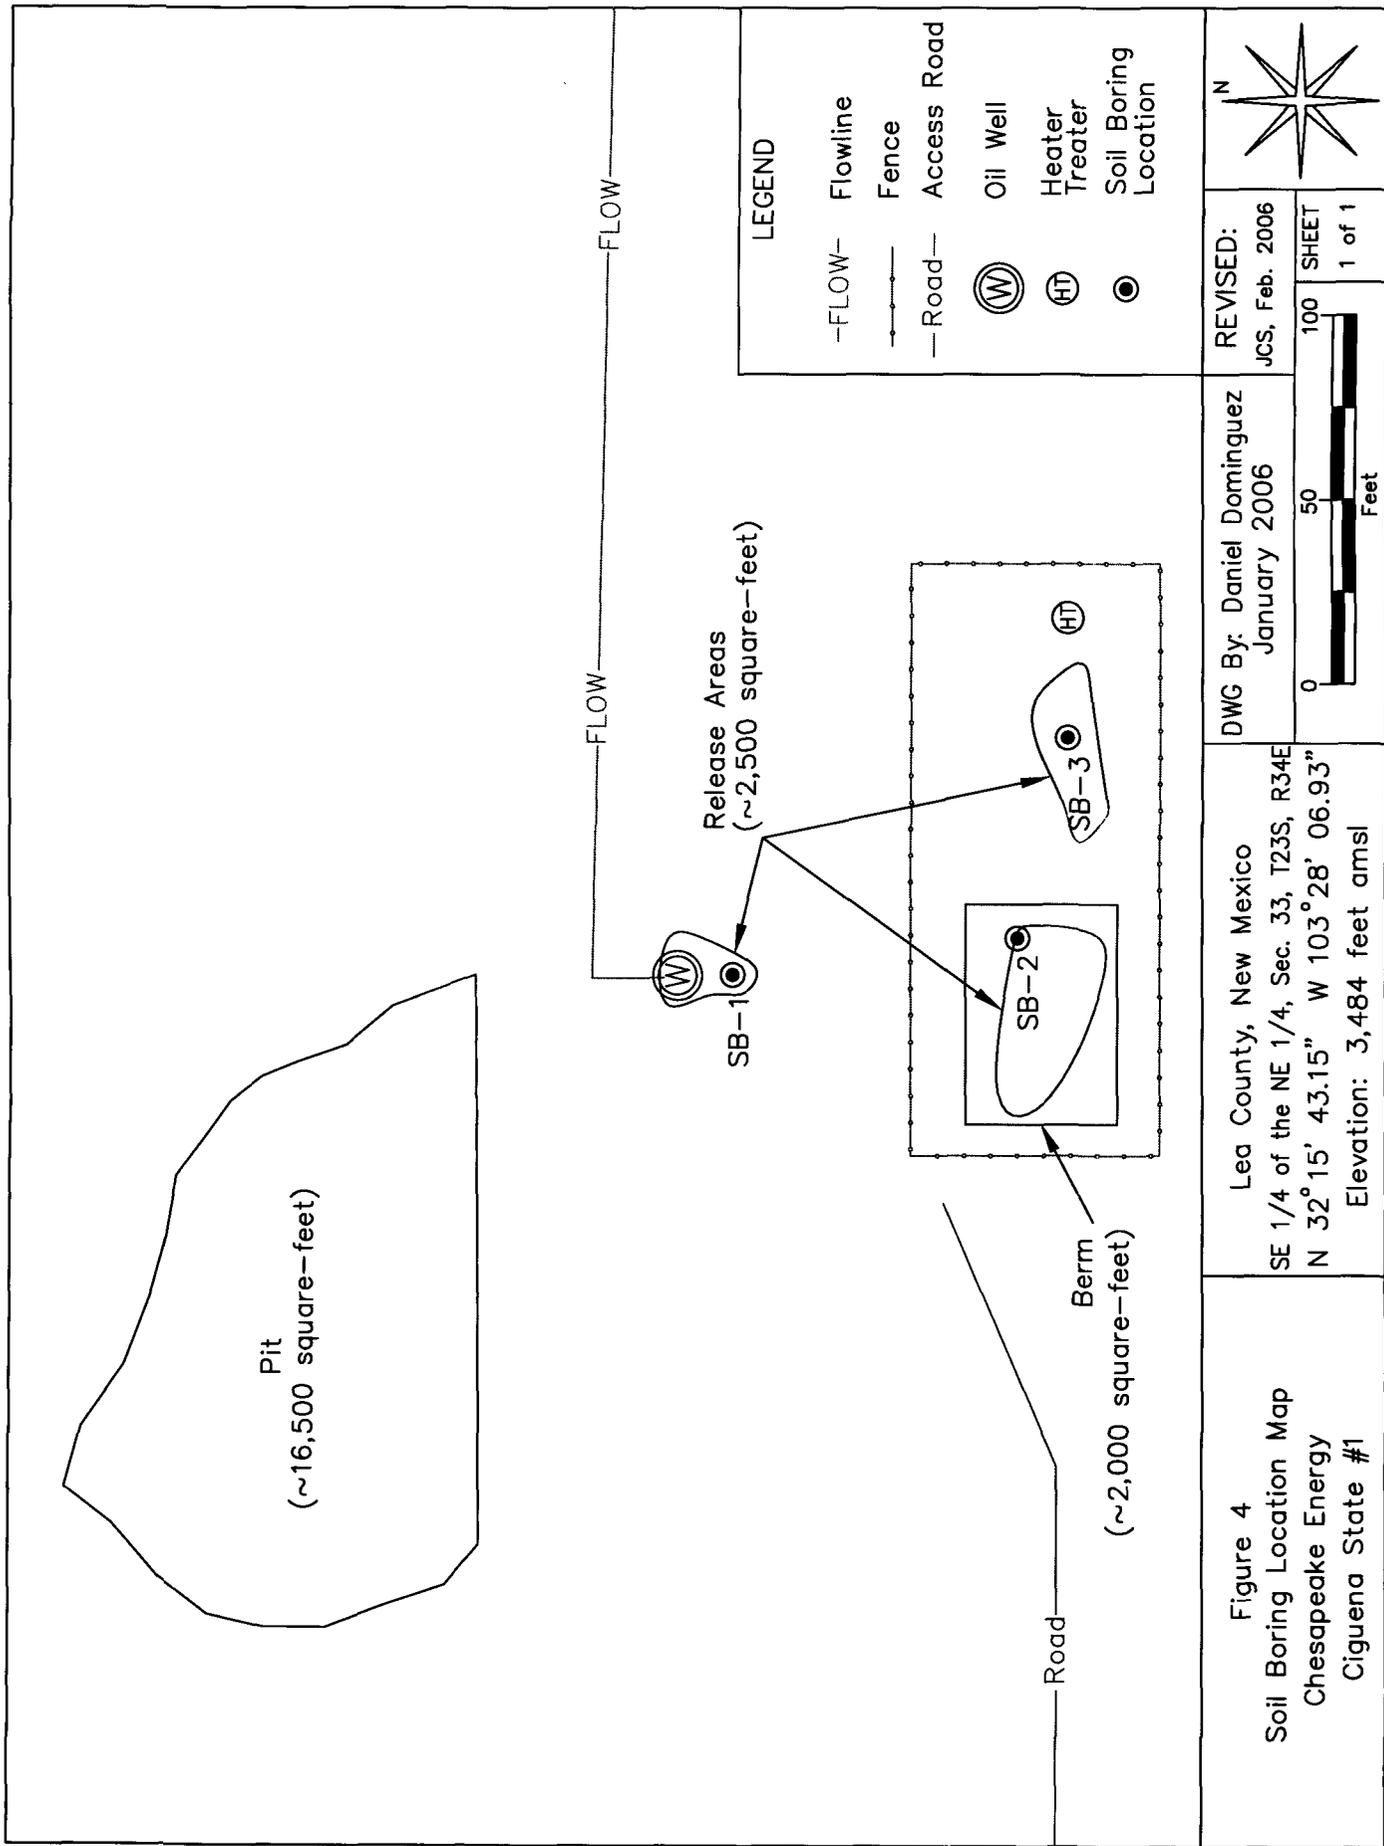
Figure 4  
Soil Boring Location Map  
Chesapeake Energy  
Ciguena State #1

Three (3) soil borings were advanced from original ground surface on the release areas on January 30, 2006 and field analyzed for chloride concentrations. Locales for soil borings (SB-1, SB-2 and SB-3) were selected to determine the vertical extent of contamination. SB-1 was advanced to a depth of fifteen (15) feet bgs as field analysis indicated elevated chloride concentrations to five (5) feet bgs; SB-2 was advanced to a depth of thirty-five (35) feet bgs as field analysis indicated elevated chloride concentrations to twenty-five (25) feet bgs; SB-3 was advanced to a depth of forty-five (45) feet bgs as field analysis indicated elevated chloride concentrations to thirty-five (35) feet bgs. Chloride concentrations ranged from 58.4 mg/Kg (SB-3 @ 30') to 4,360 mg/Kg (SB-2 @ 5') (reference *Figure 4* and *Table 2*).

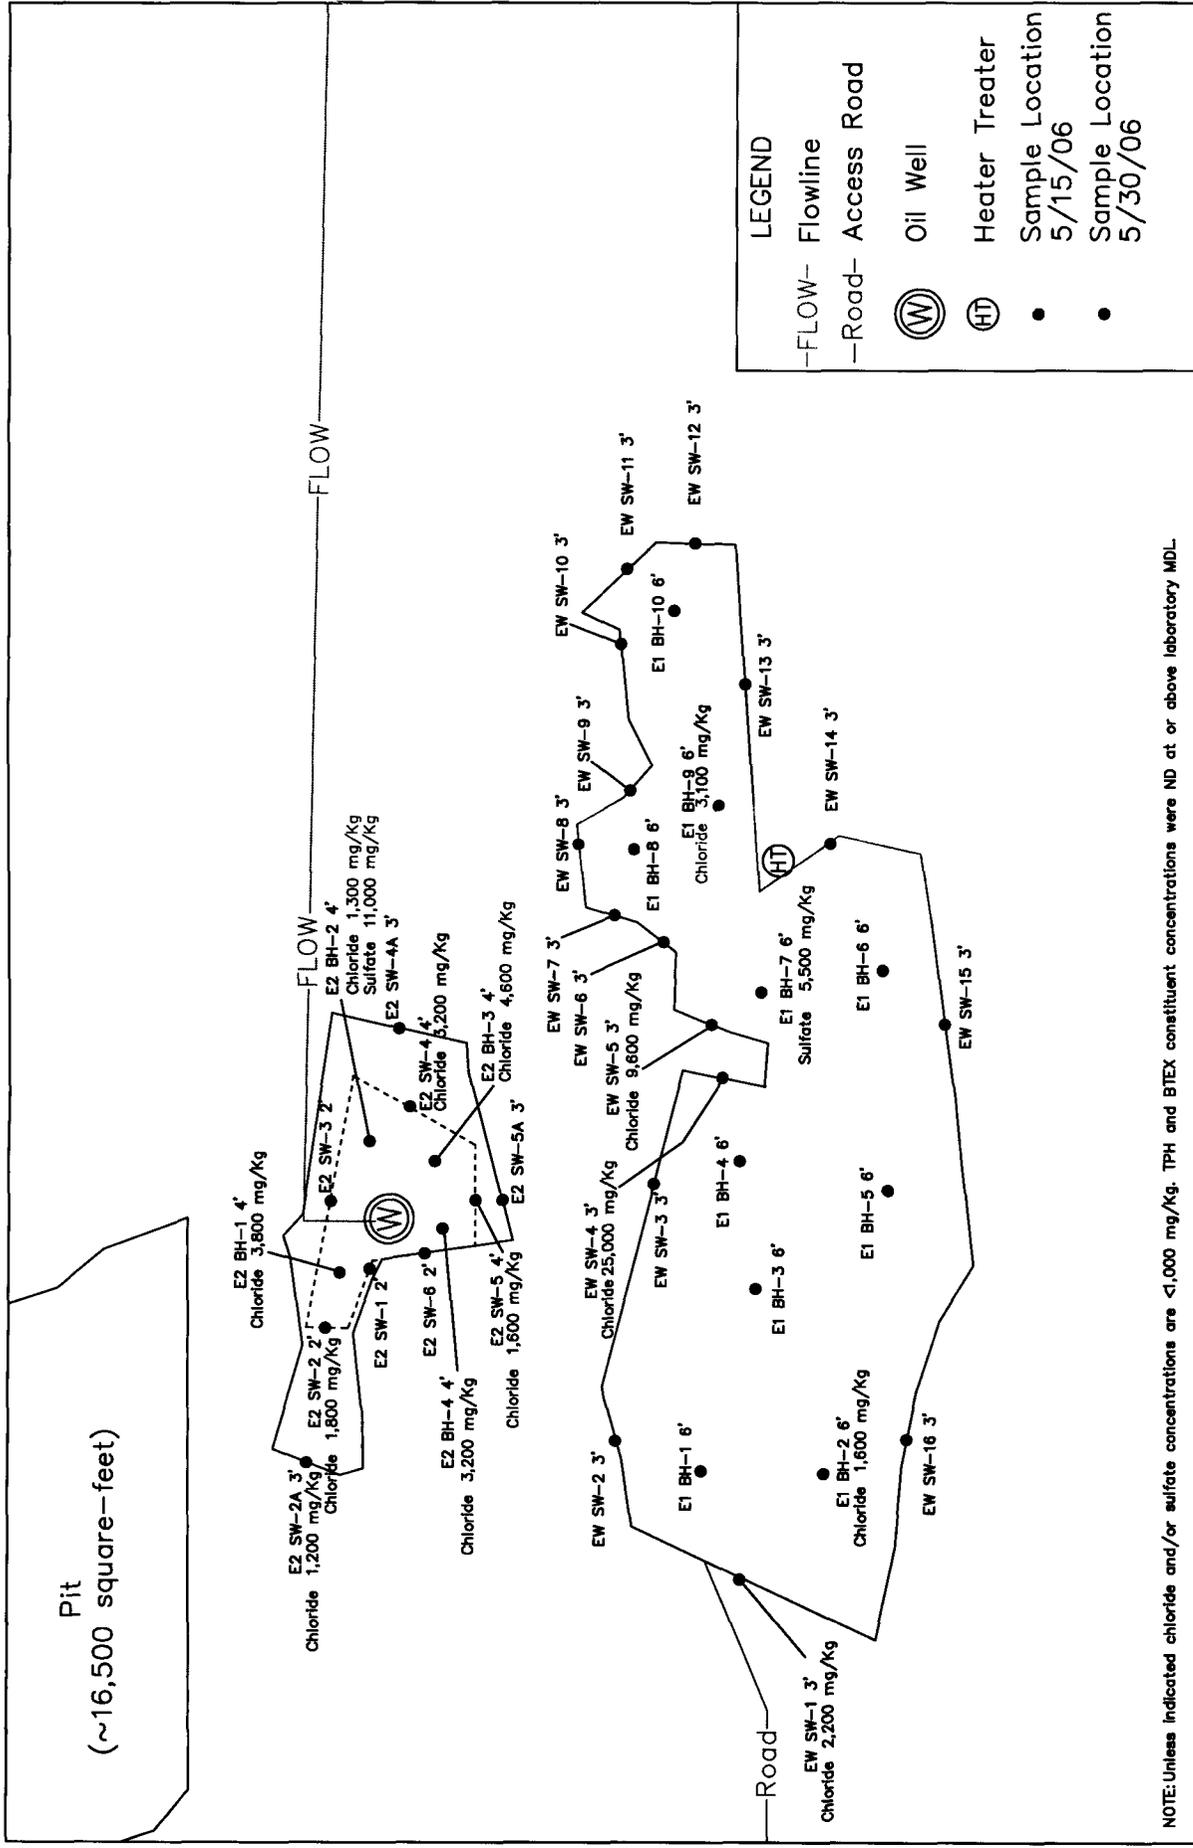
Figure 5

On May 15, through May 30, 2006 forty (40) soil samples were collected during excavation activities from the release area bottom and sidewalls (reference *Figure 5* for location). Soil samples were collected to determine extent of possible soil contamination remaining in situ. Soil samples were analyzed in the field for organic vapor and chloride concentrations utilizing analytical procedures as previously discussed. Selected soil samples were submitted to an independent laboratory for quantification of BTEX constituents, TPH, chloride and sulfate concentrations (reference *Table 4*).

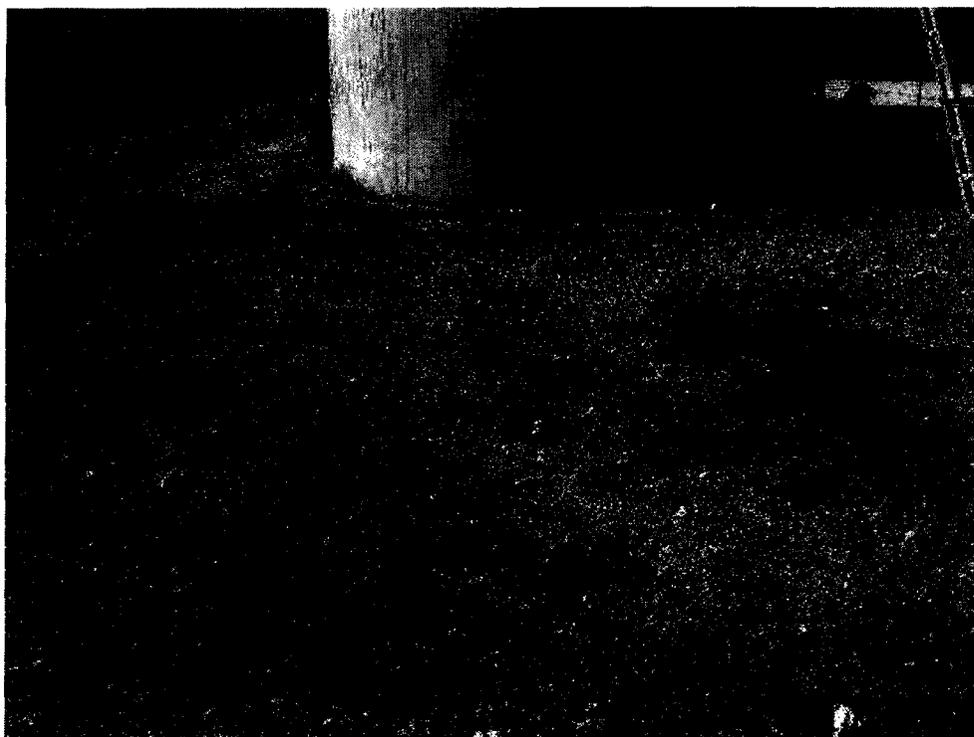
Photograph #2 - Looking southwesterly at the release area and tank battery with berm.

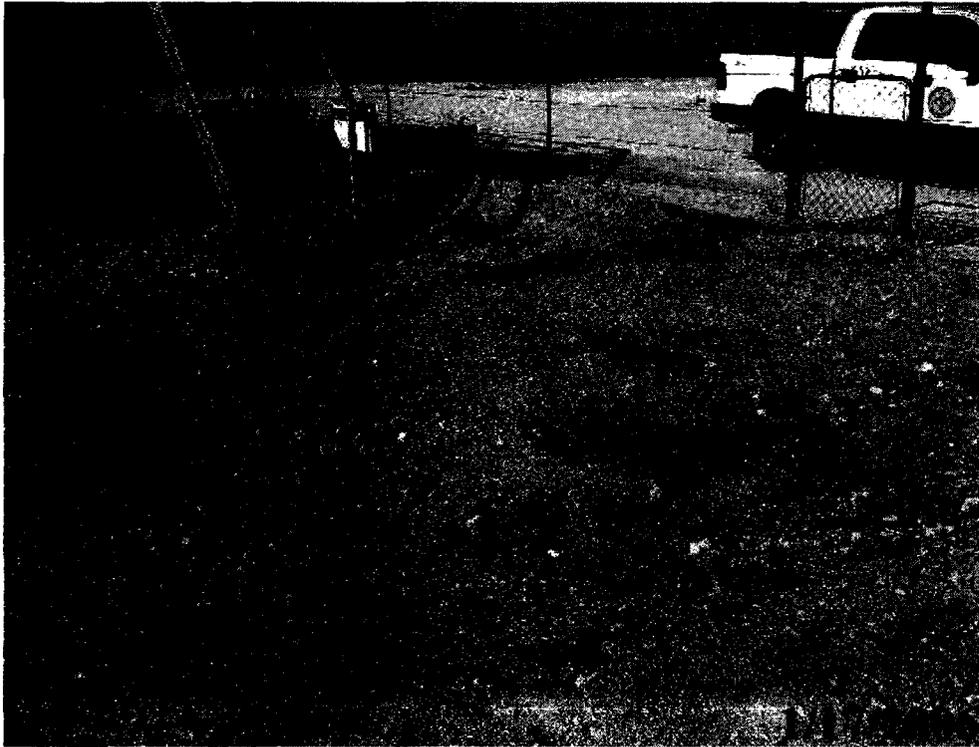
Photograph #3- Looking northwesterly at release area.

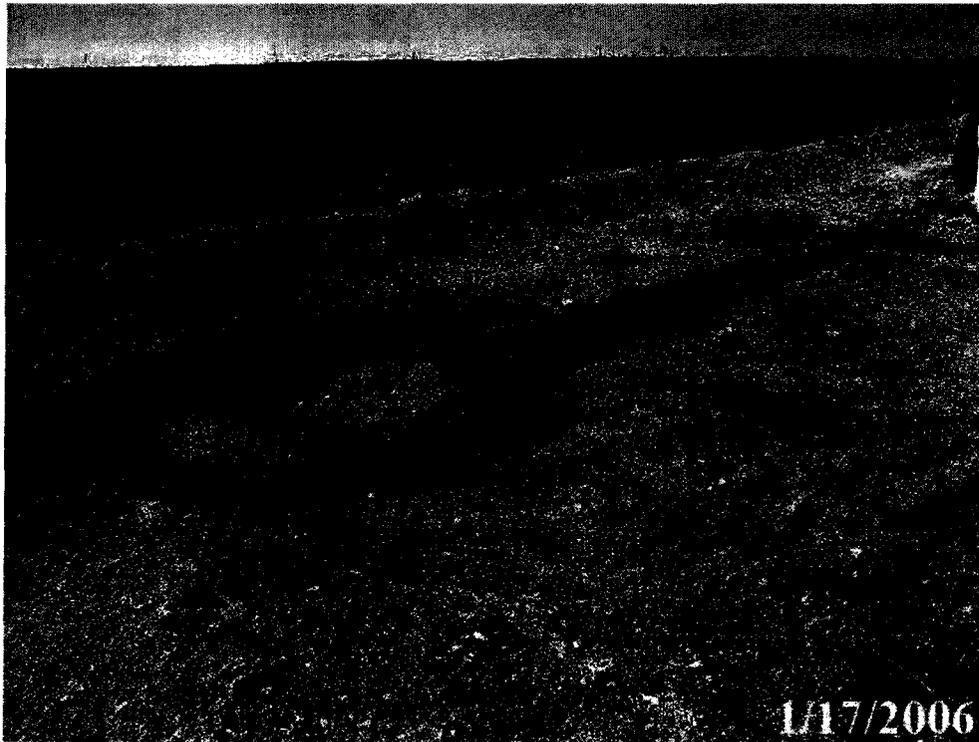
Photograph #4- Looking southwesterly at the release area and berm.

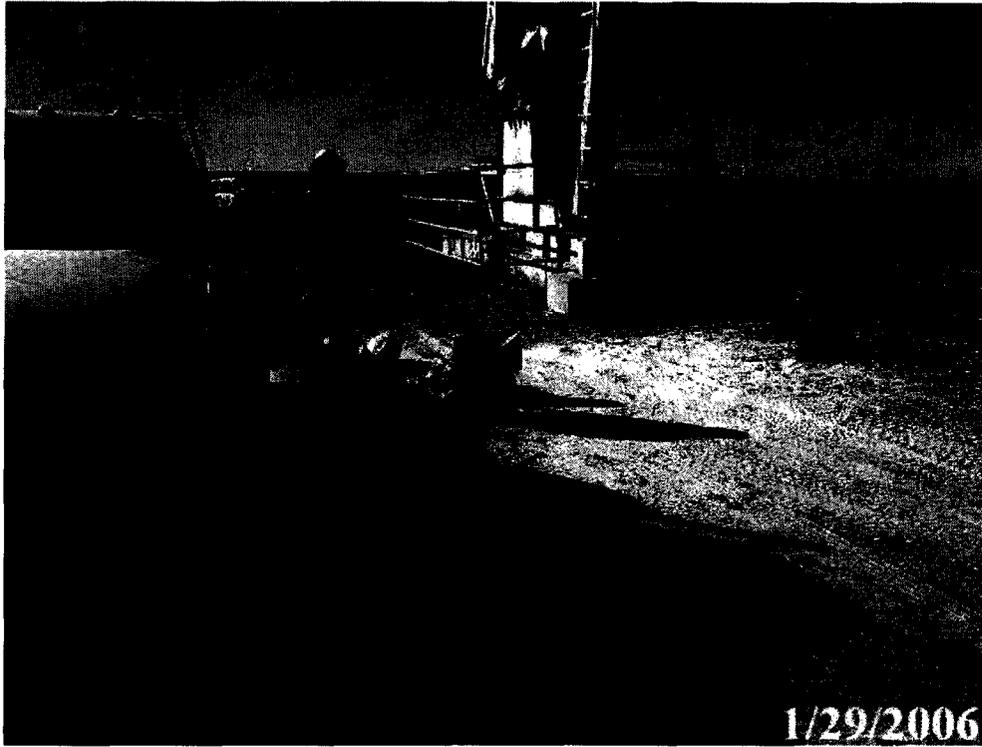
Photograph #5 – Soil boring #1

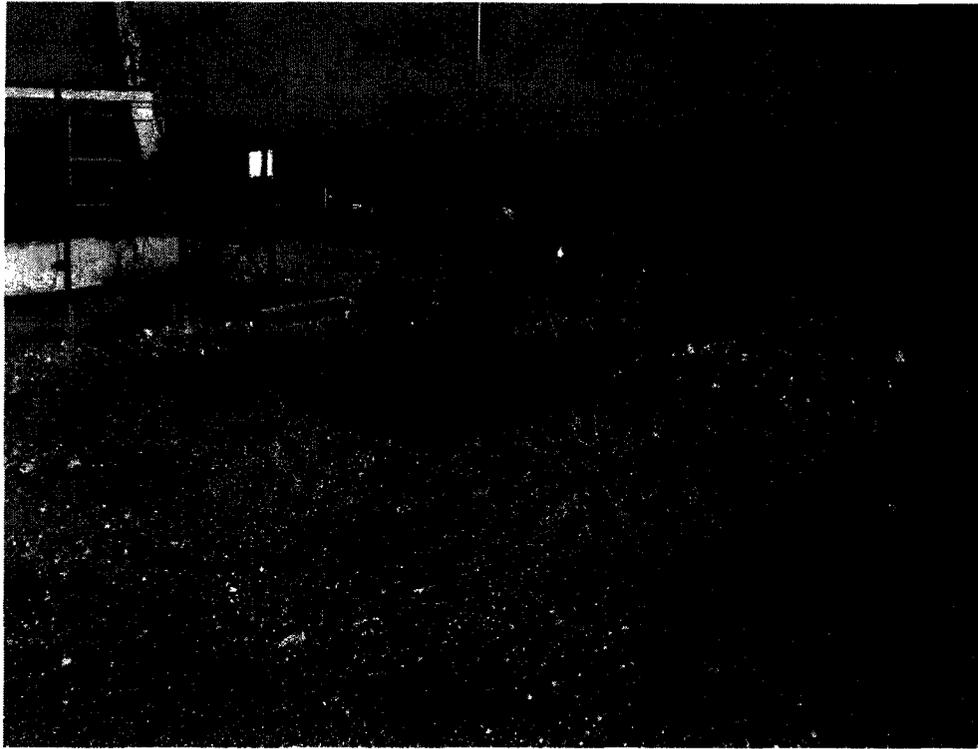
Photograph #15 – Remediated site.

From May 24 to June 12, 2006 EPI transported approximately 5,386 cubic yards of caliche plus 780 cubic yards of topsoil from local pits to the excavation site. This material was stockpiled on the job site in preparation for backfill operations. After cleaning and leveling the excavation bottom, EPI backfilled some areas with caliche to top of existing pad. Selected areas were backfilled with caliche to within two (2) feet of original ground. The remainder of the excavation was backfilled with clean top soil to original ground elevation. The entire area was contoured to allow natural drainage. Selected areas were seeded with a grass blend approved by the Bureau of Land Management.
