CLOSURE REPORT (FINAL)

C-23-10 LINE

SITES #1, 2, 3, 4, 5, 6, 7, 8, 9 AND 10

DCP Midstream, LLC – C-23-10 Line Sites #1, 2, 3, 4, 5, 6, 7, 8, 9 and 10

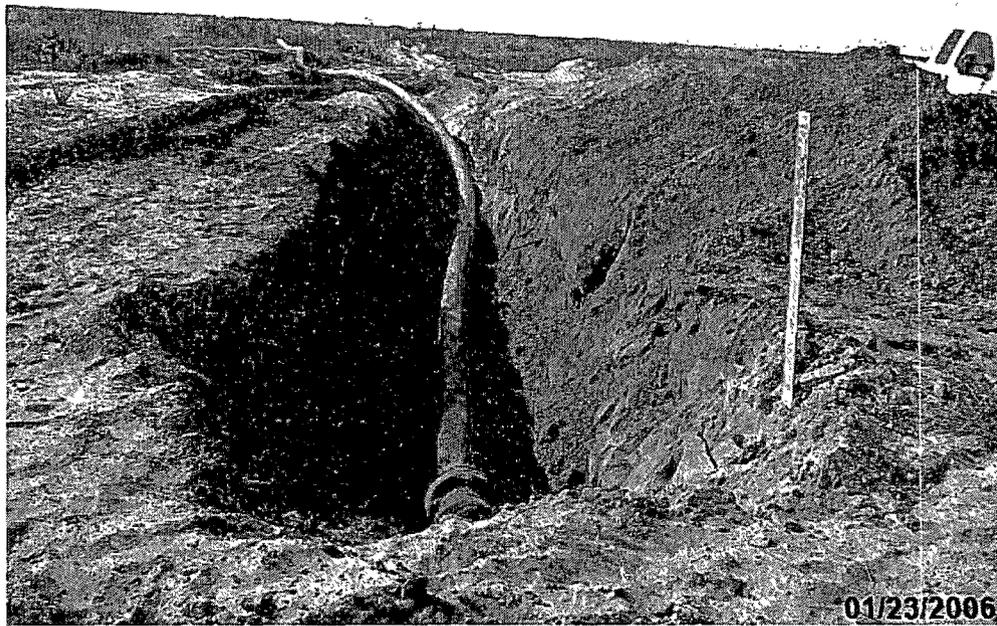
Photograph #1 – Looking west at Site #1 initial excavation activities.

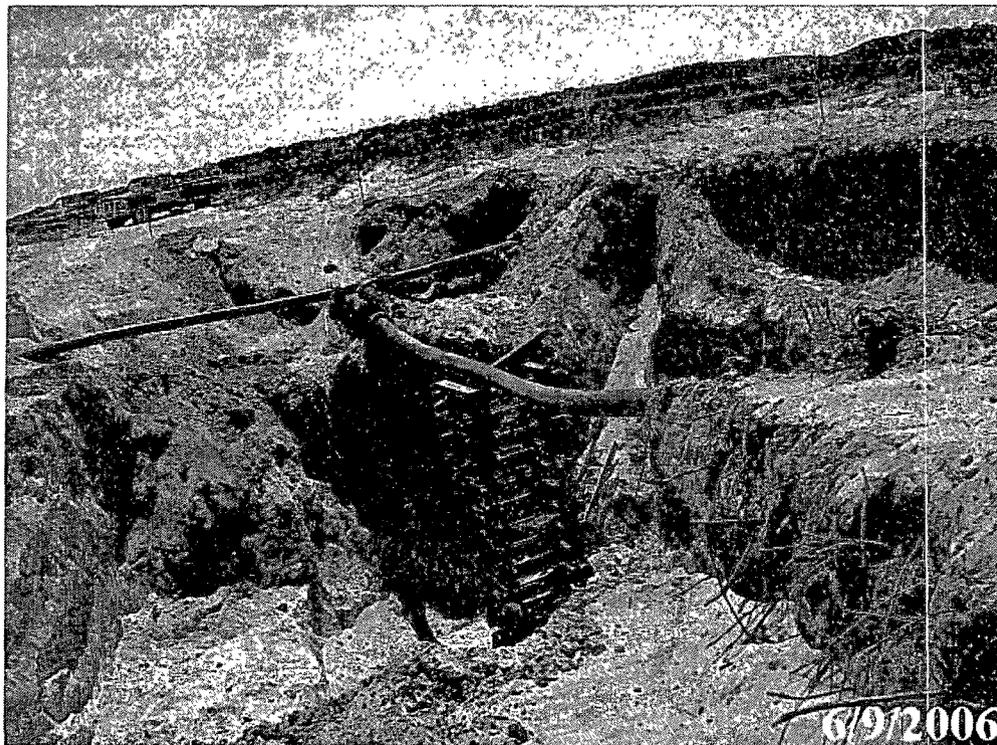
Photograph #2 – Looking southeasterly at Site #1 excavation. Orange pin flags on excavation sidewalls and floor indicate soil sample locations.

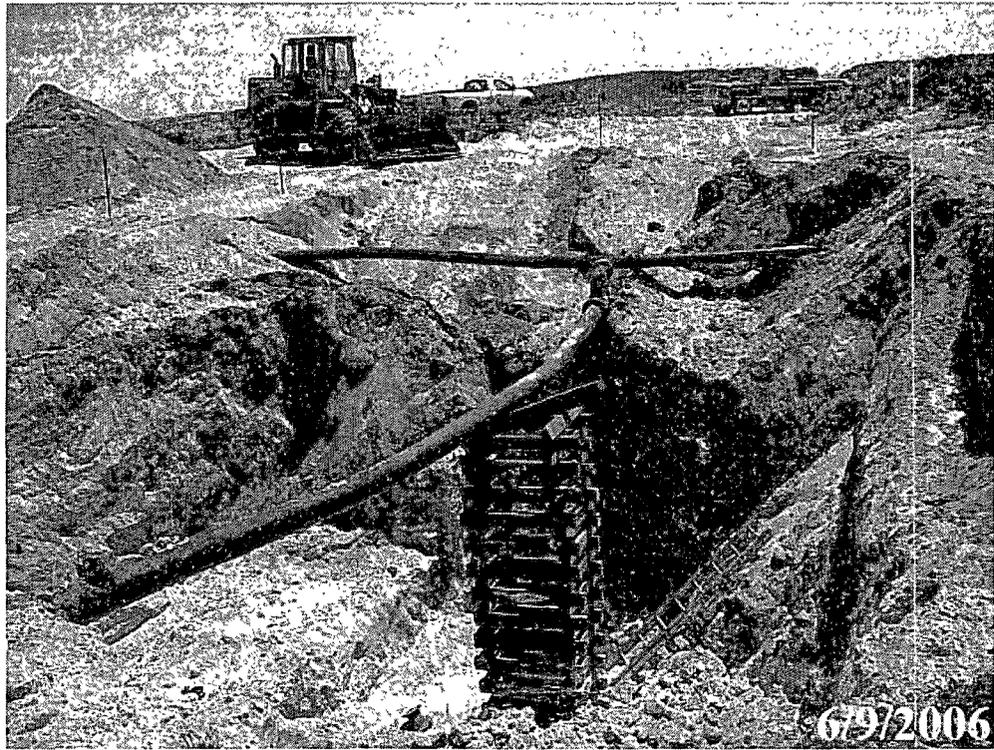
Photograph #3 – Looking easterly at Site #1 excavation. Orange pin flags on excavation sidewalls and floor indicate soil sample locations.

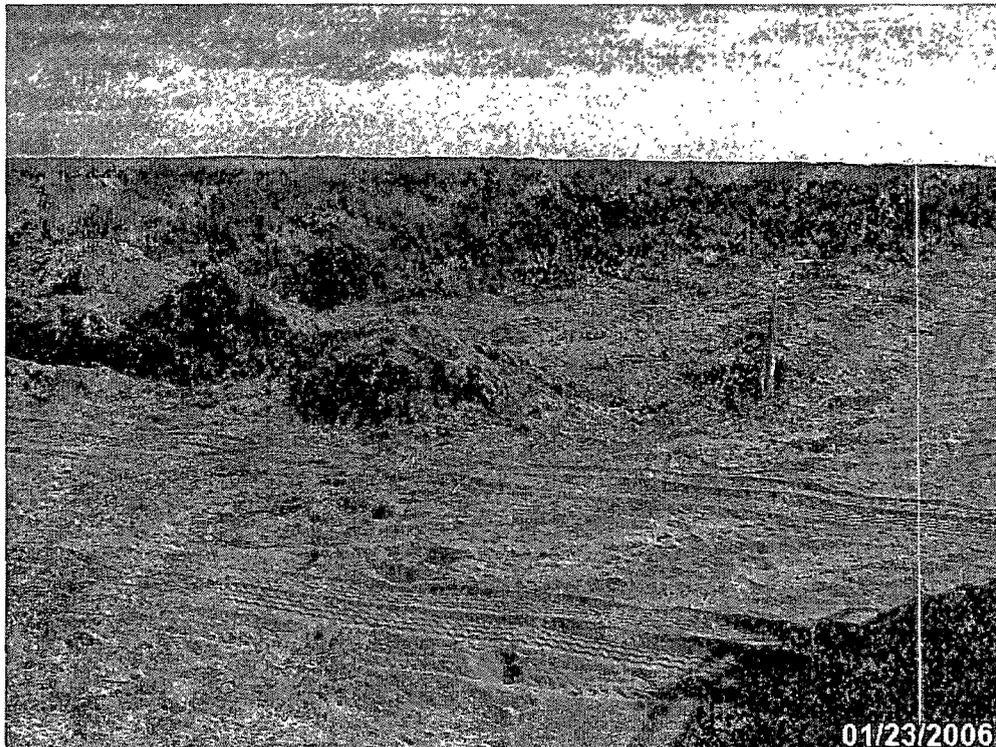
Photograph #1 – Looking northwesterly across Site #3 initial release area.

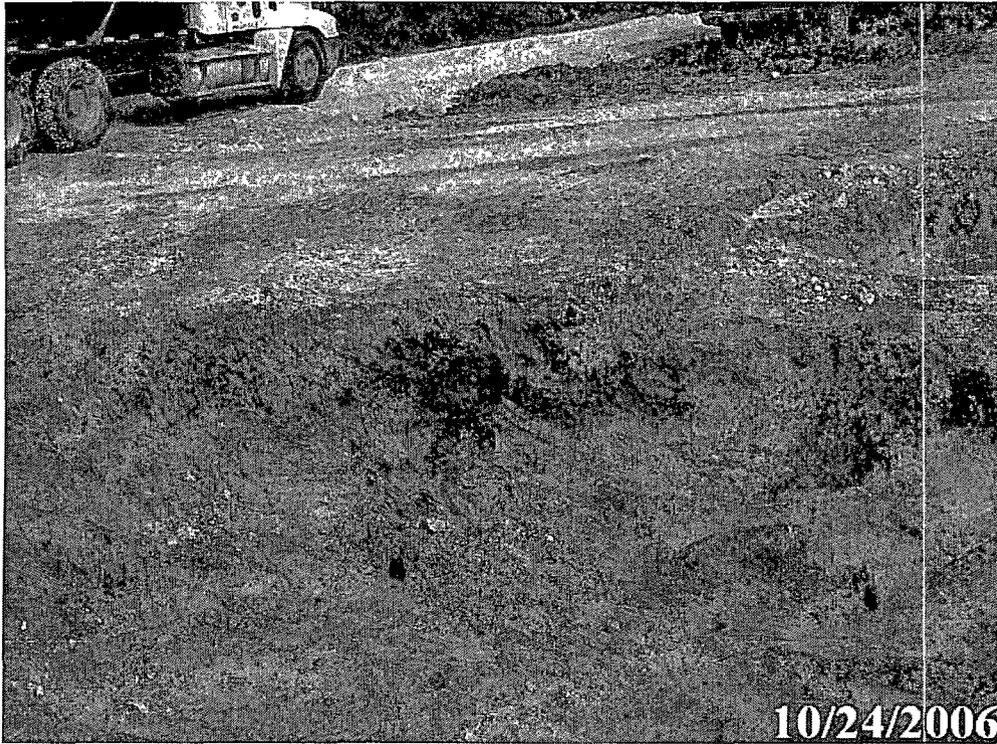
Photograph #3 – Looking westerly at Site #3 excavation. Orange pin flags on excavation sidewalls and floor indicate soil sample locations.

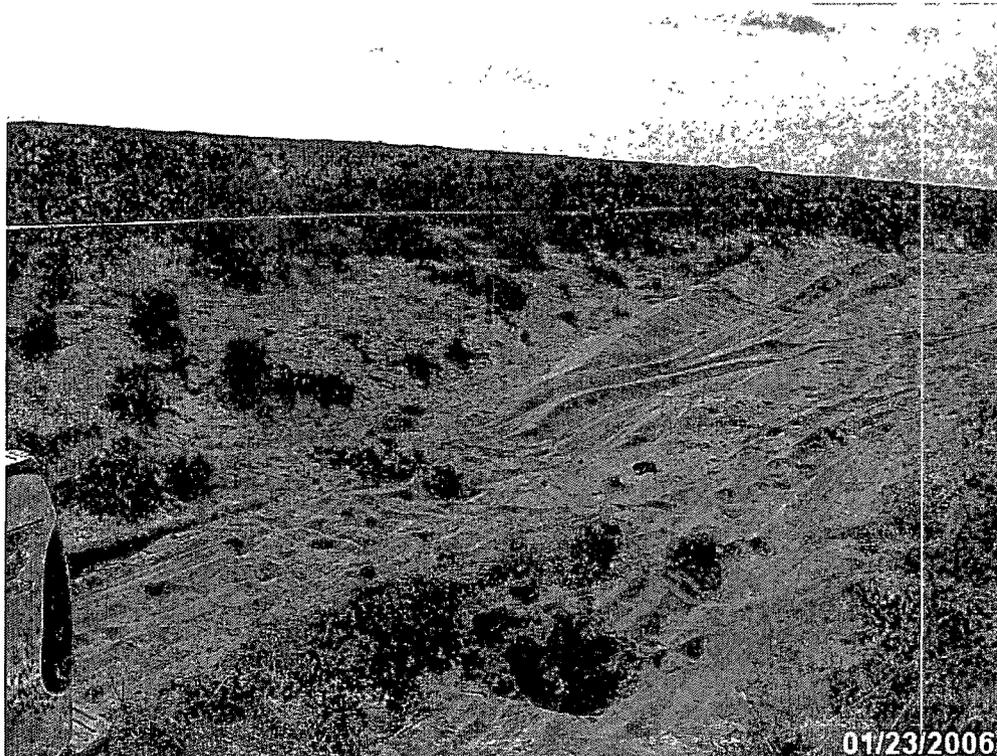
Photograph #1 – Looking southwesterly across Site #4 initial release area.

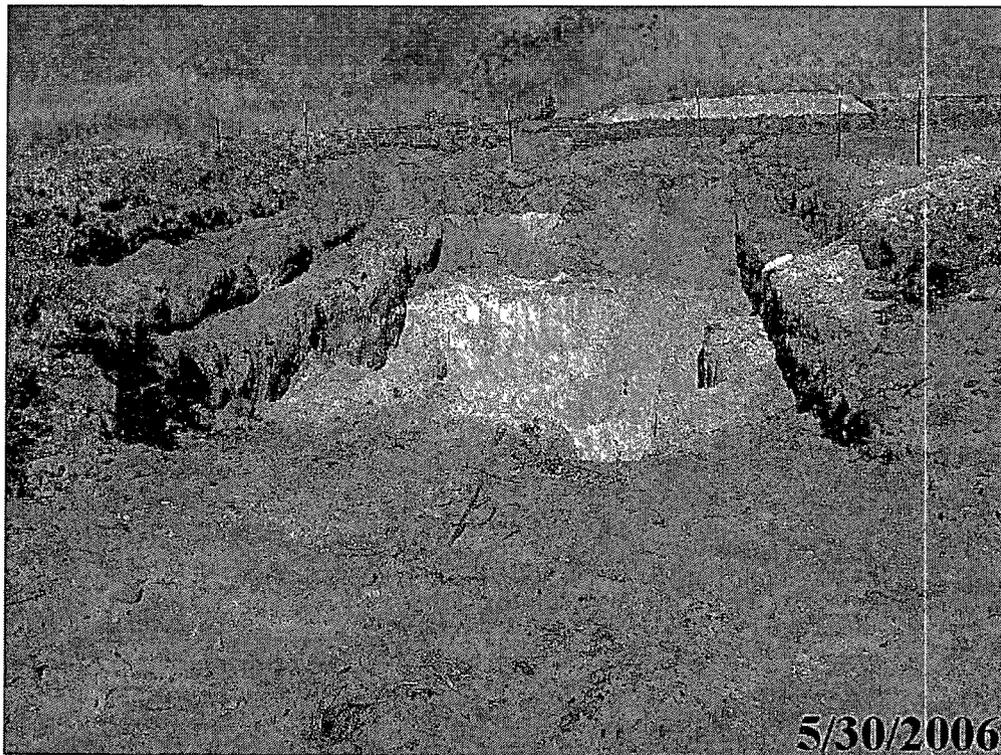
Photograph #2 – Looking westerly across Site #4 excavation. Orange pin flags on excavation sidewalls and floor indicate soil sample locations.

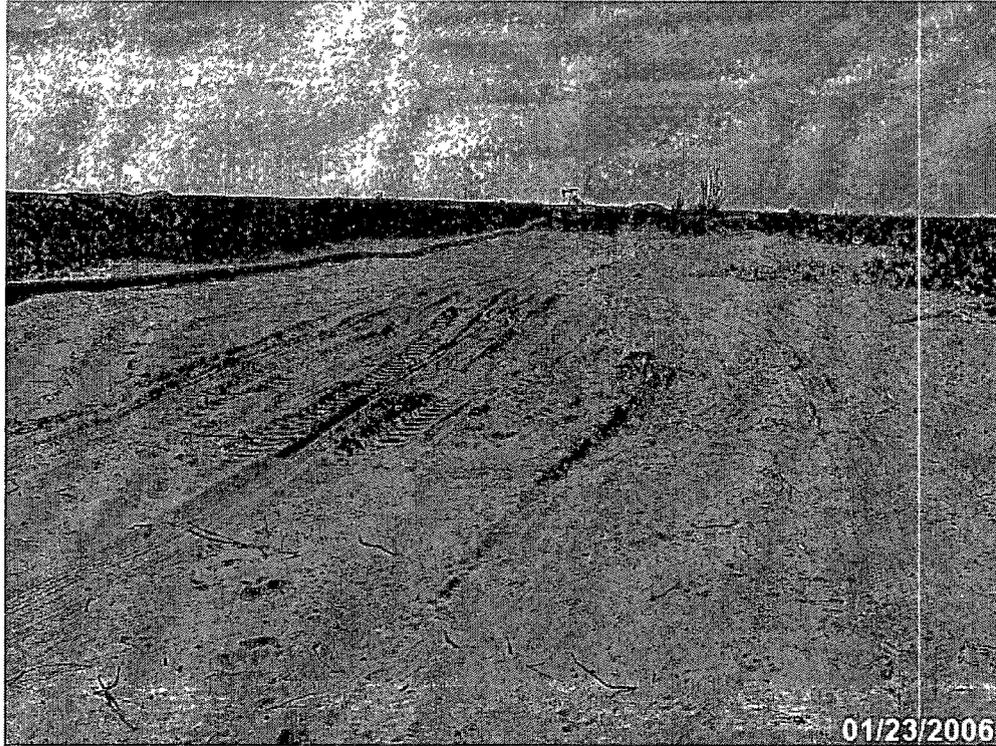
Photograph #1 – Looking westerly across Site #5 initial release area.

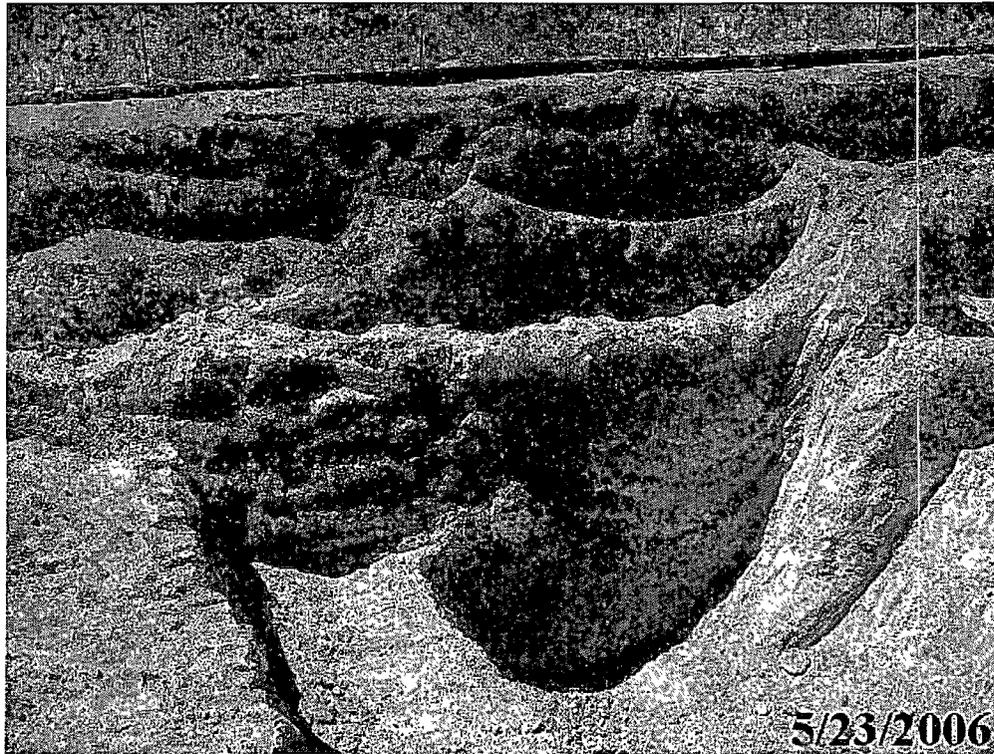
Photograph #3 – Looking southerly across Site #5 excavation at south wall.

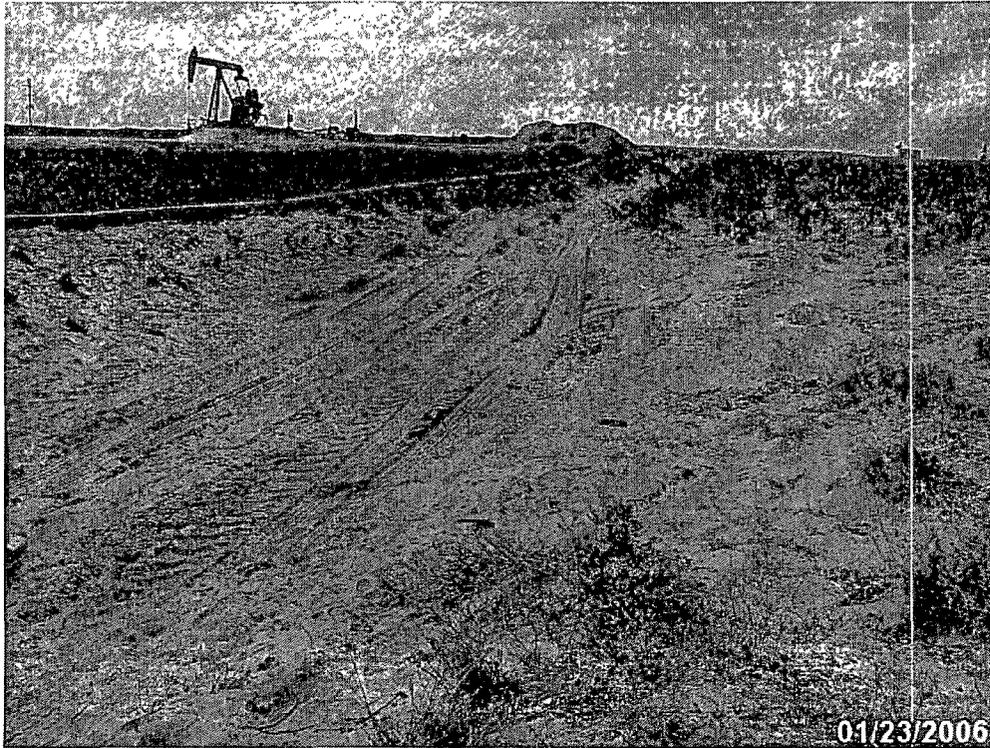
Photograph #1 – Looking westerly across Site #6 initial release area.

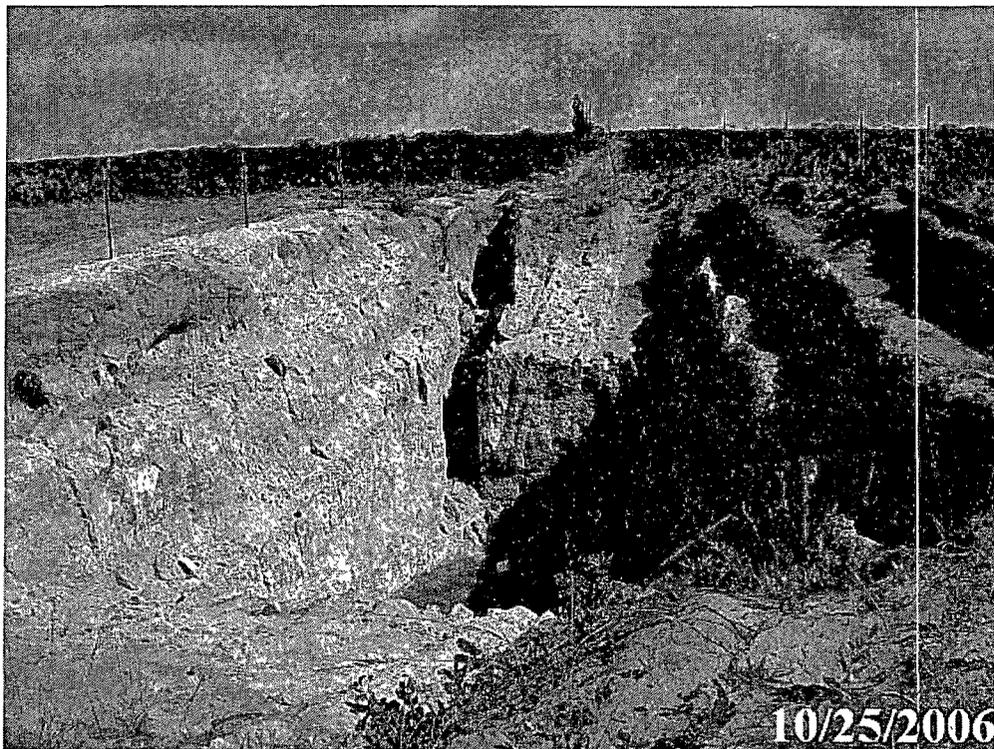
Photograph #2 – Looking easterly across Site #6 excavation.

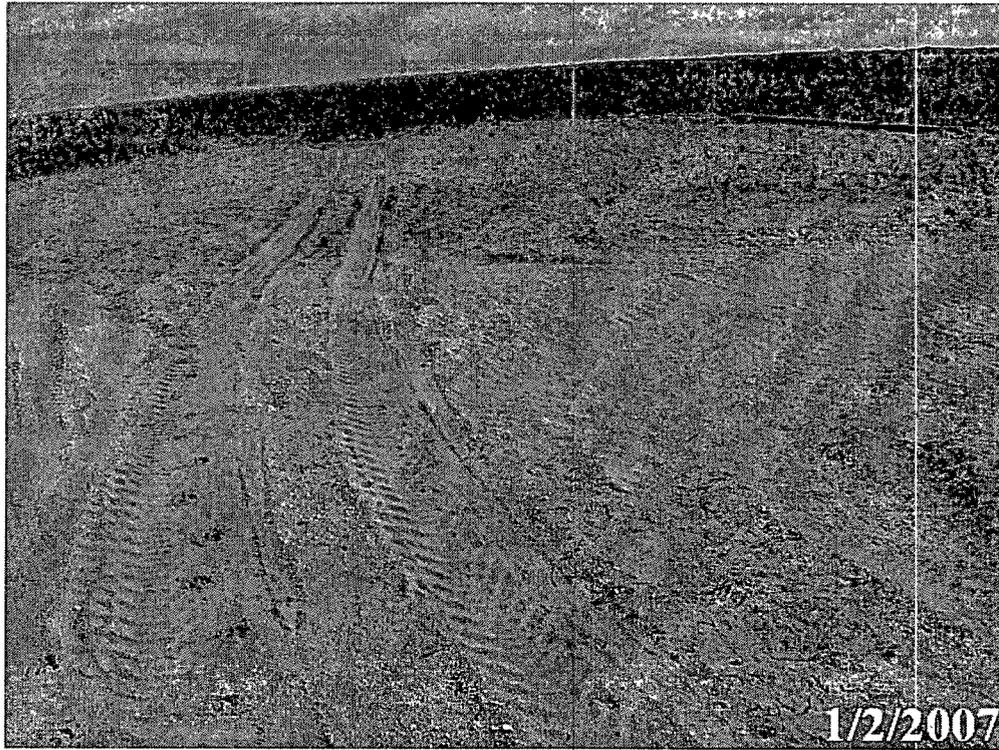
Photograph #3 – Looking northerly across Site #6 after backfilling.

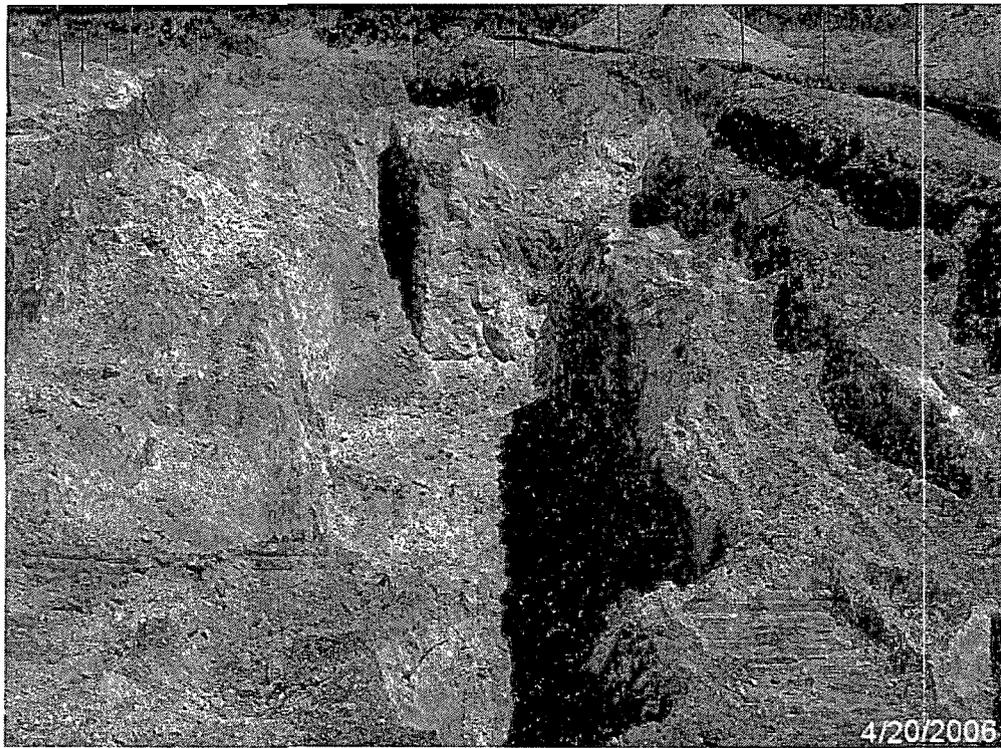
Photograph #2 – Looking easterly across Site #7 excavation.

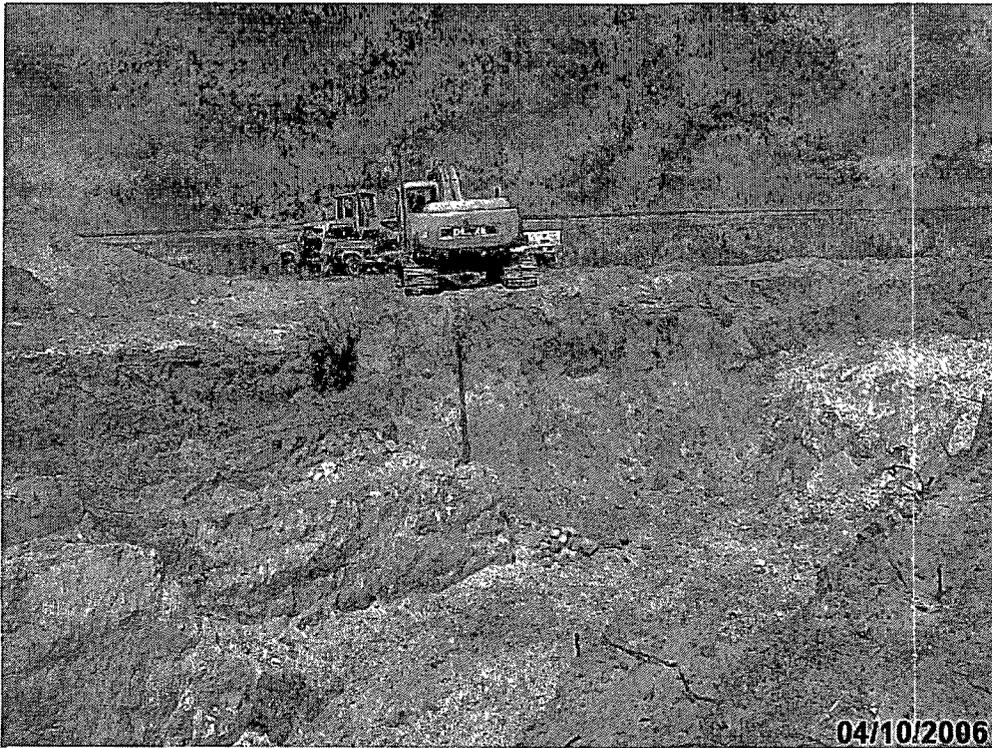
Photograph #2 – Looking northeasterly across Site #8 excavation.

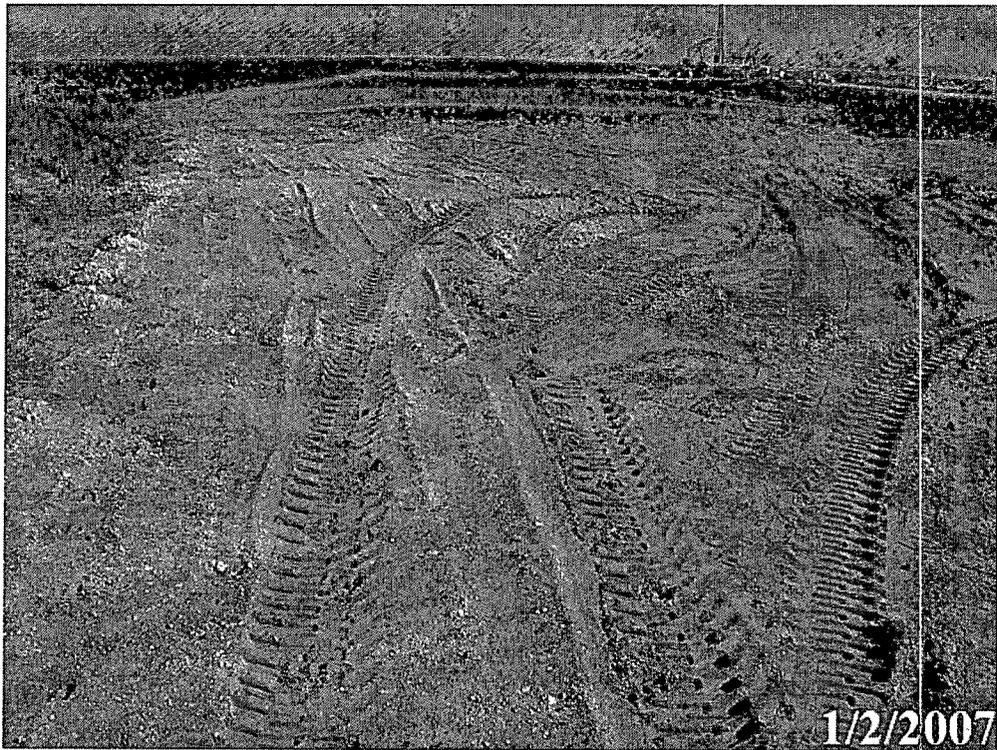
Photograph #4 – Looking easterly across Site #9 after backfilling.

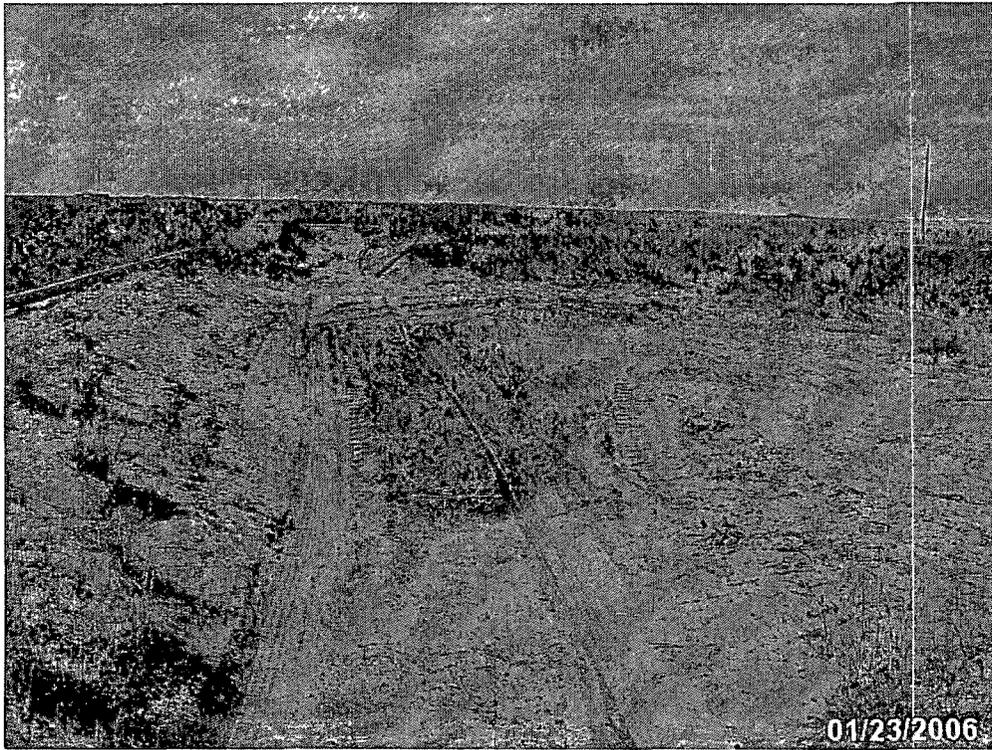
Photograph #1 – Looking westerly across Site #10 initial release area.

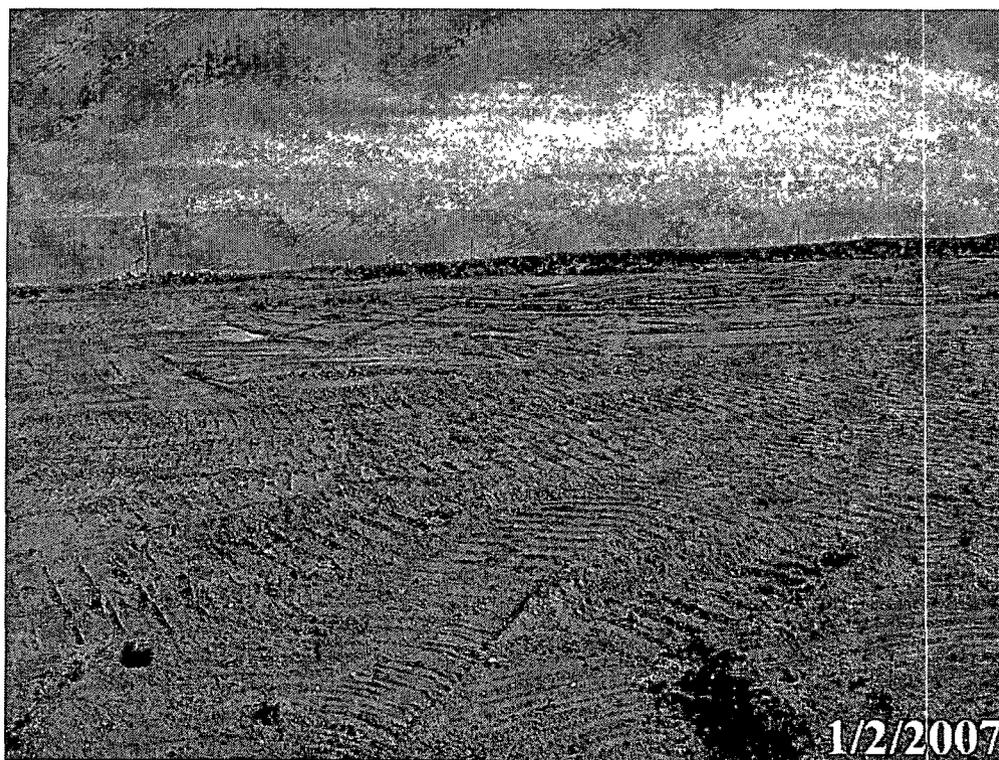
Photograph #4 – Looking southeasterly across Site #10 after backfilling.
