FINAL CLOSURE REPORT

PAPAGAYO FEDERAL #1

EPI REF: #160049

Papagayo Federal #1 Oil Unit Tank Battery

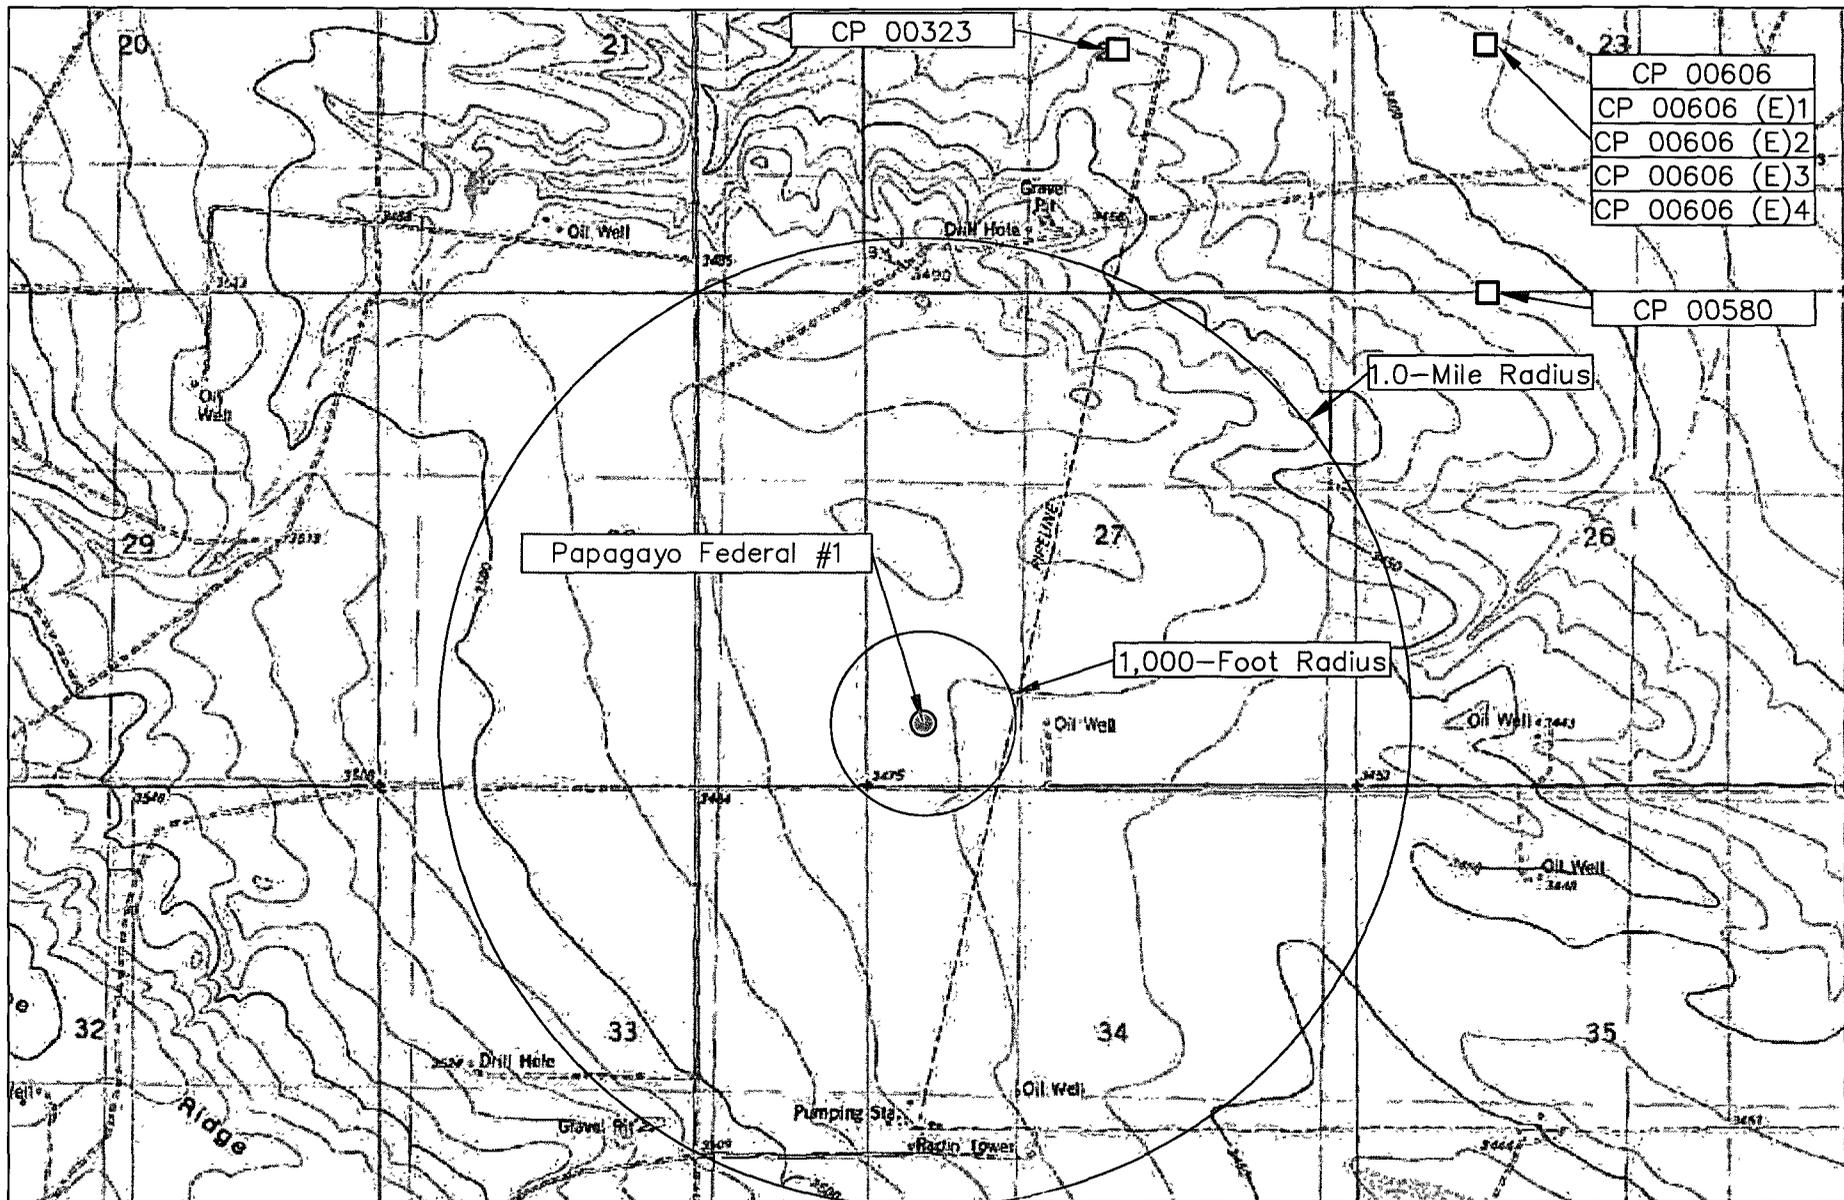
<p>Figure 2 Site Location Map Chesapeake Energy Papagayo Federal #1</p>	<p>Lea County, New Mexico SW 1/4 of the SW 1/4, Sec. 27, T23S, R34E N 32° 16' 12.55" W 103° 27' 51.63" Elevation: 3,472 feet amsl</p>	<p>DWG By: Daniel Dominguez January 2006</p>	<p>REVISED:</p>	
		<p>0 2,000 4,000 Feet</p>

1,000-Foot Radius

1.0-Mile Radius

No public water supply wells exist within 1-mile of the release site. Similarly, no private, domestic fresh water wells or springs used by less than five (5) households for domestic or stock watering purposes exist within 200-feet of the release site (reference *Figure 2* and *Table 1*).

No surface water features exist within 1,000-feet of the release site (reference *Figure 2*).

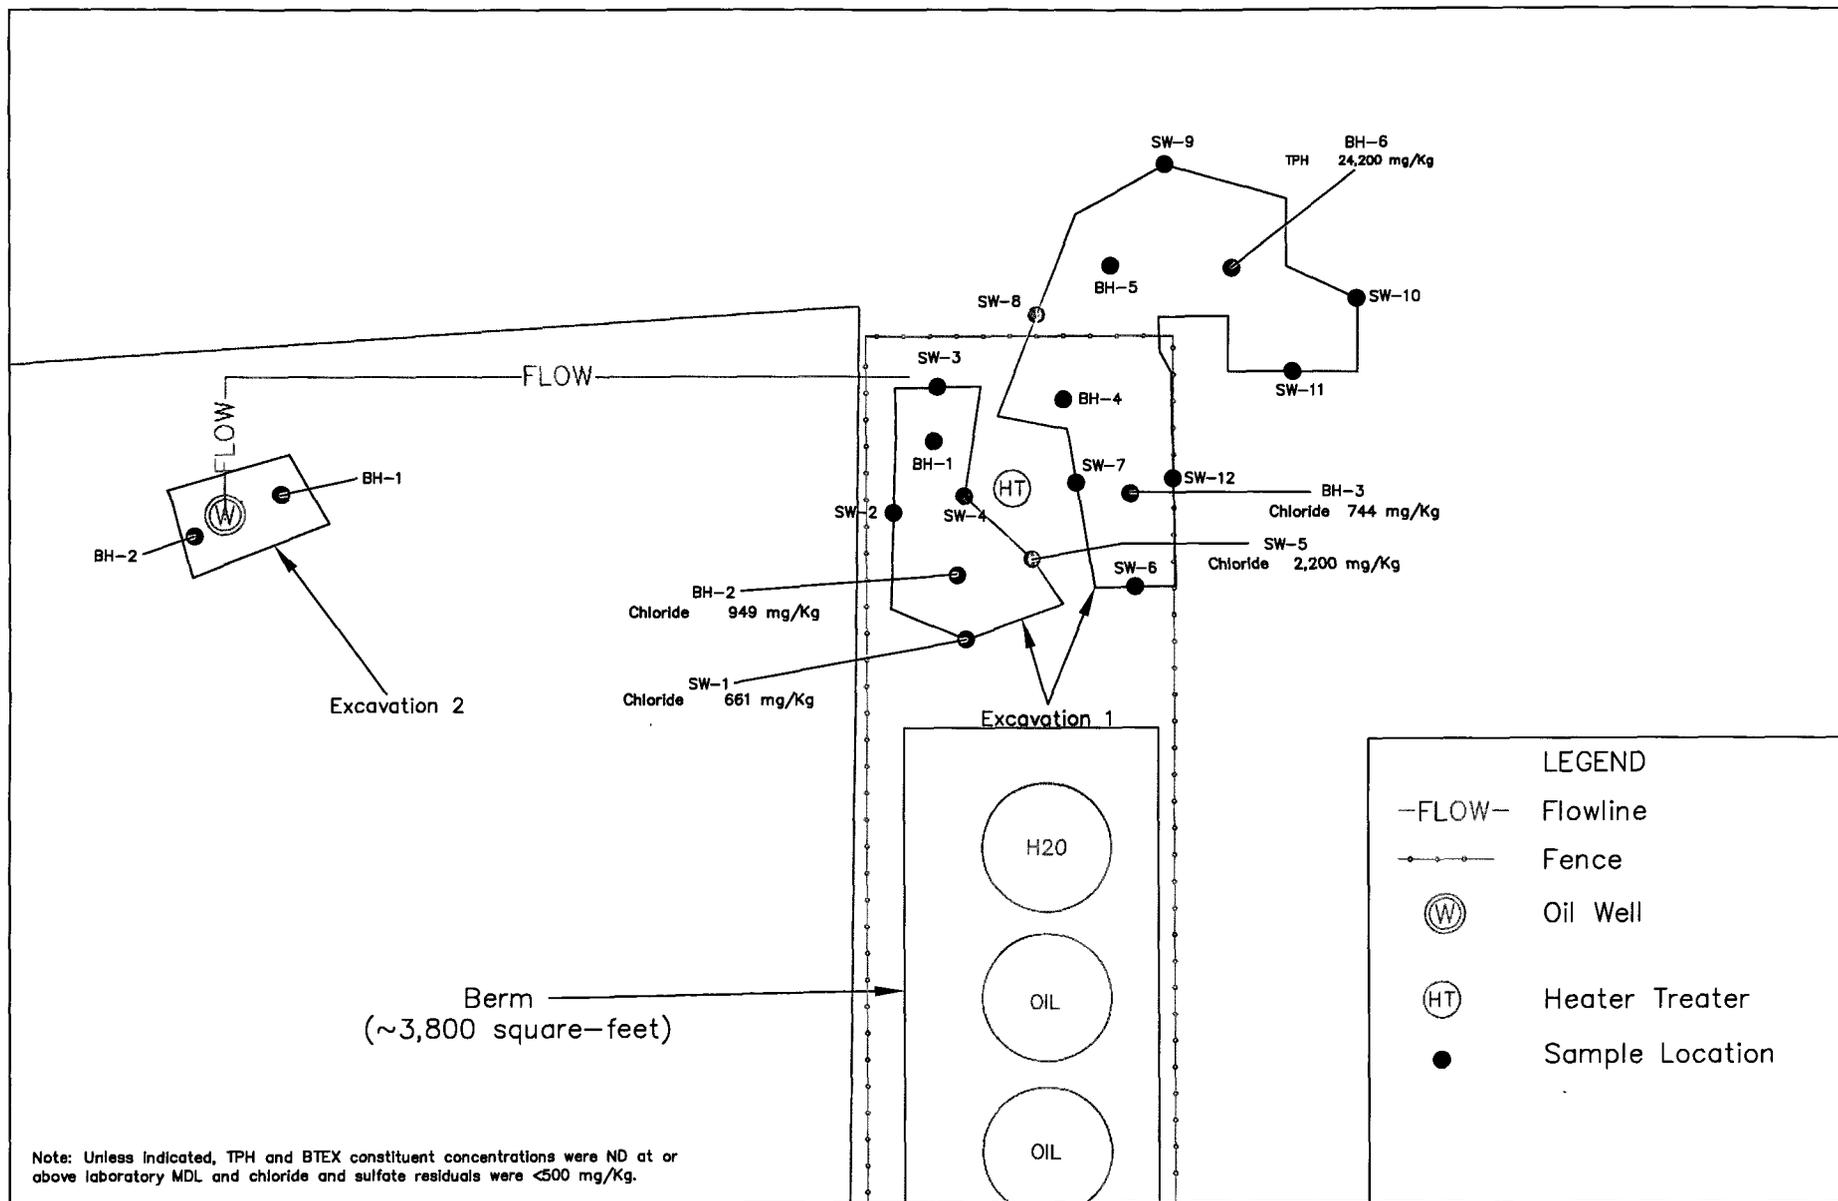
Figure 5
 April 3, 2006 Excavation Sample Map
 Chesapeake Energy
 Papagayo Federal #1

Note: Unless indicated, TPH and BTEX constituent concentrations were ND at or above laboratory MDL and chloride and sulfate residuals were <500 mg/Kg.

Three (3) separate excavation episodes were completed on April 3, 2006, April 12, 2006 and May 22, 2006. During excavation of impacted soil from the release site, soil samples were collected from bottom and sidewalls excavation at different locales and depths to characterize materials for disposal. Soil samples were analyzed in the field for organic vapor and chloride concentrations. Excavation of impacted soil continued until organic vapor concentrations were below 100 parts per million (ppm) (reference *Table 2*).

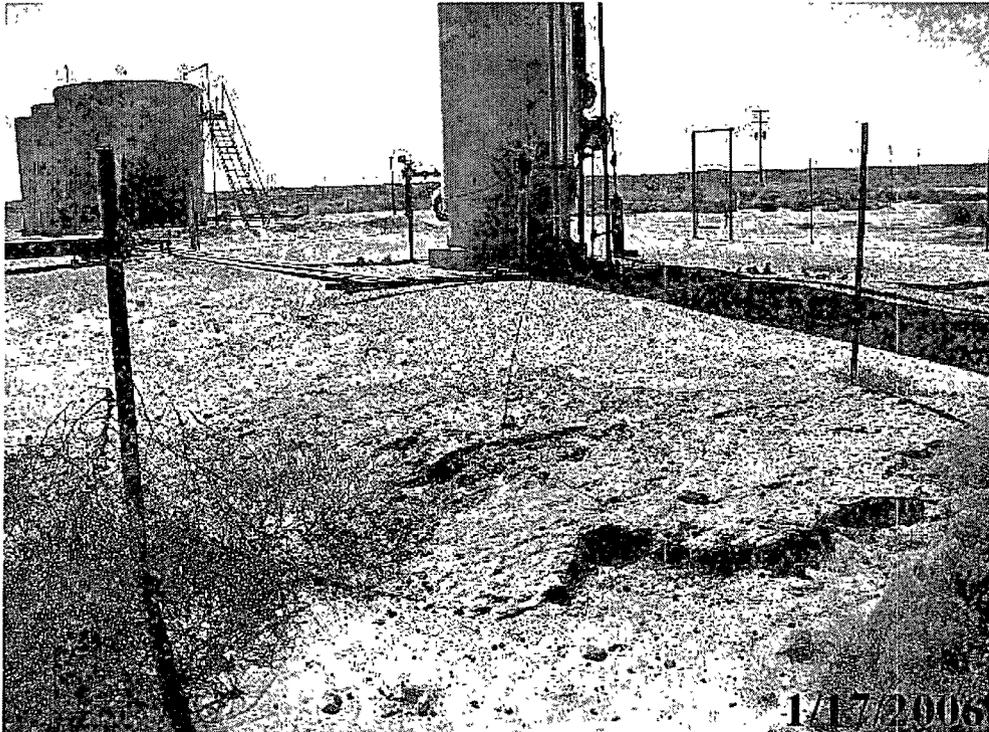
Photograph #2 – Looking southwesterly at release area.

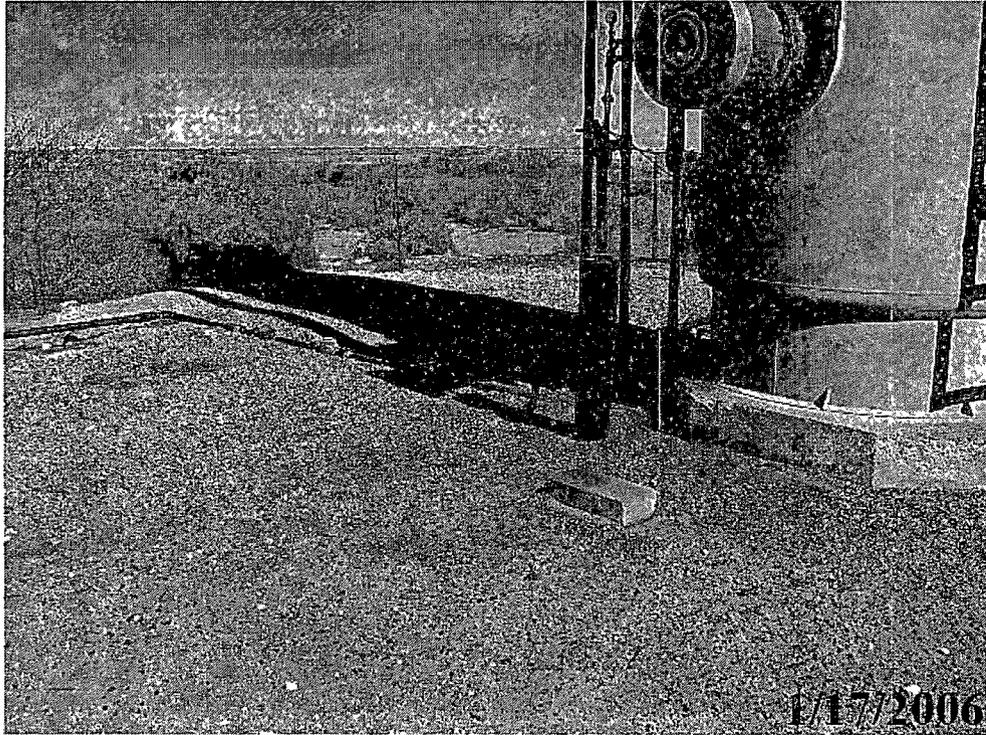
Photograph #3 – Looking northeasterly at release area.

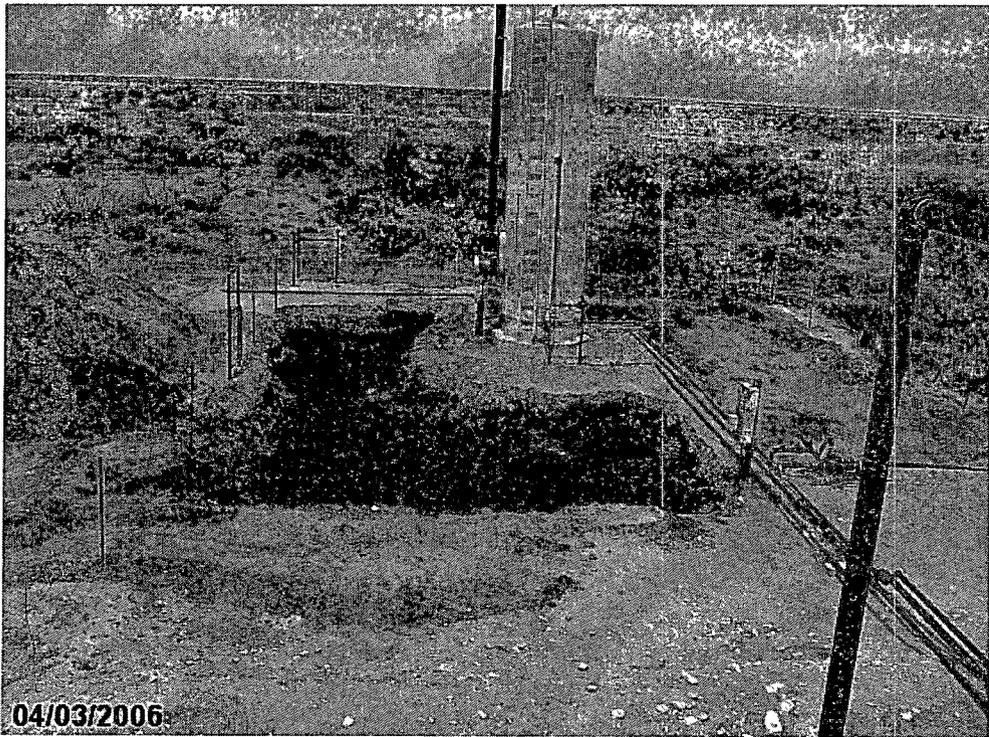
Photograph #4 – Looking northerly at excavation around heater treater.

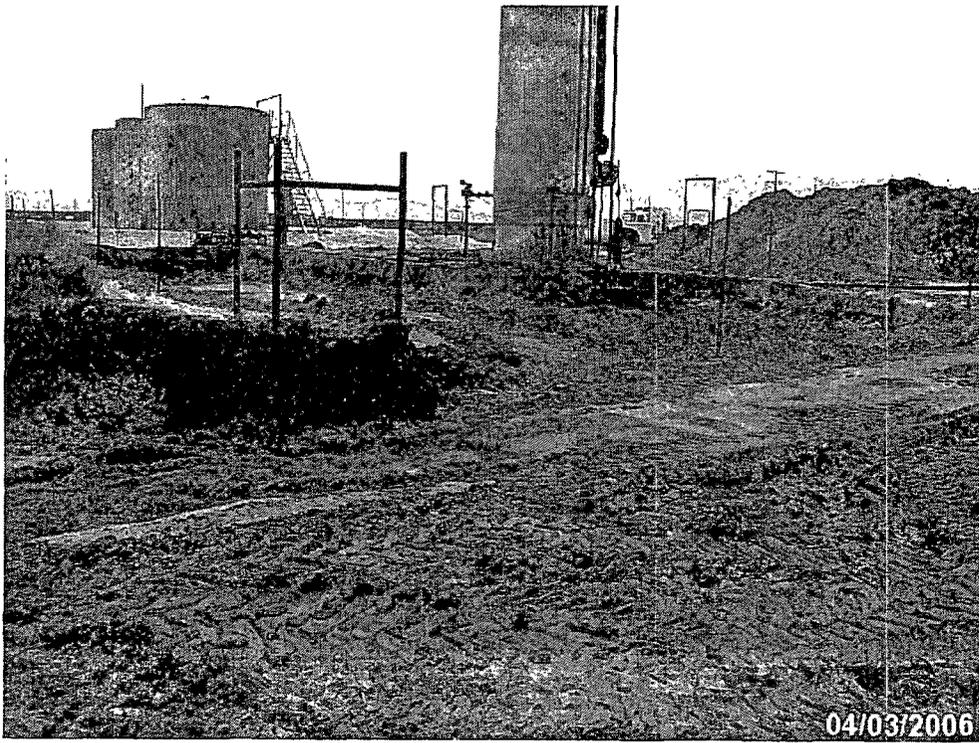
Photograph #5 – Looking southwesterly at excavation around heater treater

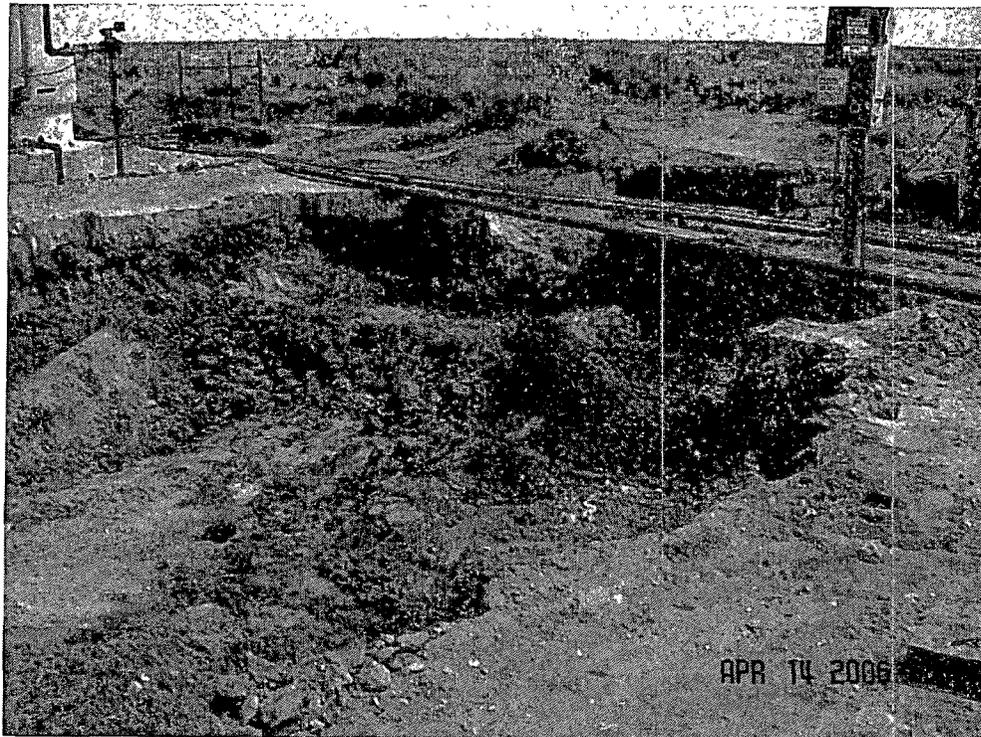
Photograph #6 – Looking northeasterly at excavation

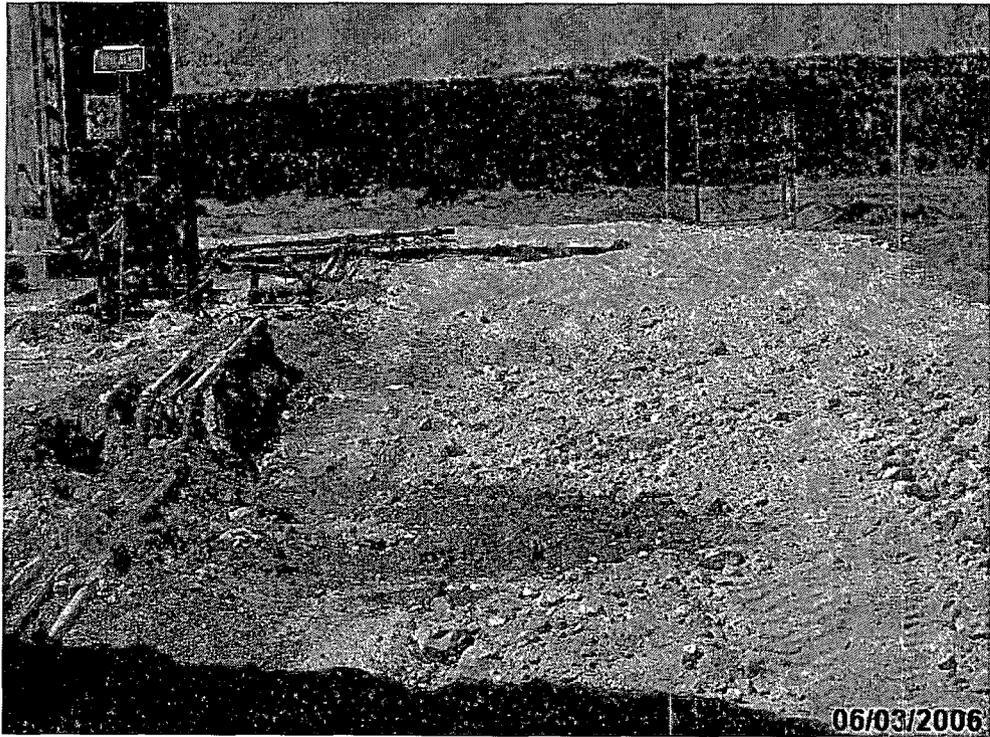
Photograph #8 – Backfilling excavation

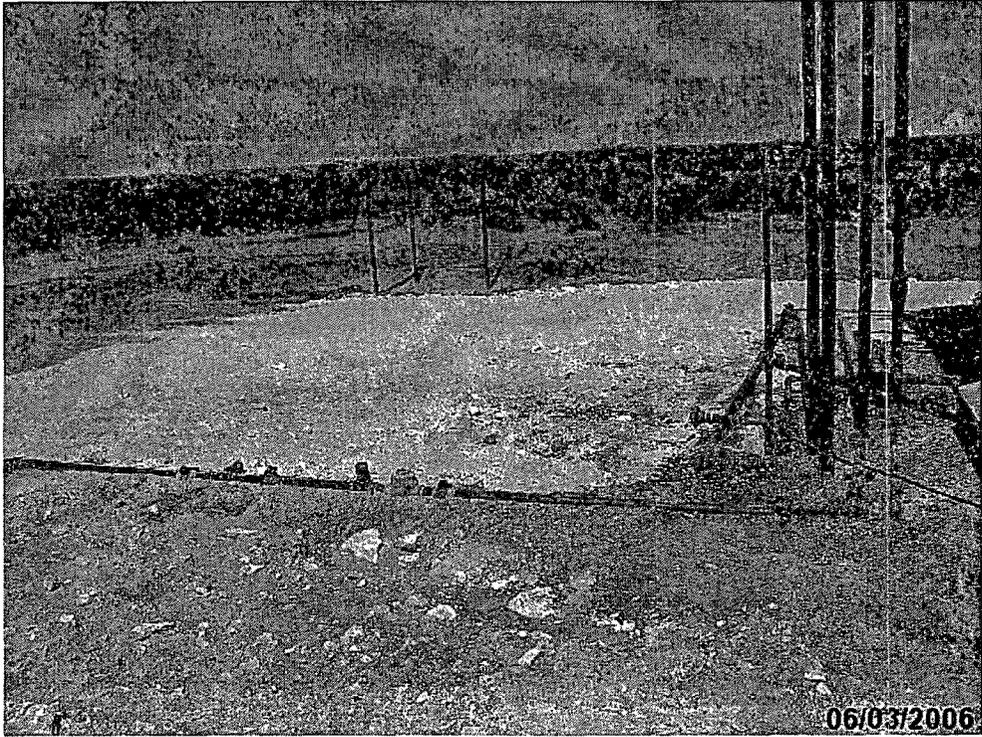
Photograph #9 – Remediated site

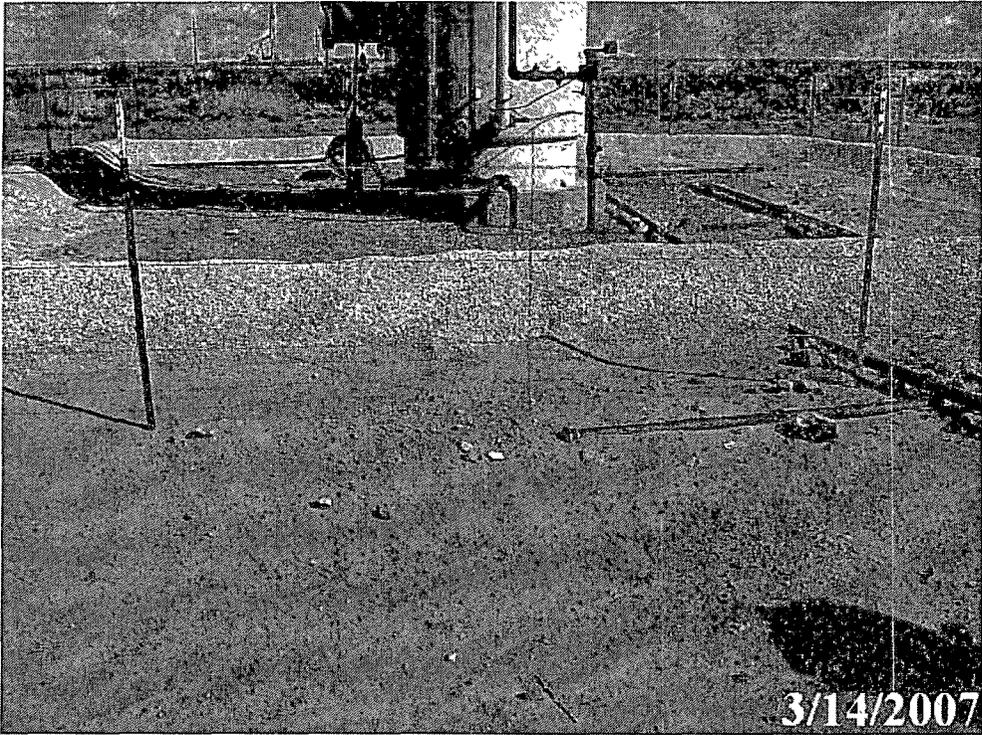
Photograph #10 – Remediated site
