FINAL CLOSURE REPORT

CONOCOPHILLIPS - STATE "E" WATER TRANSFER LINE

EPI REF: #150010

NMOCD: #1RP-1183

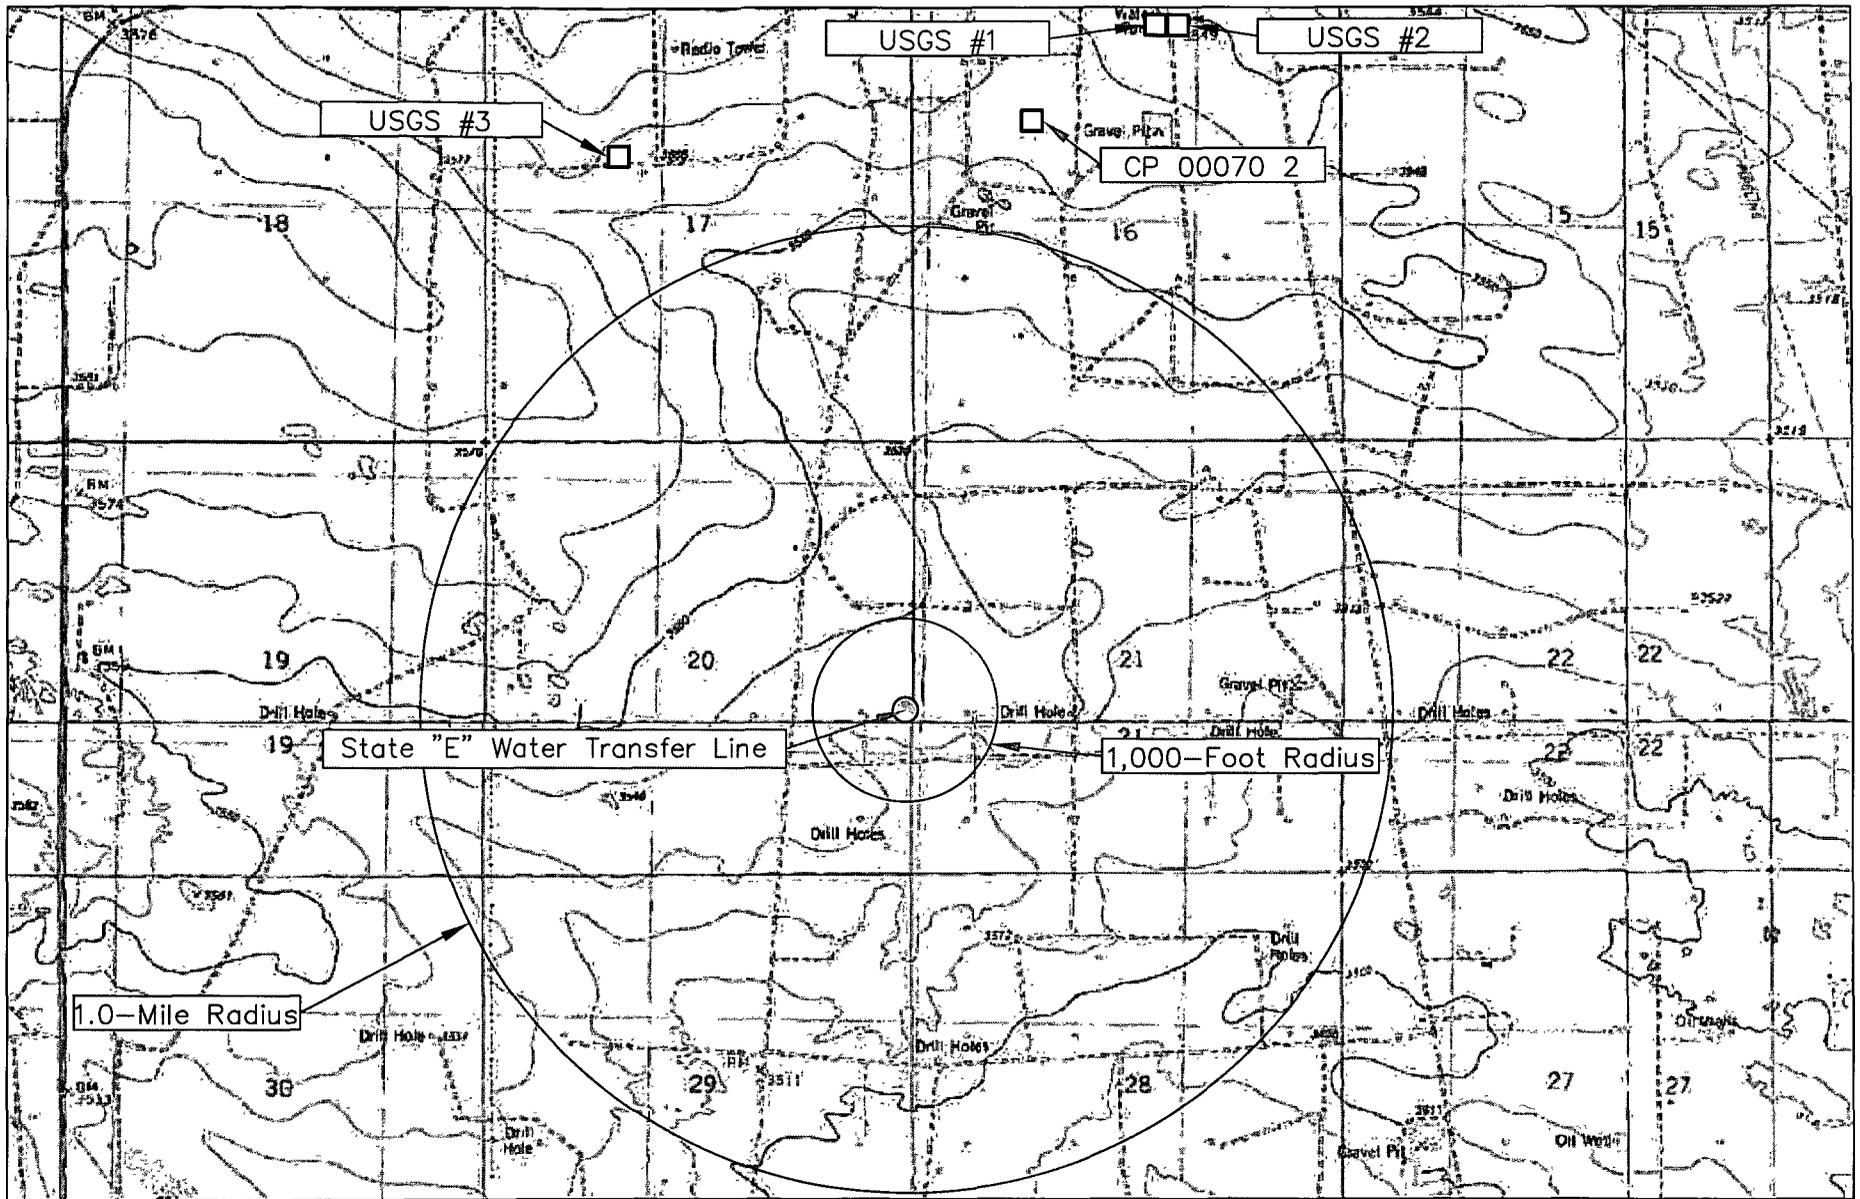
Figure 2
 Site Location Map
 ConocoPhillips
 State "E" Water Transfer Line

- 2.9 *Area Water Wells***
No public water supply wells are located within 1,000-feet of the release site. In addition, no private domestic fresh water wells or springs used by less than five households for domestic or stock watering purposes exist within 200-feet of the release site (reference *Table 1* and *Figure 2*).

- 2.10 *Area Surface Water Features***
No surface water features exist within 1,000 feet of the release site (reference *Figure 2*).

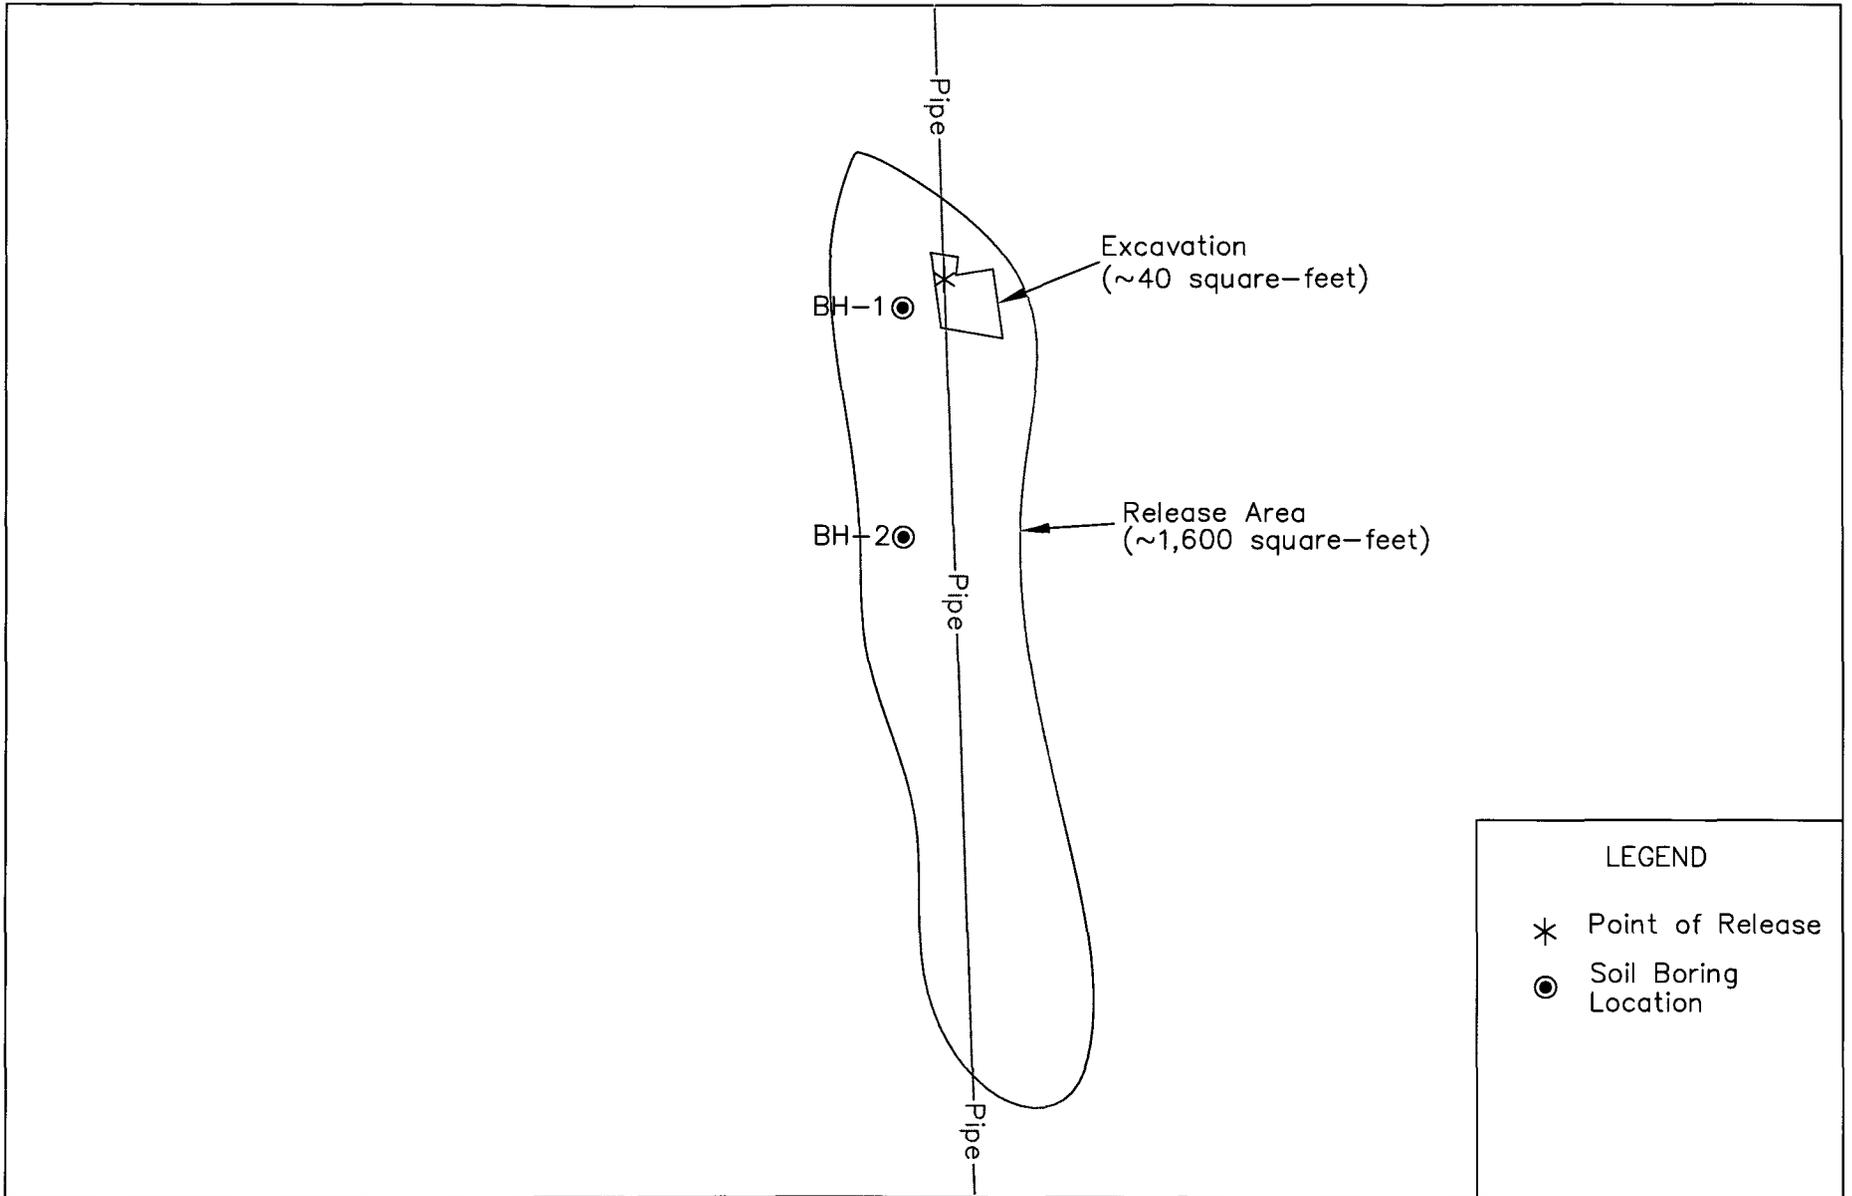
Figure 4
Soil Boring Map
ConocoPhillips
State "E" Water Transfer Line

From April 19 through April 27, 2005, two (2) soil borings were advanced varying depths within the confines of the release area to delineate vertical extent of contamination. Soil boring hole BH-1 was advanced a total depth (TD) of sixty-five feet (65-ft). Soil boring hole BH-2, located approximately twenty-five feet (25-ft) south of BH-1, was advanced a total depth (TD) of thirty-five feet (35-ft). Soil samples were collected at ground surface and at five foot (5-ft) intervals thereafter to delineate the vertical extent of soil contamination. Locale for BH-1 was chosen to be within close proximity of the point of release which should contain elevated concentration of contaminants. Locale for BH-2 was chosen to indicate lateral as well as vertical extent of the impacted area (reference *Figure 4* and Appendix III, *Soil Boring Logs*).

Laboratory analyses of soil samples collected on the surface area prior to advancement of soil boring BH-1 indicated BTEX concentrations at 26.5 mg/Kg, TPH at 5,190 mg/Kg and chloride at 37,000 mg/Kg. Analysis of soil samples collected at five feet (5-ft) below ground surface (bgs) indicated BTEX and TPH concentrations were at or below laboratory analytical method detection limits (MDL). Laboratory analyses of BTEX and TPH concentrations were not conducted in the intervals of ten feet (10-ft) bgs to sixty-five feet (65-ft) bgs as field analyses of organic vapor concentrations were non-detectable. However, during these intervals chloride concentrations ranged from 294 mg/Kg (10-ft bgs) to 1,070 mg/Kg (65-ft bgs) (reference *Figure 4* and *Table 2*).

Laboratory analyses of soil samples collected on the surface prior to advancement of soil boring BH-2 indicated BTEX concentrations at 0.103 mg/Kg, TPH at 18,501 mg/Kg and chloride at 1,030 mg/Kg. Analyses of soil samples collected at five feet (5-ft) bgs indicated BTEX and TPH concentrations were at or below laboratory analytical MDL. Laboratory analyses for BTEX and TPH were not conducted in the intervals of ten feet (10-ft) bgs to thirty-five feet (35-ft) bgs as field analyses of organic vapor concentrations were non-detectable. Chloride concentrations during these intervals ranged from 431 mg/Kg (10-ft bgs) to 717 mg/Kg (15-ft bgs) (reference *Figure 4* and *Table 2*).

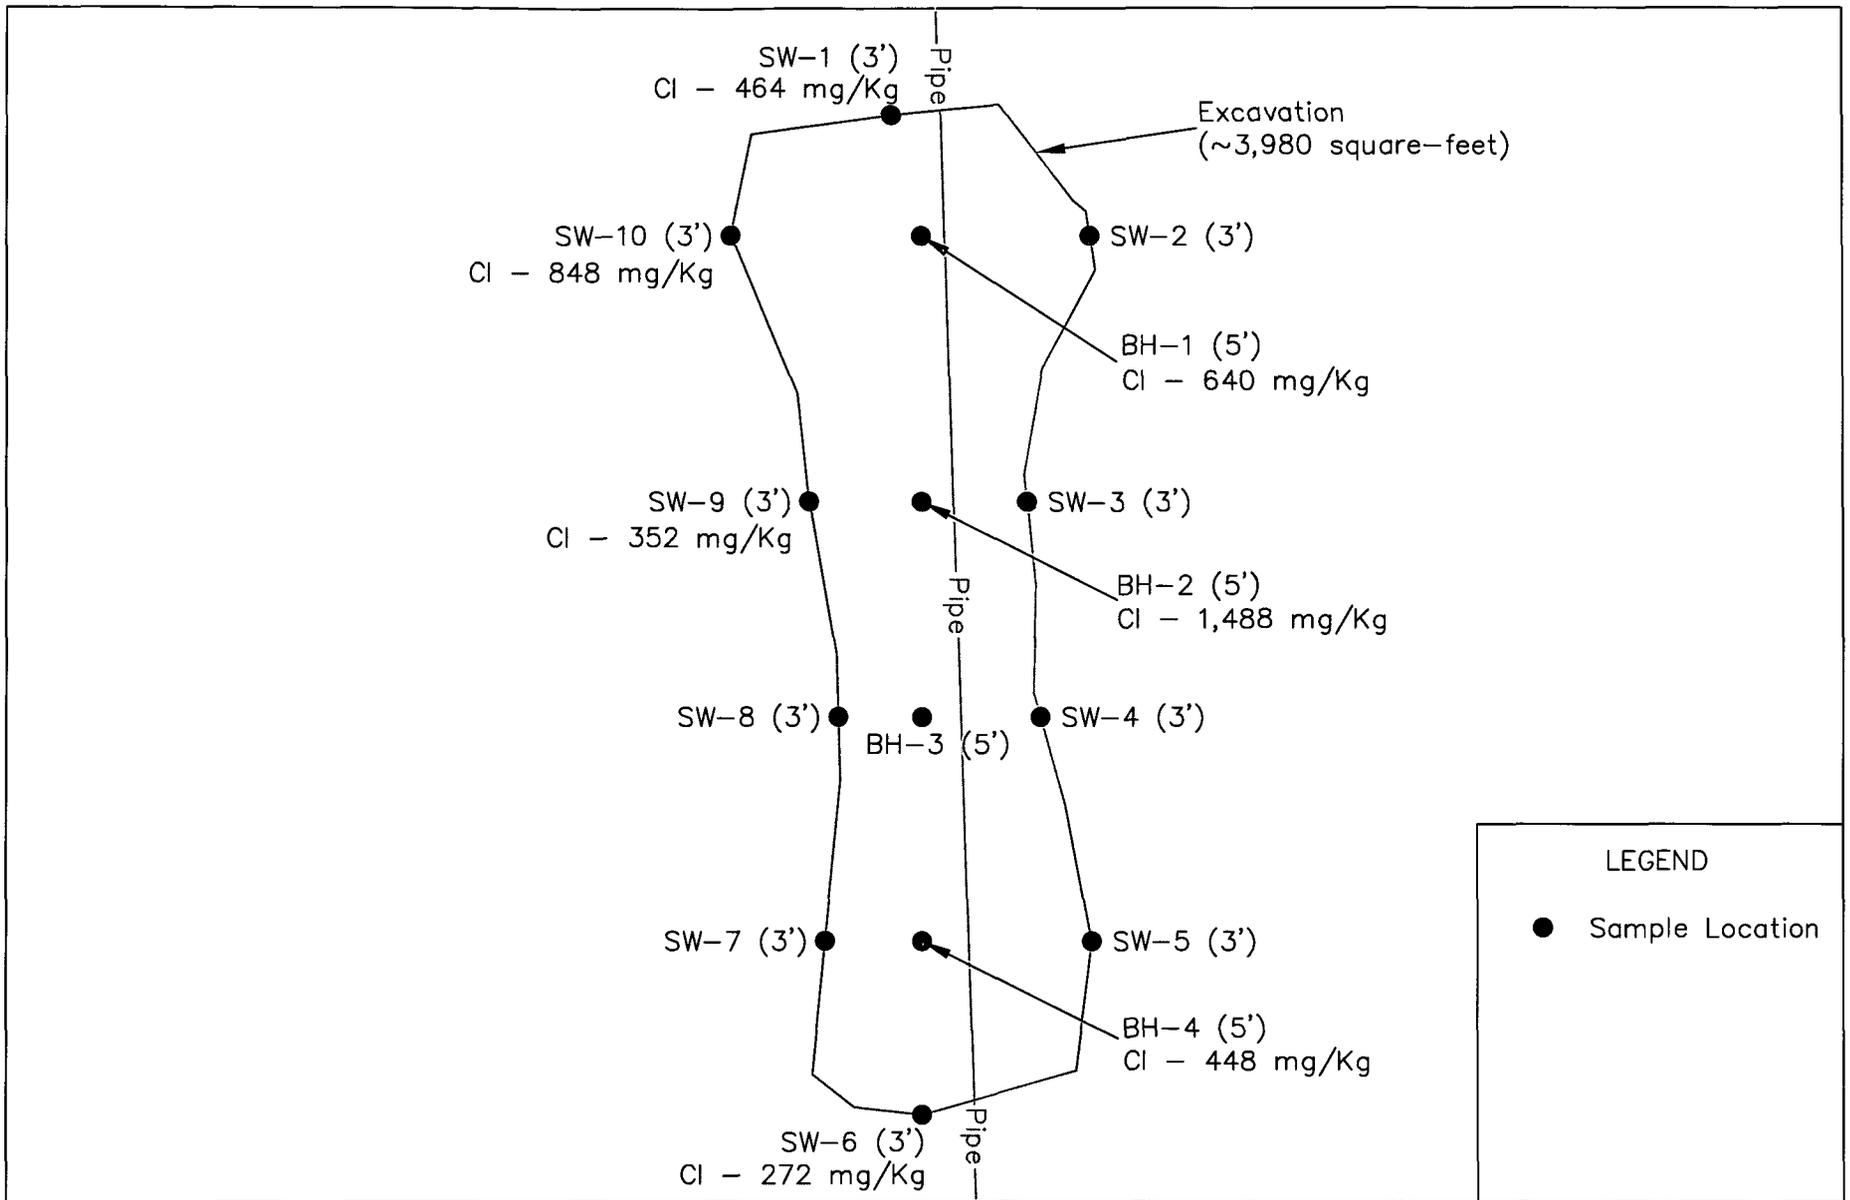
Figure 5
 Sample Map - 4/25/2006
 ConocoPhillips
 State "E" Water Transfer Line

On April 25, 2006 fourteen (14) soil samples were collected at varying depths from excavation bottom and sidewalls to delineate extent of contamination (reference *Figure 5*). Sidewall soil samples SW-1 through SW-10 were collected at 3-ft bgs. Bottom hole soil samples BH-1 through BH-4 were collected at 5-ft bgs. Locale for soil samples were chosen to indicate lateral as well as vertical extent of soil contamination (reference, *Table 3*).

Laboratory analyses of soil samples collected on April 25, 2007 indicated chloride concentrations ranged from ND at or above laboratory analytical MDL (SW-4) to 1,488 mg/Kg (BH-2) with the latter value exceeding remedial threshold goals of 250 mg/Kg (reference *Figure 5* and *Table 3*).

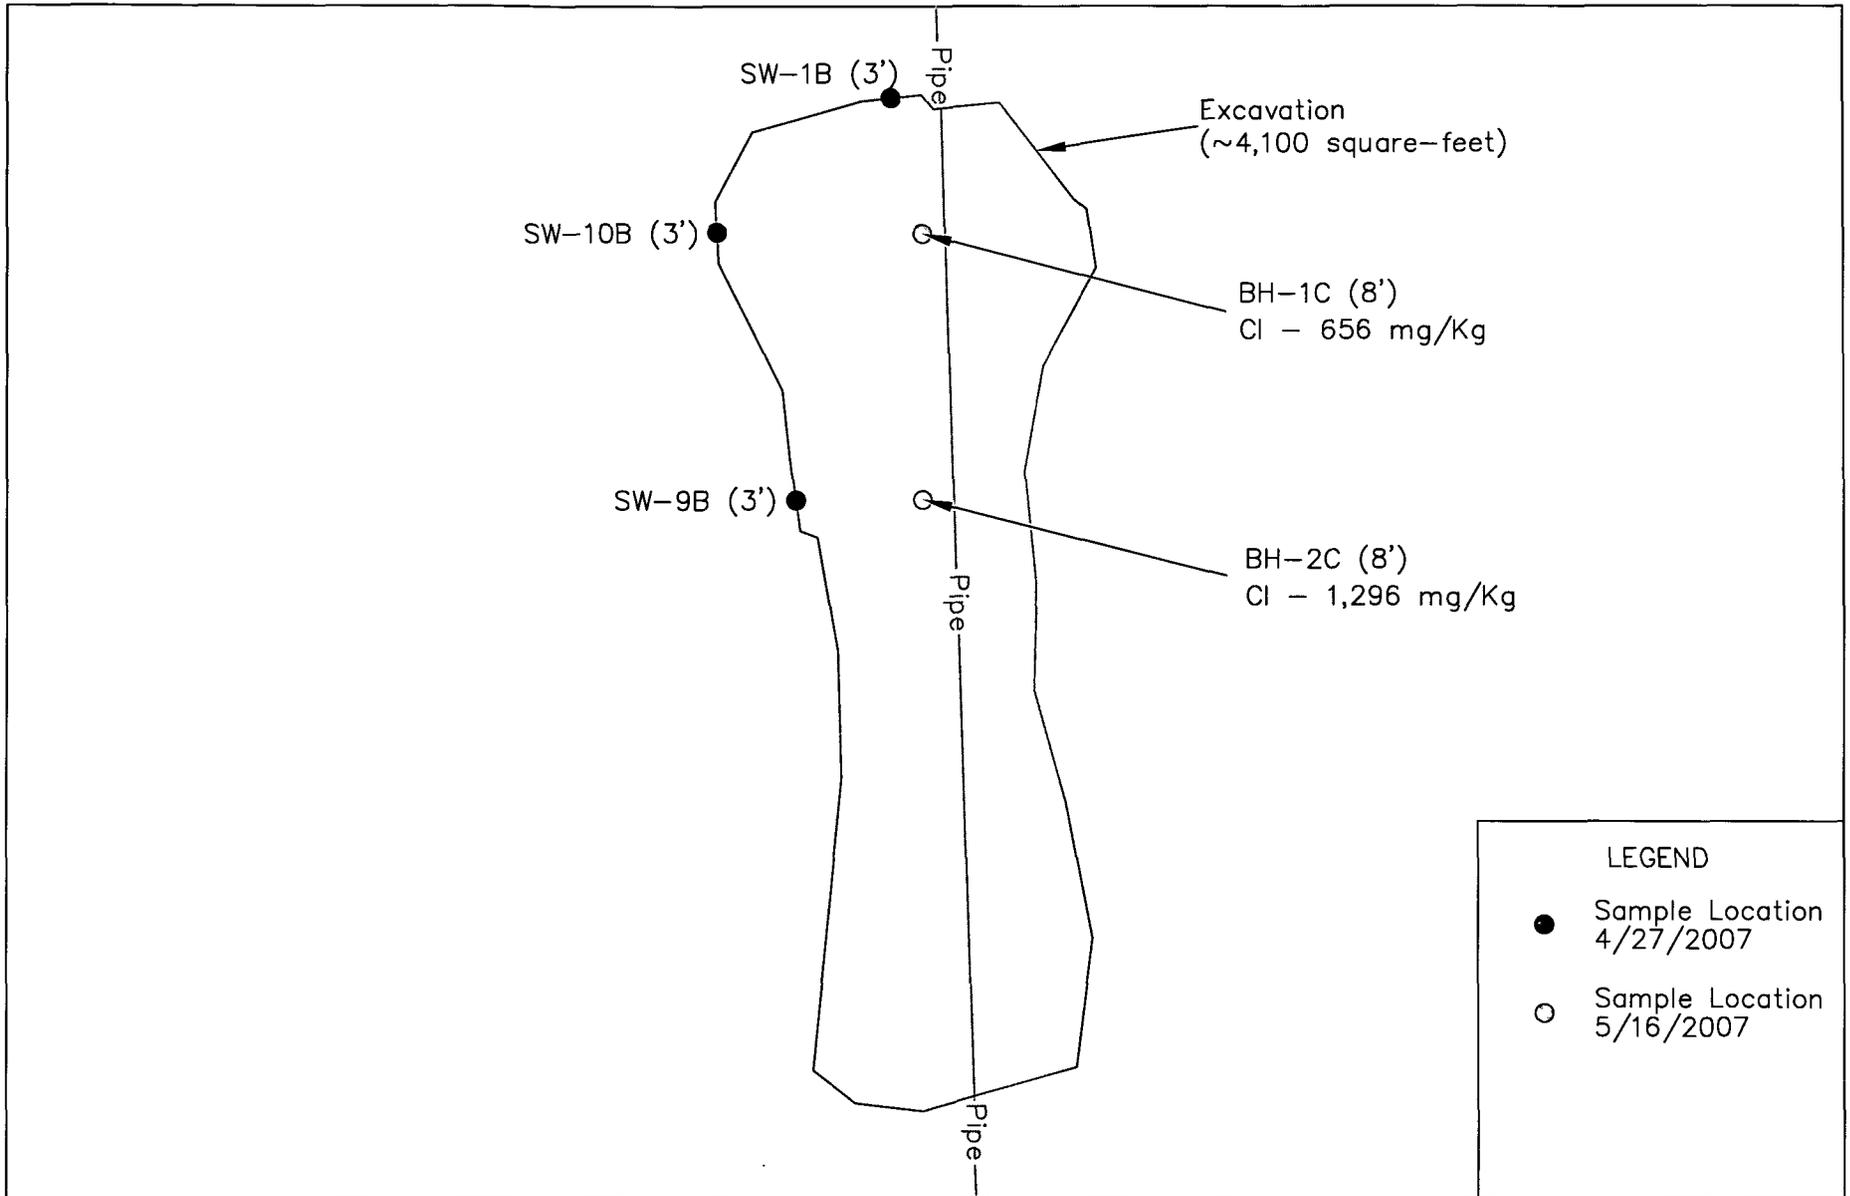
Figure 6
 Sample Map - 4/27 & 5/16 2007
 ConocoPhillips
 State "E" Water Transfer Line

On April 27 and May 16, 2007 a total of seven (7) soil samples were collected at varying depths from excavation bottom and sidewalls to delineate extent of contamination (reference *Figure 6*). SW-1B, SW-9B and SW-10B were collected at 3-ft bgs. BH-1B and BH-2B were collected at 6-ft bgs. BH-1C and BH-2C were collected at 8-ft bgs. Locale for soil samples was chosen to indicate lateral as well as vertical extent of soil contamination (reference, *Table 3*).

Laboratory analyses of soil samples collected on April 27 and May 16, 2007 indicated chloride concentrations ranged from 16 mg/Kg (SW-9B) to 1,296 mg/Kg (BH-2C) with the latter value exceeding remedial threshold goals of 250 mg/Kg (reference *Figure 6* and *Table 3*).

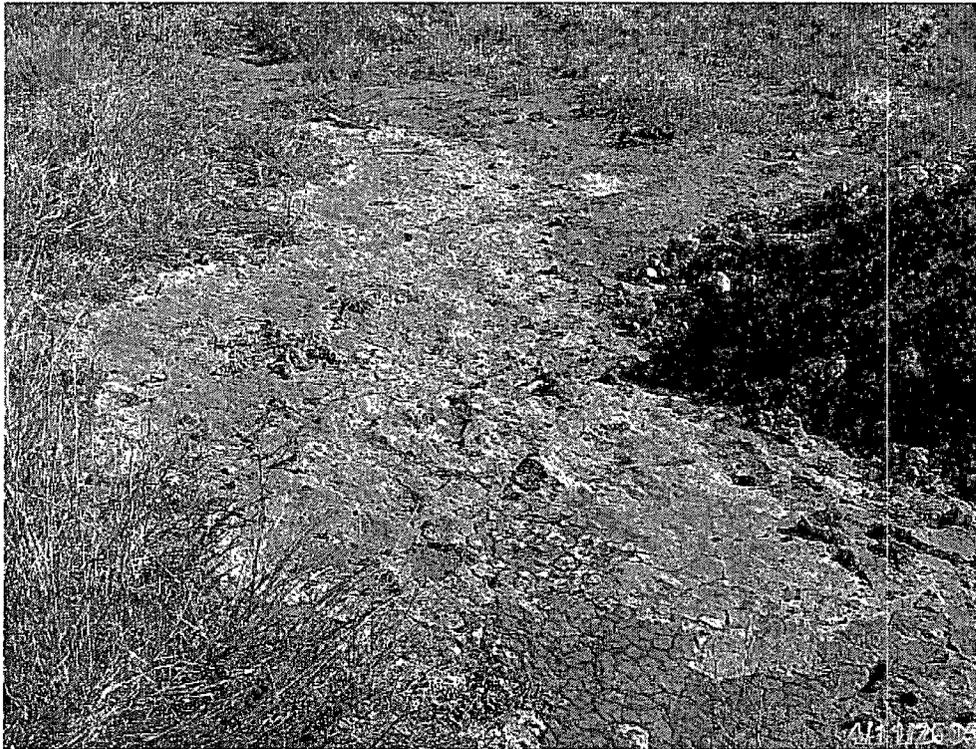
Photograph #3 - Looking north at impacted area and soil excavated to repair the ruptured pipeline

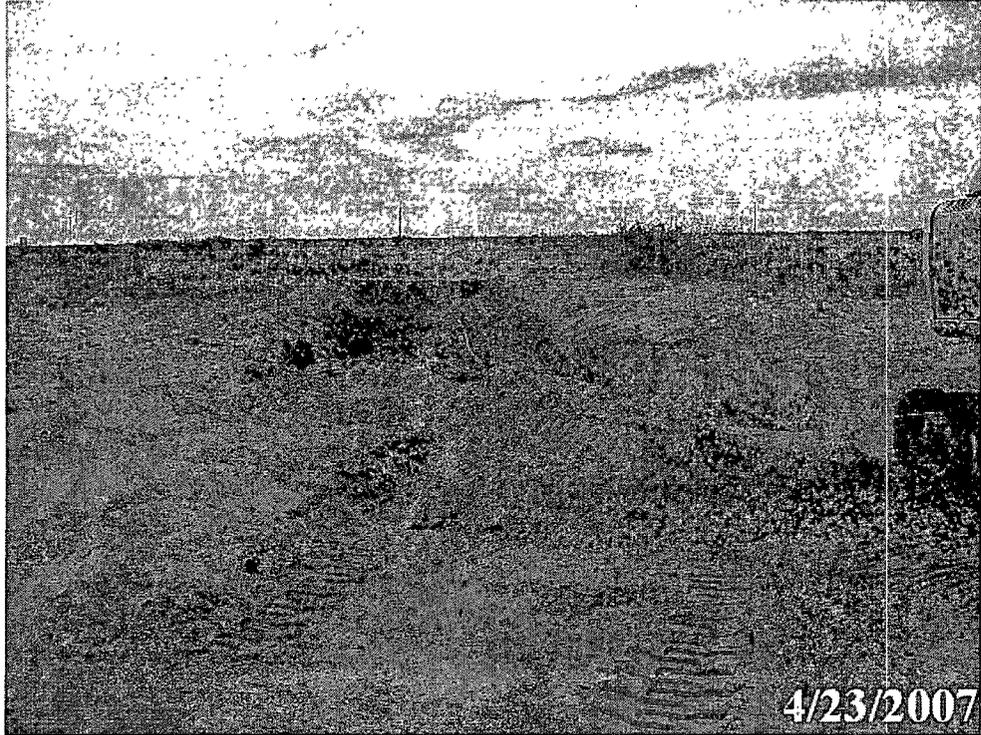
Photograph #5 – Excavation area

From February 26 through May 22, 2007 approximately 1,302 yds³ of chloride impacted soil above NMOCD remedial threshold goals were disposed at Sundance Services, Inc.

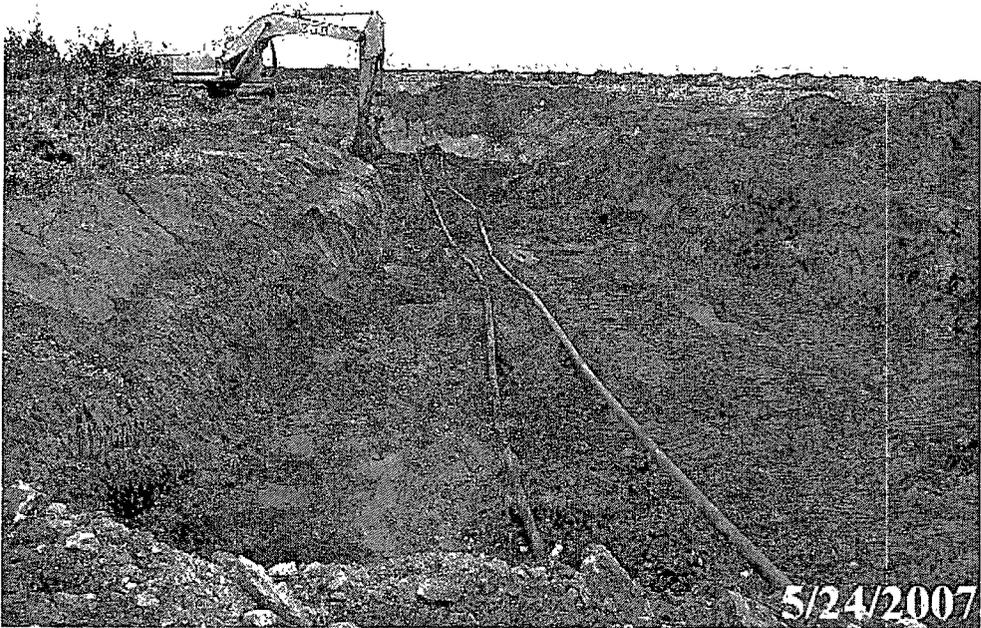
Photograph #6 – Backfilling excavation area. Preparing for installation of liner.

To prevent vertical migration of residual in situ chloride concentrations a 20-mil polyethylene liner sandwiched between one (1) foot thick layers of cushion sand was placed on the entire bottom of the excavation. The remainder of the excavation was backfilled with clean topsoil to original ground surface. The excavation was backfilled with approximately 1,414 cubic yards of imported top soil. Upon completion of backfill operations, the entire remedial area was graded to allow natural drainage and seeded with a grass blend preferred by the property owner.

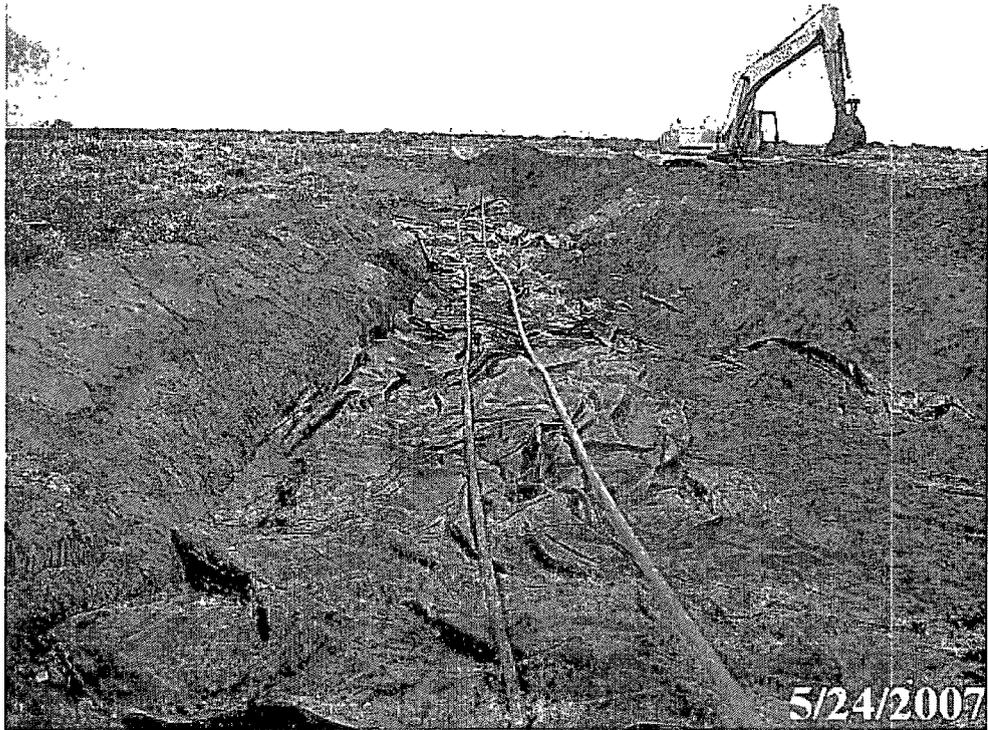
Photograph #7 – Installation of liner and backfilling of excavation

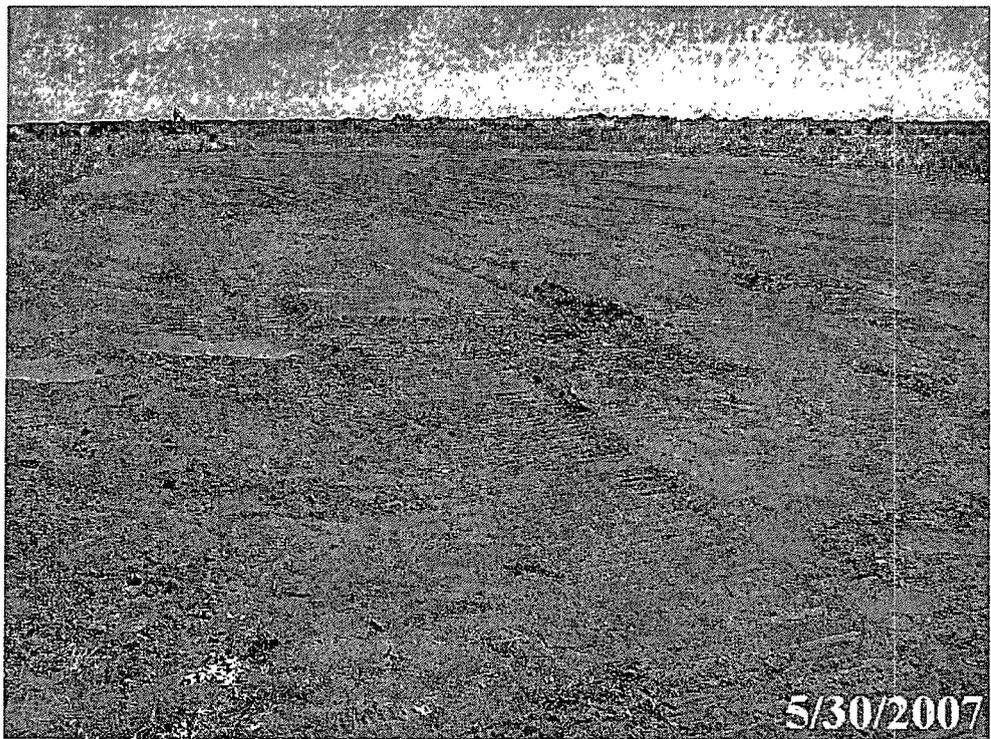
Photograph #8 – Remediated site

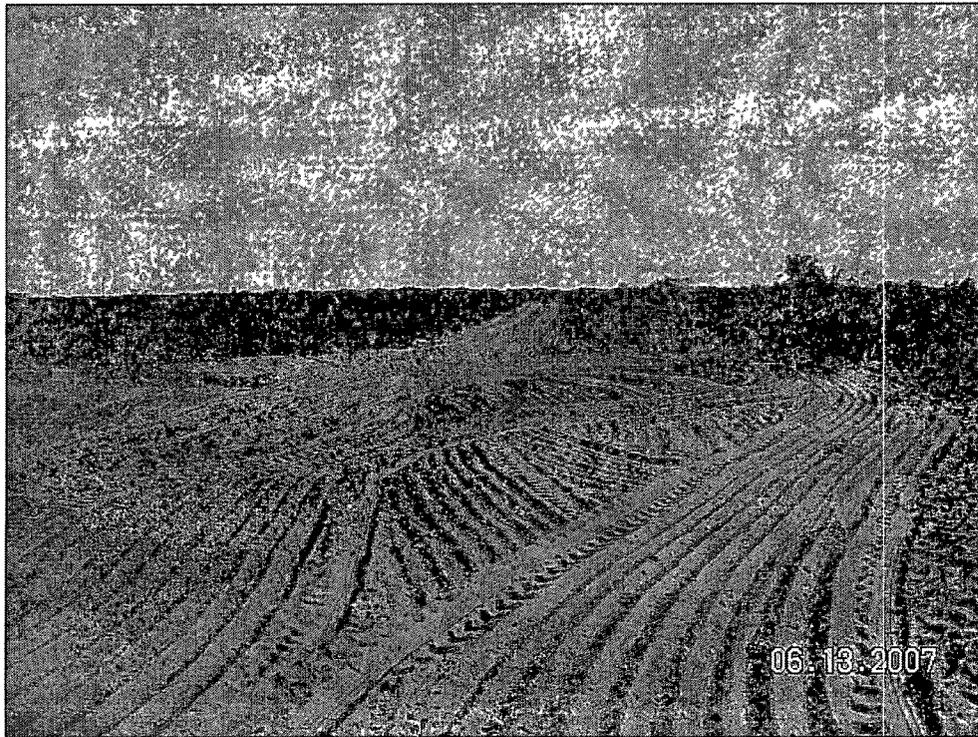
Photograph #9 – Remediated site reseeded

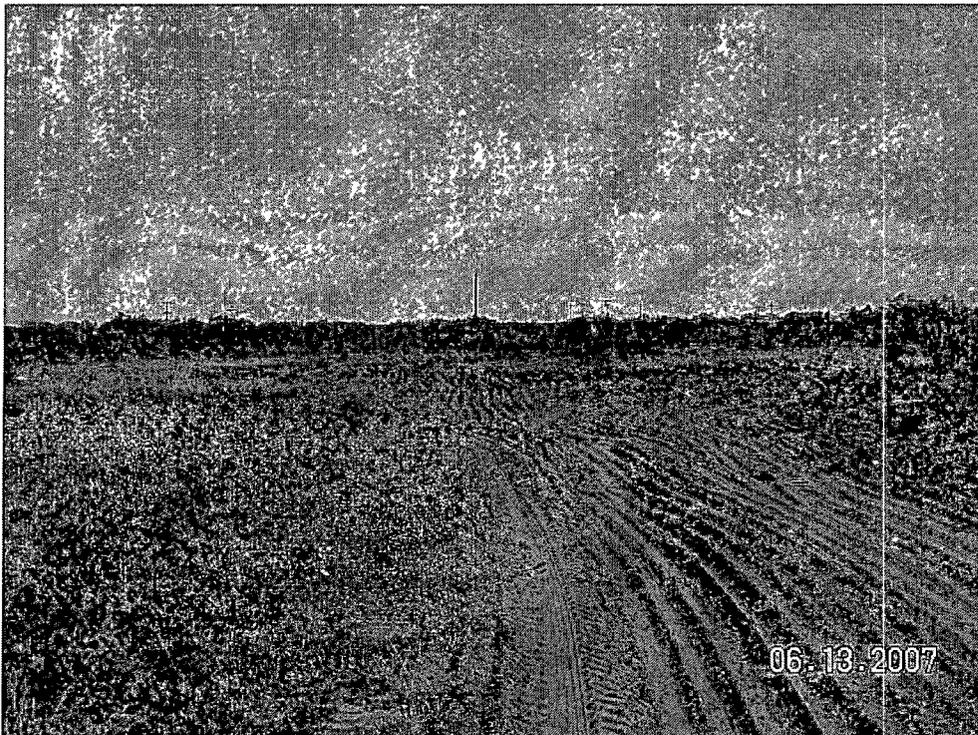
Photograph #10 – Remediated site reseeded
