CLOSURE REPORT (FINAL)

MOBIL STATE ZZ TANK BATTERY

NMOCD 1RP #1495

SEPTEMBER 2007

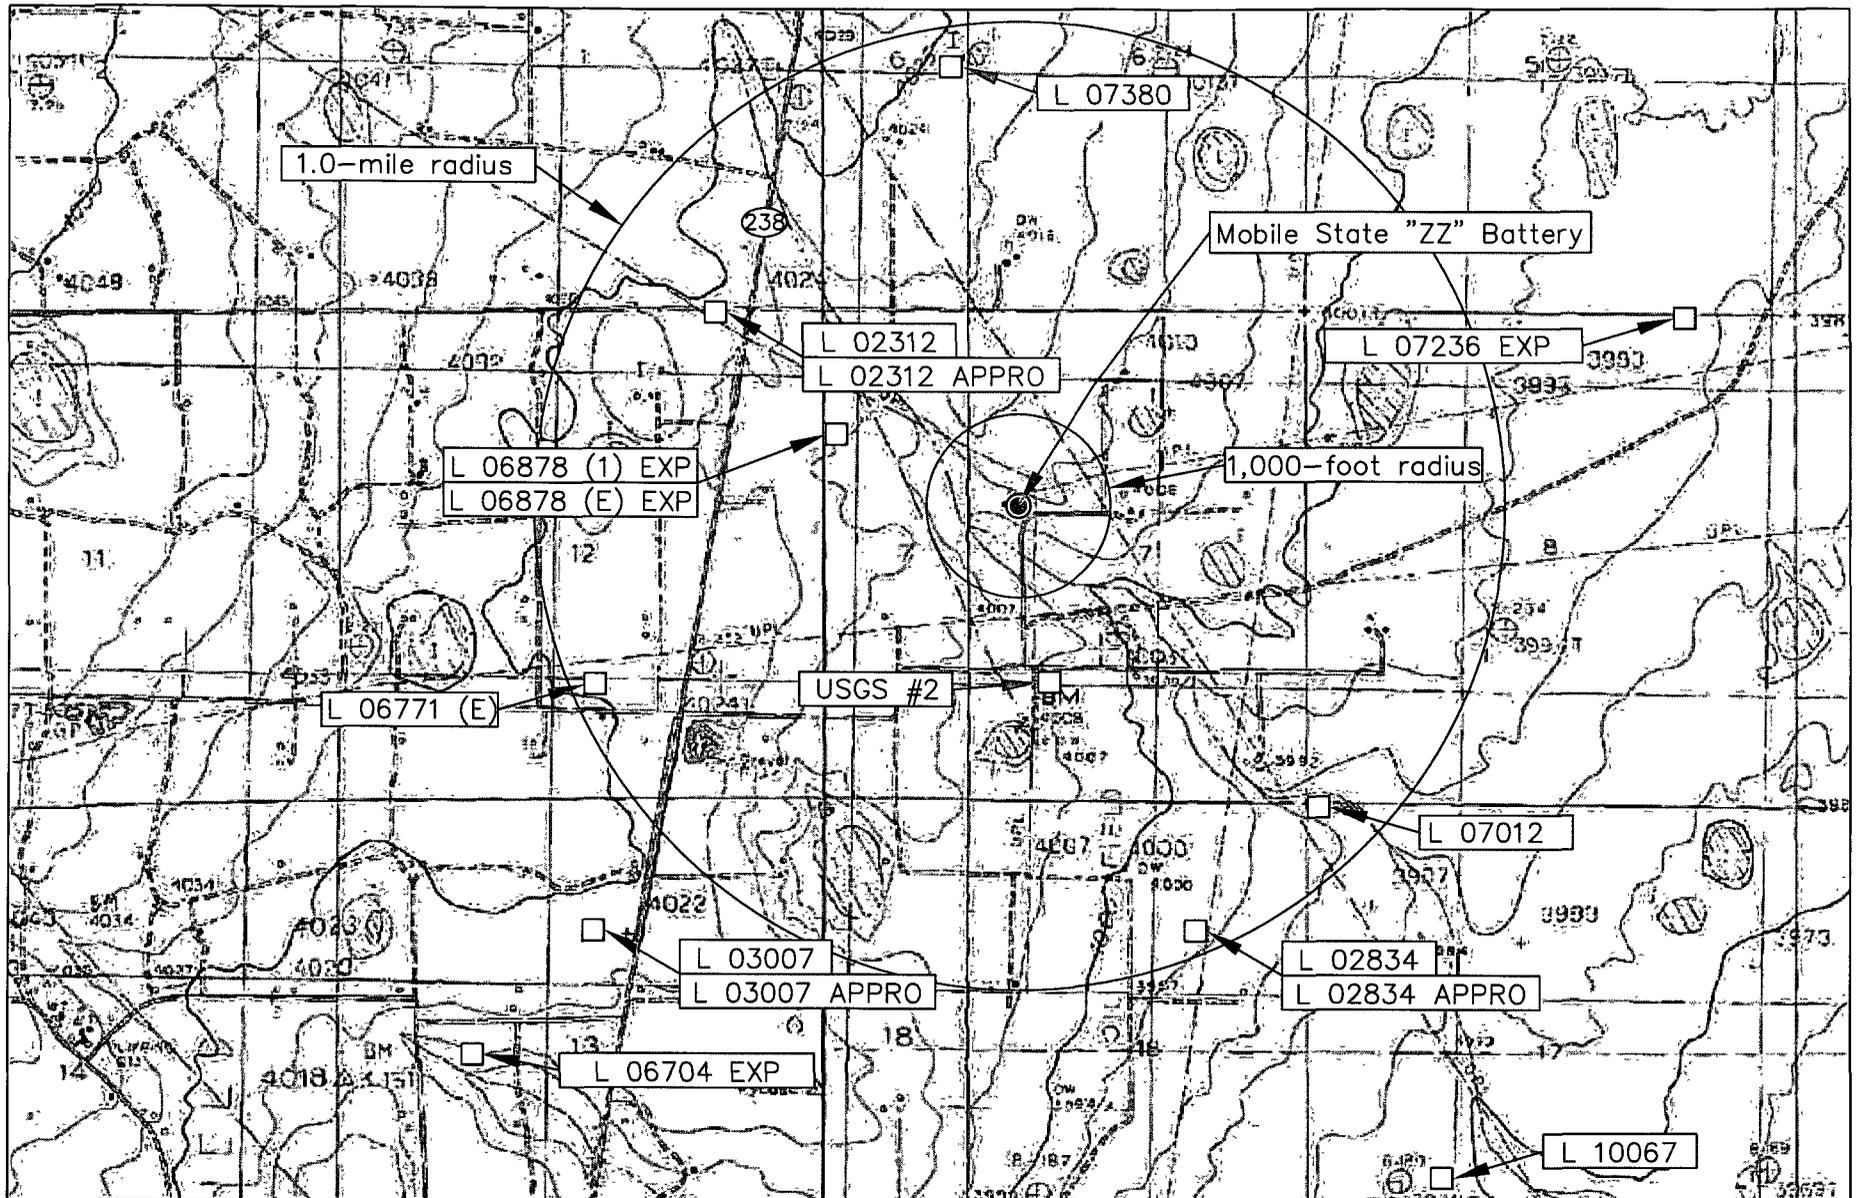
Figure 2
Site Location Map
Centurion Pipeline, L.P.
Mobile State ZZ Tank Battery

- 2.9 ***Area Water Wells***
No public water supply wells are located within 1,000-feet of the release site. A six (6) inch diameter steel cased water well existed on the well pad within 100-feet of the release area. The water well was plugged in accordance with New Mexico regulations by Straub Corporation of Stanton, Texas. In addition, no private domestic fresh water wells or springs used by less than five households for domestic or stock watering purposes exist within 200-feet of the release site (reference *Table 1*, *Figure 2* and *Appendix IV*).

- 2.10 ***Area Surface Water Features***
No surface water features exist within 1,000 feet of the release site (reference *Figure 2*).

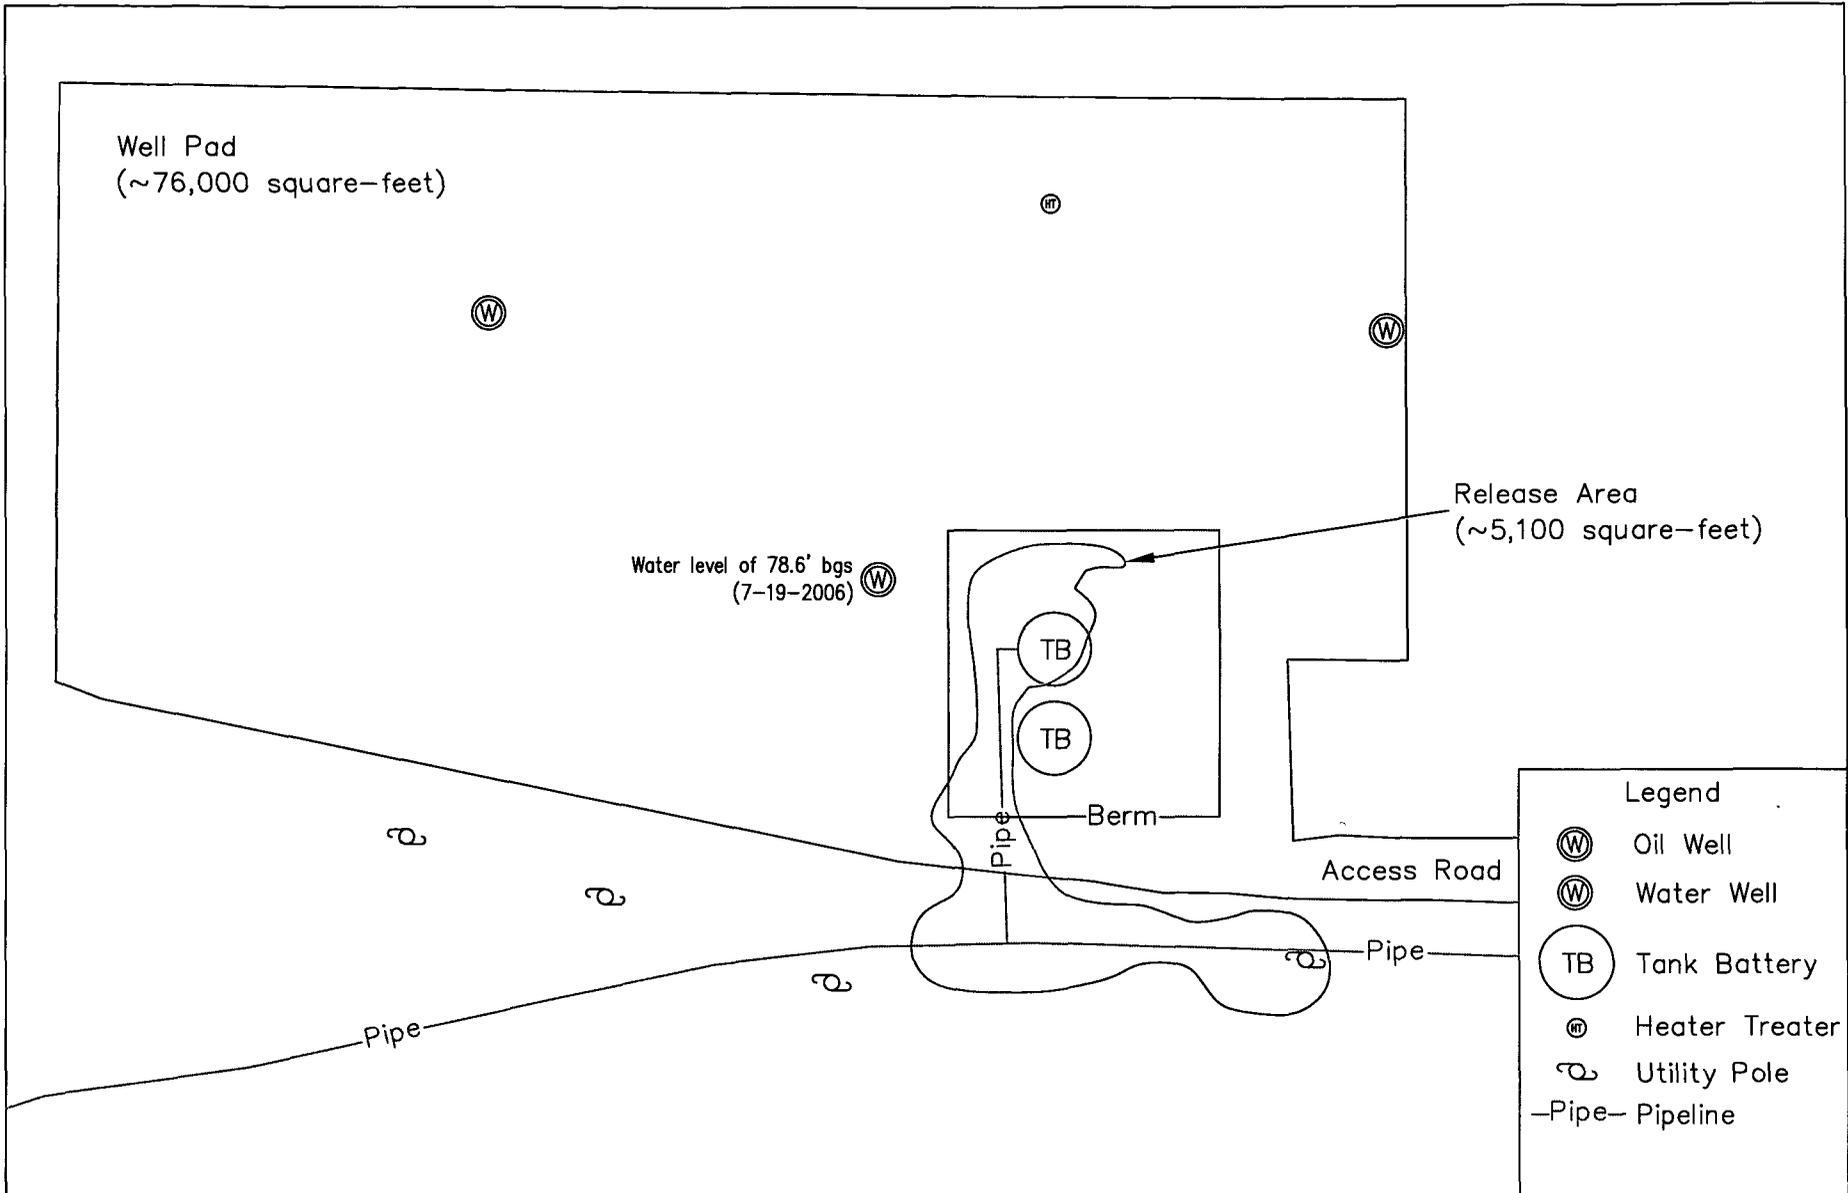
Figure 3
 Site Map
 Centurion Pipeline, L.P.
 Mobile State ZZ Tank Battery

On 17 August 2006, soil samples were collected from four (4) test trenches excavated within the initial release area. Excavation of test trenches was to a maximum depth of 4-feet bgs at T-1 and T-3, 12-feet bgs at T-2 and 6-feet bgs at T-4. Test trench samples were collected at near surface (i.e., 3-inches), 2-feet bgs and 2-foot intervals thereafter for total depth of trench (reference *Figure 3*).

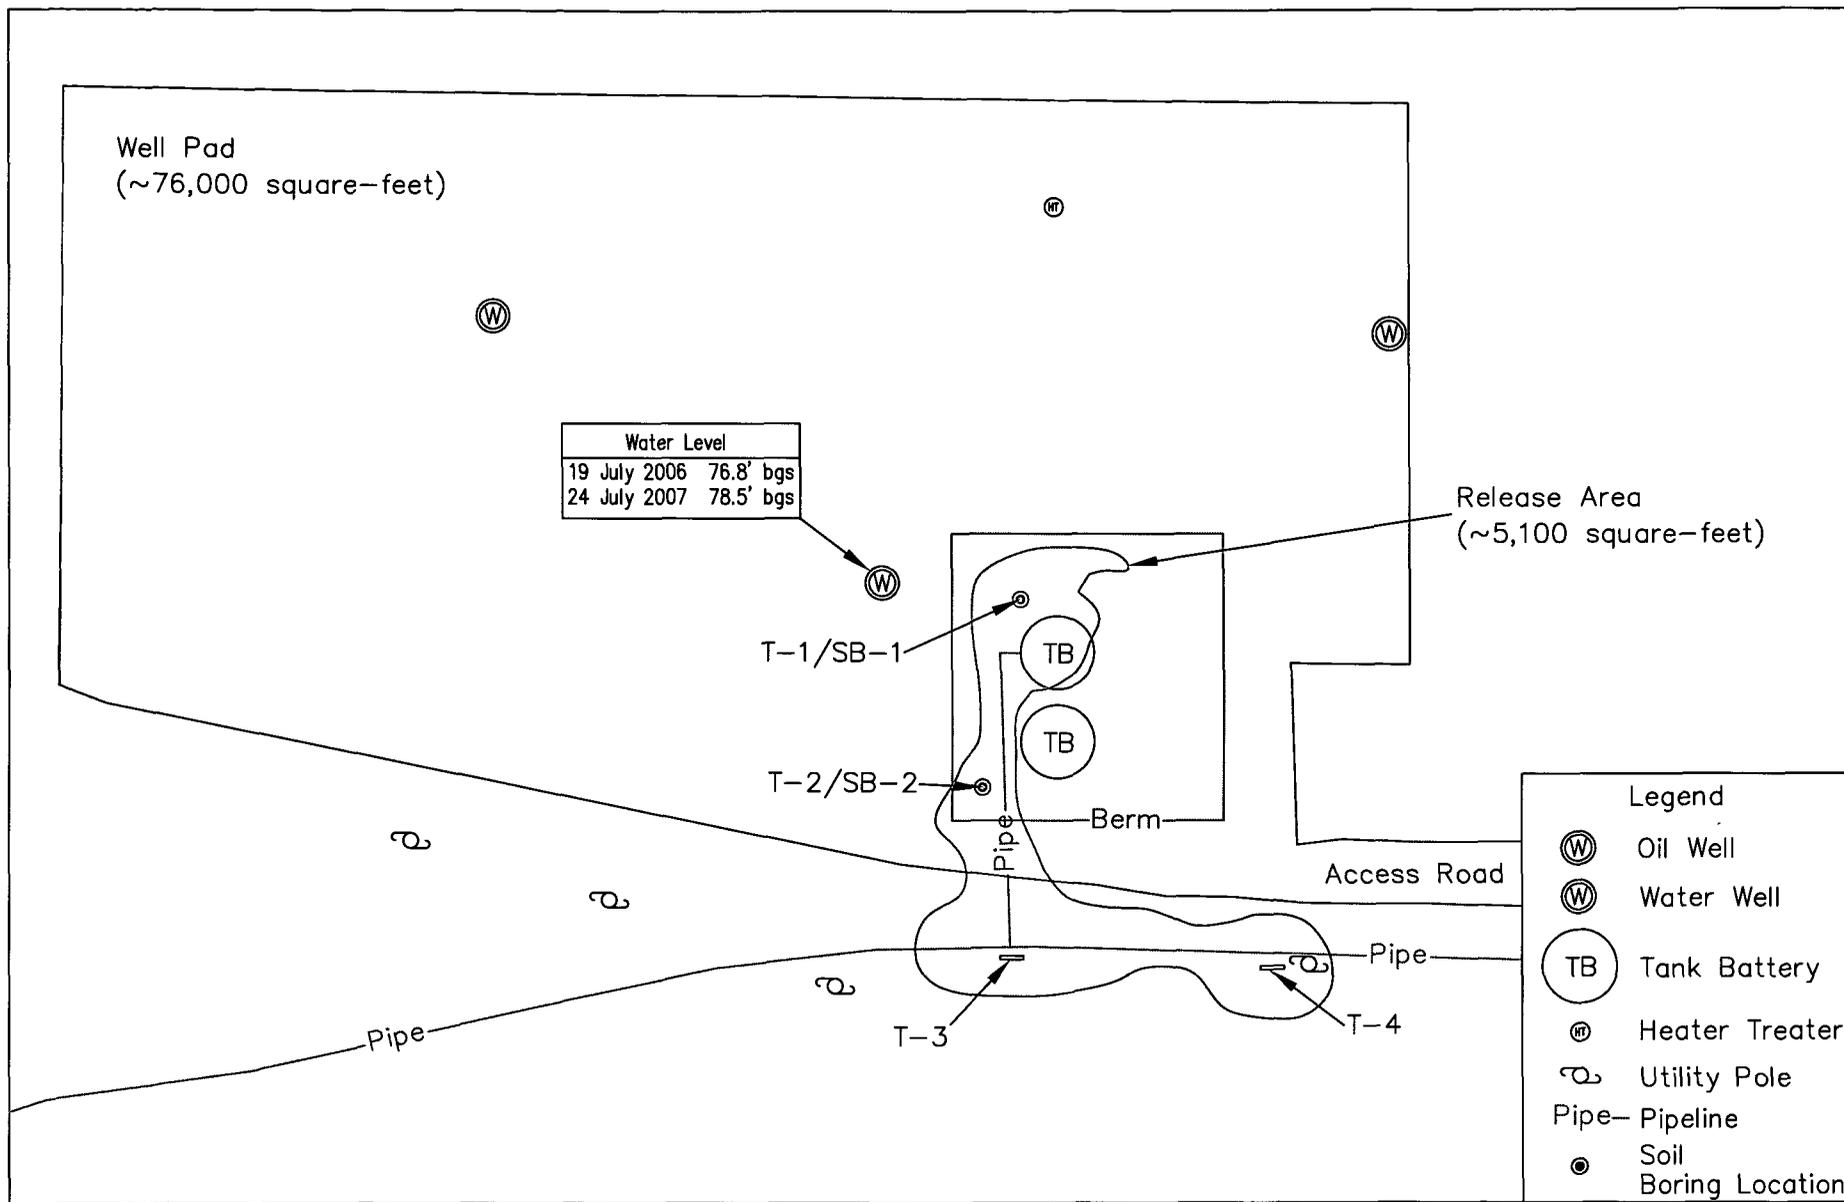
Figure 4
Test Trench/Soil Boring Location Map
Centurion Pipeline, L.P.
Mobile State ZZ Tank Battery

On 11 October, 2006, soil borings SB-1 and SB-2 were advanced near the location of test trenches T-1 and T-2. Soil samples were collected from SB-1 at 15-, 20-, 25- and 30-feet bgs. Soil samples were collected from SB-2 at 5-, 10- and 15-feet bgs. Soil boring location was chosen to delineate the vertical extent of impacts within the release area (reference *Figure 4*).

Laboratory analyses of soil samples collected on August 17, 2006 from test trenches T-1, T-2 and T-4 and October 11, 2006 from soil borings SB-1 and SB-2, indicated the bulk of impacted soil (i.e., TPH concentrations >1,000 mg/Kg) was limited to within 6-feet of ground surface. TPH concentrations in remaining sample locations (i.e., test trench T-3) and sample intervals were non-detectable (ND) at or above laboratory analytical method detection limits (MDL), with the exception of soil samples SB-1 (15') and SB-2 (12'). These samples indicated TPH concentrations were 334 and 115 mg/Kg, respectively. Reported BTEX constituent concentrations were below NMOCD remedial goals. Laboratory analyses of chloride concentrations were not performed during these sampling events (reference *Figure 4* and *Table 2*).

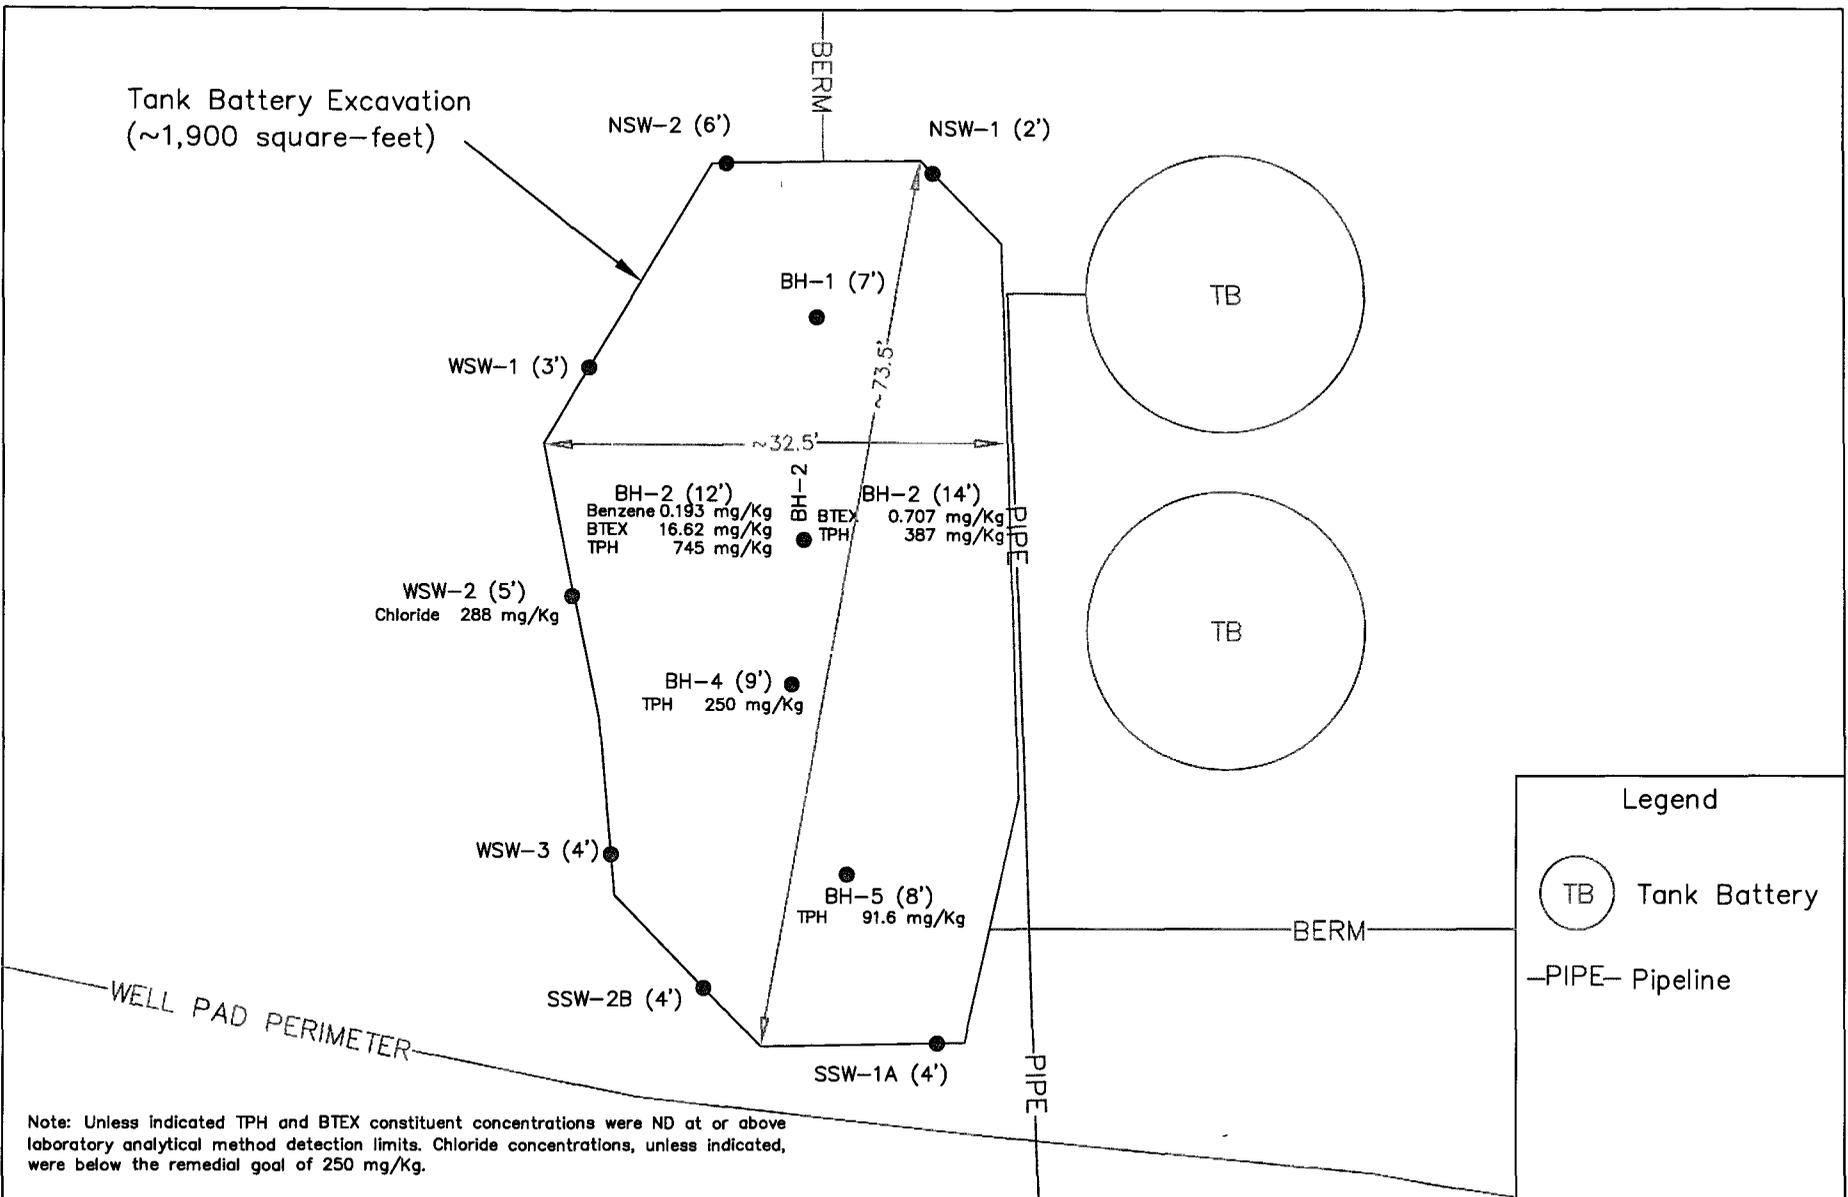
Figure 6
Tank Battery Excavation
Sample Location Map
Centurion Pipeline, L.P.
Mobile State ZZ Tank Battery

On April 23 and 26, 2007, soil samples were collected from the tank battery excavation sidewalls and floors. Based on laboratory analytical data indicating excessive TPH and chloride concentrations, remediation activities continued on the south sidewall. Soil samples were collected on May 7, 2007 from the south sidewalls (for final sample locations reference *Figure 6*).

Laboratory analyses of final soil samples collected from the tank battery excavation sidewalls indicated TPH and BTEX constituent concentrations were ND at or above laboratory analytical MDL. TPH concentrations in soil samples collected from the excavation floor ranged from ND to 745 mg/Kg. Benzene concentrations in excavation floor soil samples ranged from ND to 0.193 mg/Kg. BTEX concentrations ranged from ND to 16.62 mg/Kg. Chloride concentrations ranged from ND to 288 mg/Kg (reference *Figure 6* and *Table 3*).

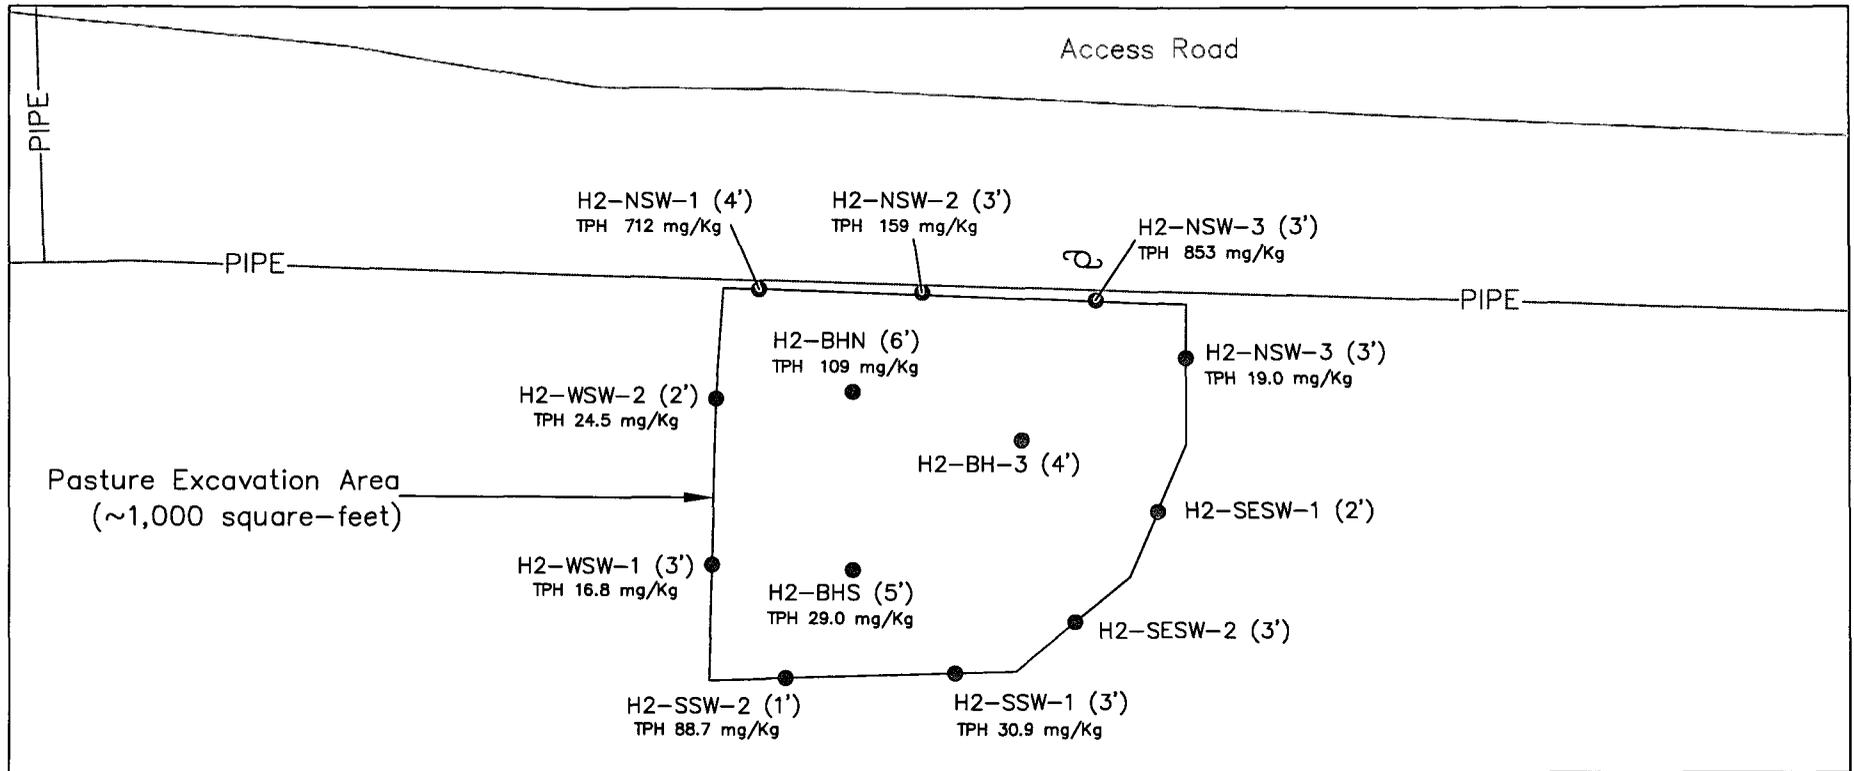
Figure 7
Pasture Excavation
Sample Location Map
Centurion Pipeline, L.P.
Mobile State ZZ Tank Battery

Soil samples were collected on April 30 2007, from the pasture excavation sidewalls and floor. Based on laboratory analytical data indicating excessive TPH concentrations, remediation activities continued on the east sidewall. Soil samples were collected on May 4, 2007 from the east sidewall and the newly excavated portions along the north and south sidewalls (for final sample locations reference *Figure 7*).

Laboratory analyses of final soil samples collected from the pasture excavation indicated TPH concentrations in the east, southeast and south sidewalls were less than 100 mg/Kg. TPH concentrations in the excavation floor ranged from ND to 109 mg/Kg. TPH concentrations in the north sidewall soil samples ranged from 159 to 853 mg/Kg. BTEX constituent concentrations in all sample locations was reported as ND at or above laboratory analytical MDL. Chloride concentrations ranged from 16 to 112 mg/Kg (reference *Figure 7* and *Table 4*).

Note: Unless indicated TPH and BTEX constituent concentrations were ND at or above laboratory analytical method detection limits. Chloride concentrations, unless indicated, were below the remedial goal of 250 mg/Kg.

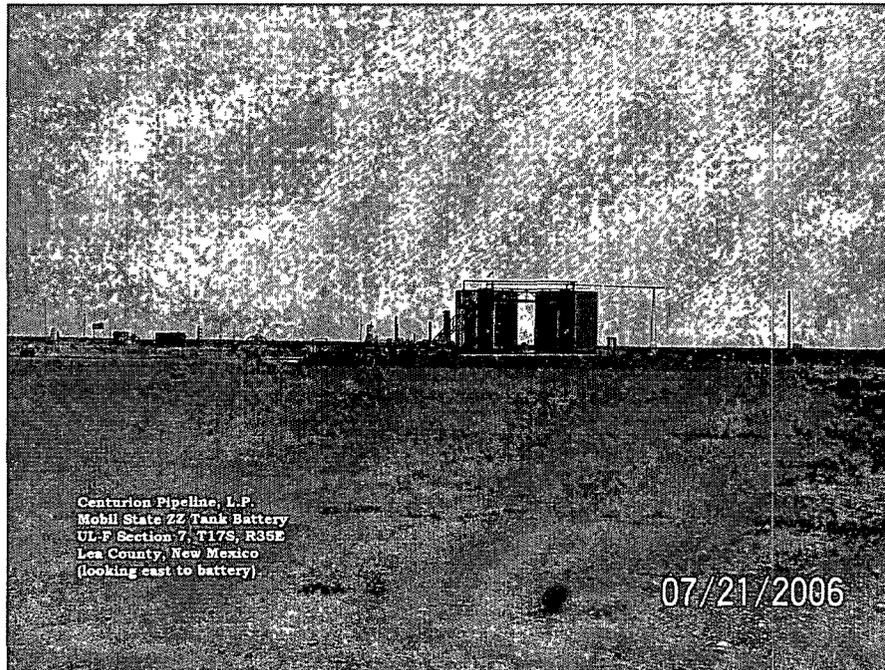
Photo #1: Looking easterly across site during initial site assessment.

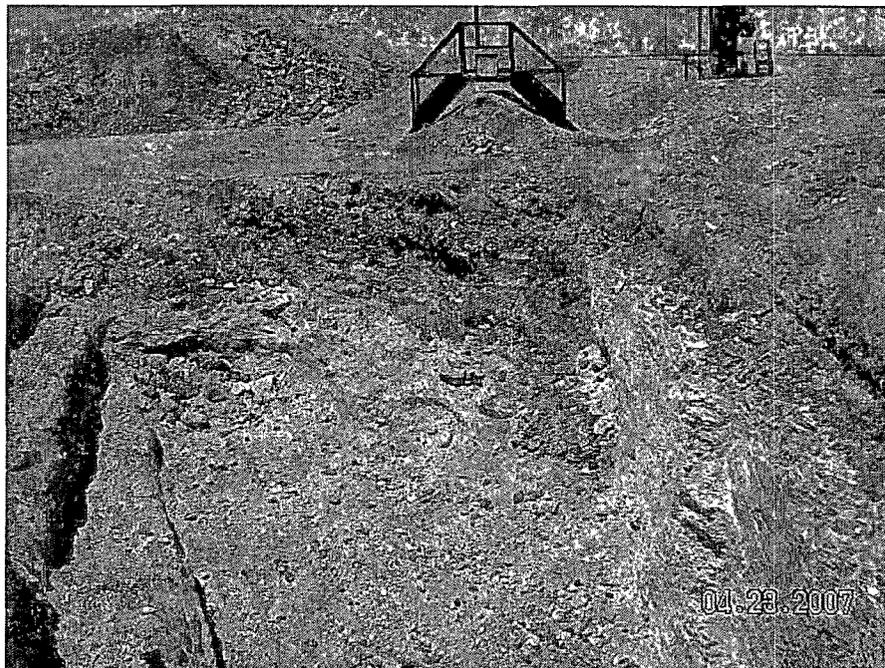
Photo #2: Looking northerly at north wall of tank battery excavation area.

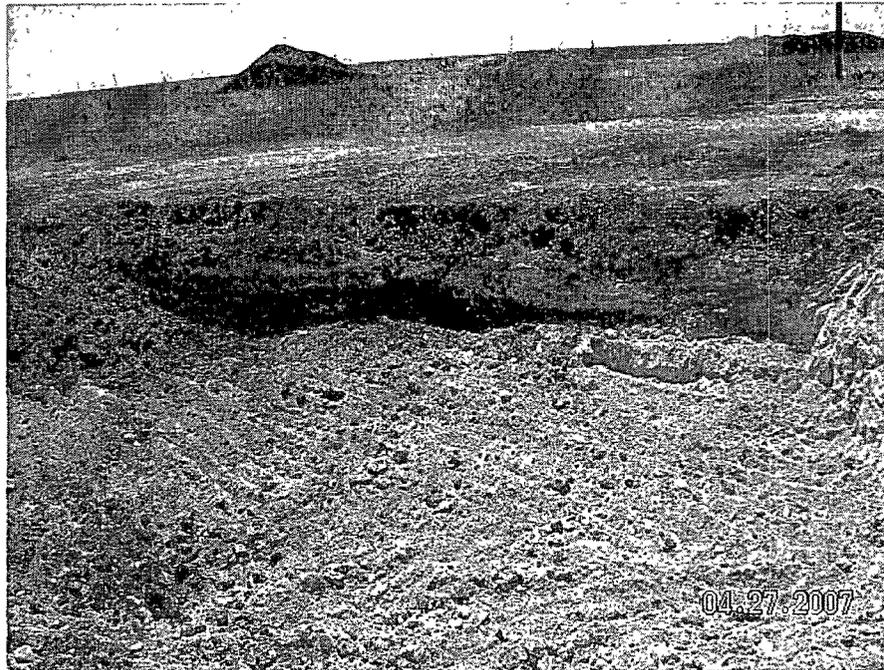
Photo #3: Looking southerly across pasture excavation area.

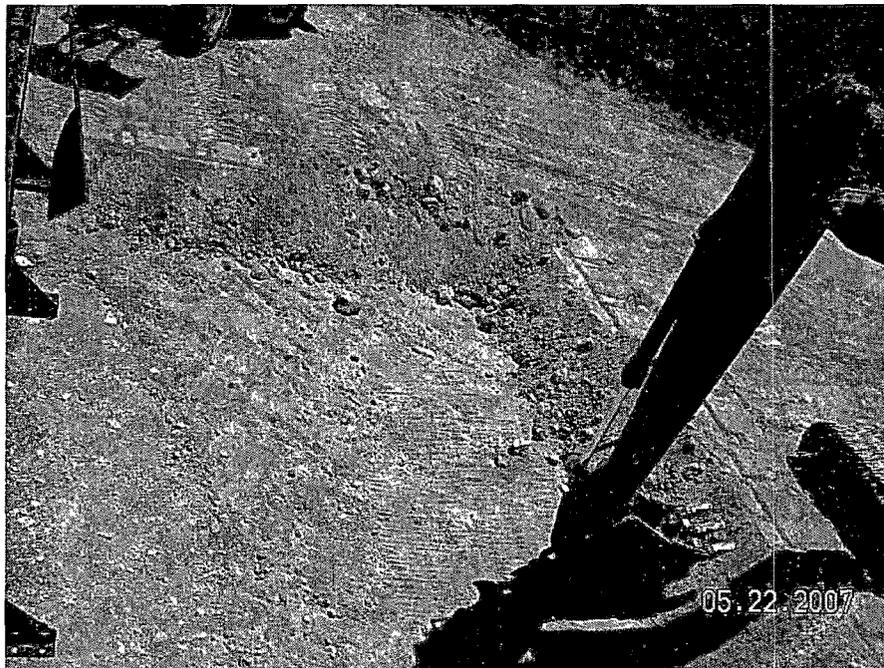
Photo #4: Looking down on tank battery excavation area upon completion of backfilling.

Approximately 1,746-cubic yards of hydrocarbon impacted soil were excavated from the tank battery area (~1,800-square feet) and pasture area (~1,000-square feet) to a maximum depth of 14-feet bgs. With plugging and abandoning the on-site water well, adequate depth to groundwater and NMOCD approval of TPH, BTEX constituent and chloride concentrations represented in field and laboratory analyses of soil samples, groundwater should not be impacted from this release. Excavated, hydrocarbon impacted soil was transported to Artesia Aeration and South Monument Landfarm for treatment. The excavation was backfilled with clean soil and the pasture remediation area seeded with a blend suitable to the landowner.

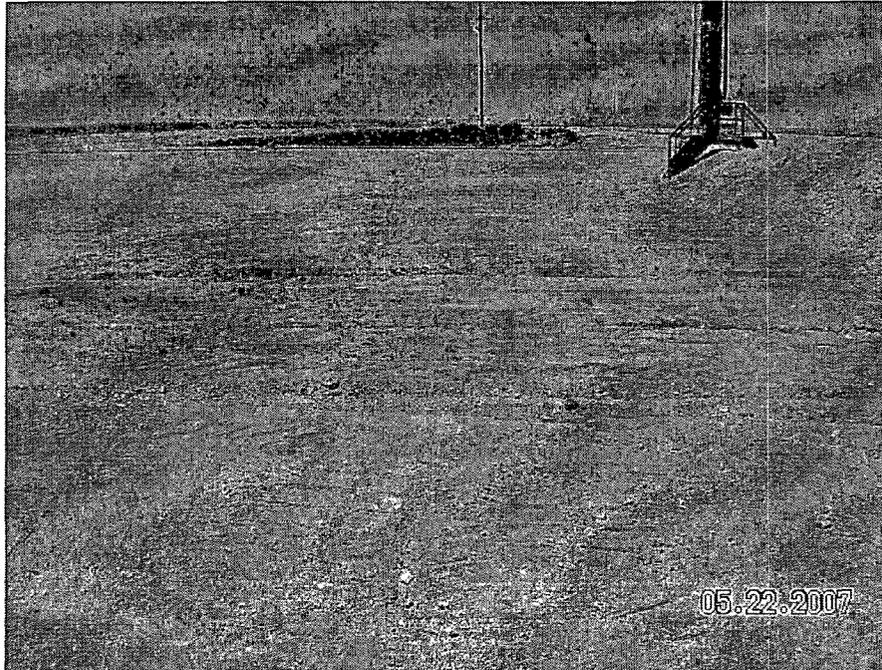
Photo #5: Looking northerly across tank battery excavation area after grading/contouring.
