Teledyne 12 Federal Battery

Located in Unit Letter L, SEC. 12, T23S, R28E of Eddy Co., NM

API # 30-015-33928

Spill Remediation Report

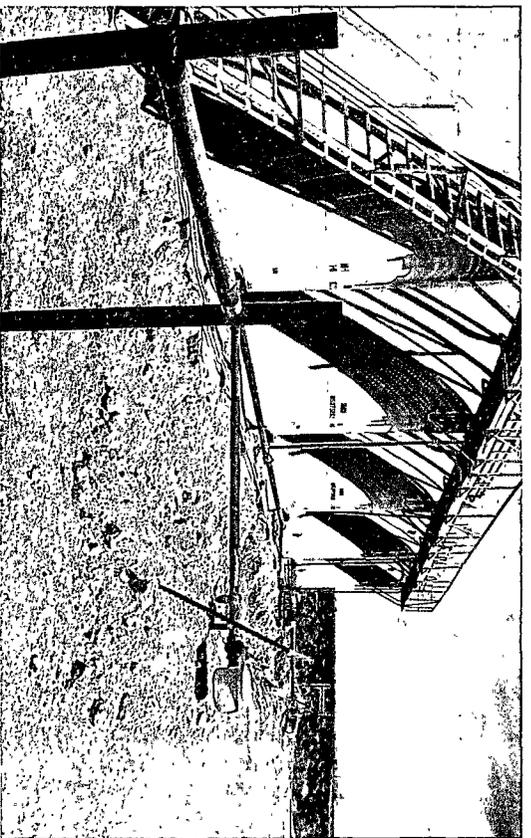
Photo #6 Starting To Build New Firewall

- 5. September 6, 2007 – Crew backfilled impacted soil areas with clean caliche and built new firewall around tank battery, dressed location, and put fencing back up around the facility to complete job.*

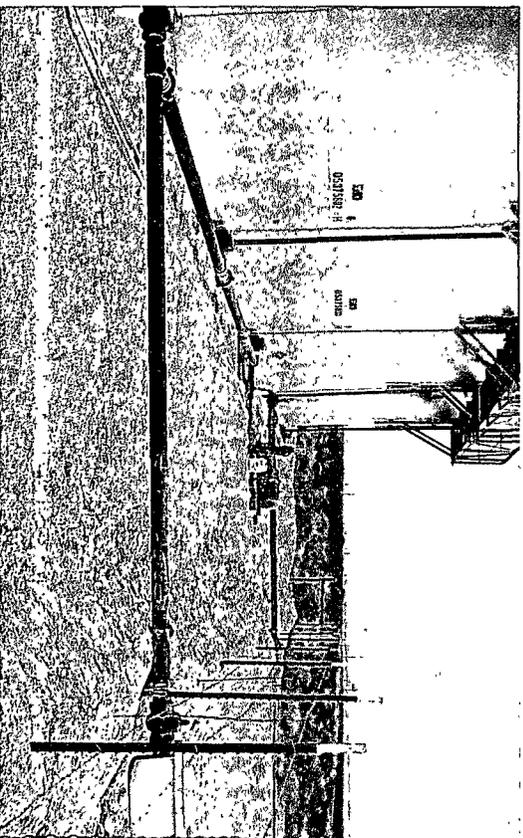
Photo #8 Final View of Clean Up

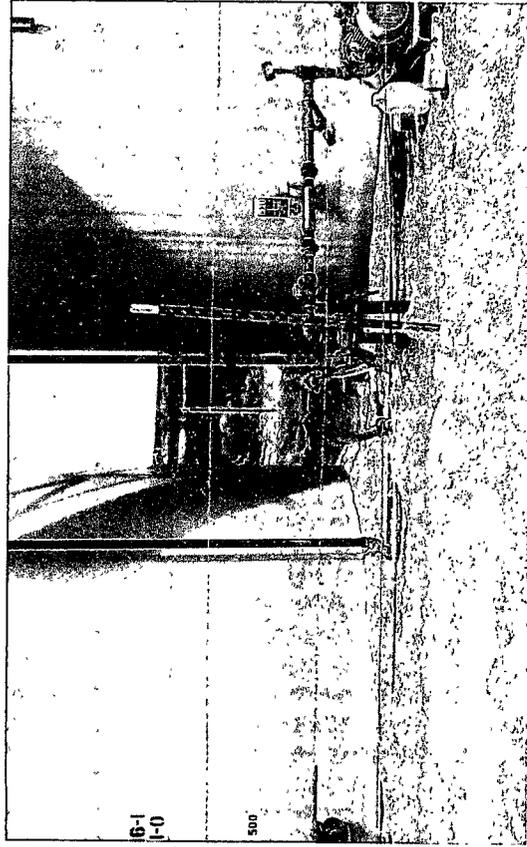
Photo #10 Final View of Cleaned Up Tank Battery

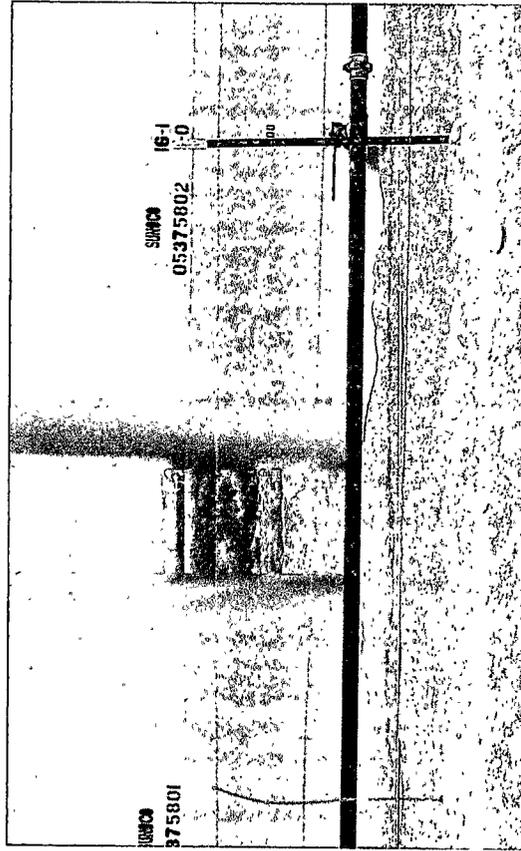
Photo #12 Final View of Clean Up

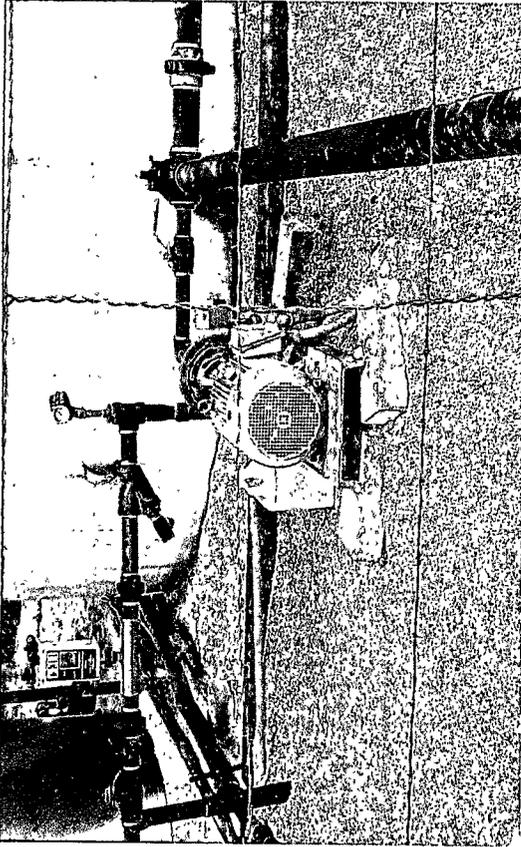
Photo #9 Final View of Cleaned Up Tank Battery
