DATA EVALUATION AND CLOSURE PROPOSAL

TRACT 5 – 4" GATHERING

PLAINS SRS NO.: 2006-378
NMOCD 1RP# 1124

Project No. 207167.00

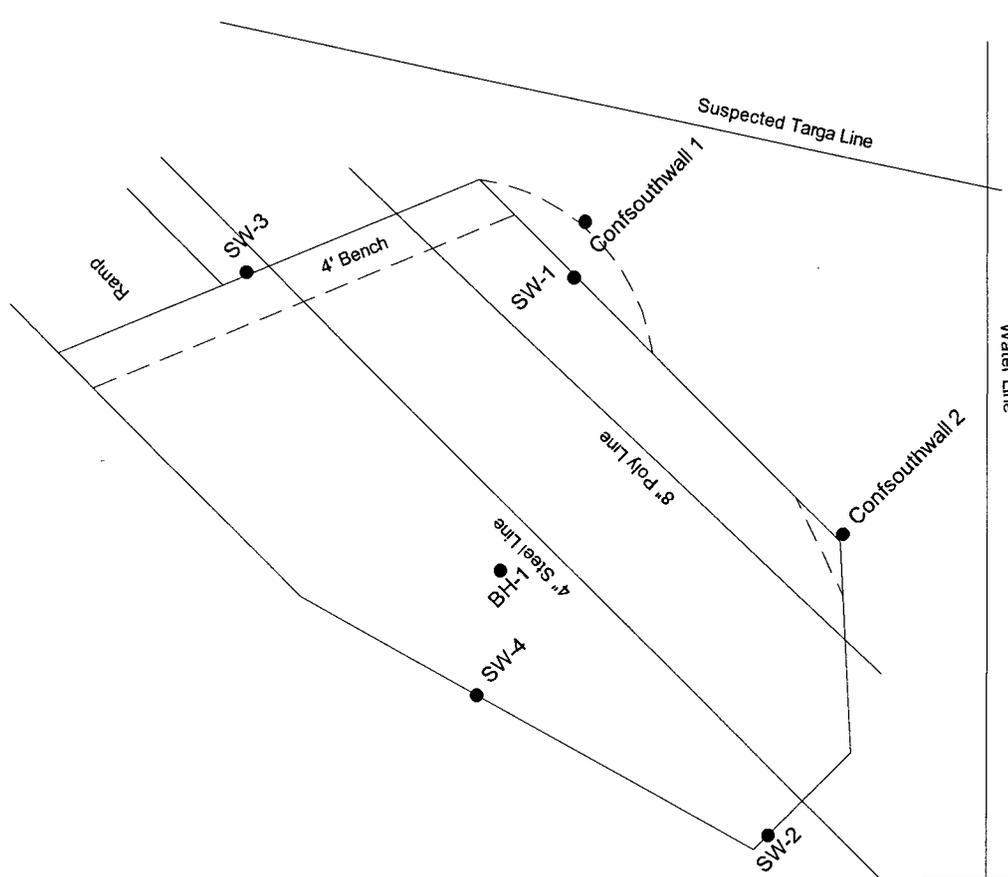
Figure 2 – Site Map

On June 28, 2007, soil samples were collected by Premier Environmental Services, Inc. (Premier) to determine the concentration of residual hydrocarbons in the side-walls of the excavation and in the base of the excavation. The walls and base of the excavation were first screened using visual and olfactory senses and the samples with the highest staining and/or odor were submitted for laboratory analyses. The analytical data displayed TPH concentrations above NMOCD cleanup goals in the samples collected from the base of the excavation (sample BH-1) and the south wall (sample SW-1). The analytical results for these two samples are summarized in Table 3, Appendix B. The analytical data for soil sample BH-1 display concentrations of TPH via EPA method 8015 modified as 12,046 mg/Kg, benzene and BETX concentrations via EPA method 8021b as 4.862 mg/Kg and 84.912 mg/Kg respectively. The analytical data for soil sample SW-1 display concentrations of TPH via EPA method 8015 modified as 6,964 mg/Kg, benzene and BETX concentrations via EPA method 8021b as <0.0021 mg/Kg and 0.037 mg/Kg, respectively.

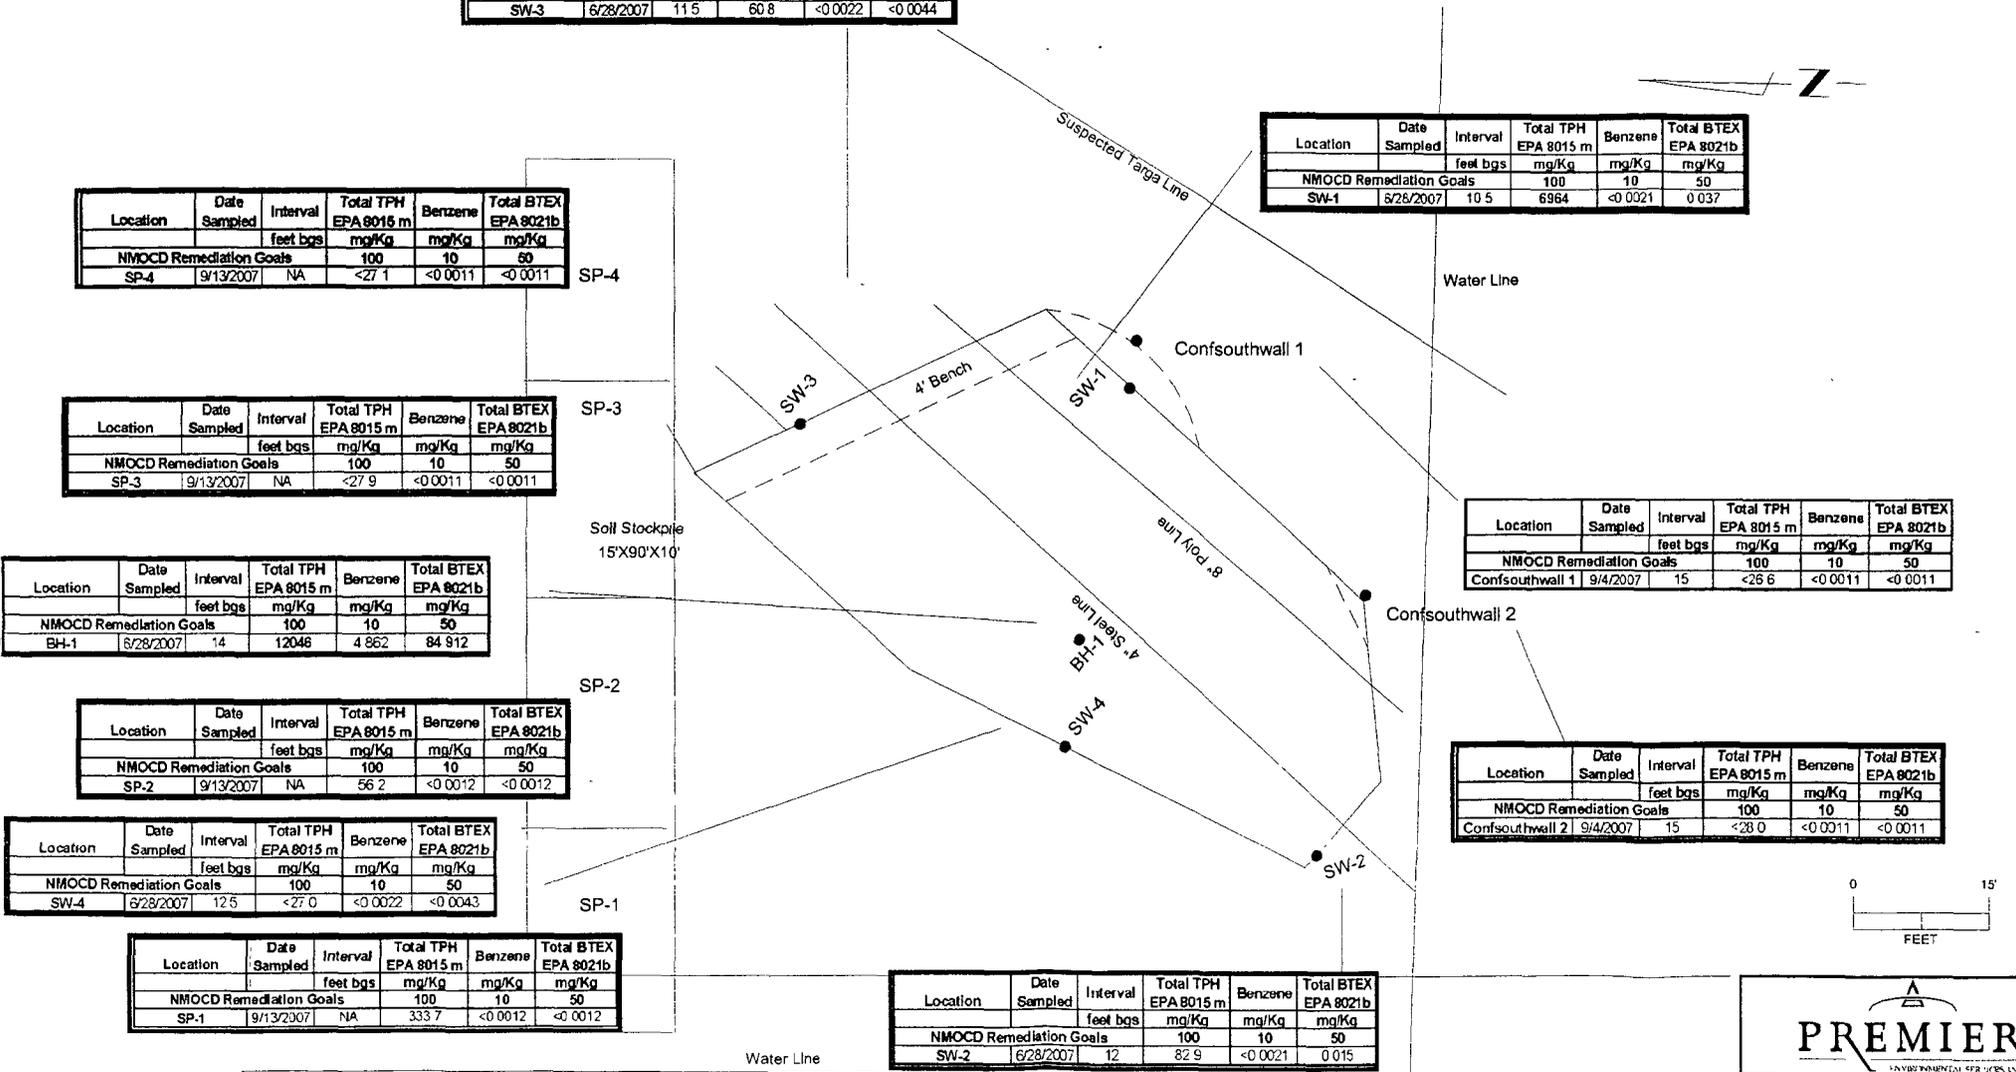
Figure 3 – Map of Soil Samples with COC Concentrations in Soil

crude oil affected soil, on December 7, 2006, a single soil boring was advanced in the bottom of the excavation below the leak origin by EPI. Five soil samples were collected from 22 feet bgs to 47 feet bgs at five foot intervals. The analytical data illustrates the concentrations of the contaminants of concern were below regulatory guidelines from 27 to 47 feet. Soil samples collected in this interval (27 to 47 feet bgs or alternatively stated from 5 feet or greater below the base of the excavation) indicate TPH and BTEX concentrations were generally below the laboratory method detection limits of 5 mg/Kg for TPH and below 0.020 mg/Kg for BTEX and benzene. Analytical results are shown on Figure 3, Appendix A, and are summarized in Table 3, Appendix B.
