**Release Notification and Corrective Action**

Name of Company: Rice Operating	Contact: Tony Grieco
Address: 122 W. Taylor St., Hobbs, NM 88240	Telephone No.: (575) 393-9174
Facility Name: BD	Facility Type: Salt Water Gathering System
Surface Owner: Irvin Boyd	Mineral Owner
Lease No.

# BD P-15 LEAK

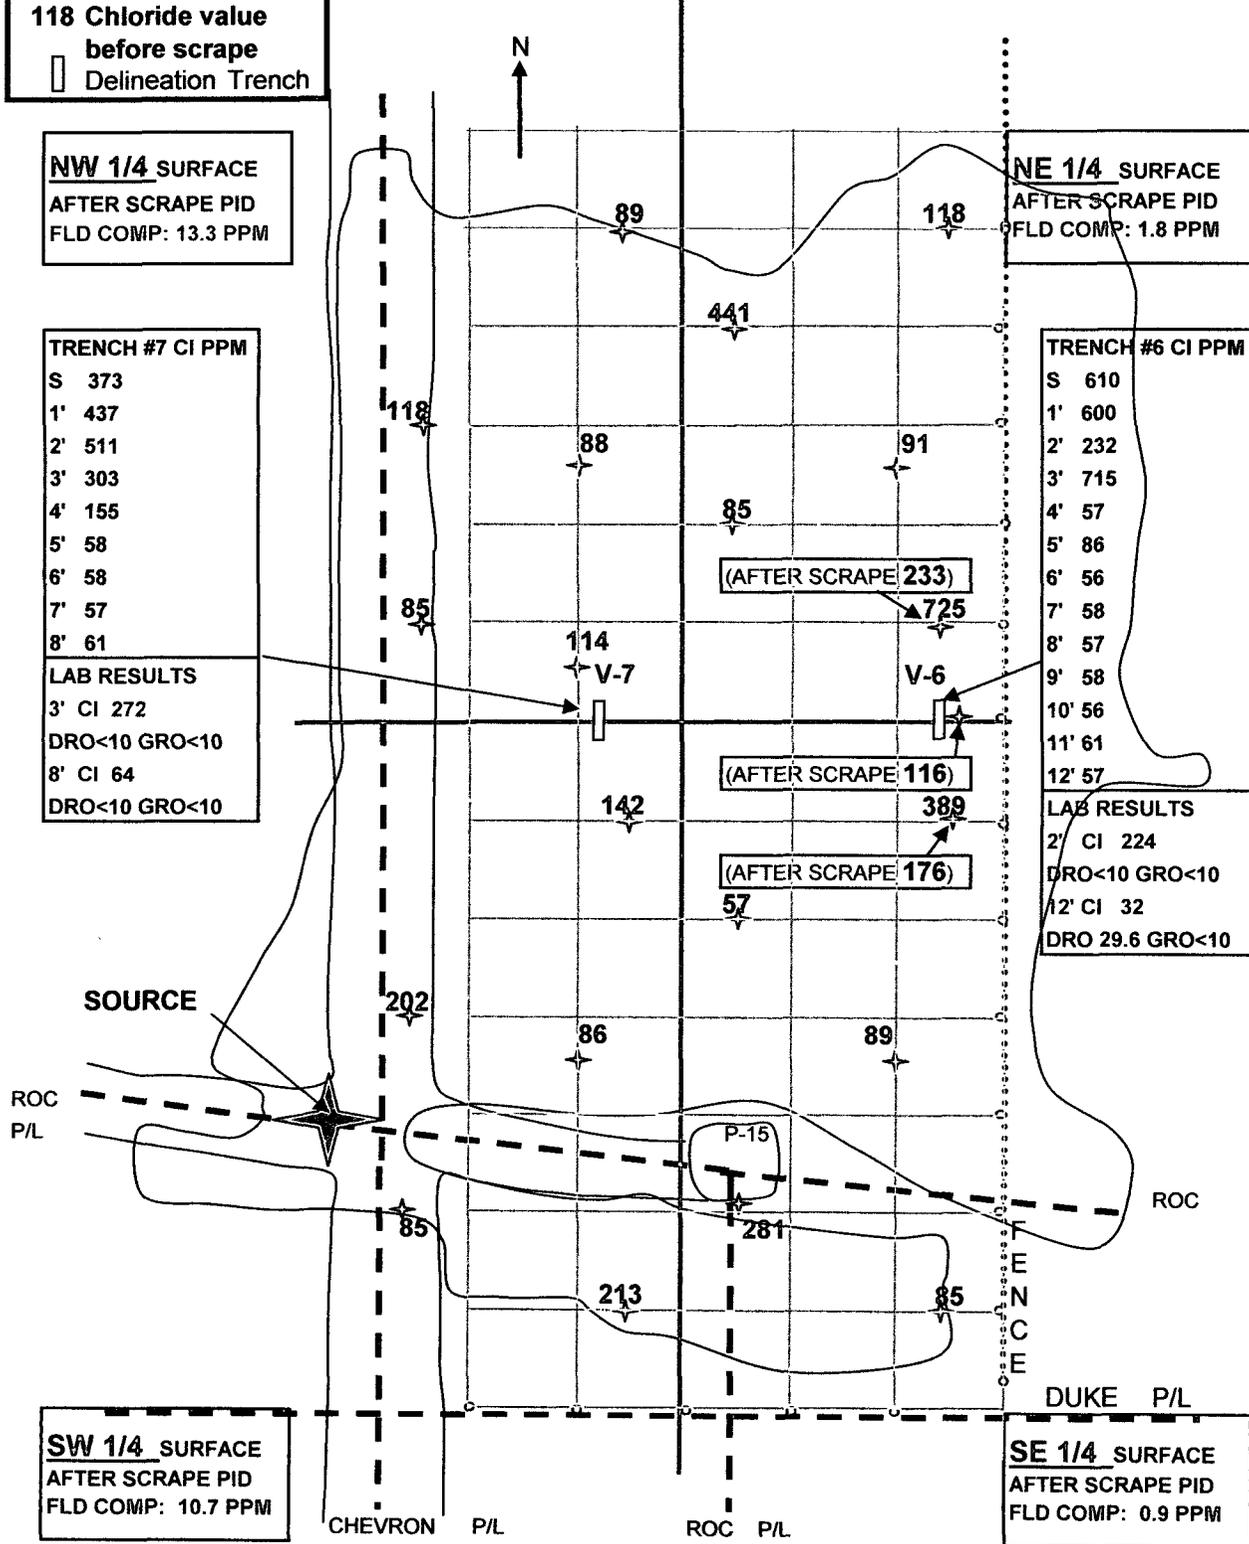
# BD P-15 LEAK SITE WEST OF HWY 18

UL/P SEC 15 T-22-S R-37-E GW: 75ft LANDOWNER: IRVIN BOYD

## FIELD CHLORIDE RESULTS (PPM) BEFORE AND AFTER SCRAPE

**NW 1/4 SURFACE**  
AFTER SCRAPE PID  
FLD COMP: 13.3 PPM

**NE 1/4 SURFACE**  
AFTER SCRAPE PID  
FLD COMP: 1.8 PPM

**TRENCH #7 CI PPM**

- S 373
- 1' 437
- 2' 511
- 3' 303
- 4' 155
- 5' 58
- 6' 58
- 7' 57
- 8' 61

- 3' CI 272
- DRO<10 GRO<10
- 8' CI 64
- DRO<10 GRO<10

**TRENCH #6 CI PPM**

- S 610
- 1' 600
- 2' 232
- 3' 715
- 4' 57
- 5' 86
- 6' 56
- 7' 58
- 8' 57
- 9' 58
- 10' 56
- 11' 61
- 12' 57

- 2' CI 224
- DRO<10 GRO<10
- 12' CI 32
- DRO 29.6 GRO<10

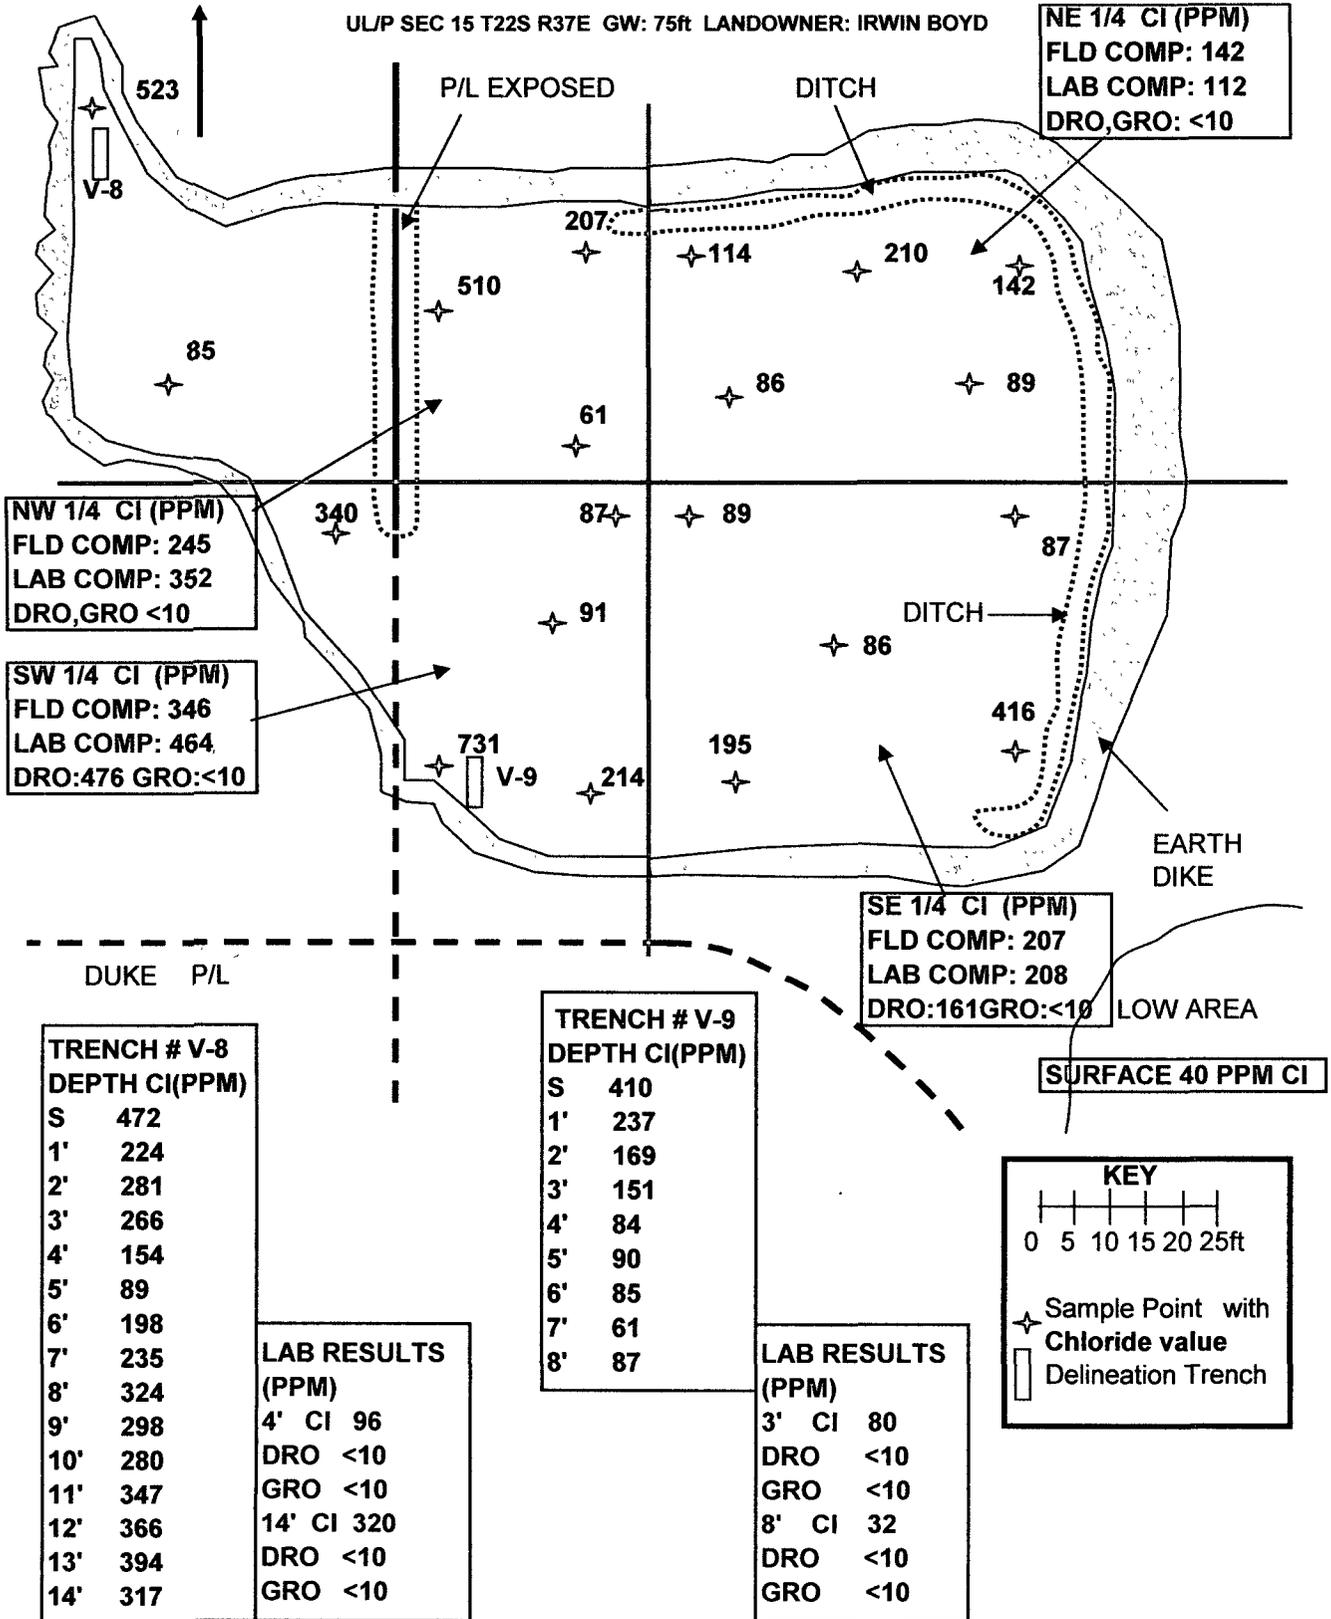
**P-15 LEAK EAST SIDE OF HWY**

FIELD CHLORIDE RESULTS (PPM) AFTER SCRAPE

UL/P SEC 15 T22S R37E GW: 75ft LANDOWNER: IRWIN BOYD

**NE 1/4 CI (PPM)**  
 FLD COMP: 142  
 LAB COMP: 112  
 DRO,GRO: <10

**NW 1/4 CI (PPM)**  
 FLD COMP: 245  
 LAB COMP: 352  
 DRO,GRO <10

**SW 1/4 CI (PPM)**  
 FLD COMP: 346  
 LAB COMP: 464  
 DRO:476 GRO:<10

**SE 1/4 CI (PPM)**  
 FLD COMP: 207  
 LAB COMP: 208  
 DRO:161GRO:<10

**TRENCH # V-8**

DEPTH	CI(PPM)
S	472
1'	224
2'	281
3'	266
4'	154
5'	89
6'	198
7'	235
8'	324
9'	298
10'	280
11'	347
12'	366
13'	394
14'	317

**LAB RESULTS (PPM)**  
 4' CI 96  
 DRO <10  
 GRO <10  
 14' CI 320  
 DRO <10  
 GRO <10

**TRENCH # V-9**

DEPTH	CI(PPM)
S	410
1'	237
2'	169
3'	151
4'	84
5'	90
6'	85
7'	61
8'	87

**LAB RESULTS (PPM)**  
 3' CI 80  
 DRO <10  
 GRO <10  
 8' CI 32  
 DRO <10  
 GRO <10

**SURFACE 40 PPM CI**
