1R-427-210

Final Report

**RICE OPERATING COMPANY
JUNCTION BOX FINAL REPORT**

EMF Amerada Hartman 'J' FOI

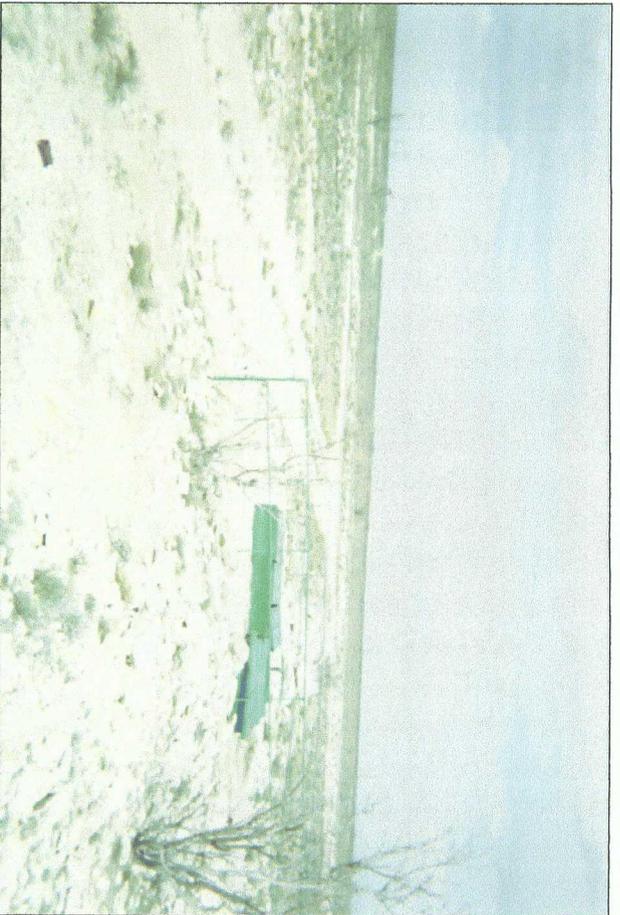
1/6/2004

undisturbed junction box

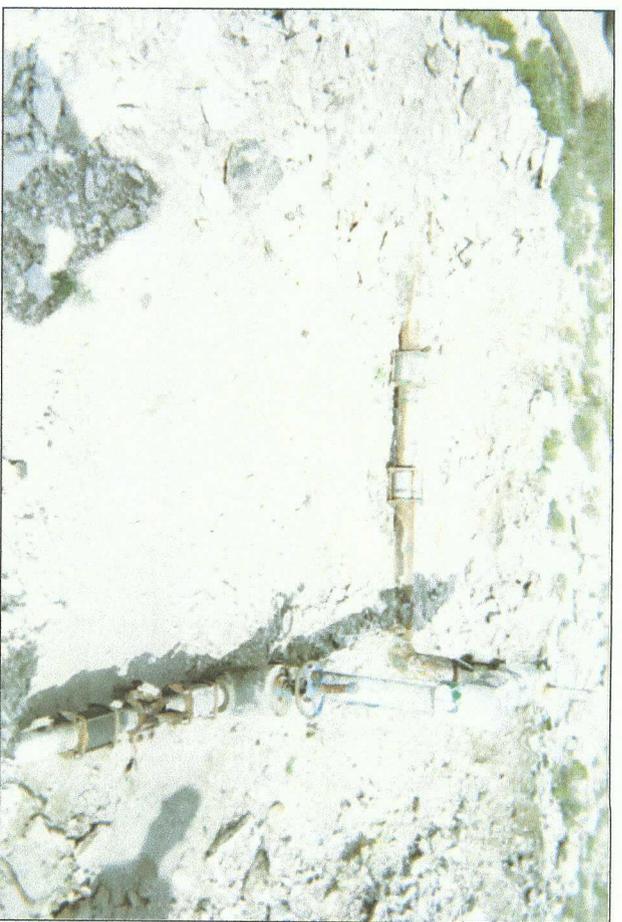
box removed; old plumbing

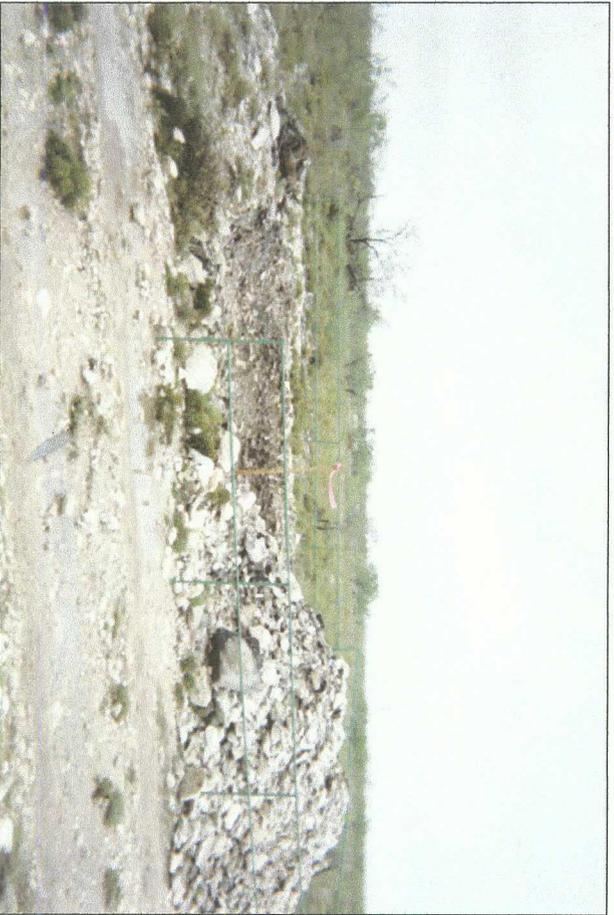
11/2/2004

NORM decontaminated; box removed

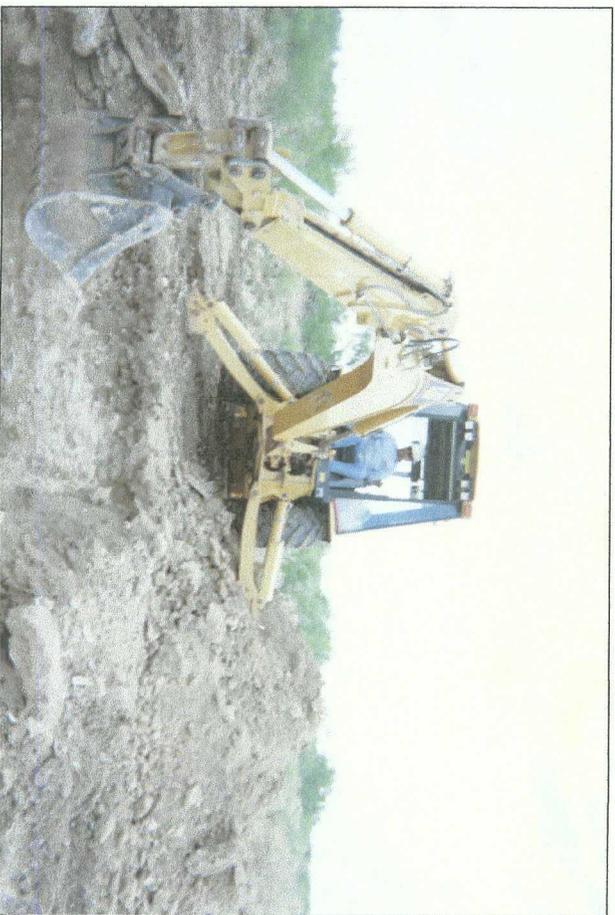
July 2006

beginning excavation & delineation of box site

This junction was eliminated with the pipeline replacement/upgrade program. After the box was removed, the site was delineated and excavated using a backhoe to collect soil samples at regular intervals to produce a 30 x 30 x 12-ft-deep excavation. Chloride field tests were conducted on each sample and concentrations were very low and declined considerably with depth. VOCs were also measured using a PID and the delineation samples exhibited concentrations less than 100 ppm. However, 2 components of the 4-wall composite sample off the final excavation had concentrations greater than 100 ppm so this sample was analyzed for BTEX at a commercial laboratory. These results did not yield BTEX within detection limits. The excavated soil was blended on site and then backfilled into the excavation and contoured to the surrounding terrain. The remaining low concentration of TPH can be expected to naturally attenuate. A top dress of 108 yds³ of imported topsoil was placed on top of the backfilled area and seeded with a blend of native vegetation. The disturbed surface is expected to return to productive capacity at a normal rate.

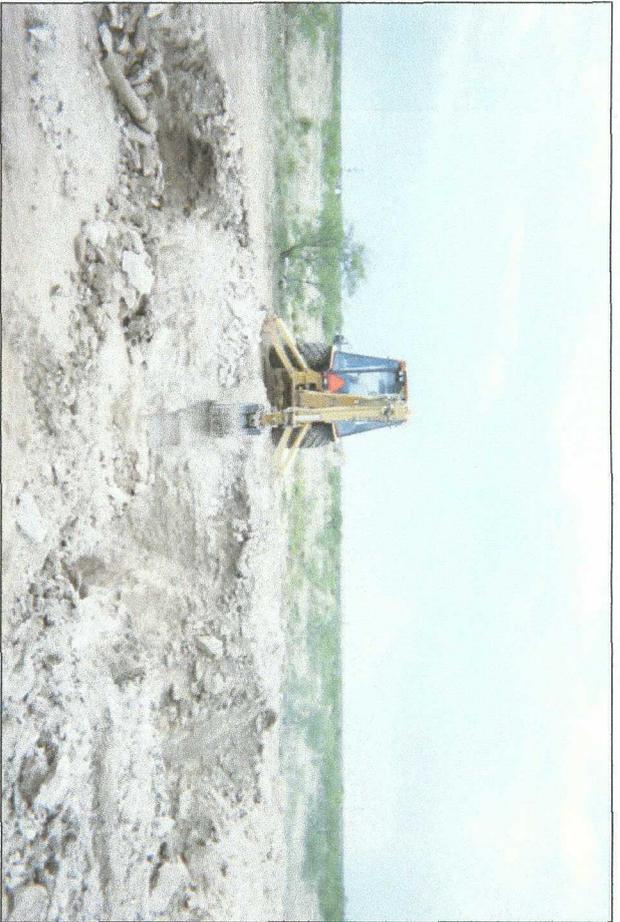
July 2006

delineation & excavation

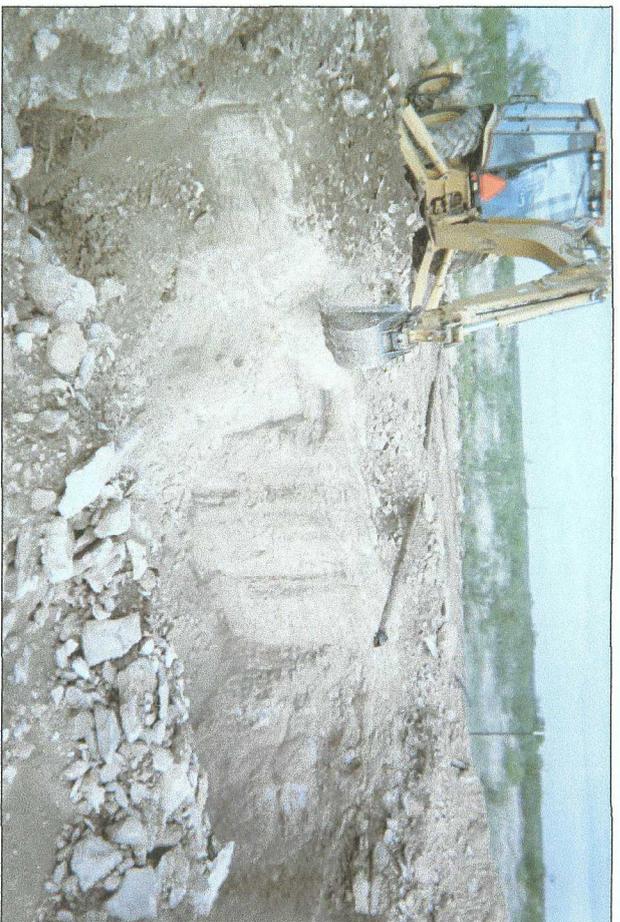
30 x 30 x 12-ft-deep excavation

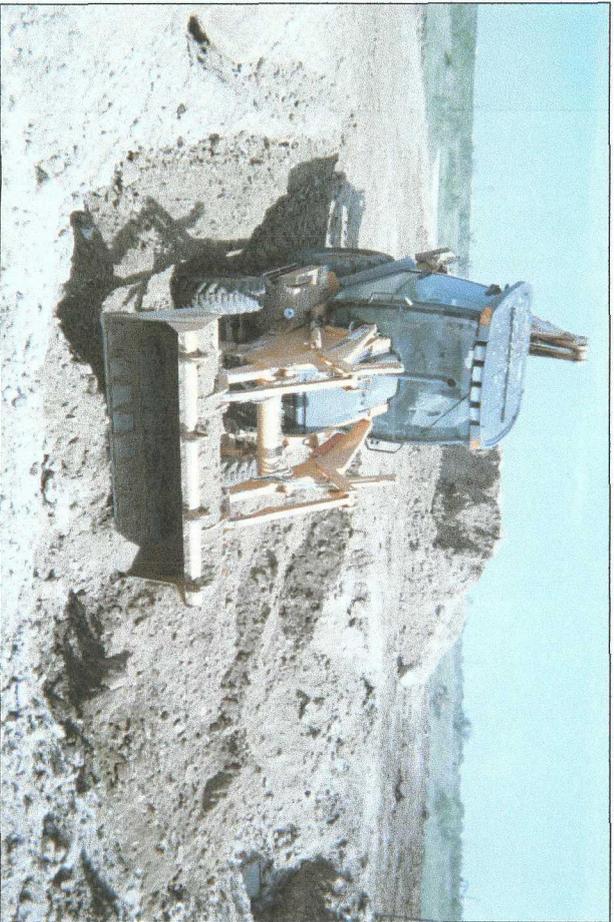
August 2006

backfilling excavation

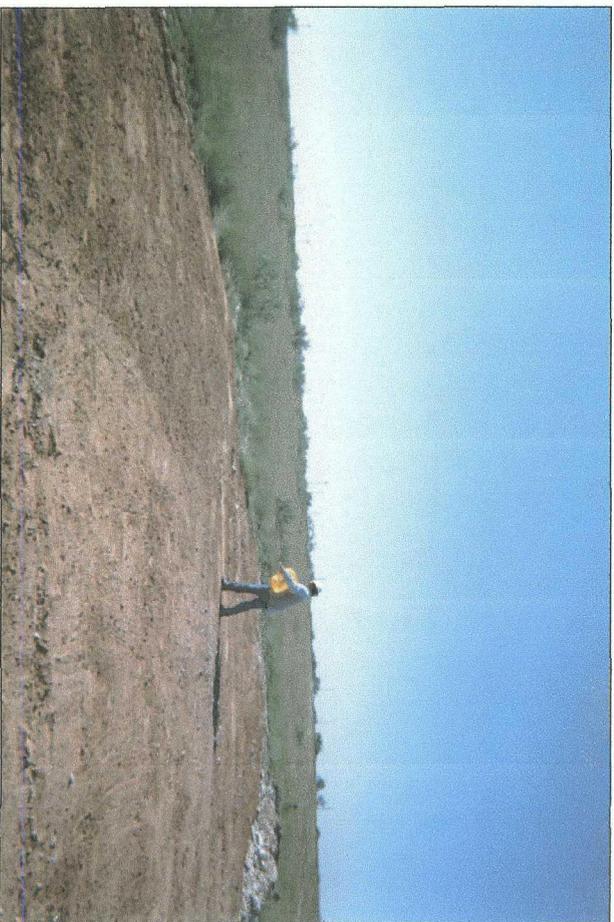
9/19/2006

seeding backfilled site with imported topsoil

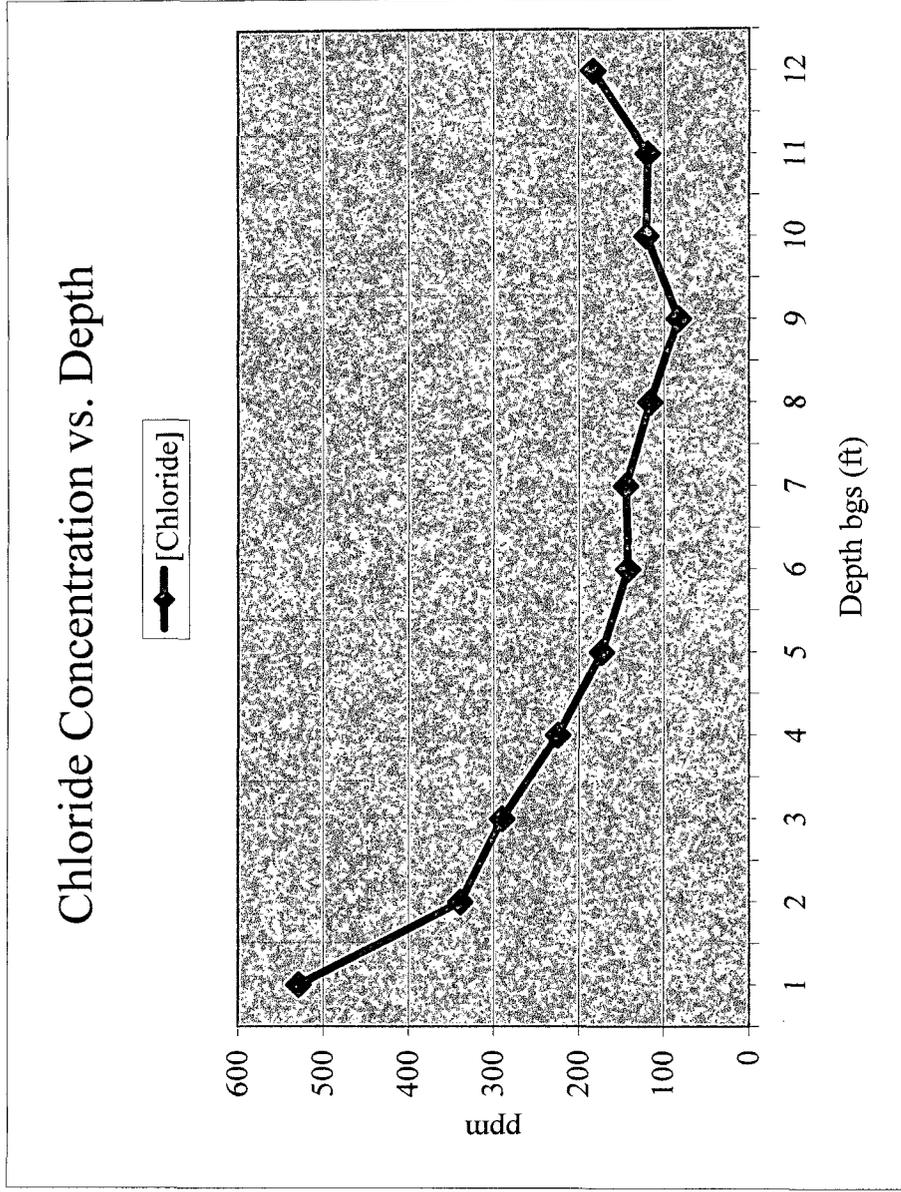
Depth bgs (ft)	[Cl] ppm
1	529
2	339
3	290
4	225
5	173
6	142
7	145
8	116
9	83
10	121
11	119
12	183

Groundwater = 50 ft

LOCATION	DEPTH (ft)	ppm
5 ft SOUTH of junction	1	529
	2	339
	3	290
	4	225
	5	173
	6	142
	7	145
	8	116
	9	83
	10	121
	11	119
	12	183
4-wall comp.	n/a	220
bottom comp.	12	225
backfill comp.	n/a	209
