Final Report

RICE OPERATING COMPANY
JUNCTION BOX FINAL REPORT

EMME jct. N-30

Unit 'N', Section 30, T21S, R36E

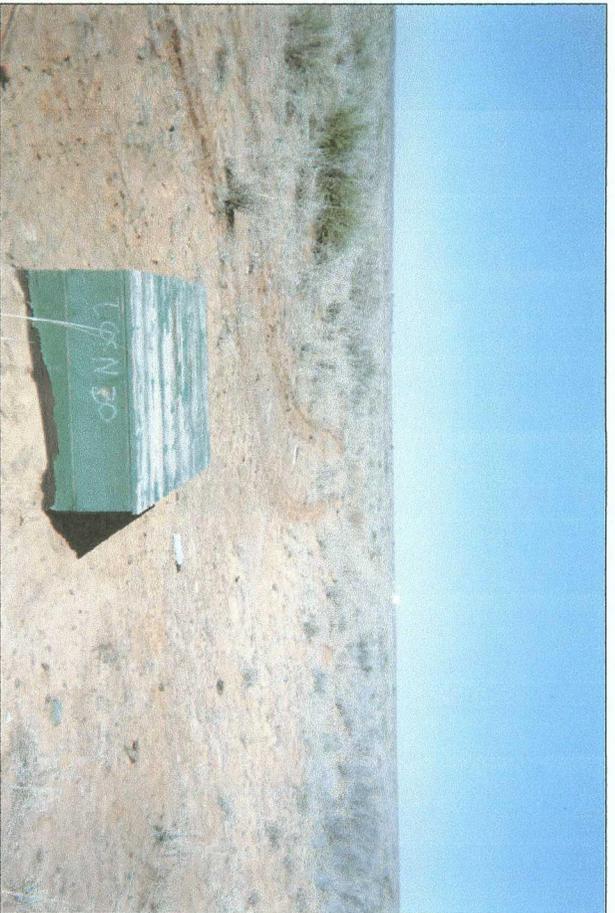
1/28/2005

undisturbed junction box

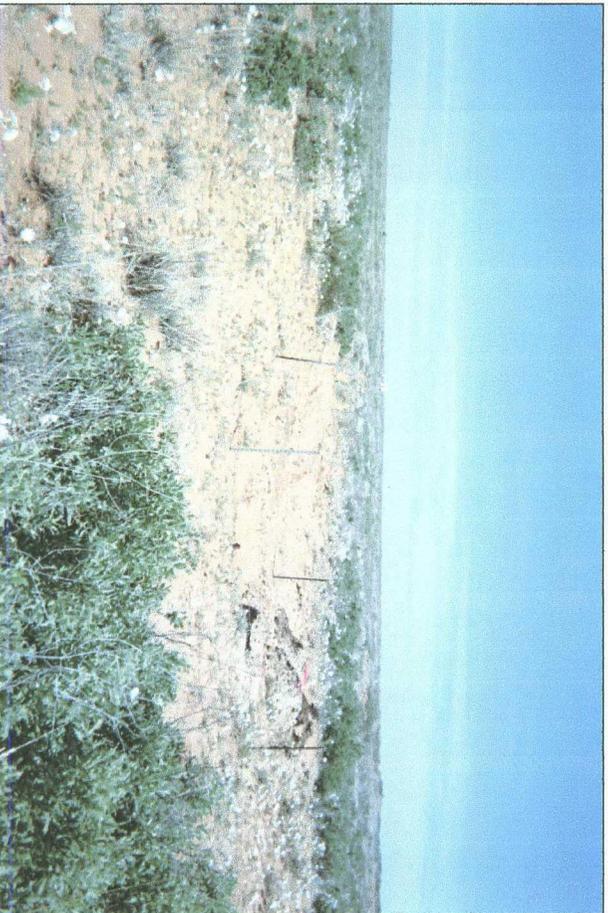
4/28/2005

box removed after NORM decontamination

This junction was eliminated with the pipeline replacement program. After the box material was removed, samples were collected at the site using a hand auger. There were no physical indications of impacts to the soil from the junction box and chloride concentrations were very low throughout and similar to those of background samples. PID readings on this samples were also very low. The deepest soil sample (4 ft) from directly below the former box site was analyzed at a laboratory for confirmation. TPH and chloride were not present within the lab's detection limits. The site was backfilled with the placement of the new poly pipeline and the disturbed surface is expected to return to productive capacity at a normal rate.

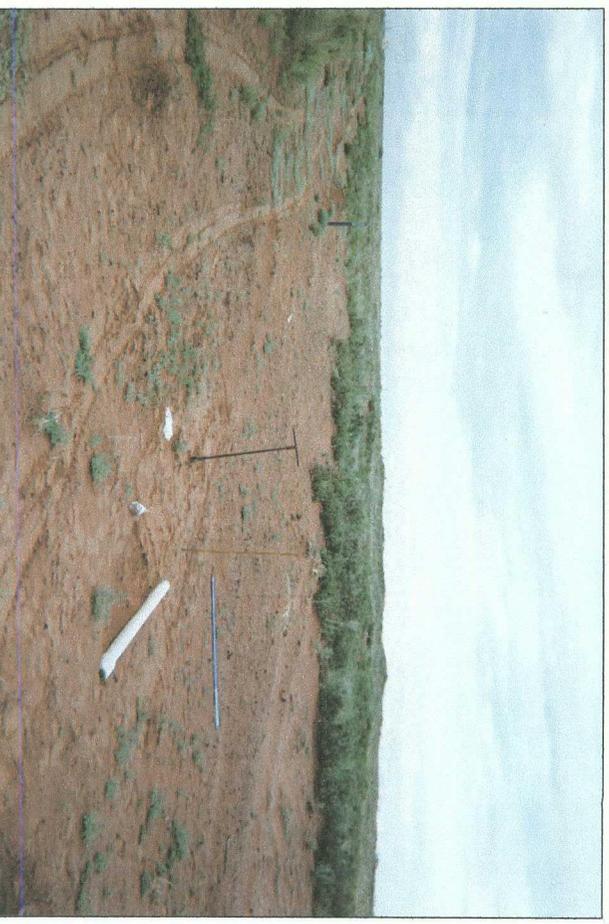
8/14/2006

hand auger placed at former box site
