Final Report

Closure

**RICE OPERATING COMPANY
JUNCTION BOX FINAL REPORT**

EME jct. A-31

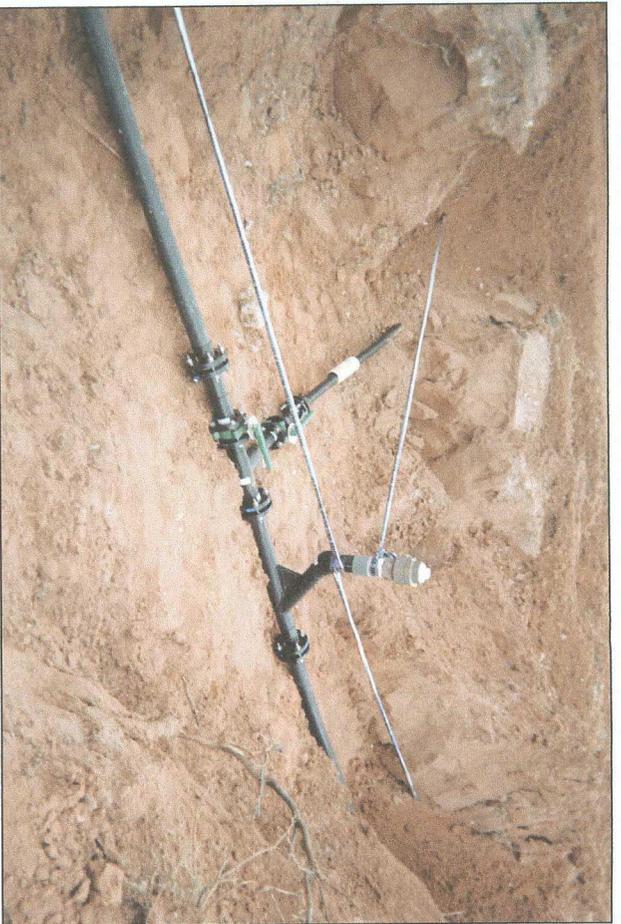
11/23/2005

new junction 50 ft northeast of former

A new, watertight junction box was built 50 ft northeast of this site. The former junction site was delineated and excavated using a backhoe while soil samples were collected at regular intervals, creating a 10 x 10 x 6-ft-deep hole. The samples were field tested for chloride and VOCs, all yielded very low concentrations. Composite samples from the final excavation were sent to a laboratory for confirmation. The excavation was backfilled and contoured to the surrounding landscape. The disturbed surface was seeded with a blend of native vegetation on 11/7/2006 and is expected to return to productive capacity at a normal rate.

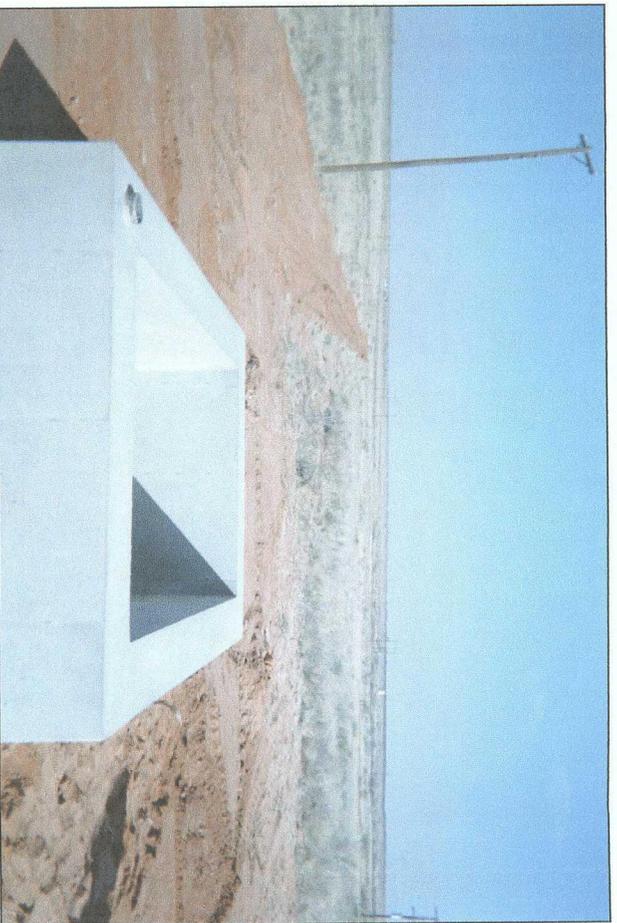
12/1/2005

new concrete junction box

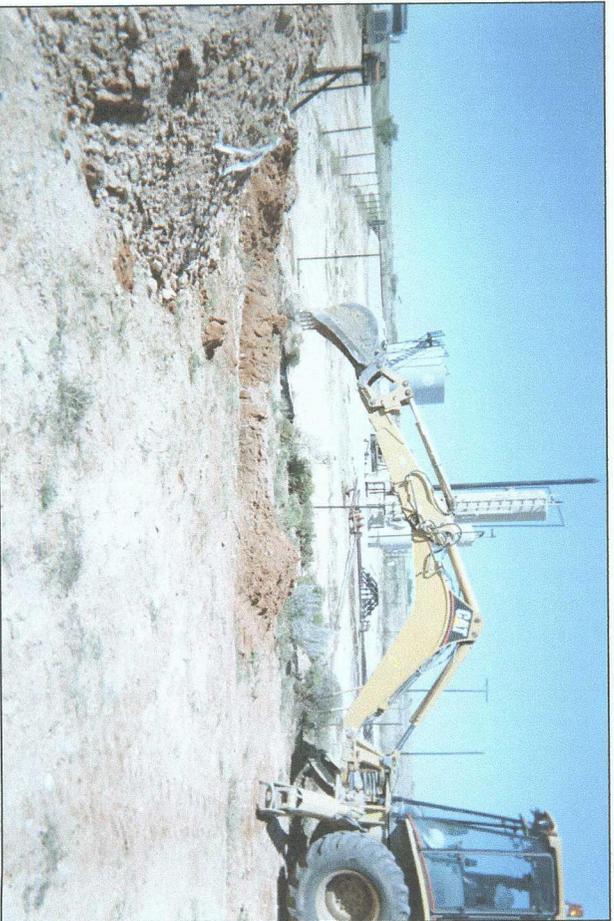
10/23/2006

beginning delineation of former box site

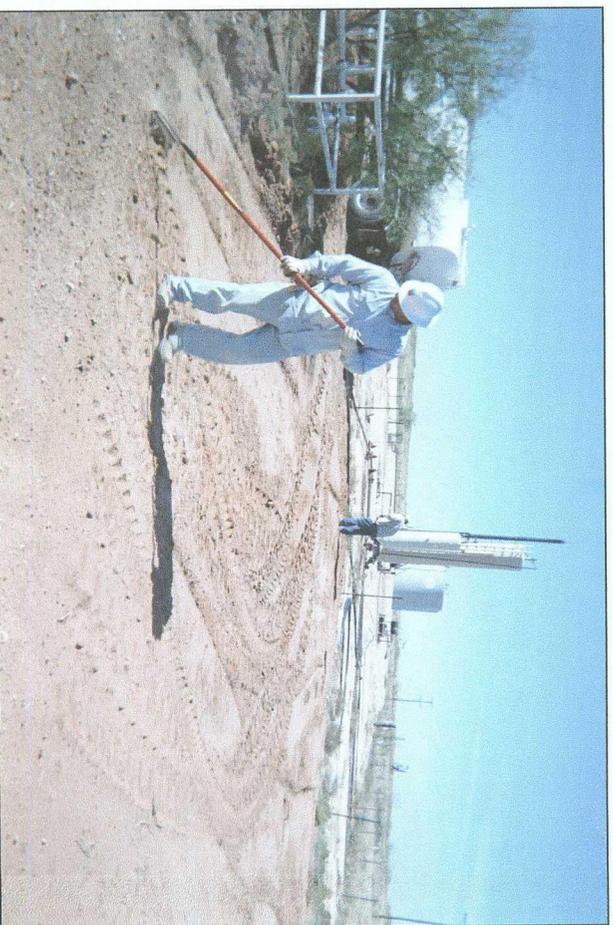
11/7/2006

raking seed at backfilled site

FINAL 10' x 10' x 6'
