Final Report

**RICE OPERATING COMPANY
JUNCTION BOX FINAL REPORT**

SWD SYSTEM	JUNCTION	UNIT	SECTION	TOWNSHIP	RANGE	COUNTY	BOX DIMENSIONS - FEET		
							Length	Width	Depth
Vacuum	K-35 vent	K	35	17S	35E	Lea	no box--System Abandonment

Vacuum K-35 vent

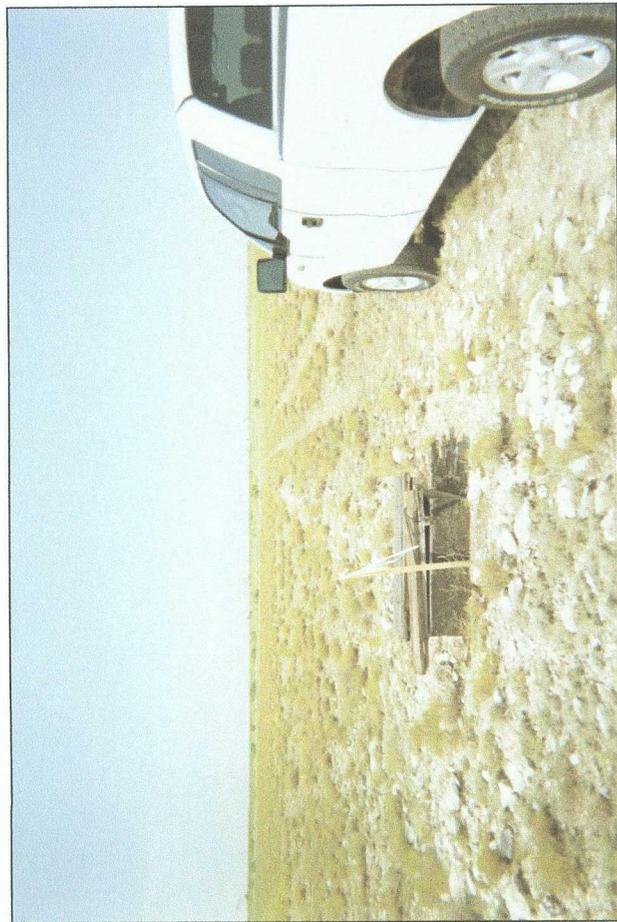
junction box prior to excavation 7/11/2005

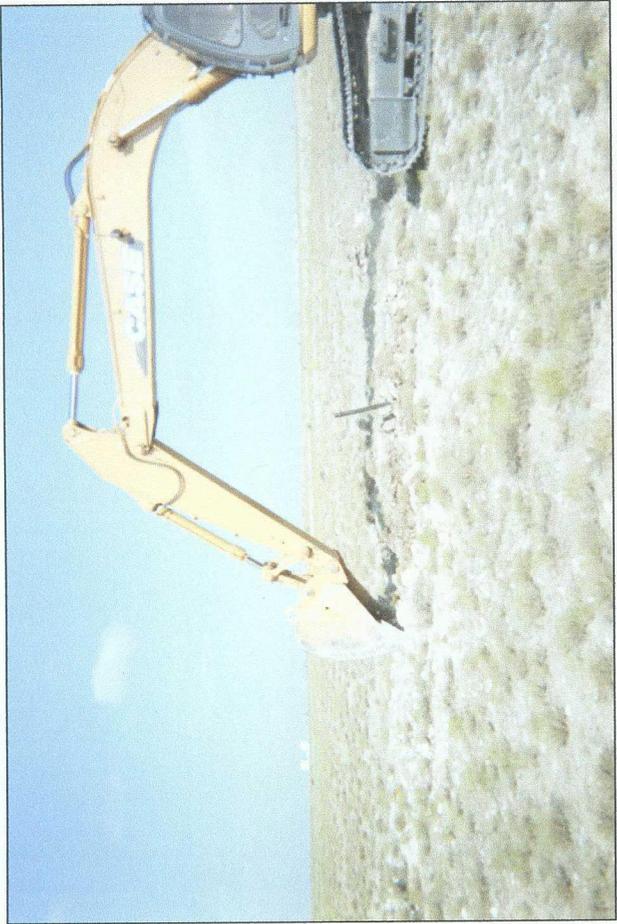
beginning delineation trench at former jct. site 8/12/2005

General Description of Remedial Action: This junction box site was addressed as part of the Vacuum SWD System Abandonment. After the box was removed, the site was delineated using a backhoe to collect soil samples at regular intervals to a depth of 7 ft. Chloride field tests and PID readings were conducted on all of the samples. Concentrations of both constituents were very low. A sample from the bottom of the trench was analyzed by a laboratory for confirmation of field tests. The excavated soil was blended on site and then backfilled into the trench and contoured to the surrounding terrain. The disturbed surface was seeded with a blend of native vegetation on 2/22/2006 and is expected to return to productive capacity at a normal rate.

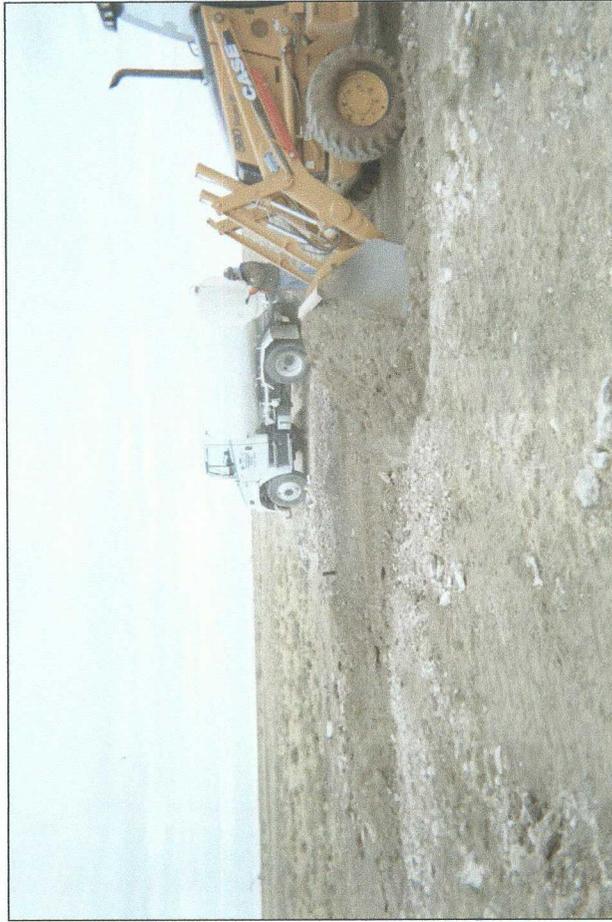
spreading imported topsoil on backfilled site

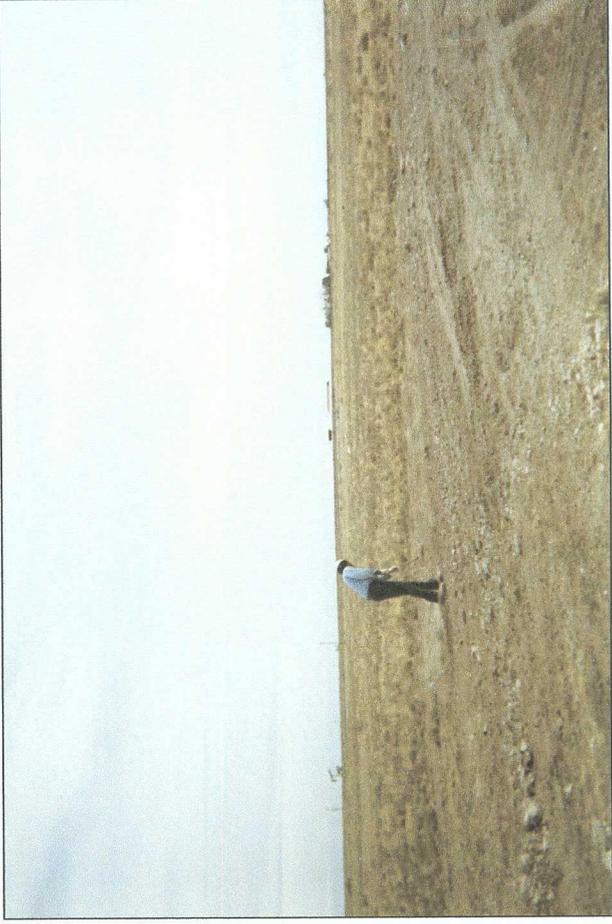
raking seed 2/22/2006
