**EME Sarah Phillips EOL
Remediation Project**

IR-427-17

Executive Summary

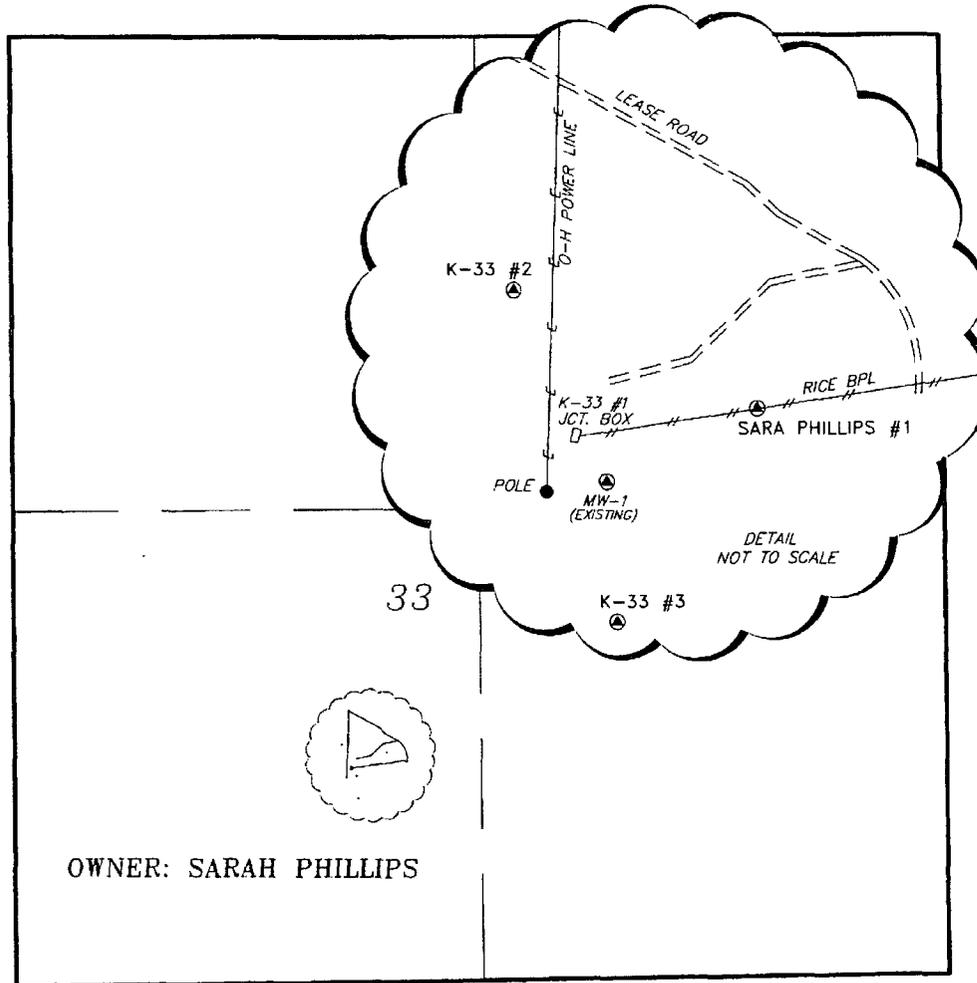
REF: MONITOR WELLS

NOTE:
ELEVATIONS ARE ON BLACK MARK
ON NORTH SIDE OF PVC CASING.

MONITOR WELLS LOCATED IN
SECTION 33, TOWNSHIP 19 SOUTH, RANGE 37 EAST,
N.M.P.M., LEA COUNTY, NEW MEXICO.

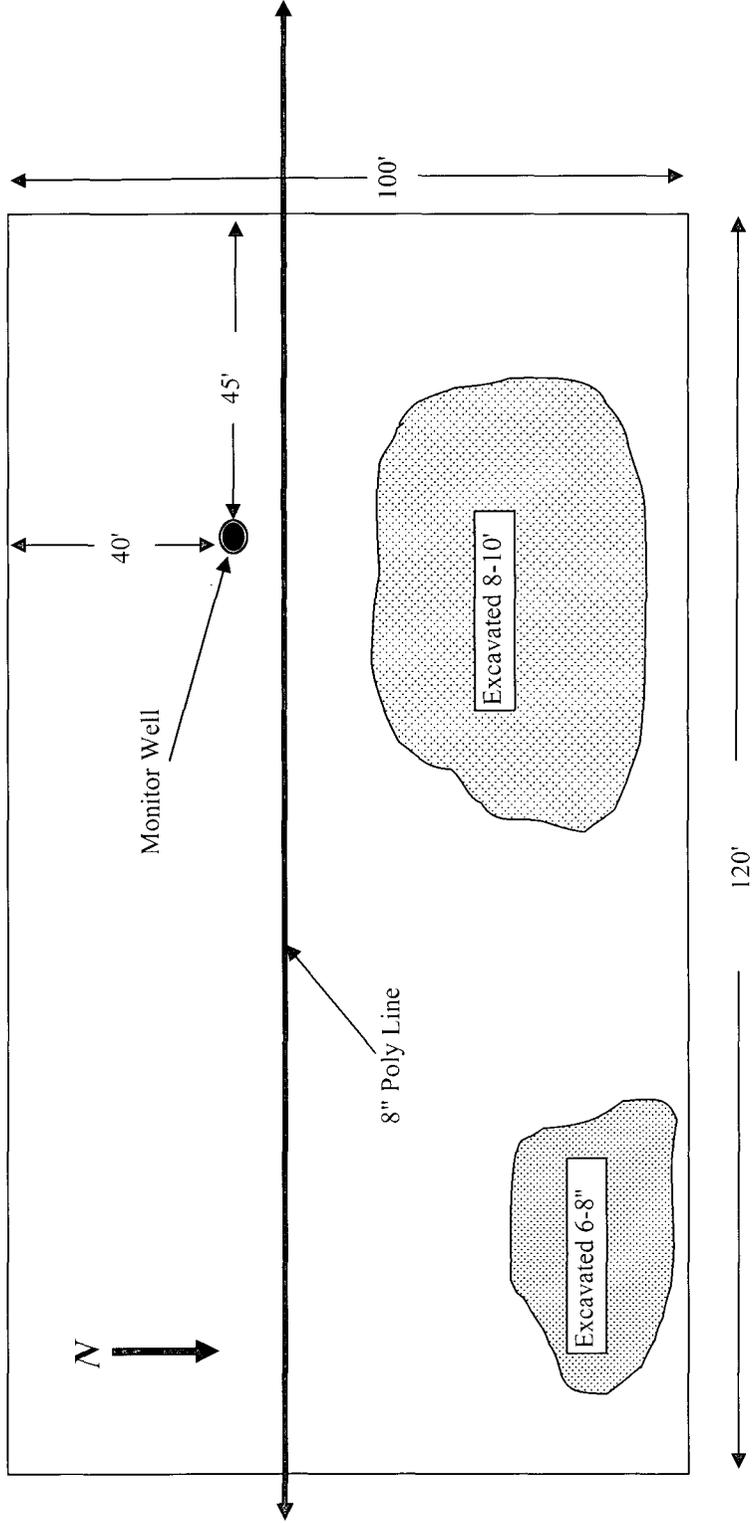
Sarah Phillips EOL Initial Electrical Conductivities 1:1 by weight (mmhos/cm)

EME Sarah Phillips EOL
Excavation & Remediation Area

In accordance with the approved remediation plan, PR-77, the area of 120' X 100' was gridded on 20' centers and composite soil samples were collected to a depth at each grid point to a depth of 0-24' bgs. The soil samples were submitted to Cardinal Laboratories in Hobbs, New Mexico for electrical conductivity testing. The test results were incorporated into Surfer and a histogram developed to determine the true areal extent of contamination and the location of any "hot spots" within the tested grid.

Two such "hot spots" were discovered to the north and northeast of the monitor well and were excavated to depths between 6-10' bgs. with a total of 60 cubic yards of the material sent to commercial disposal at Sundance Services. The two areas were backfilled with fresh topsoils. The entire 120' X 100' area was excavated to a minimum depth of 4' bgs and a geosynthetic clay liner, (.75lb./sq. ft. Denefix EC) was set in place at the 4' depth.

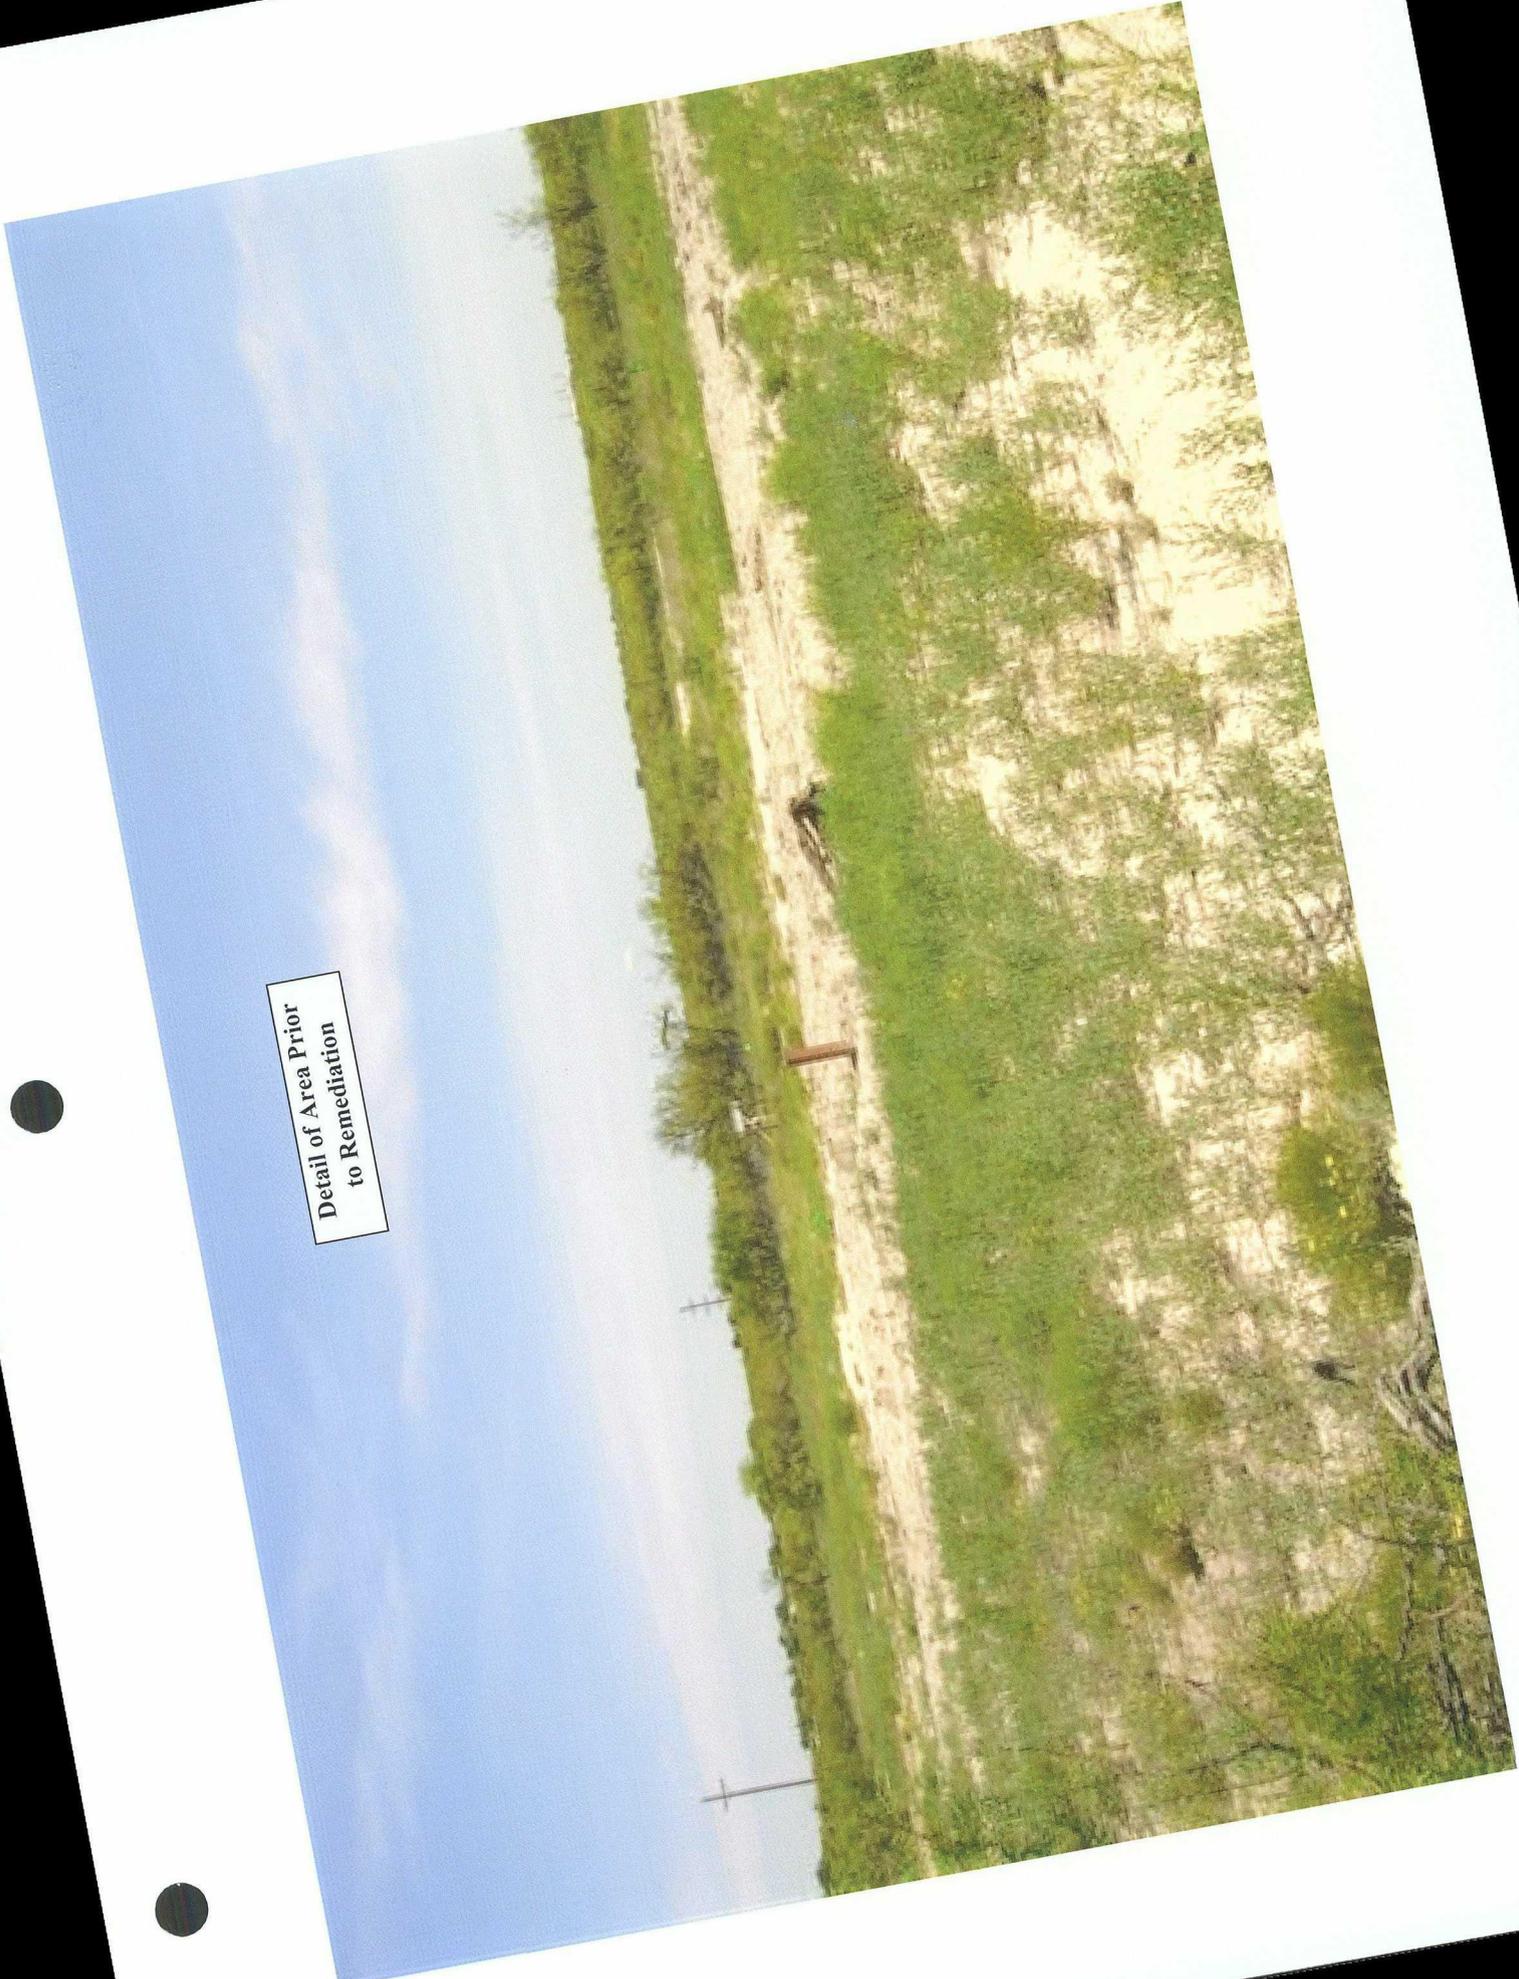
Detail of Area Prior
to Remediation

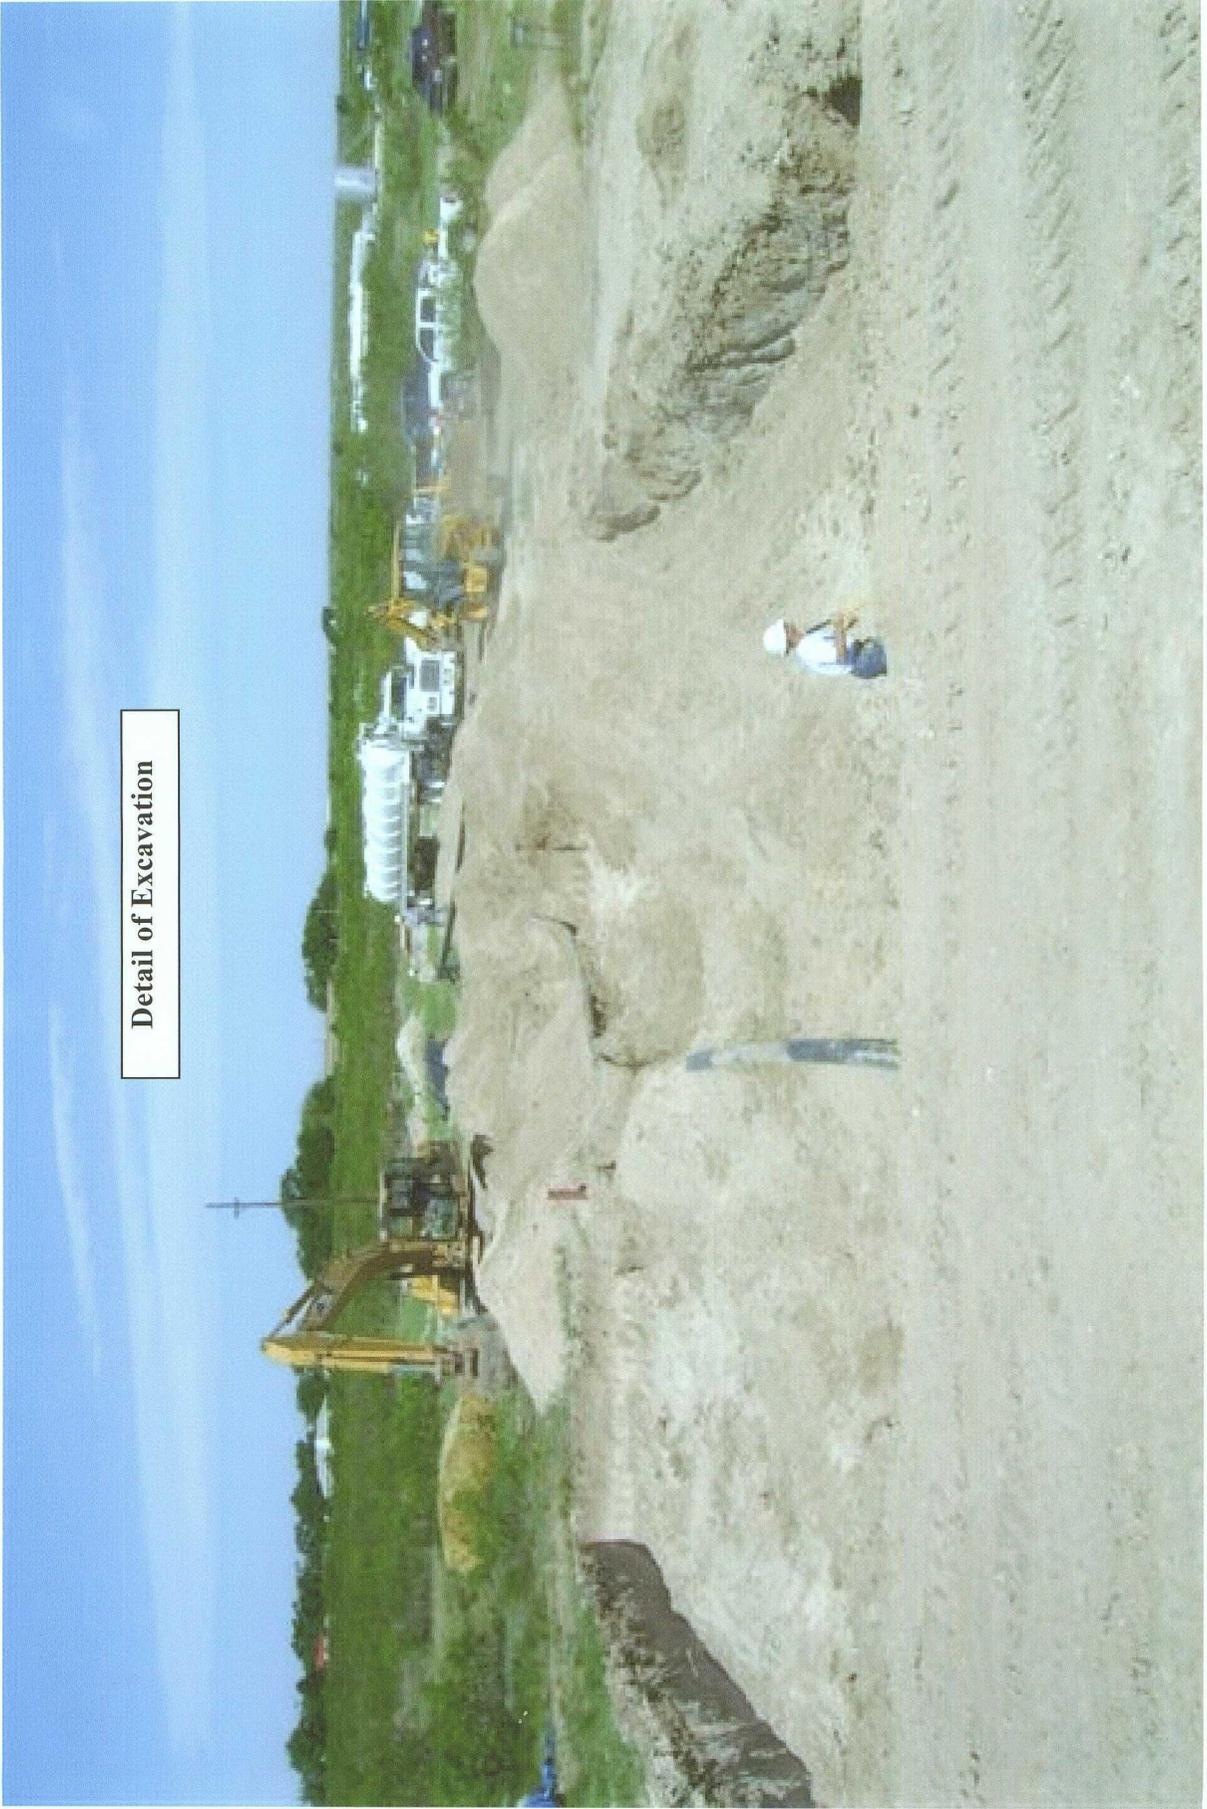
Detail of Excavation

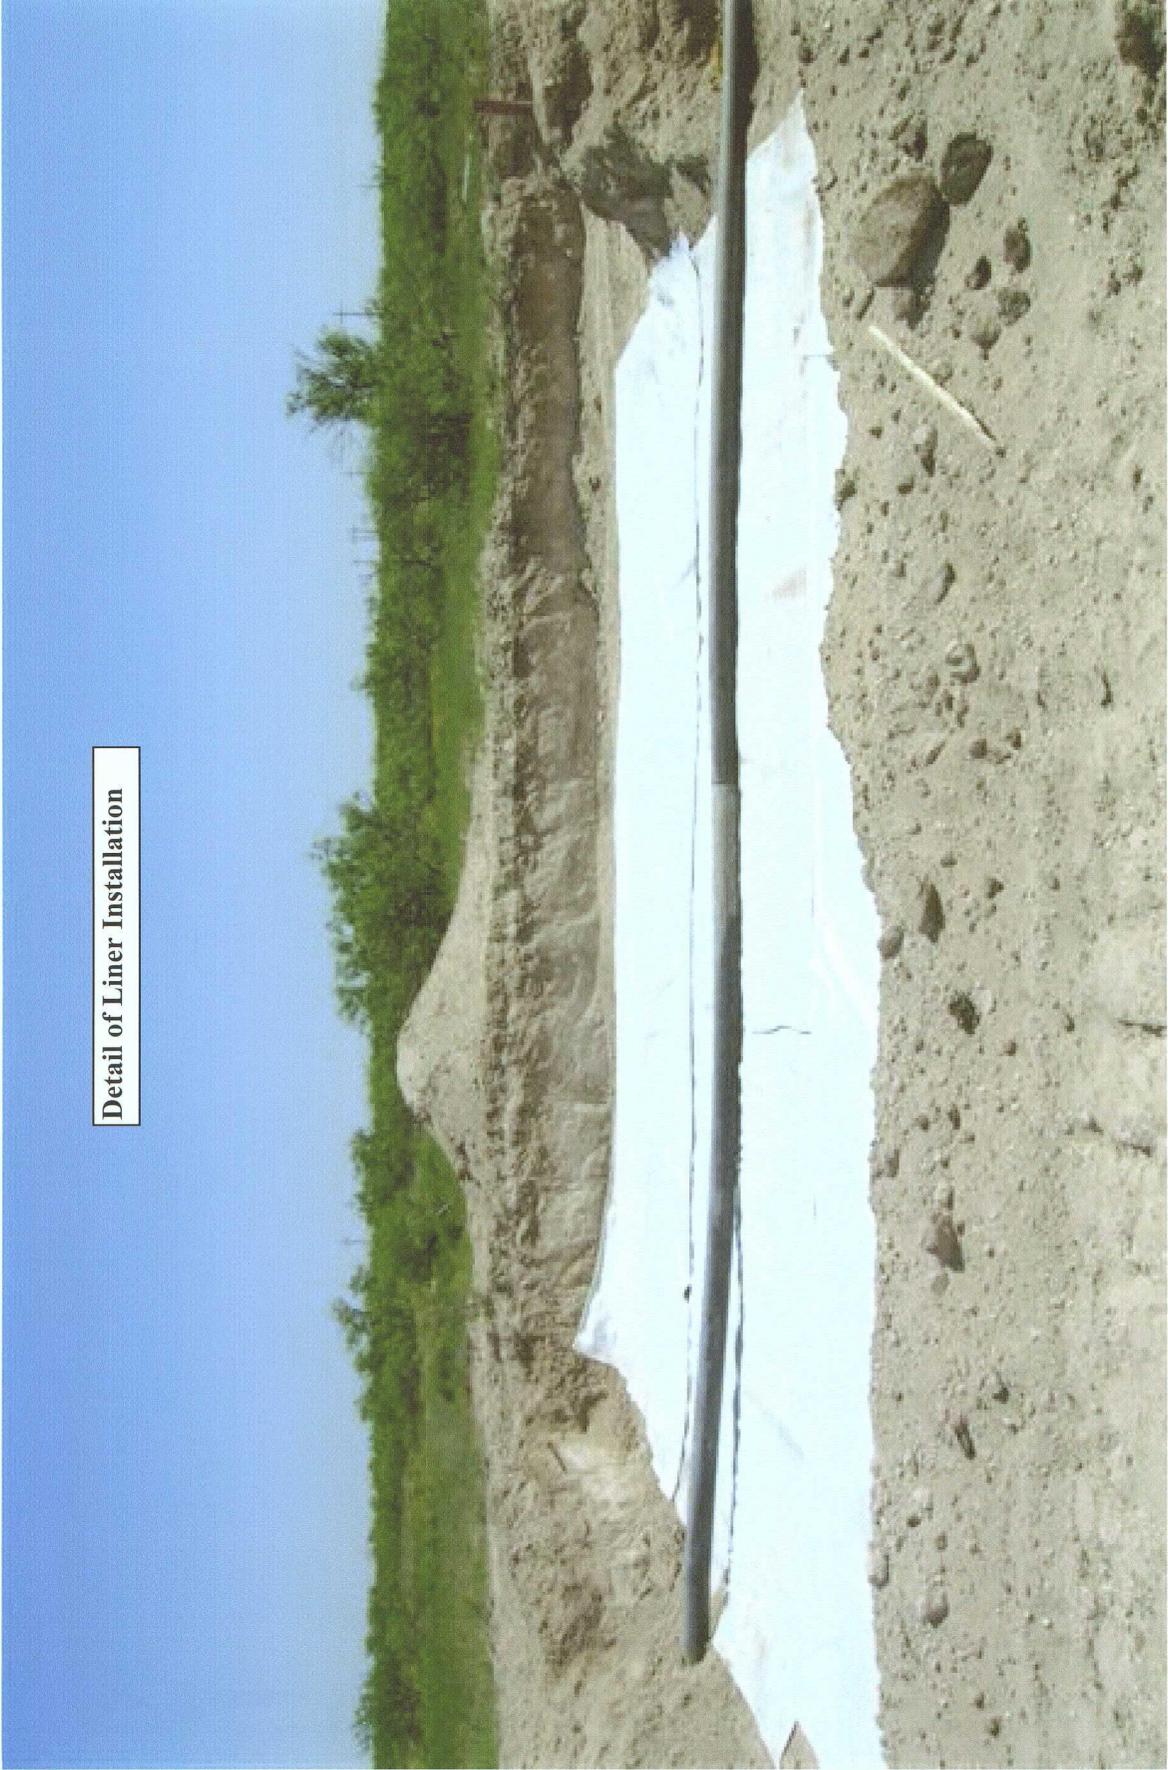
Detail of Liner Installation

**Detail of Bentofix Geosynthetic
Bentonite Liner Installation**

5.4 Sections of .75 lb/sq. ft. Denefix EC bentonite matting will be applied to the bottom of the excavations and watered to fill all voids.

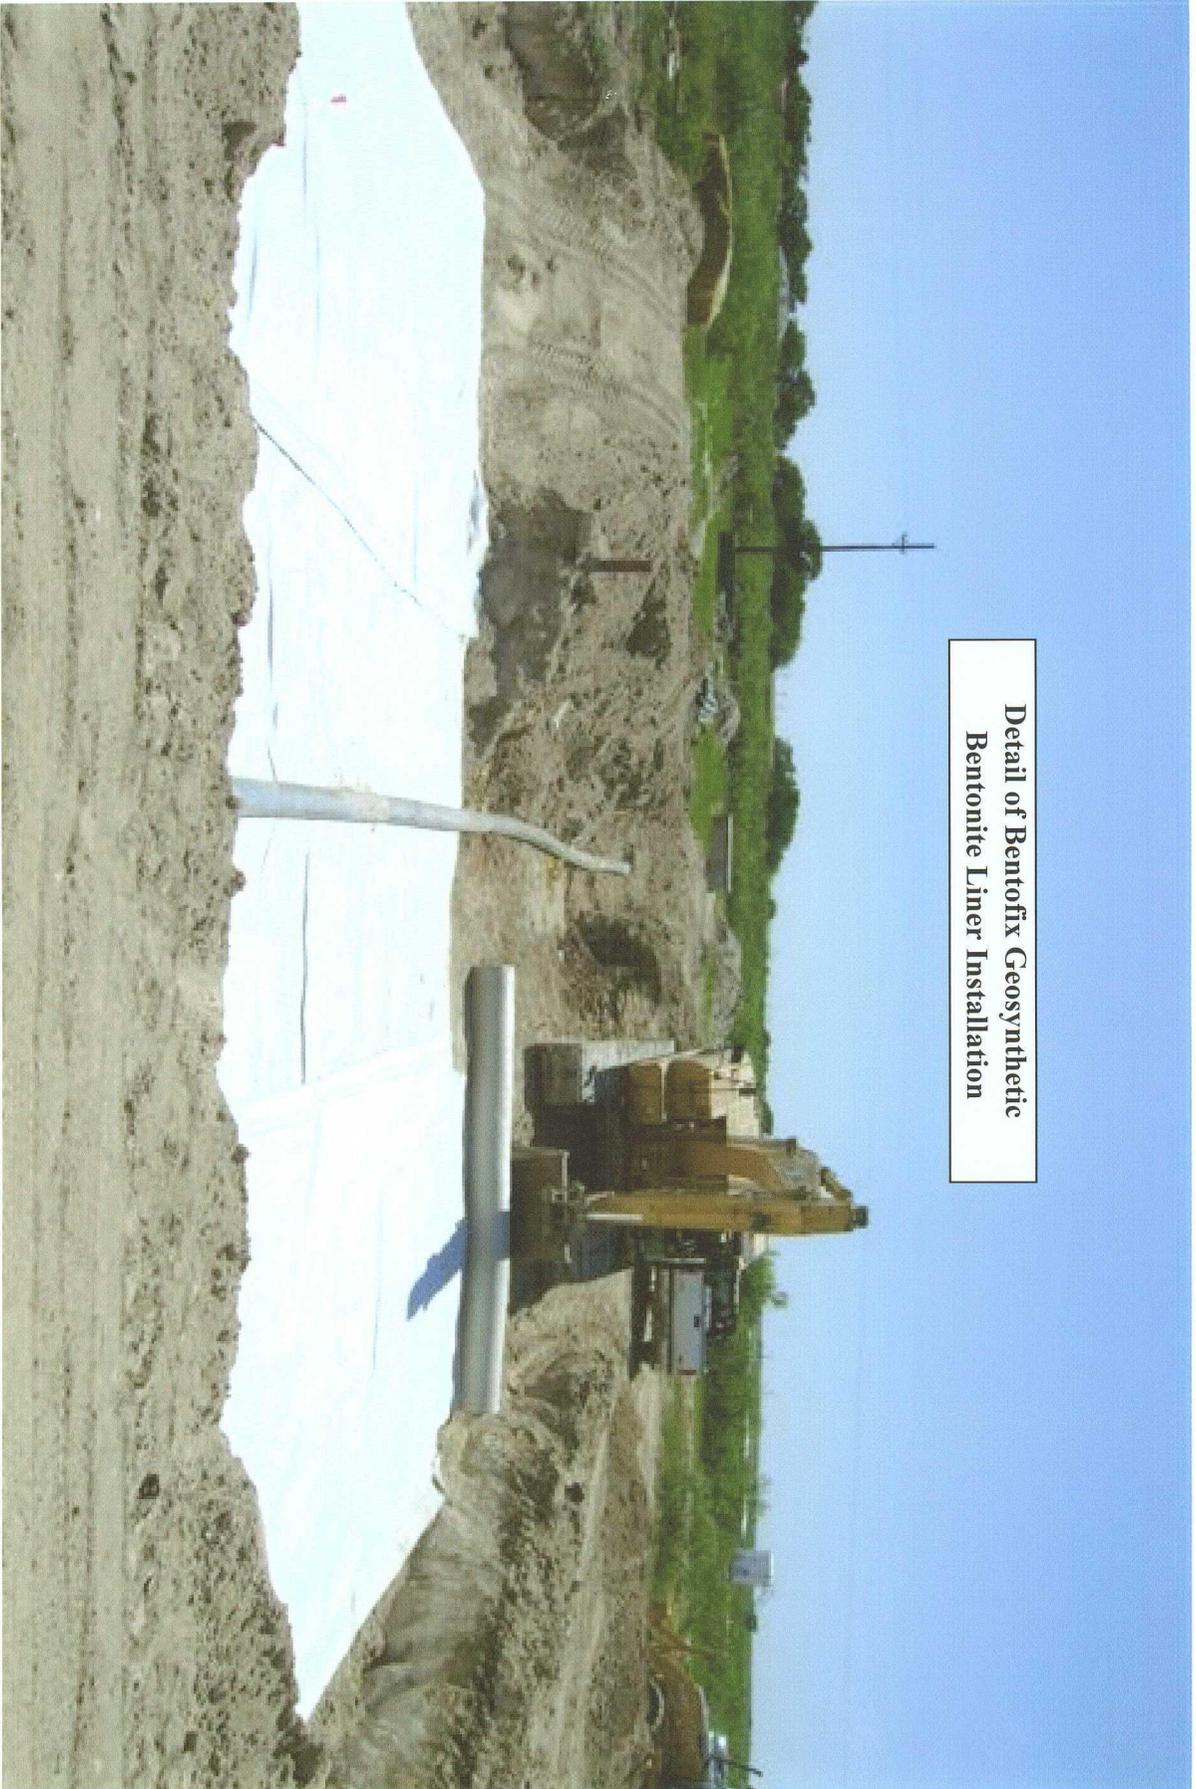
Detail of Staged Organics

The area was backfilled with the excavated soils mixed with four tons of organics and 108 cubic yards of fresh soils. The area was finally re-contoured, compacted, watered and seeded with native grasses.

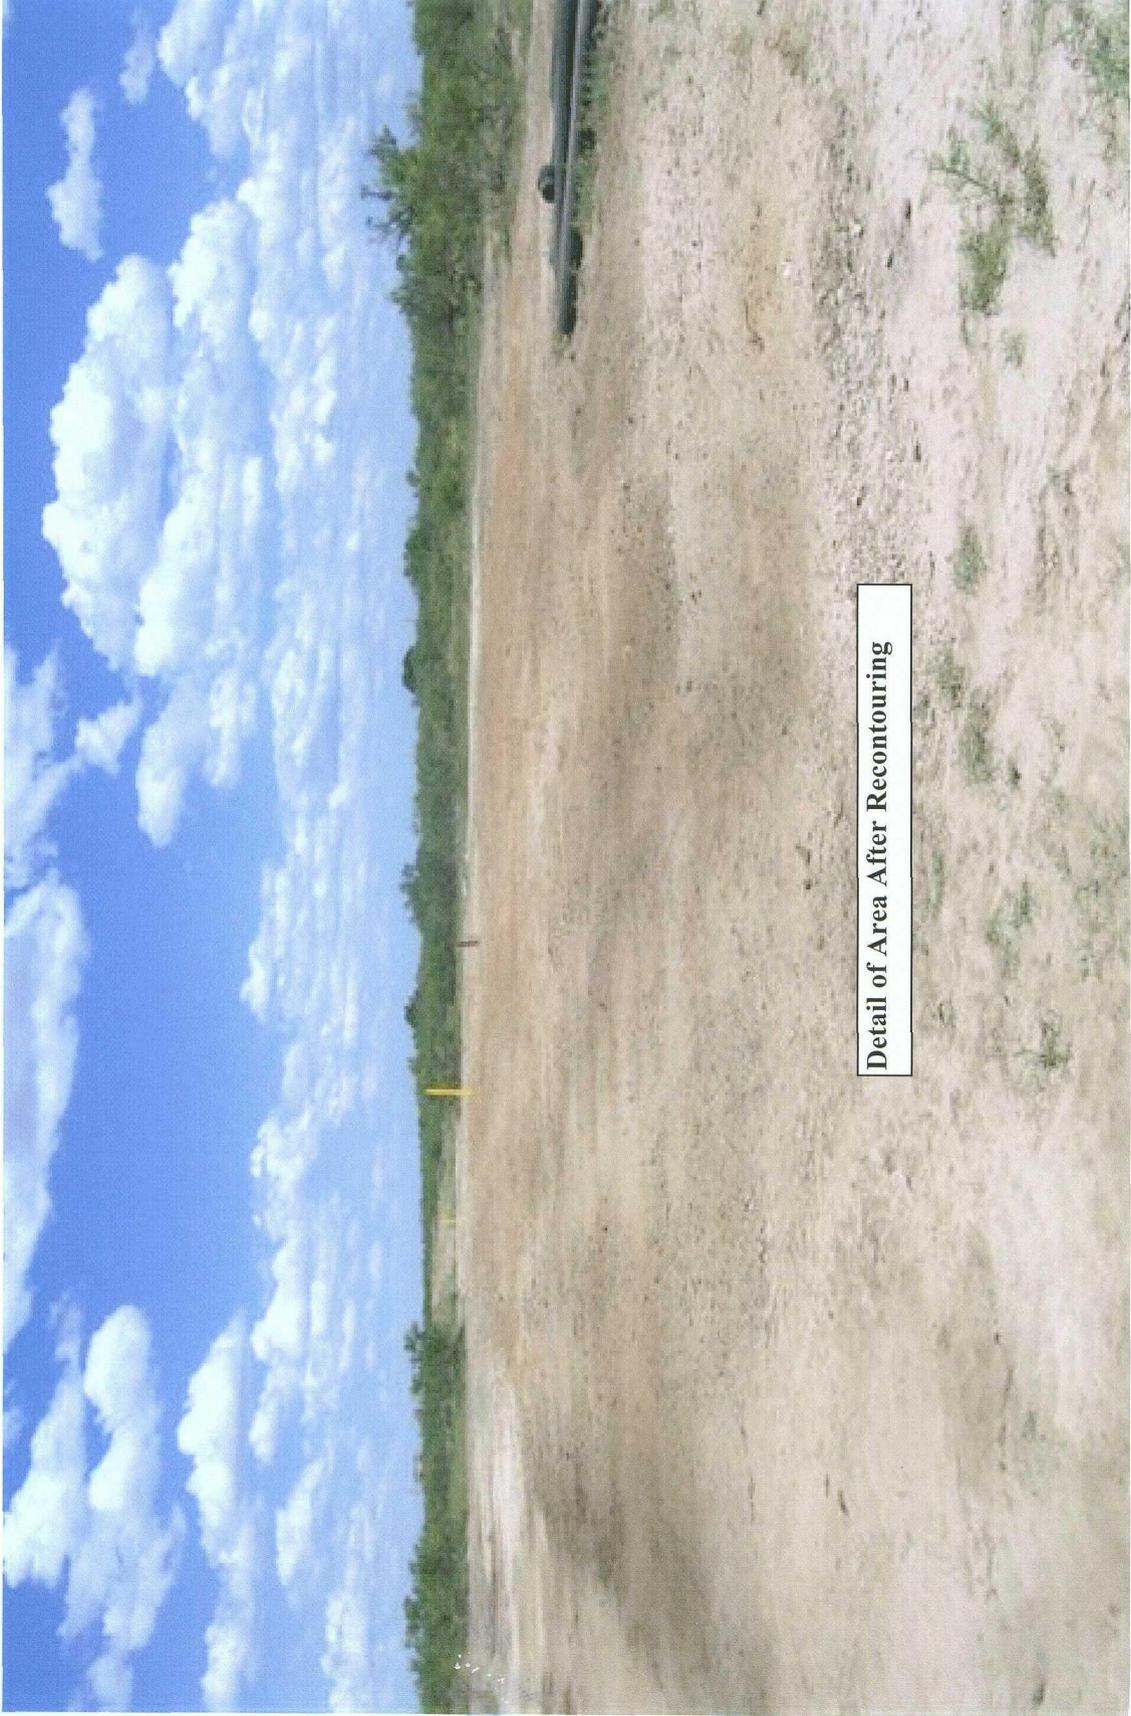
Detail of Area After Recontouring

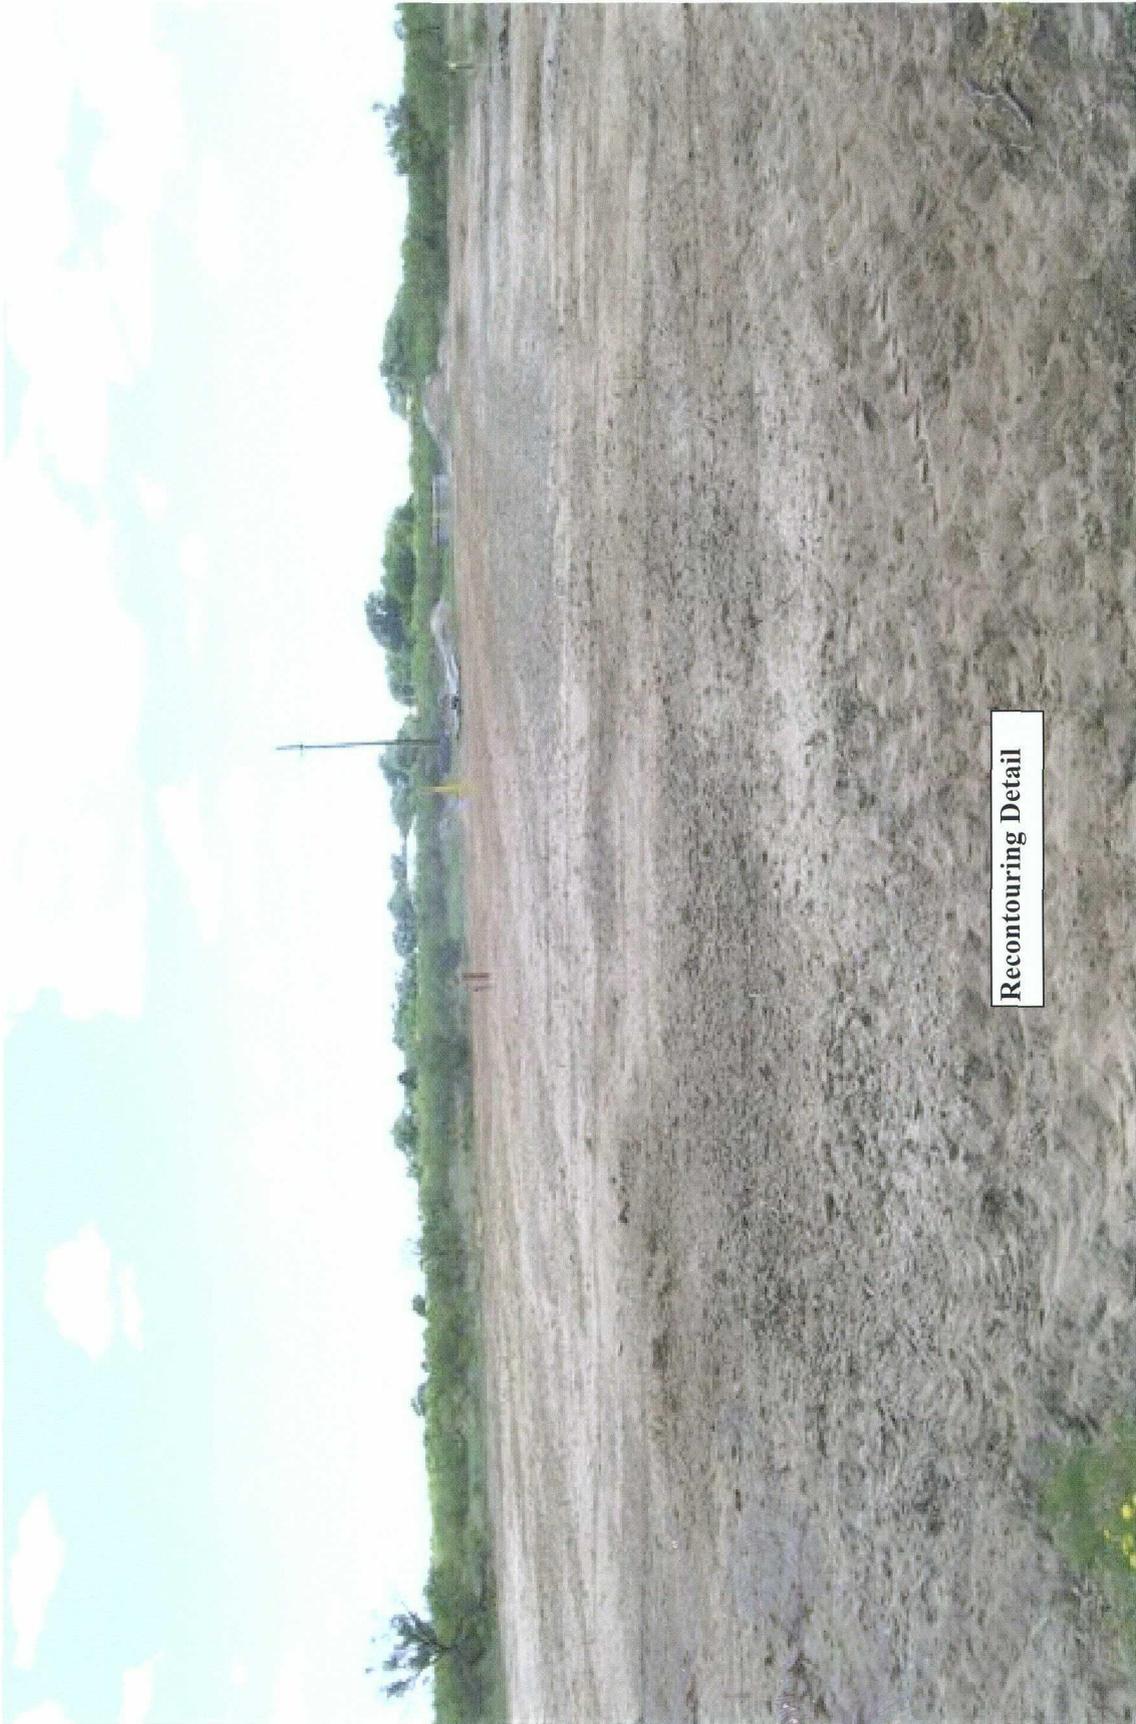
Recontouring Detail

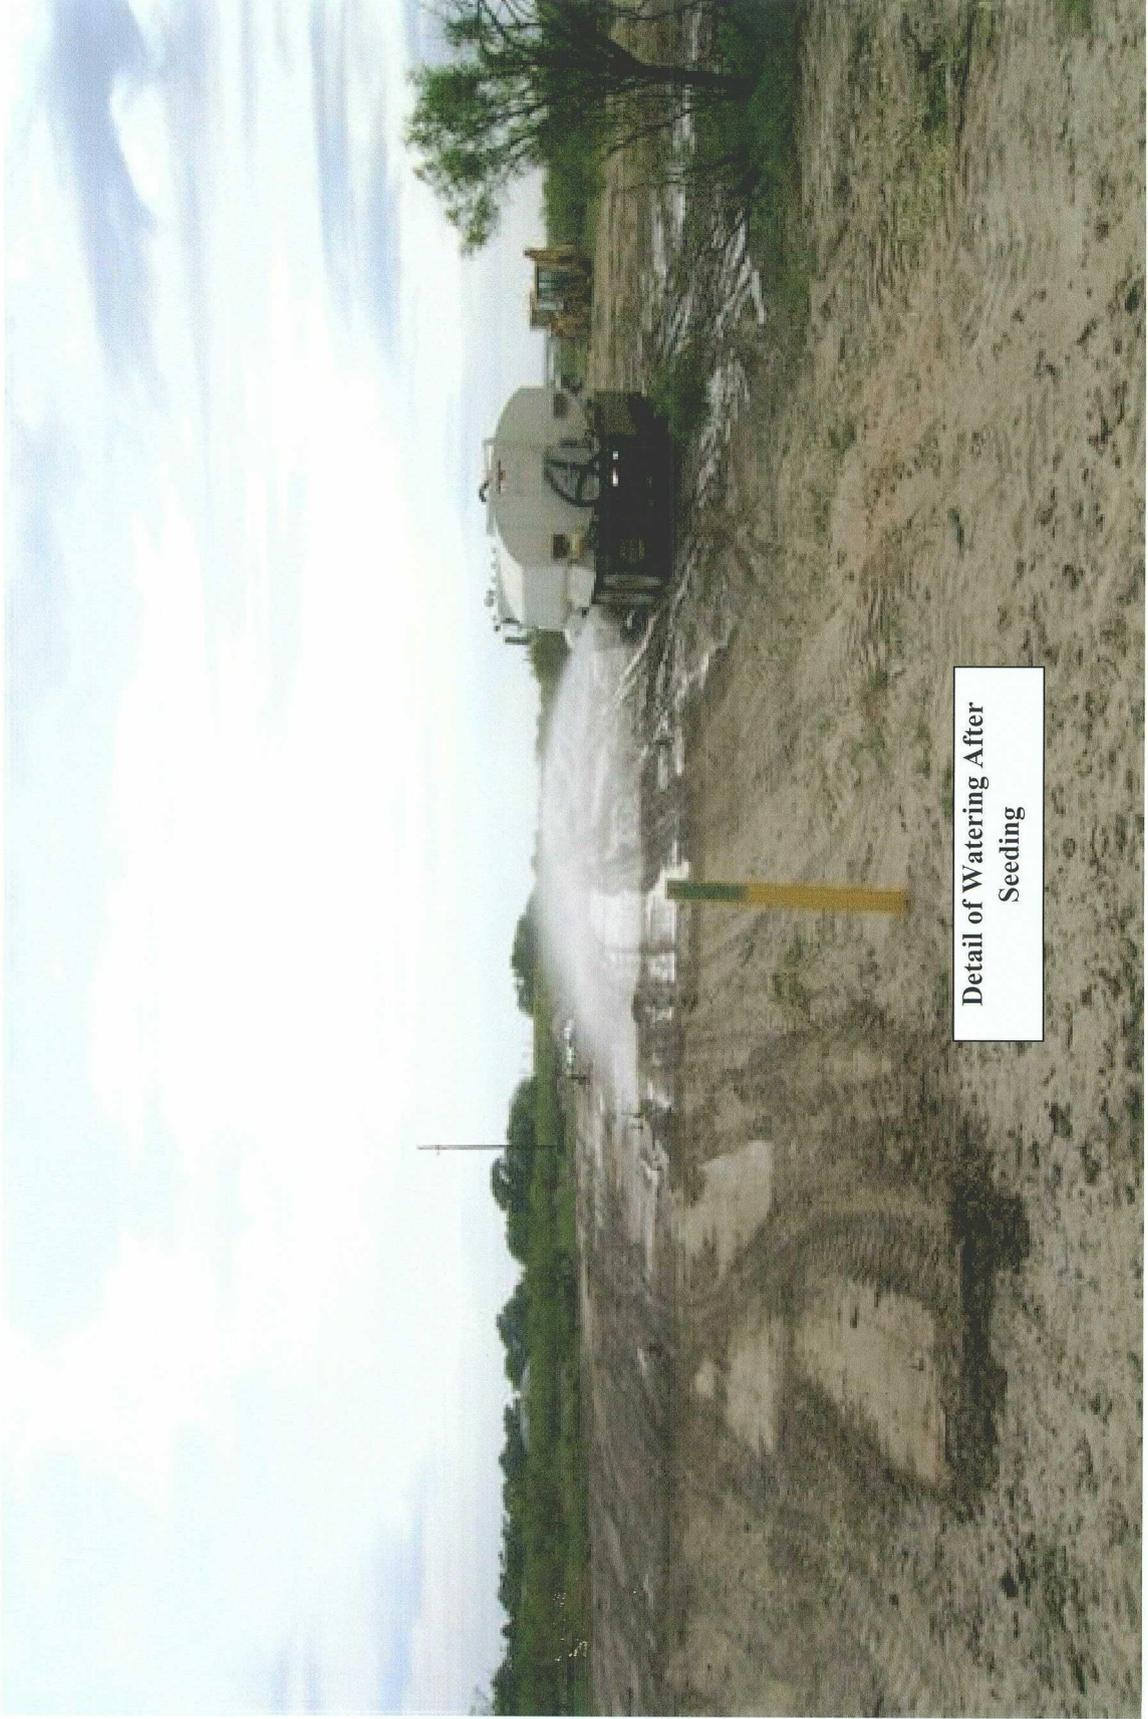
Detail of Watering After Seeding

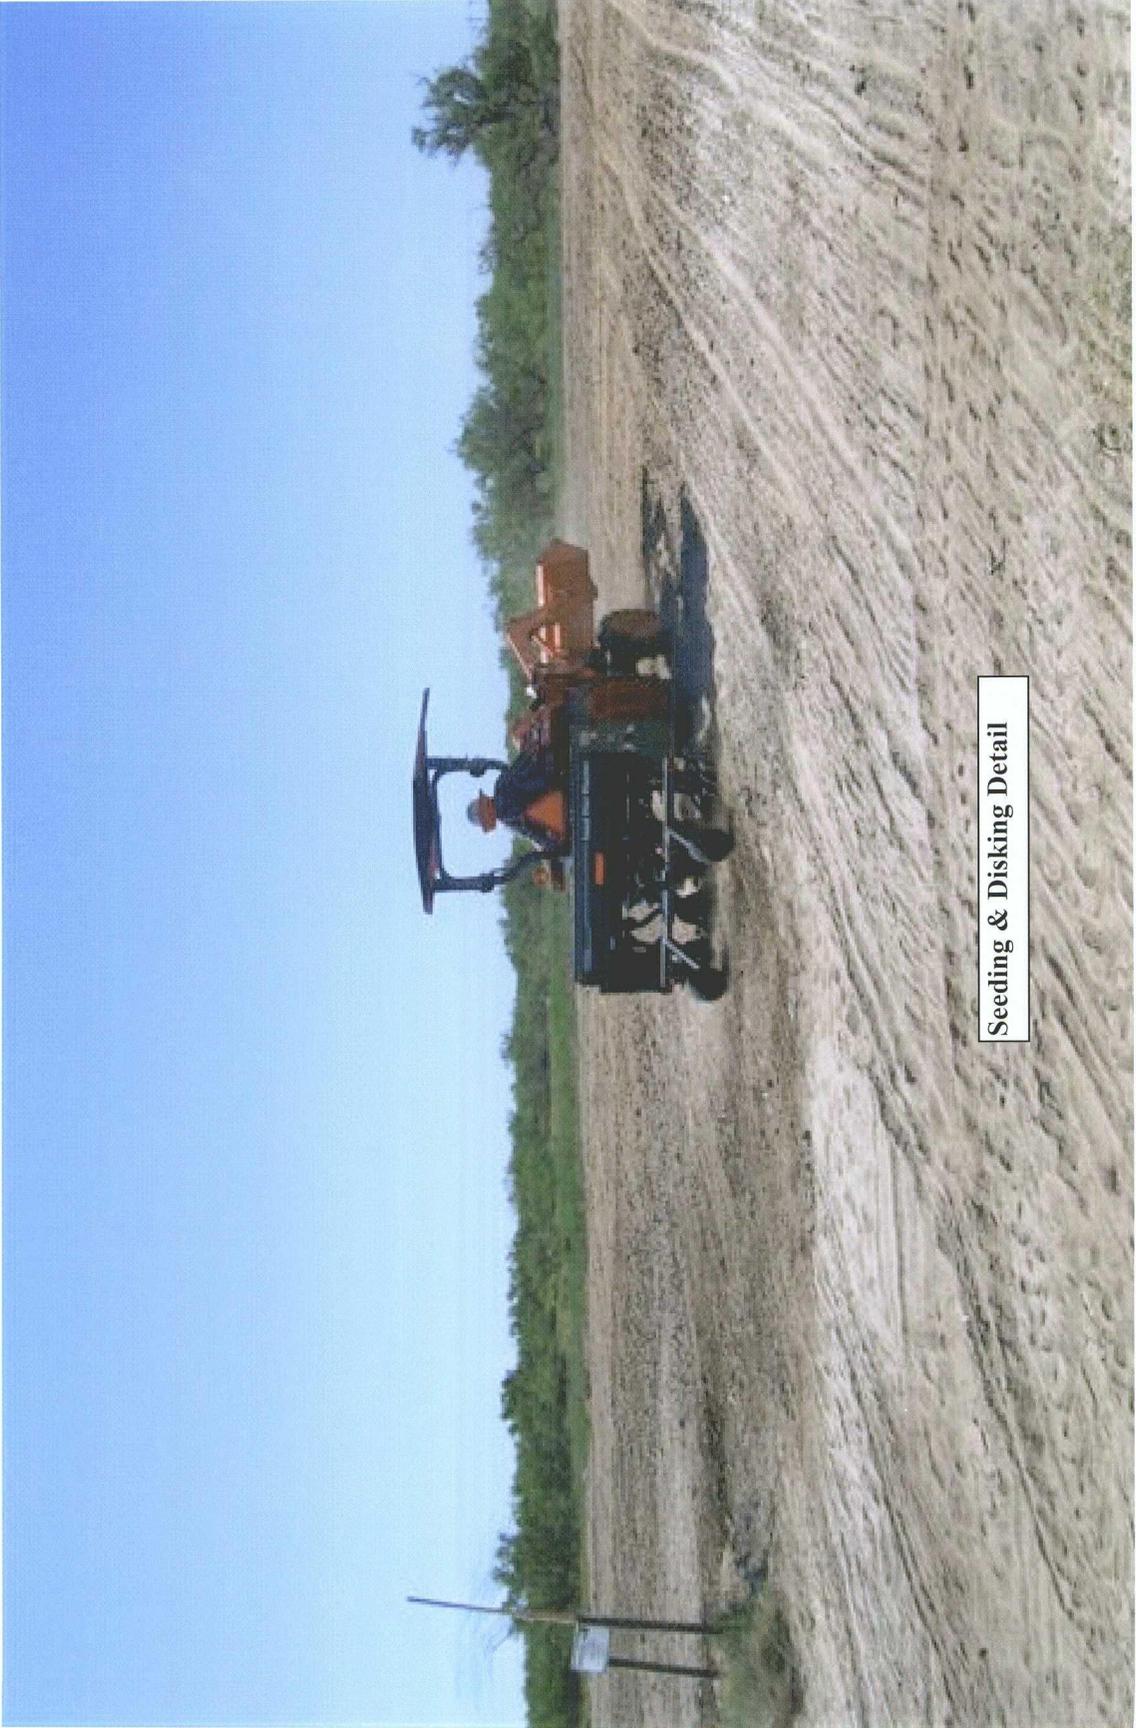
Seeding & Disking Detail

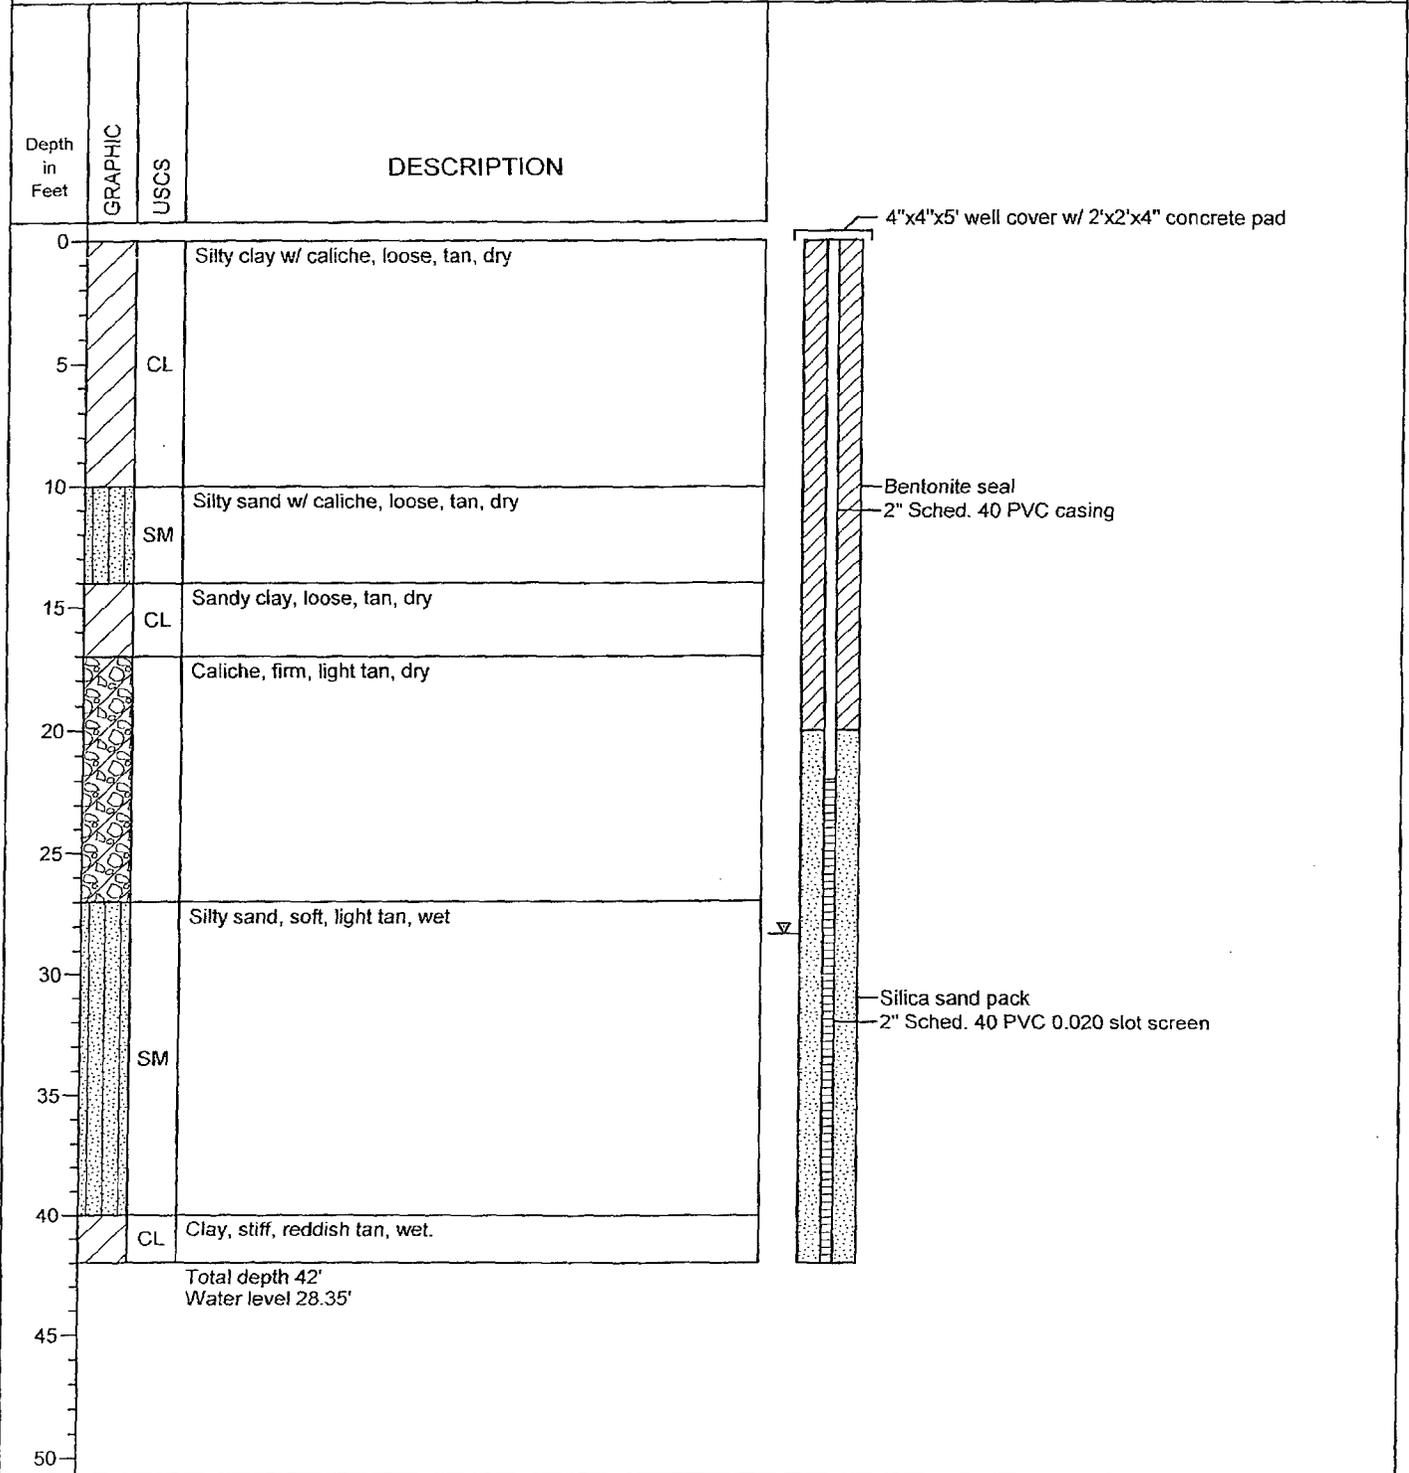
Log of Boring Sarah Phillips EOL

The attached boring log describes the soil profile as sandy with thin bands of sandy clay and unconsolidated caliche.

Date : 10-06-06
 Drill Start : 0800
 Drill End : 1130
 Boring Location : East of MW K33-1
 Site Location : Sarah Phillips EOL, Monument, NM

Auger Type : 4 1/4 Hollow Stem
 Logged By : Mort Bates
