BD Hendrix Weatherly EOL

1R-426-131

CLOSURE

**RICE OPERATING COMPANY
JUNCTION BOX FINAL REPORT**

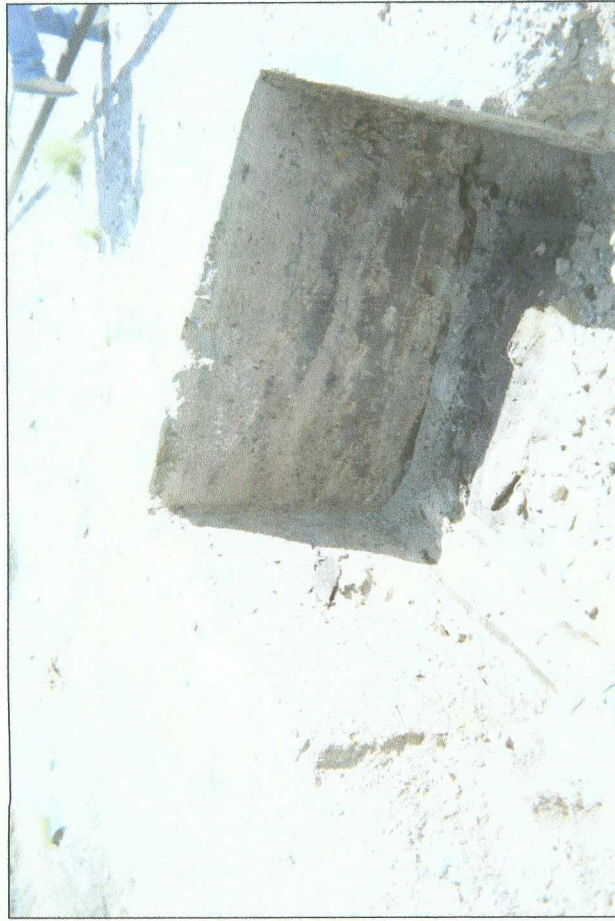
box lumber & junction removed; prior to excavation 7/15/2003

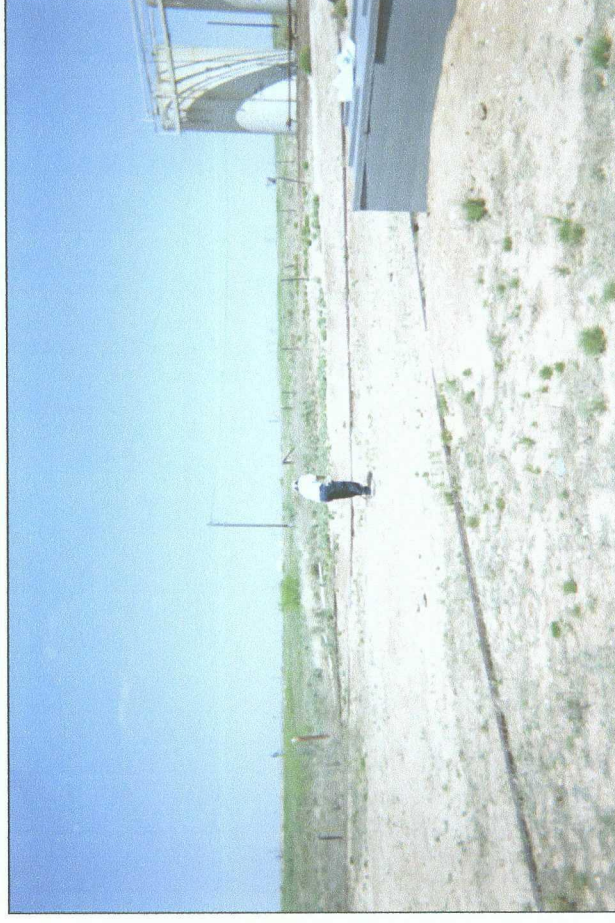
seeding disturbed surface; new junction box in foreground (right) 4/21/2006
