REMEDIATION CLOSURE REPORT

STATE A-26 BATTERY

NMOCD REF. 1RP-1221

JANUARY 2008

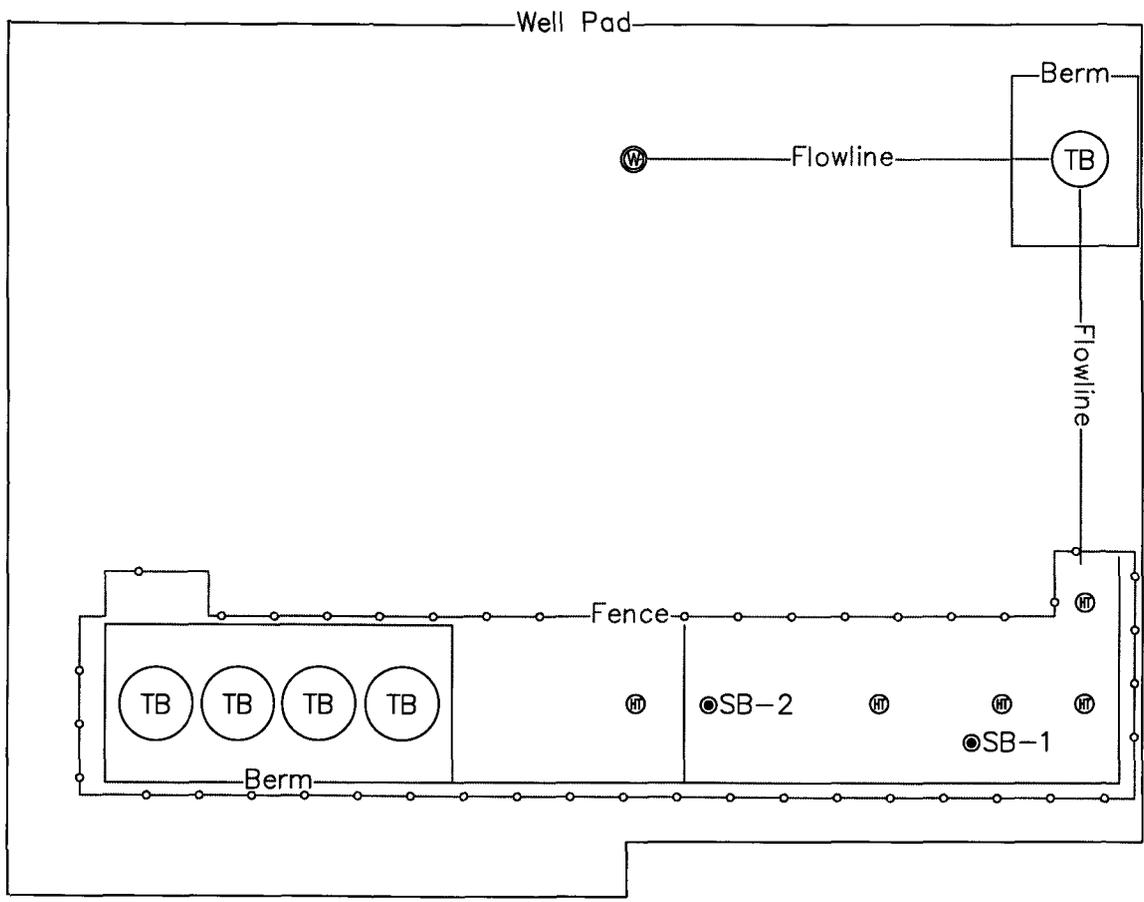
Figure 4
Soil Boring Map
Chevron Corporation
State A #26 Battery

- B. **Field Work** – On 06 April 2006 EPI mobilized at the tank battery to direct locations and depth of two (2) soil borings. Both soil borings were advanced within confines of the tank battery area to total depth (TD) of fifteen (15) feet bgs (reference *Figure 5*). During advancement of soil borings, soil samples were collected at 4.5'-5' feet increments to total depth (TD) of each respective soil boring. Information regarding lithology of soil borings is provided in Attachment III, *Soil Boring Logs*.

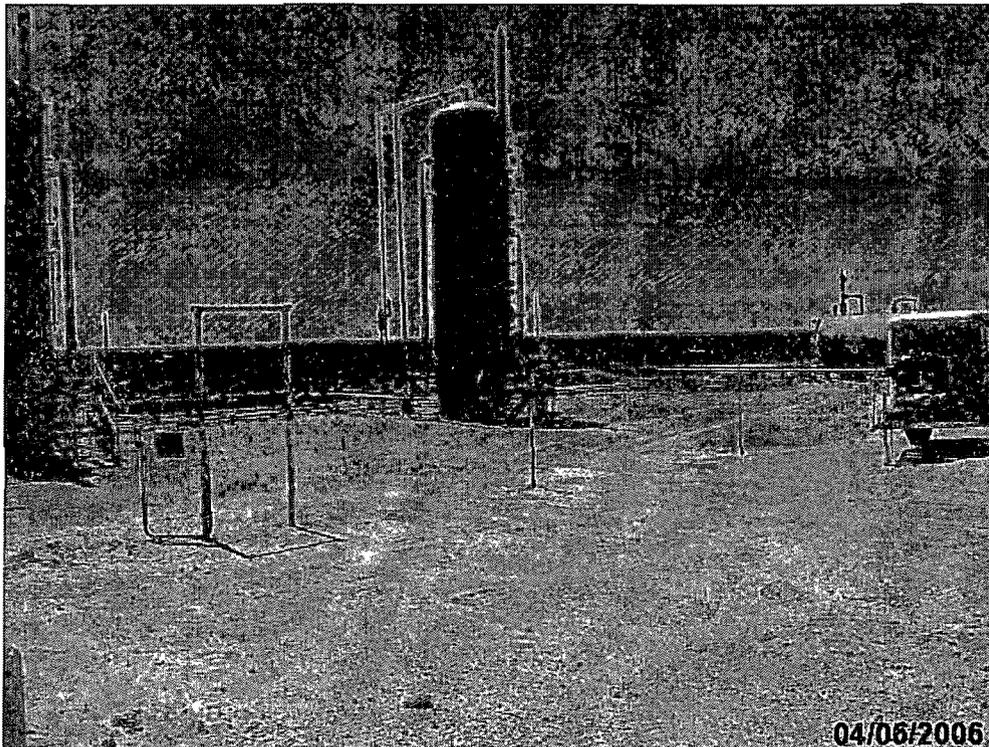
Photograph No. 2 – Tank Battery interior, caliche berms and heater treaters.

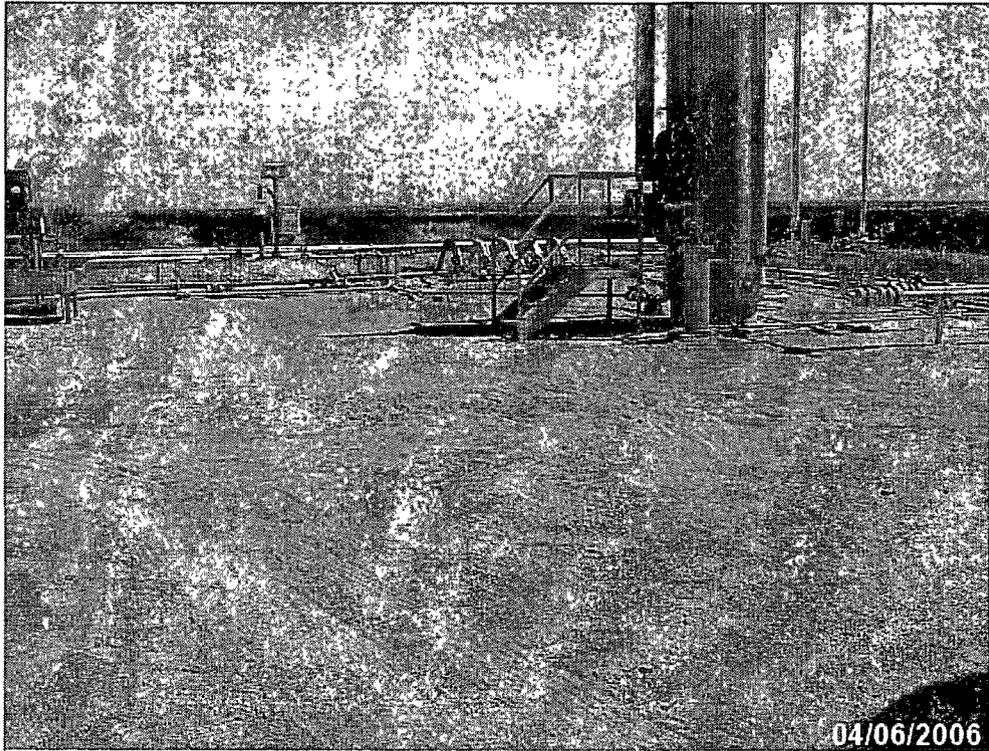
Photograph No. 3 – Interior of caliche bermed area.

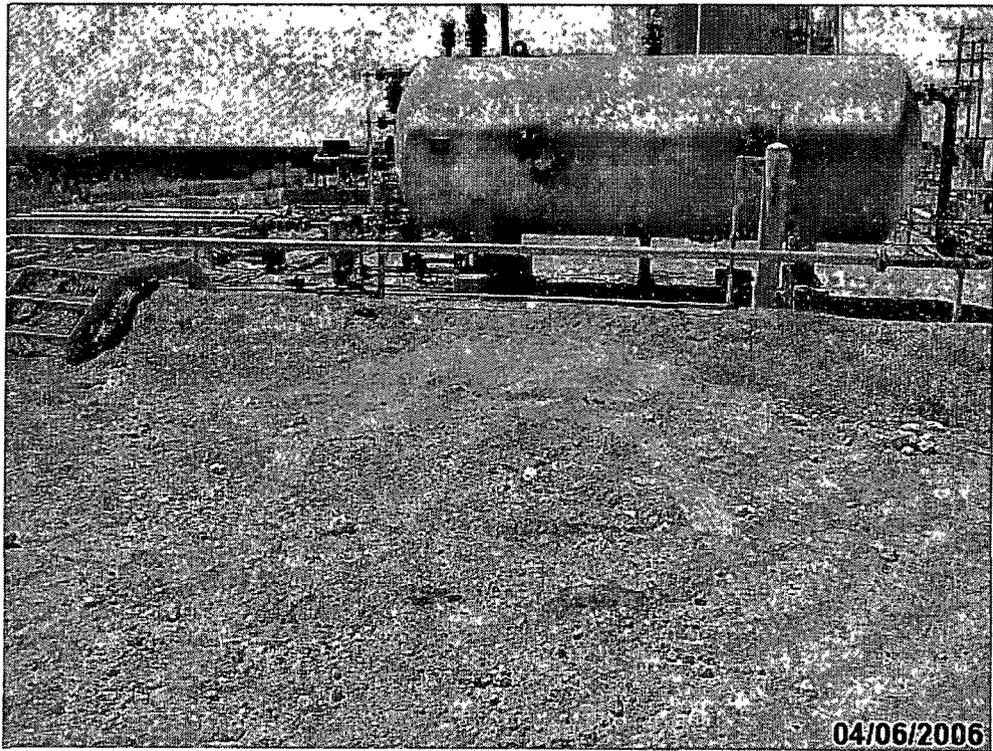
Photograph No. 4 – Caliche berm, horizontal separator and tankage.

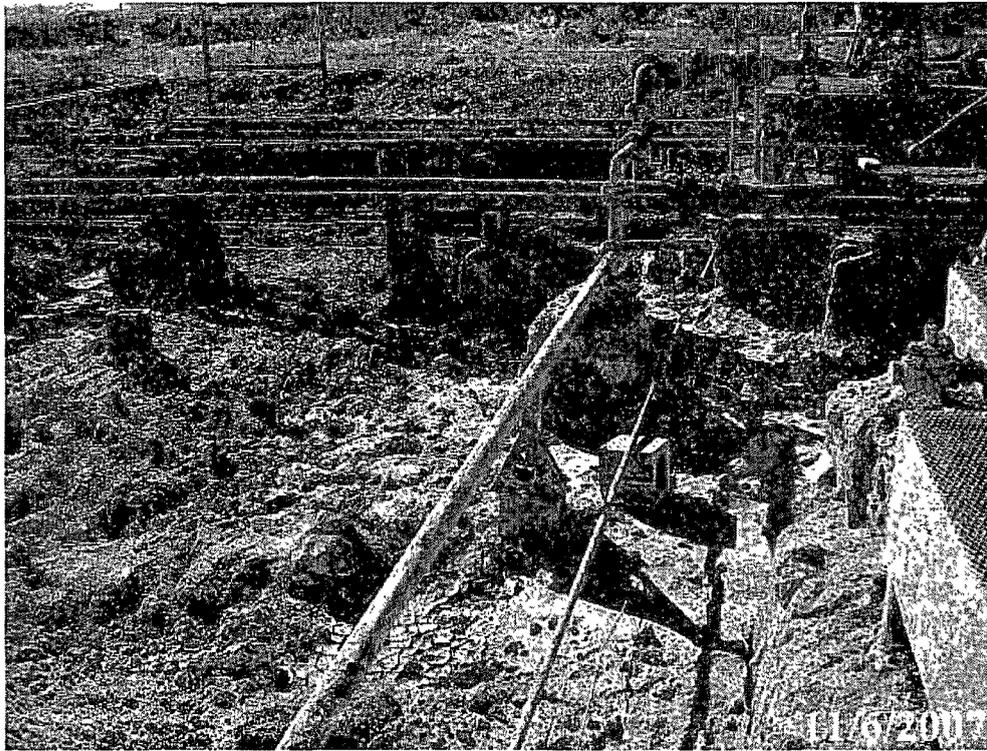
Photograph No. 5 – Excavation area and piping with earthen supports.

From 15 - 29 October 2007 approximately 217yds³ of visibly stained impacted material (i.e., slurry solution ratio composed of ±75% impacted soil:±25% water) were hydro-excavated to a maximum depth of two (2) feet bgs. During the hydro-excavation process, care was taken not to undermine soil stability beneath existing vessels and piping. Impacted soil was transported to Sundance Services, Inc., for disposal.

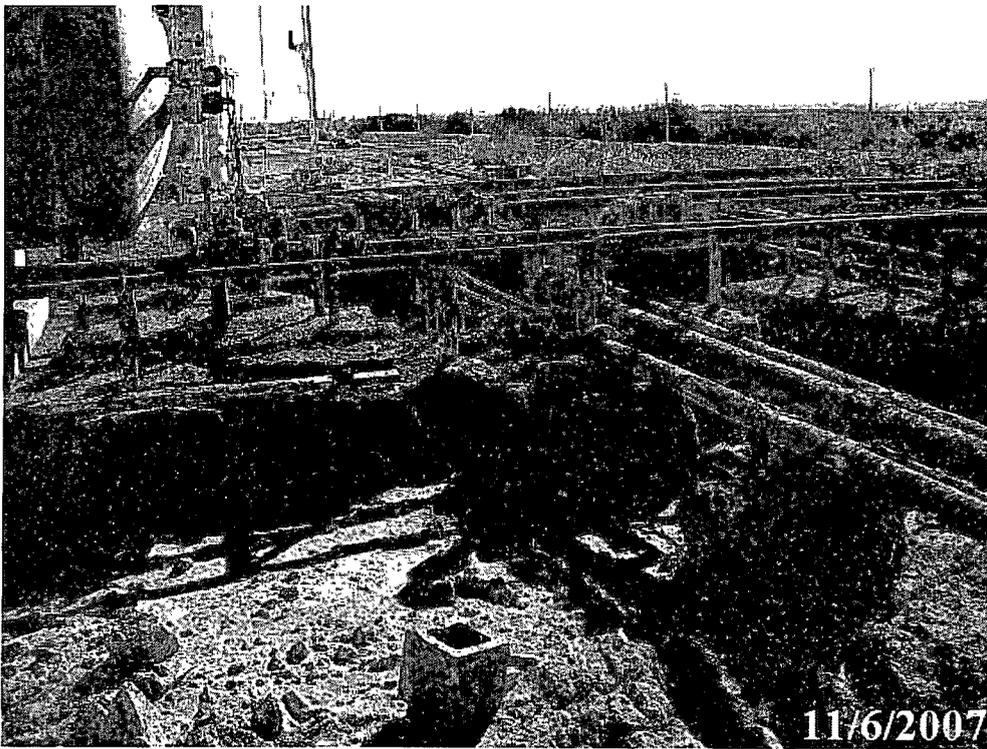
Photograph No. 6 – Excavation area showing piping, horizontal separator and earthen supports

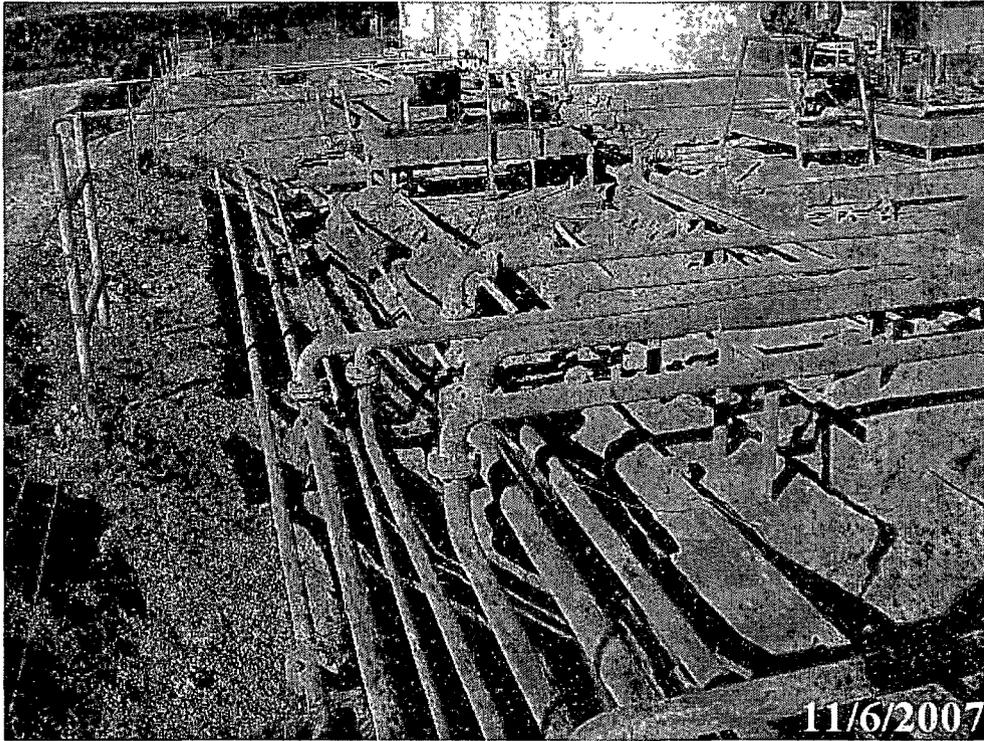
Photograph No. 7 – Excavation area and piping system

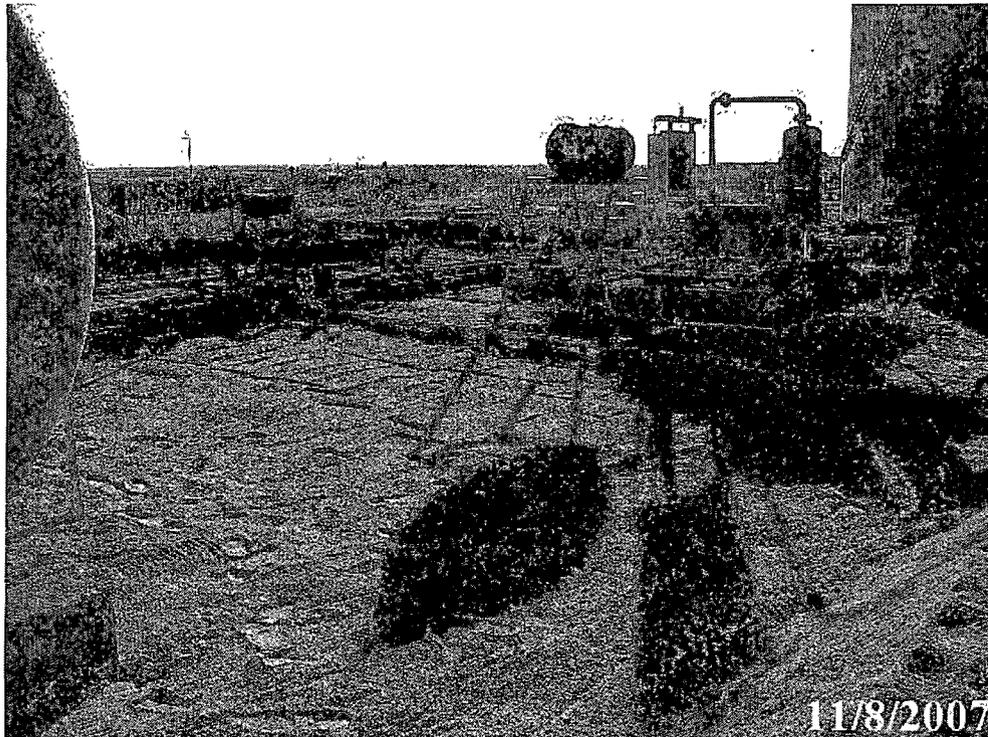
Photograph No. 8 – Remediated site showing graded caliche backfill material

The excavation was backfilled with approximately 190 yds³ of imported graded caliche. Backfilling was completed to original elevation with existing caliche berms repaired and raised in elevation. A caliche berm was added to the north side of the remediated area to provide closure on all four (4) sides. The interior and caliche berms were smoothly graded. A felt liner was placed over the bottom of the interior sector and overlapped caliche berms. A plastic coating was sprayed over the felt liner to form an impervious barrier. Overlapping caliche berms was undertaken to reduce erosion effects caused by wind/rain and produce a totally enclosed catch basin.

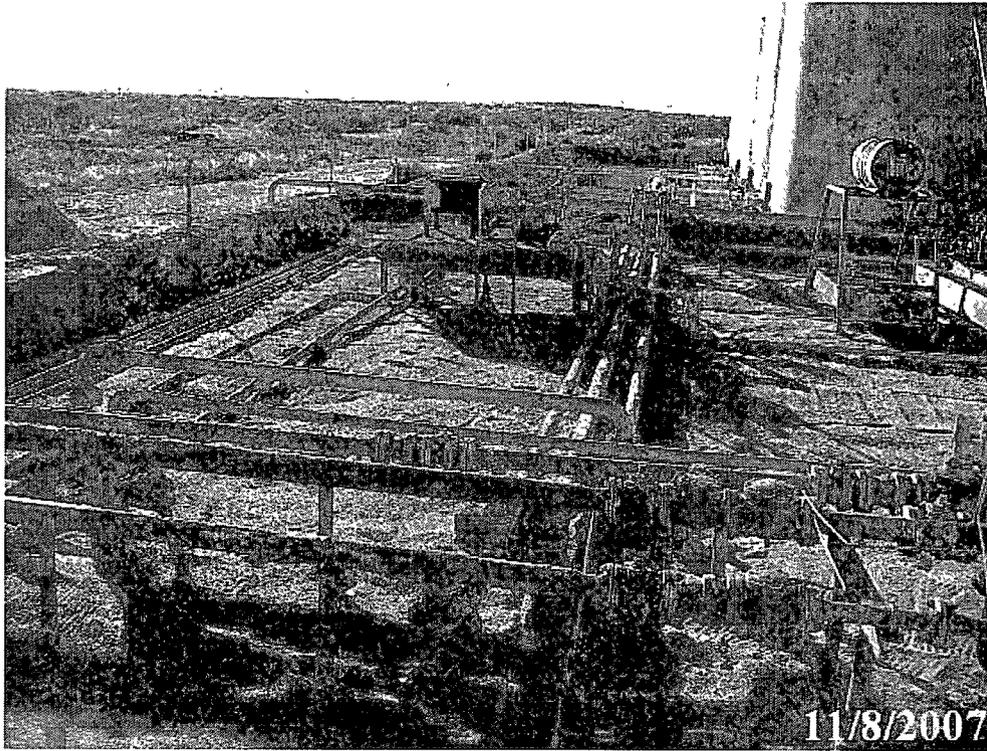
Photograph No. 9 – Remediated site showing graded caliche backfill material

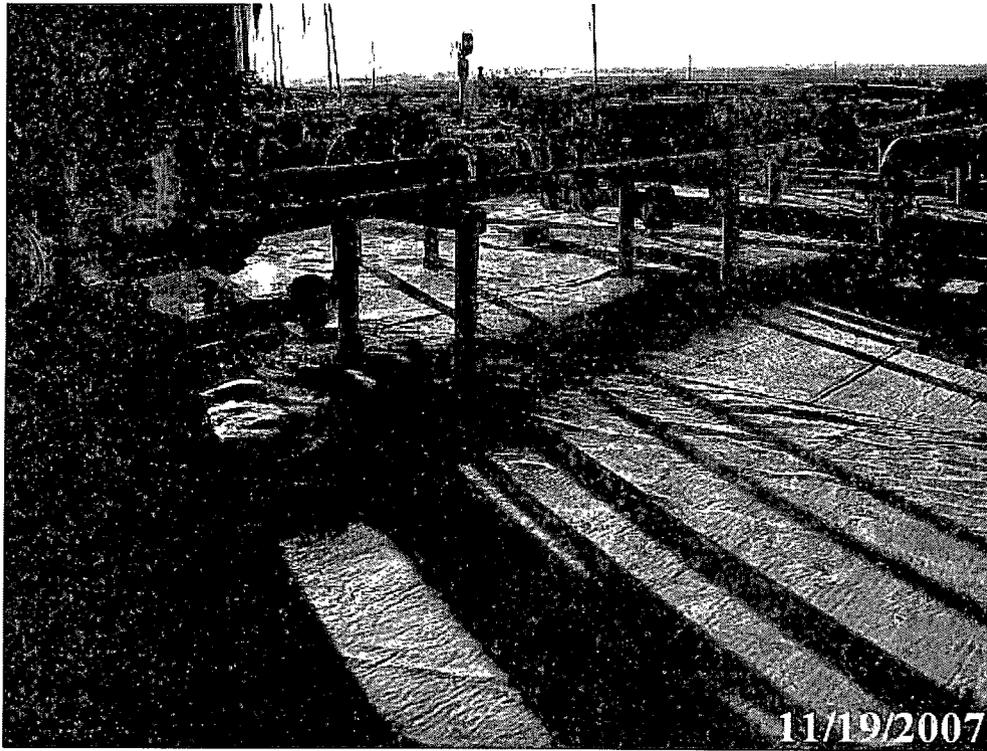
Photograph No. 10 – Remediated site with liner.

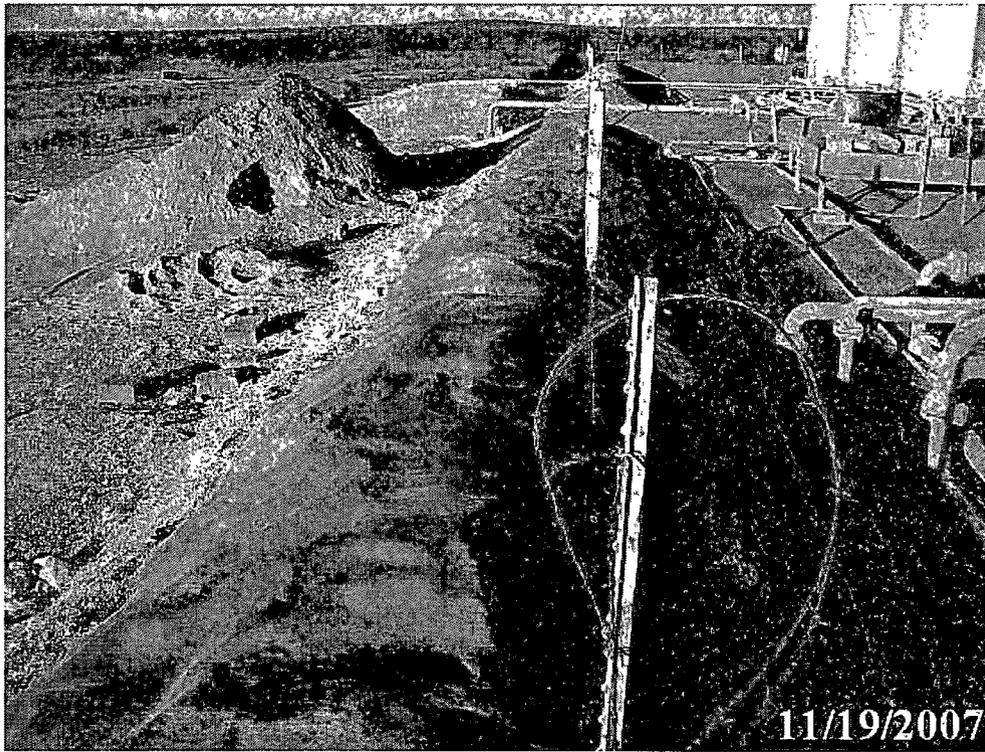
Photograph No. 11 – Remediated site showing liner overlapping caliche berms.

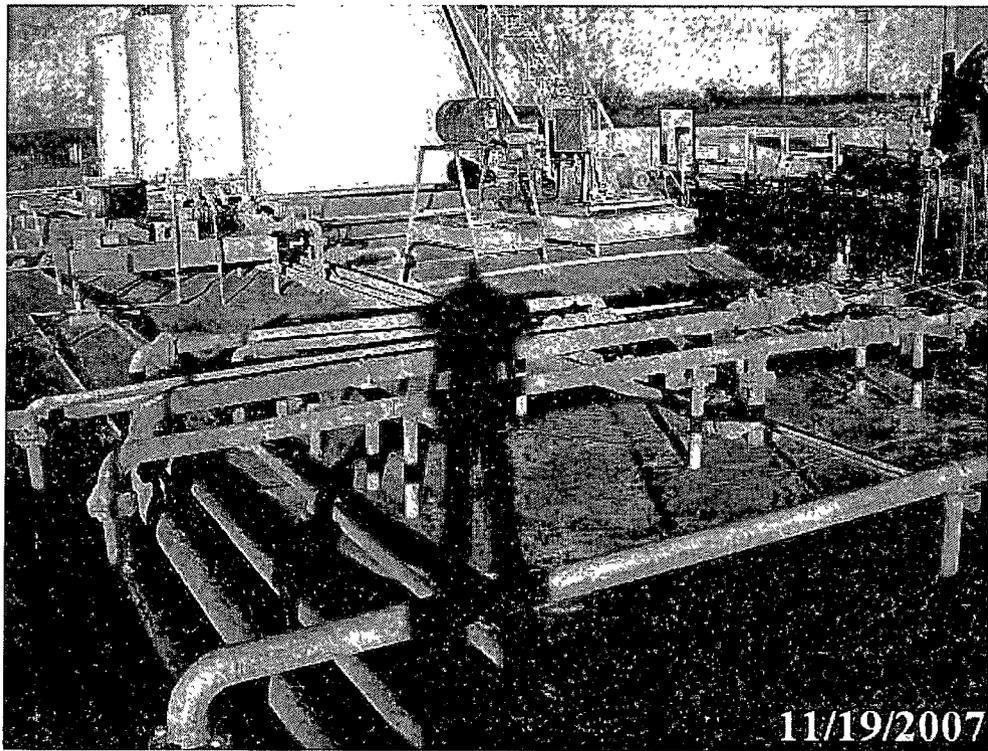
Photograph No. 12 – Remediated site with liner.
