# CLOSURE REPORT

NM A.S. NCT-1 #1 & 2 B-9765

EPI REF: #160069

**RE: Final Closure Report**

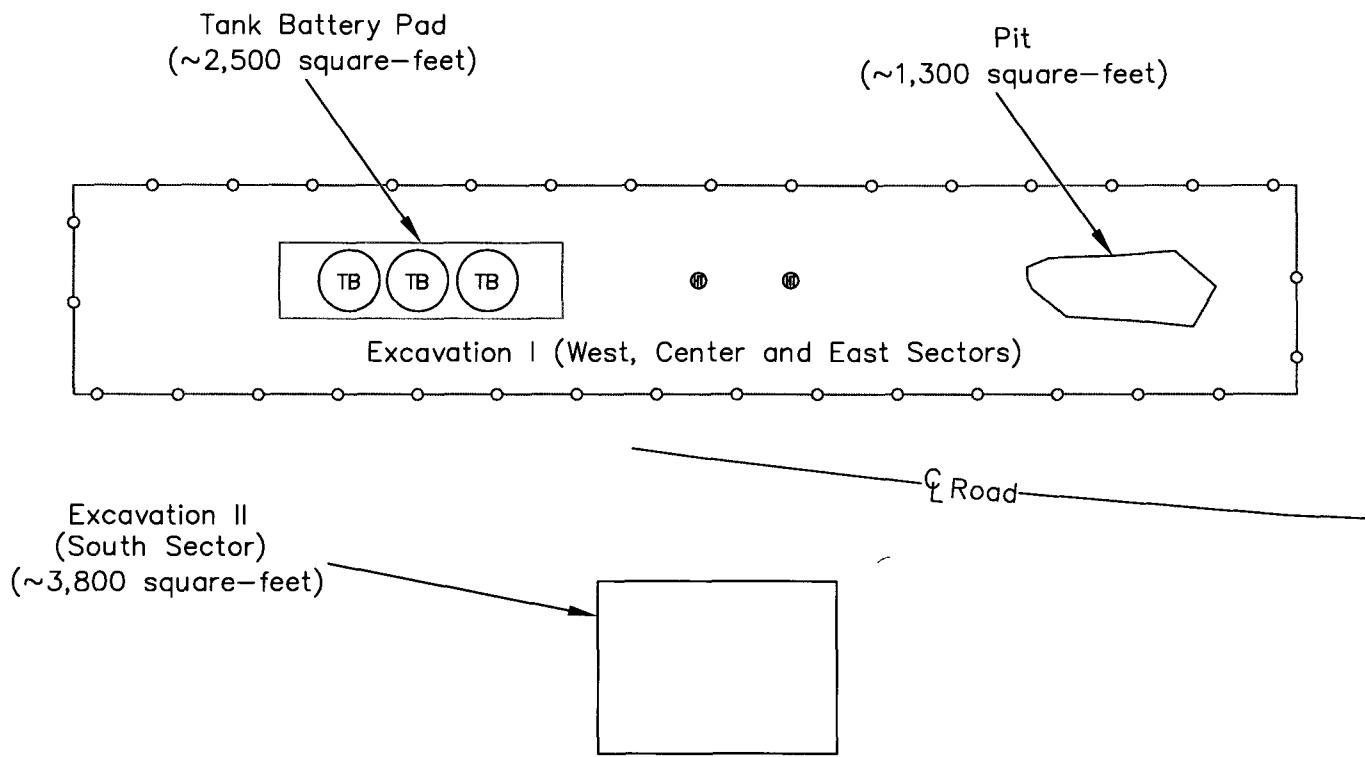
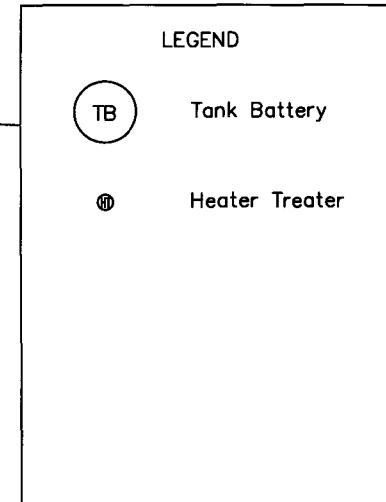
Figure 3 Site Map Chesapeake Energy NM A.S. State NCT-1 #1&2 Tank Battery	Lea County, New Mexico NE 1/4 of the SW 1/4, Sec. 6, T15S, R32E N 33° 02' 58.06" W 103° 45' 10.80" Elevation: 4,345 feet amsl	DWG By: Daniel Dominguez September 2006	REVISED:	
		 0      60      120 Feet	SHEET 1 of 1

The site was divided into two (2) separate excavations with Excavation I containing the east, center and west sectors. This fenced site contained the bulk of the Tank Battery components (i.e., storage tanks, heater treaters, separators, transfer pumps, pit, fill lines, etc.). Excavation II located south of fenced Excavation I area contained a storage tank (reference *Figure 3* for locations).

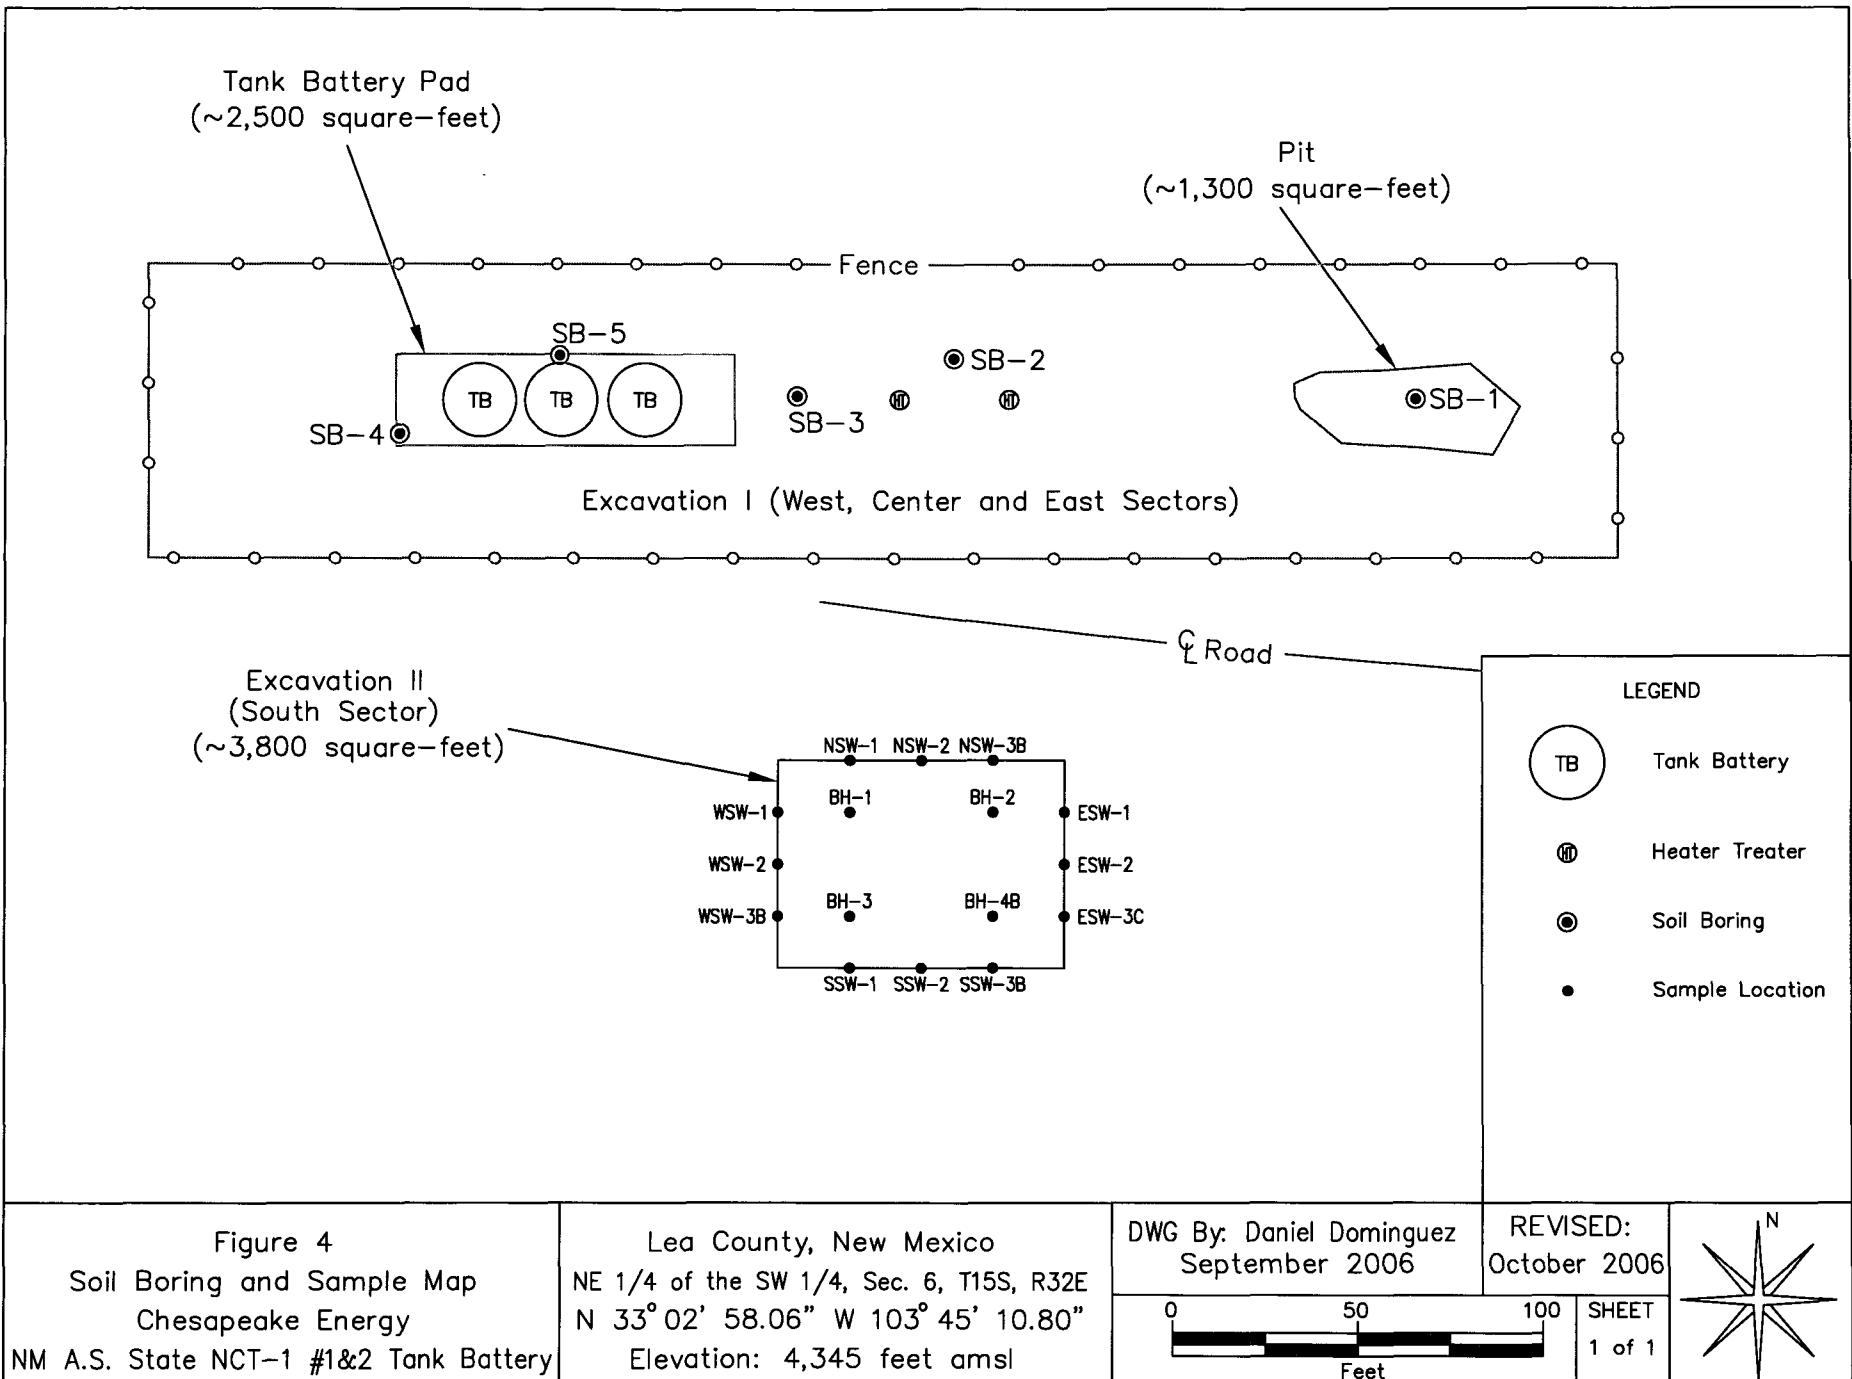
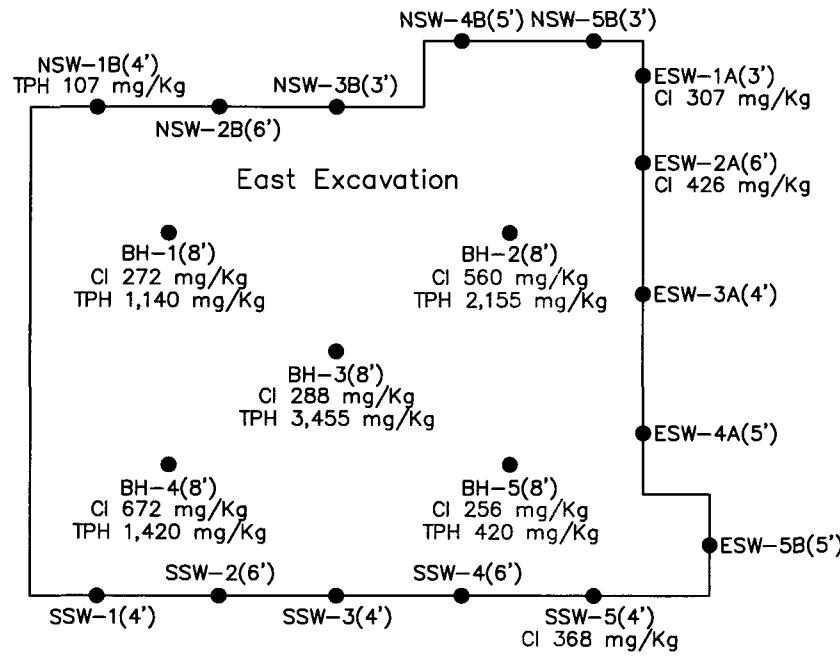
Figure 5 East Excavation/Sample Map Chesapeake Energy NM A.S. State NCT-1 #1&2 Tank Battery	Lea County, New Mexico NE 1/4 of the SW 1/4, Sec. 6, T15S, R32E N 33° 02' 58.06" W 103° 45' 10.80" Elevation: 4,345 feet amsl	DWG By: Daniel Dominguez September 2006	REVISED: Oct 2007	N

Note: Sample locations not showing contaminant concentrations are below NMOCD Remedial Threshold Goals.

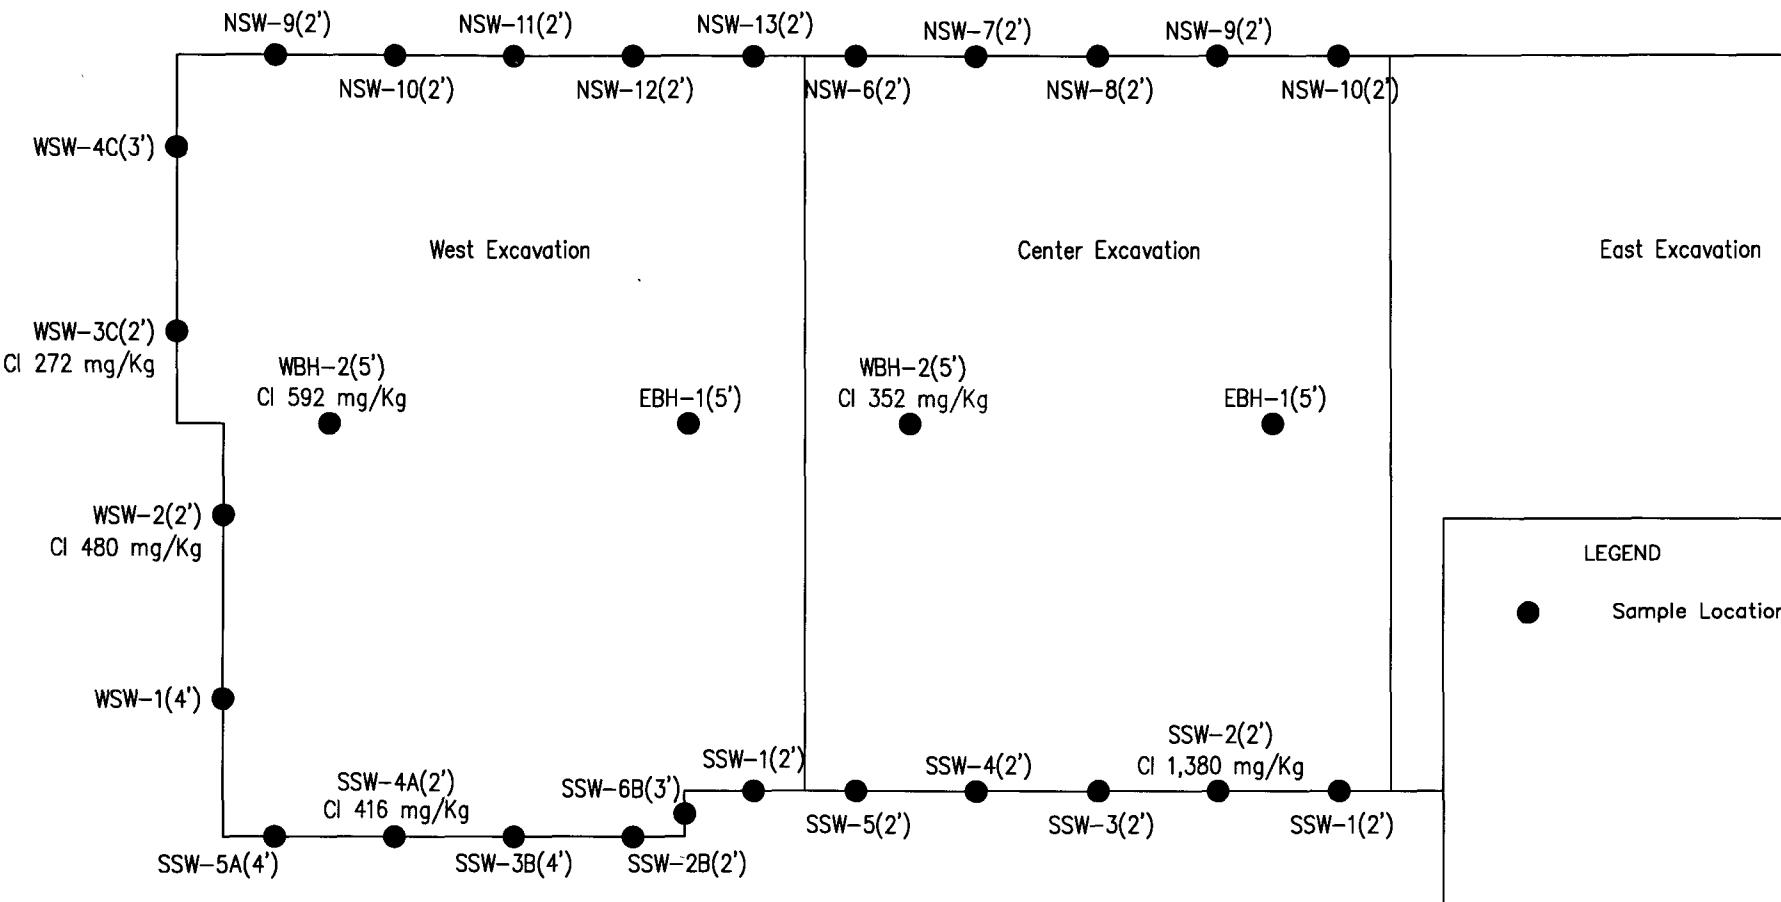
Figure 6  
 West/Center Excavation & Sample Map  
 Chesapeake Energy  
 NM A.S. State NCT-1 #1&2 Tank Battery

Note: Sample locations not showing contaminant concentrations are below NMOCD Remedial Threshold Goals.

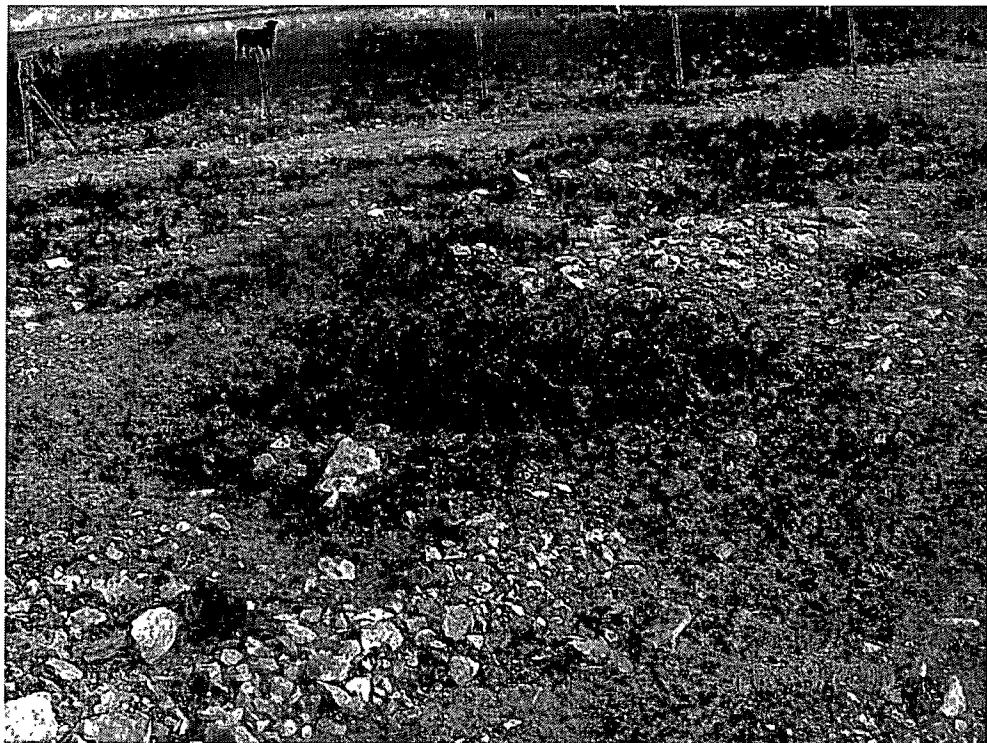
Photograph No. 2 – Looking northerly across possible pit area.

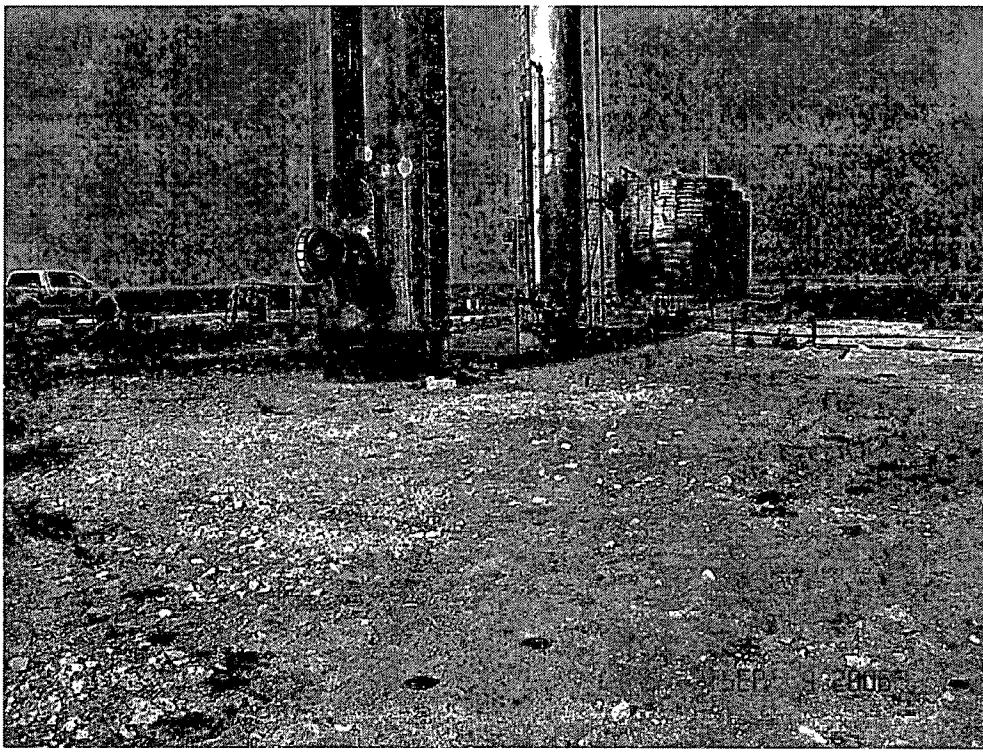
Photograph No. 3 – Looking southwesterly at existing heater treaters and storage tanks.

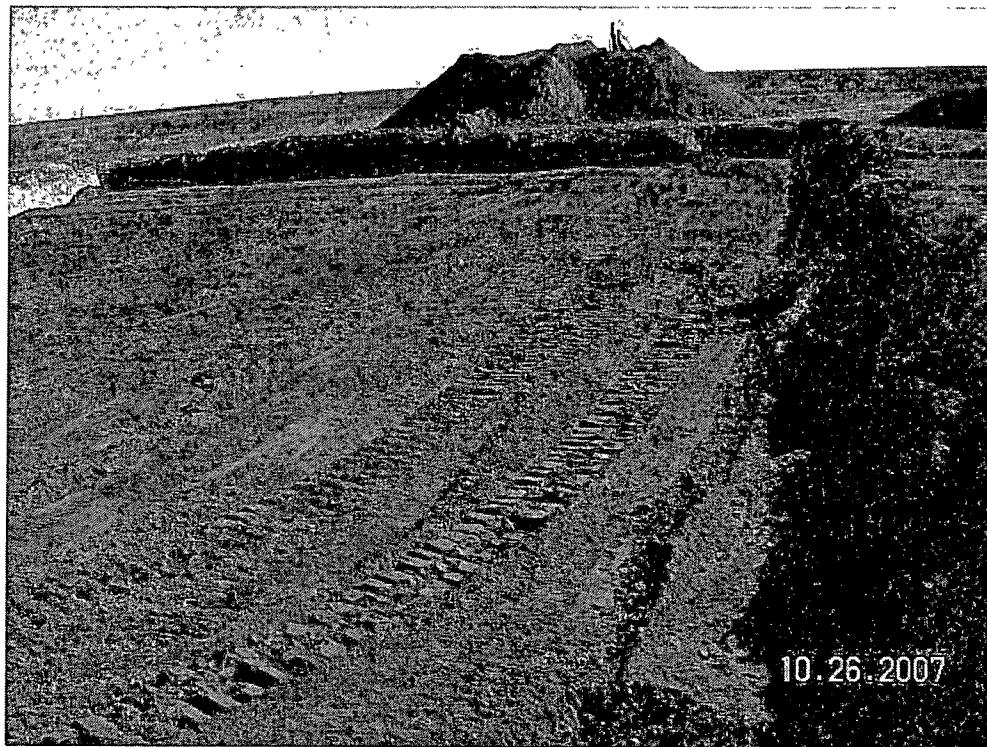
Photograph No. 4 – Looking easterly at backfilling of excavation area.

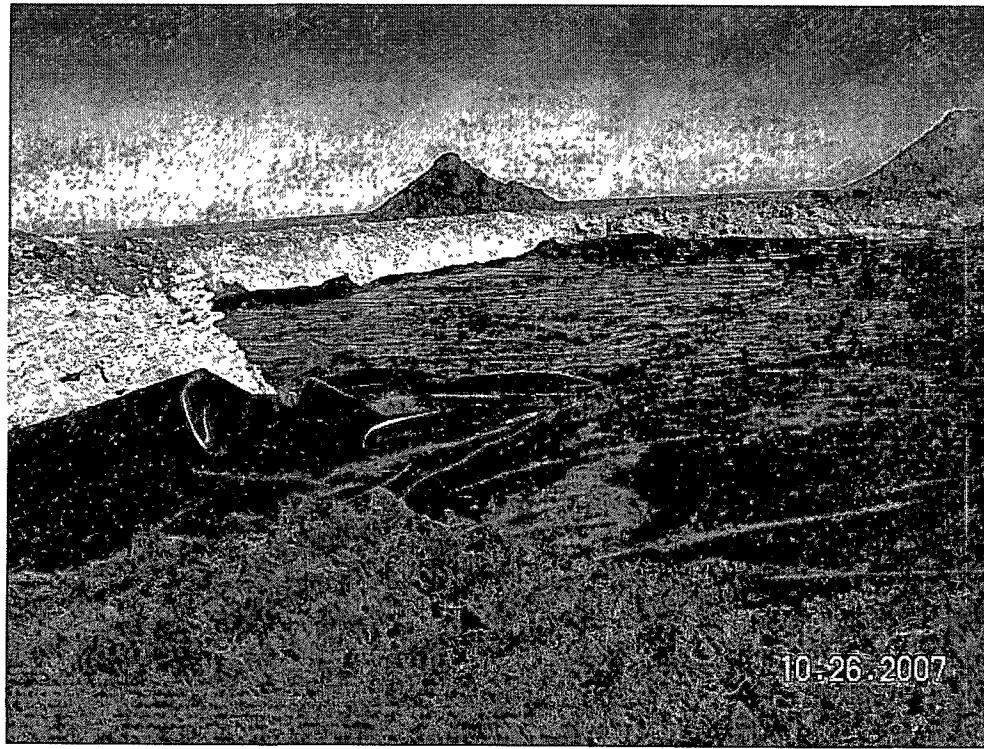
Photograph No. 6 – Looking northeasterly during installation of liner.

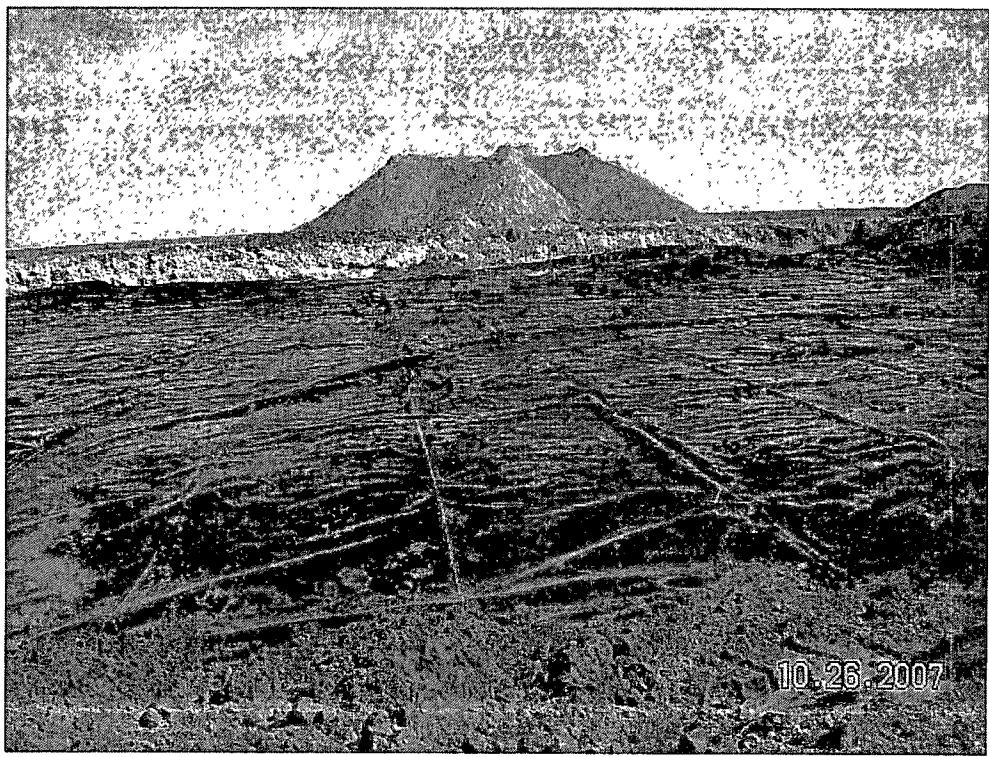
Photograph No. 7 – Looking easterly during installation of liner.

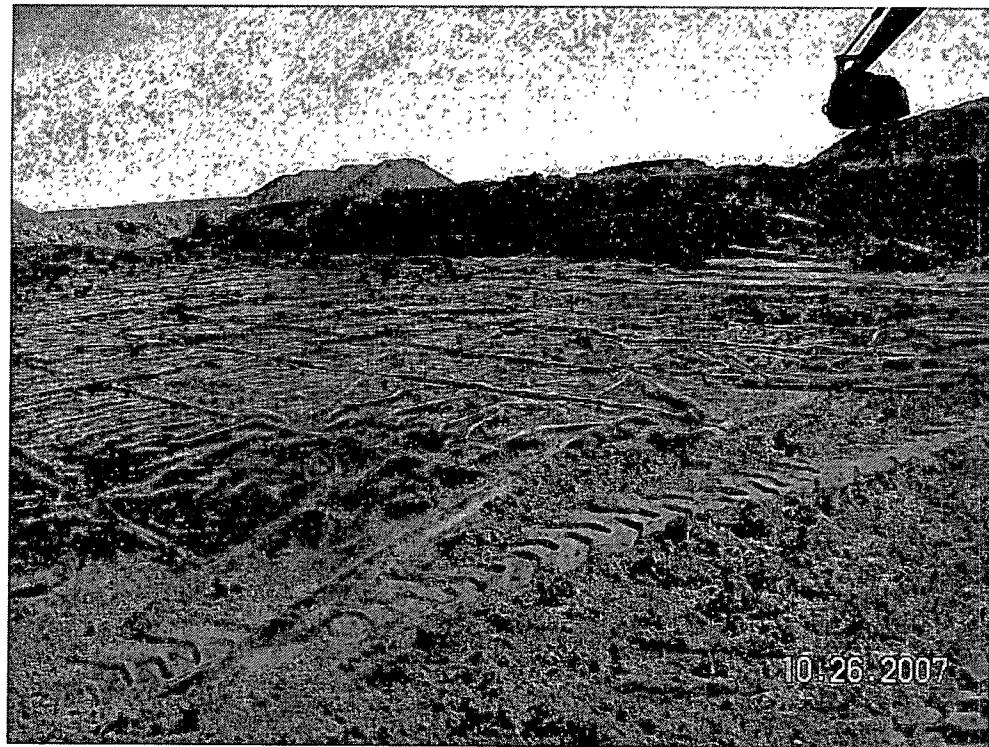
Photograph No. 8 – Looking northeasterly at liner and cushion material.

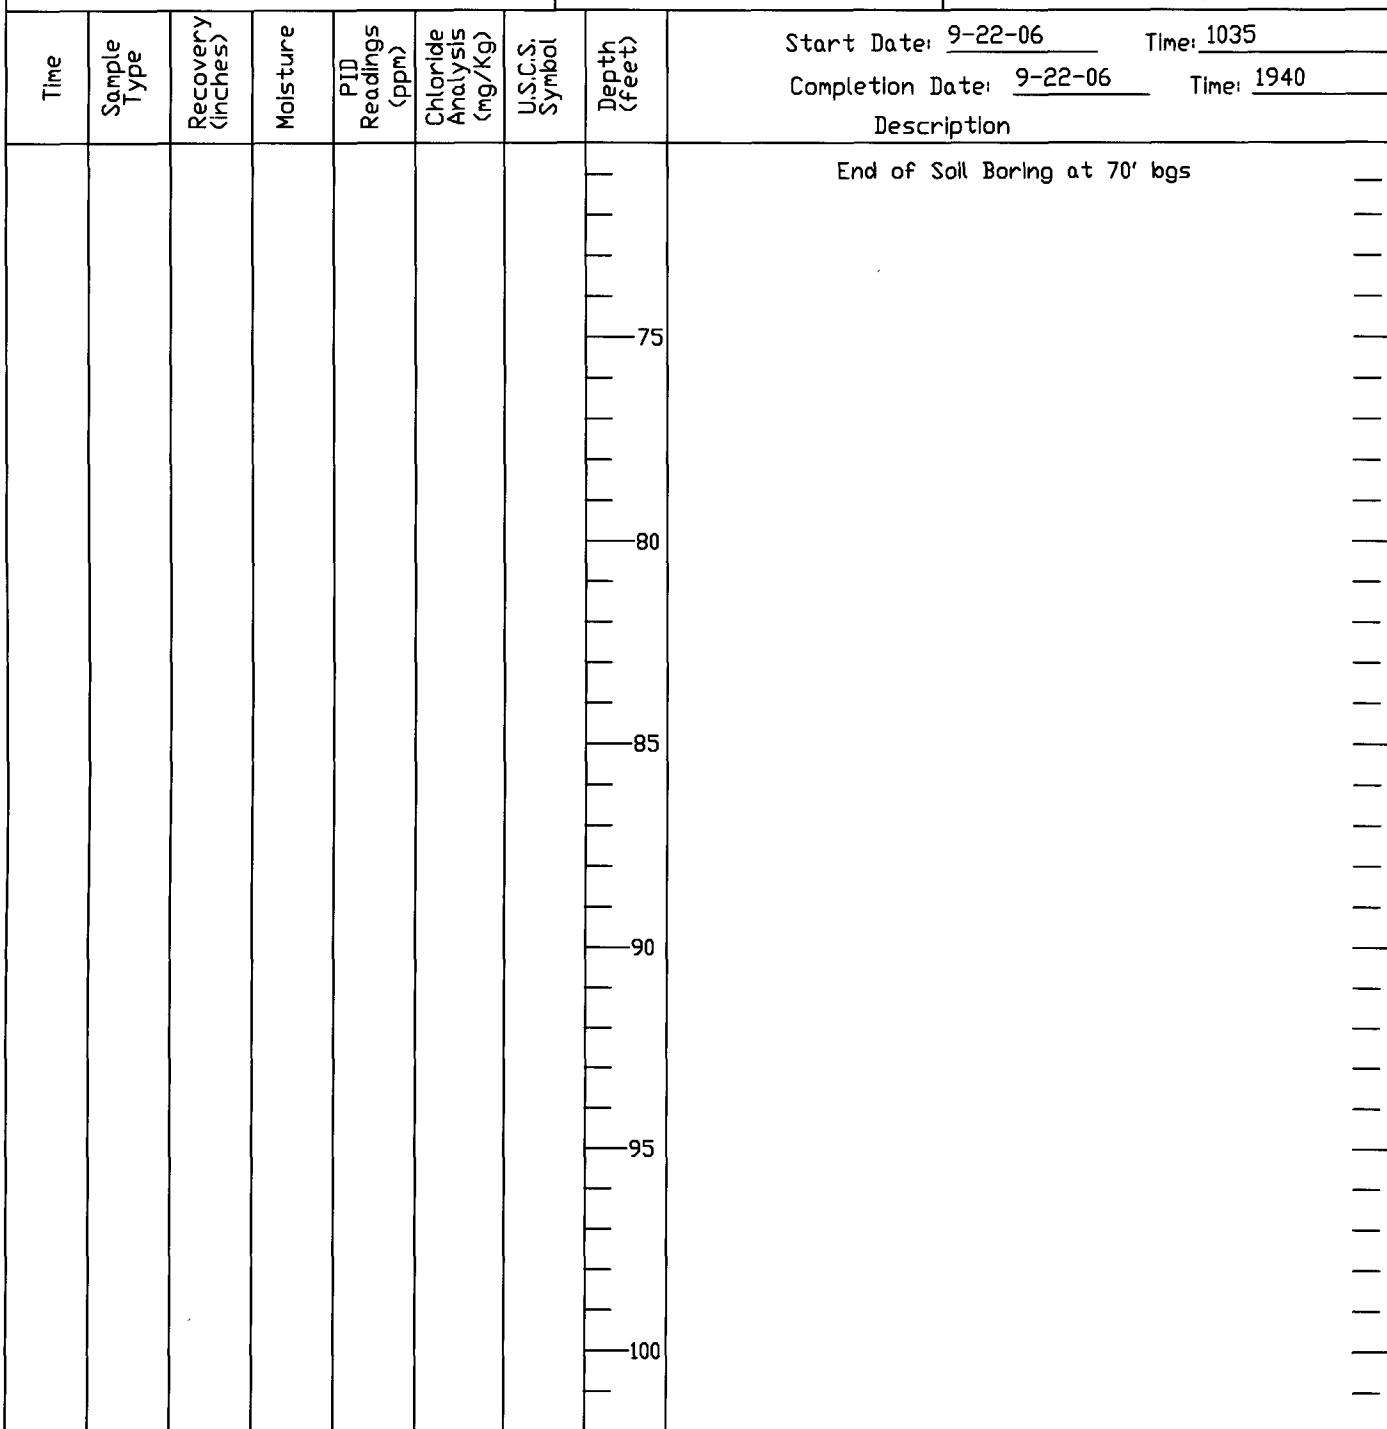
Boring Number: SB-4

Time	Sample Type	Recovery (inches)	Moisture	PIT Readings (ppm)	Chloride Analysis (mg/kg)	USCS Symbol	Depth (feet)	Description
1401	SS	8	no	0	880		40	40' SANDSTONE, Tan, Dense
1436	SS	10	no	0	1,520		45	45' SANDSTONE, Tan, Dense
1515	SS	8	no	0	1,400		50	50' SANDSTONE, Tan, Dense
1559	SS	8	no	0	1,400		55	55' SANDSTONE, Tan, Dense
1658	SS	8	no	0	1,240		60	60' SANDSTONE, Tan, Dense
1800	SS	8	no	0	920		65	65' SANDSTONE, Tan, Dense
1859	SS	8	no	0	620		70	70' SANDSTONE, Tan, Dense
