RE: **Closure Report**
DCP Midstream – G-28-14 Ext. 3
NMOCD 1RP# 1029; EPI Ref. #130018
UL-D (NW¼ of the NW ¼) of Section 26, T23S, R36E
Latitude N 32° 16' 49.349" and Longitude W 103° 14' 27.415"

DCP Midstream retained Environmental Plus, Inc. (EPI) to delineate and remediate soils impacted from a release of natural gas and natural gas liquids (NGL) due to weld failure on a 6-inch Marlex natural gas pipeline. Upon initial assessment, the site exhibited approximately 6,600-ft² of impacted surface area consisting primarily of lightly misted overspray area. This letter report documents delineation activities, excavation of impacted soil and site closure procedures.

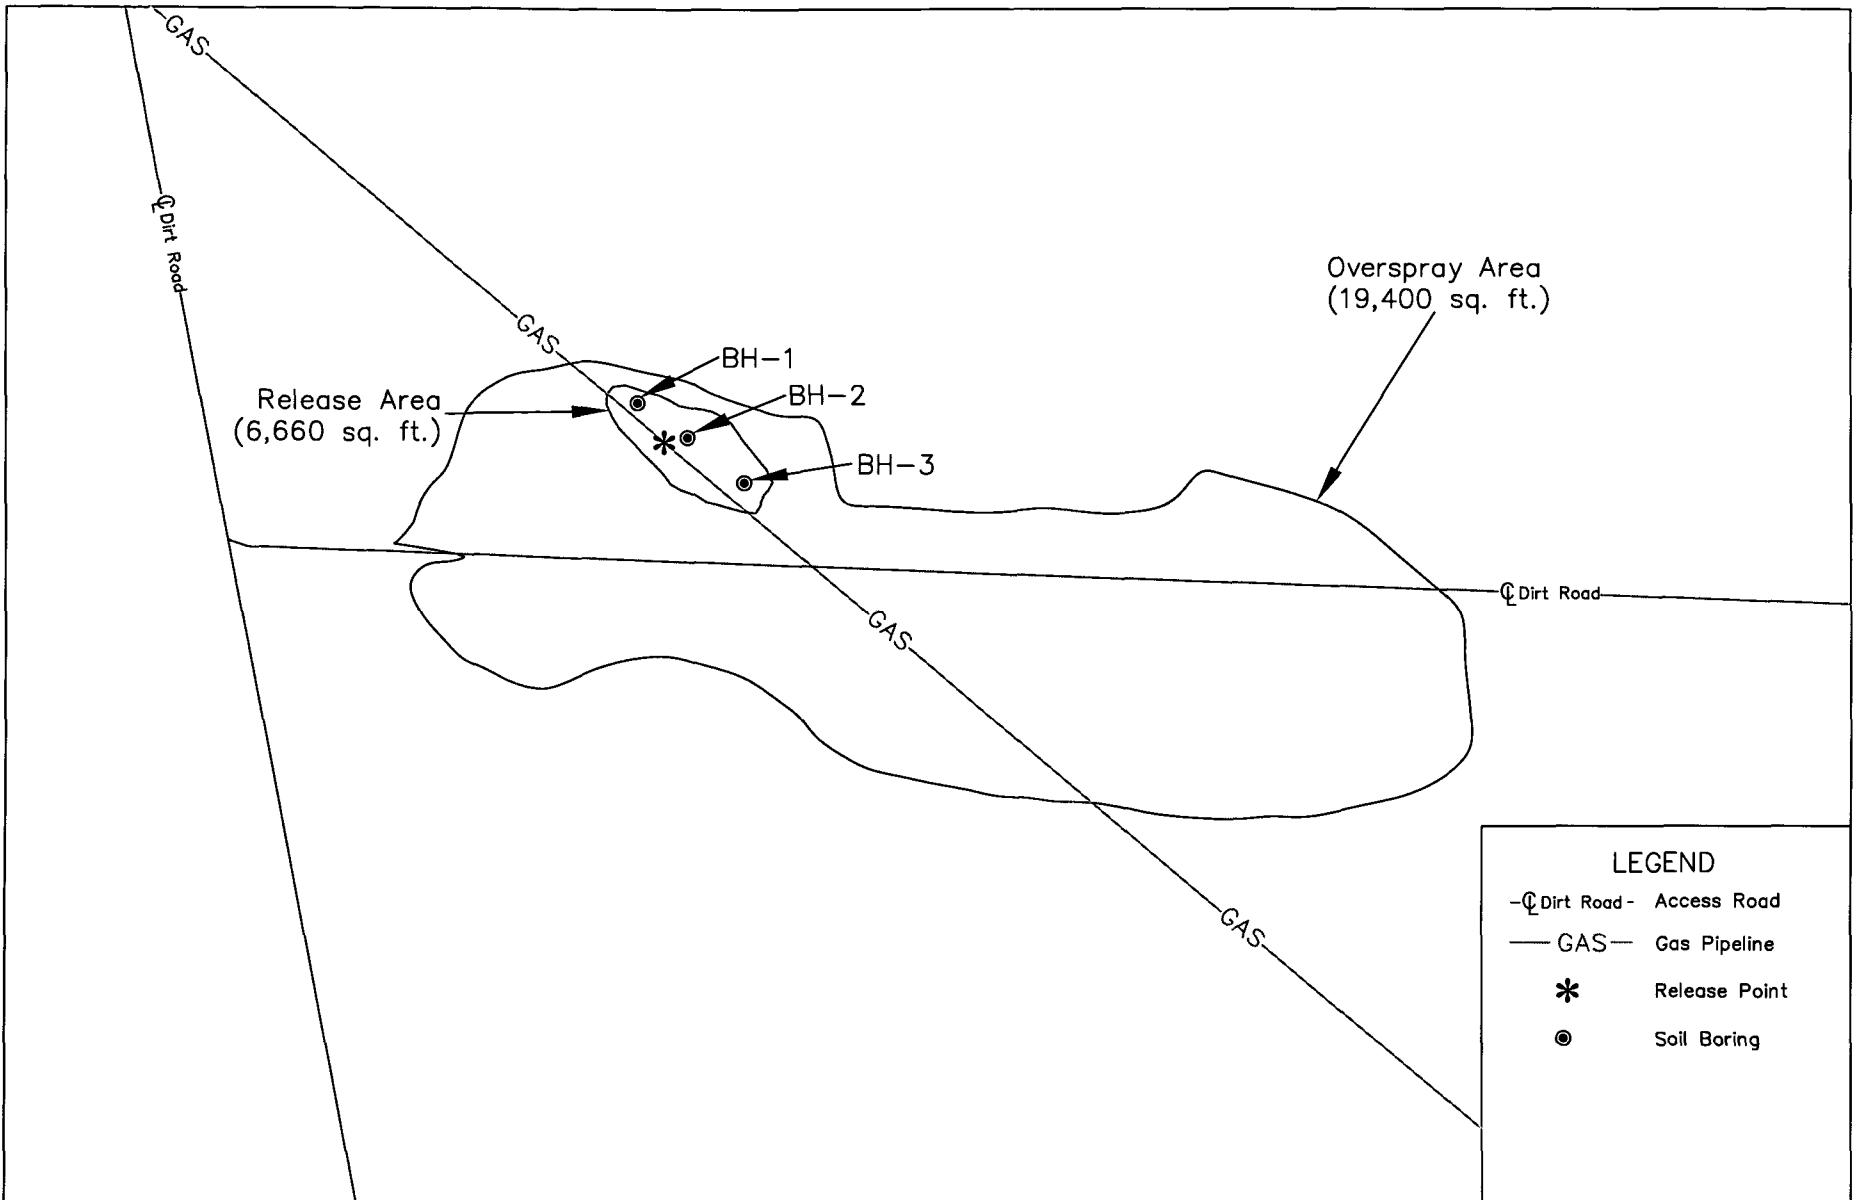
Figure 4
 Soil Boring Location Map
 DCP Midstream, LLC
 G-28-14 Ext. 3

EPI field personnel conducted an initial site assessment of on 28 March 2005 to photograph, GPS and document existing site conditions. On 1 August 2005, a series of three soil borings (BH-1, BH-2 and BH-3) were advanced within the release area. Soil boring BH-1 was advanced north of the point of release to approximately 20-foot bgs. Soil boring BH-2 was advanced adjacent to the point of release to approximately 15-foot bgs. Soil boring BH-3 was advanced south of the point of release to approximately 15-foot bgs. Soil samples were collected from the soil borings initially at 5-foot bgs and then 5-foot intervals thereafter (reference *Figure 4*).

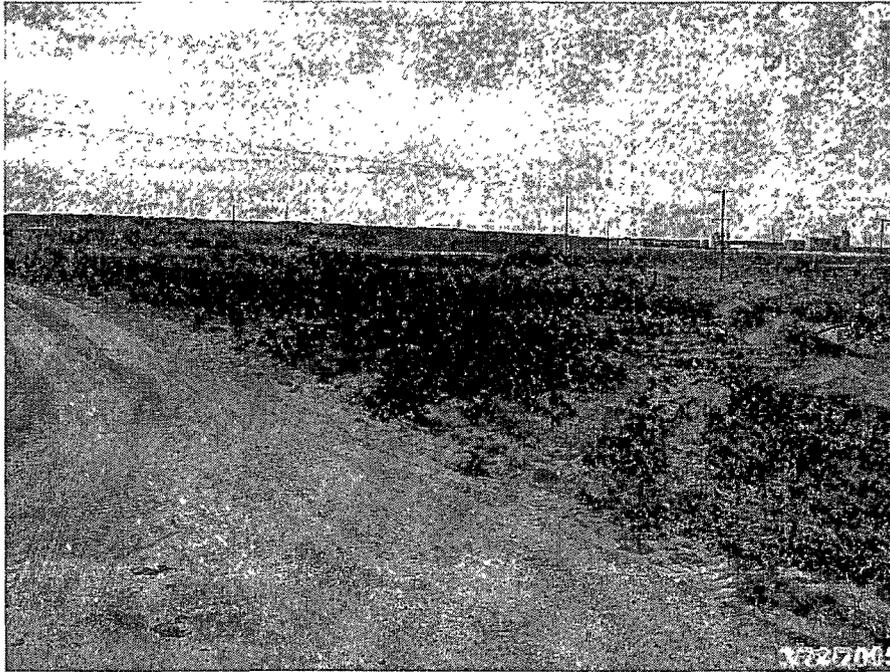
Photograph #1 - Looking northwest across release area.

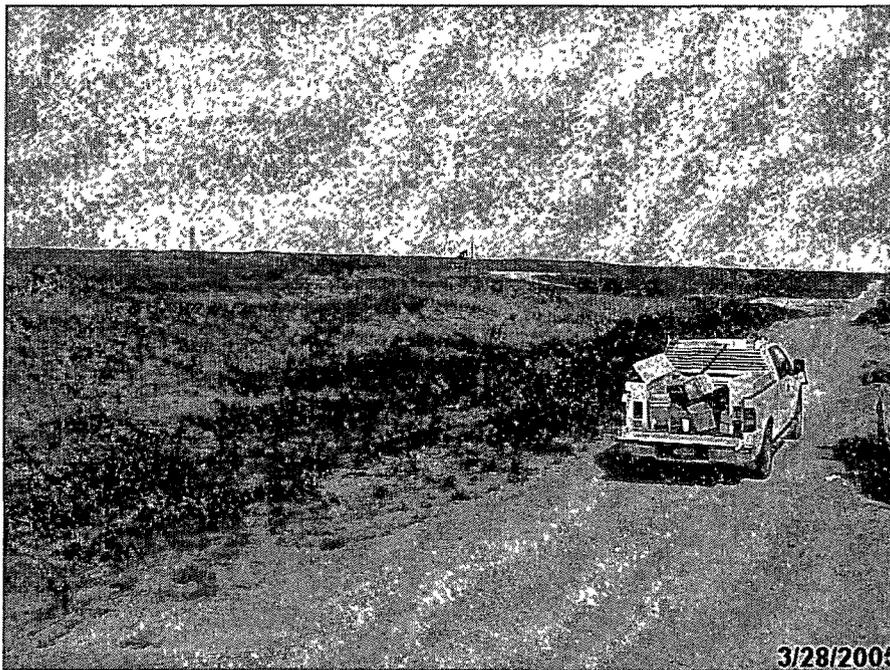
Photograph #2 - Looking northeast across overspray area.

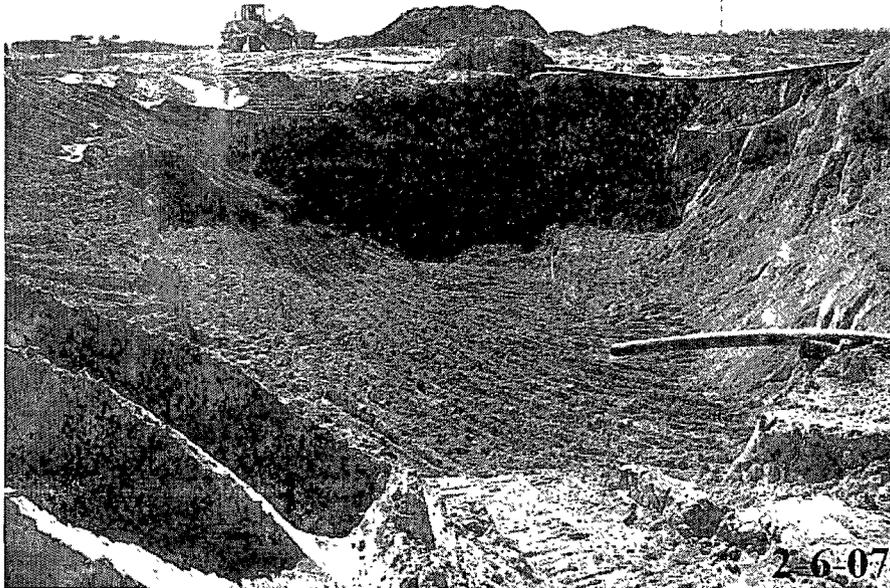
Photograph #3 – Looking easterly across southeast excavation.

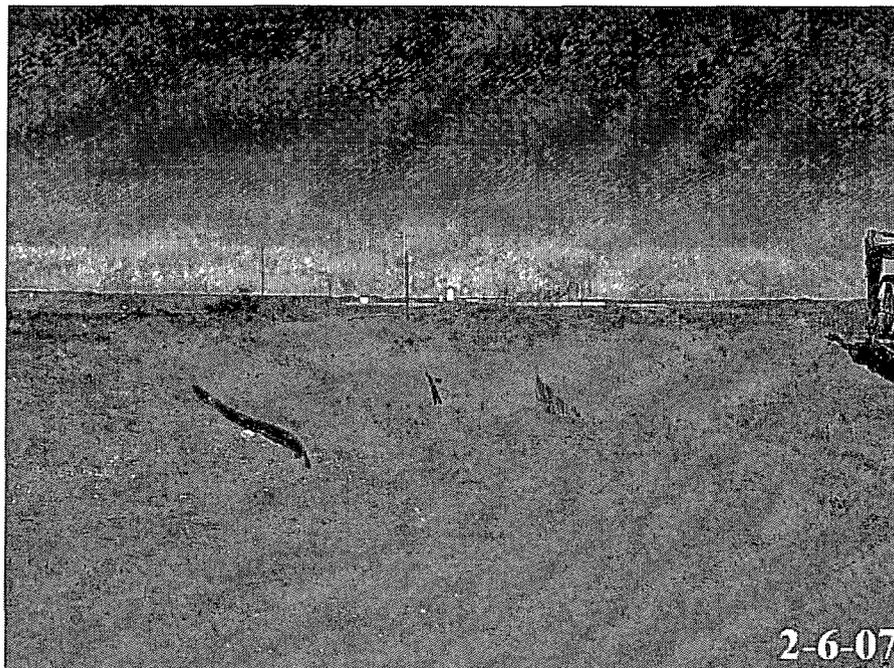
Photograph #4 – Looking northerly across southeast excavation.

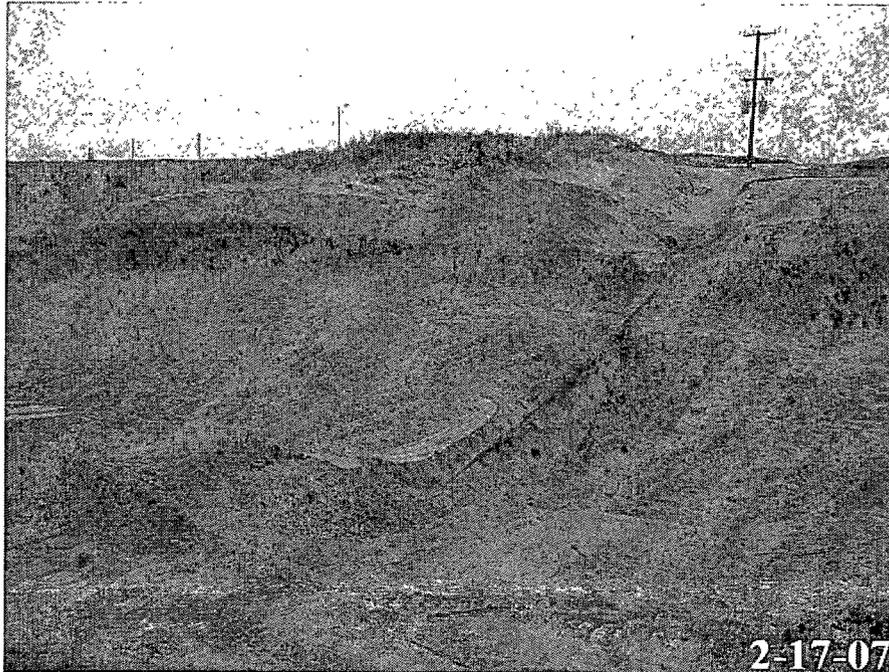
Photograph #5 – Looking easterly across northwest excavation.

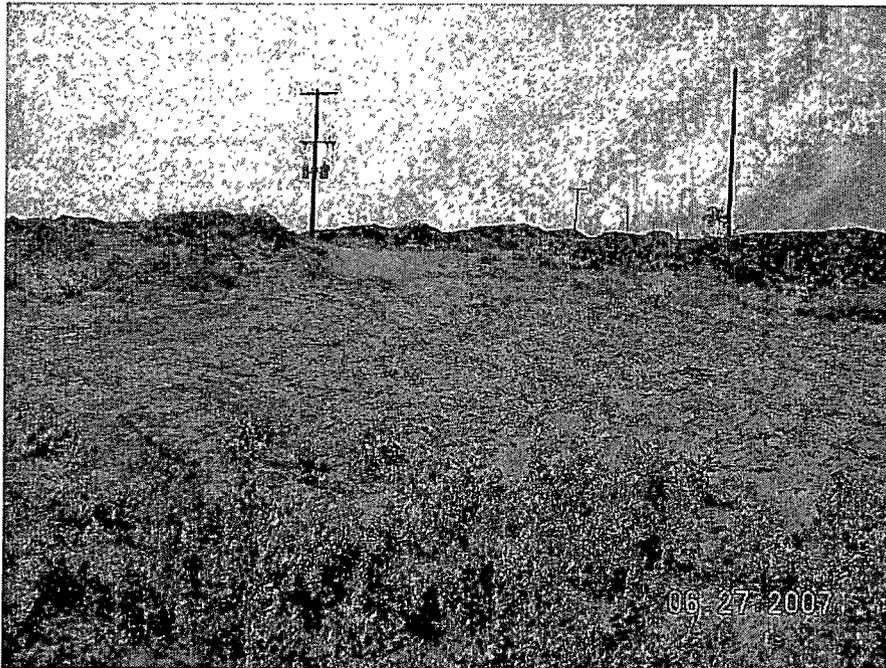
Photograph #6 – Looking easterly across northwest excavation after completion of backfilling and reseeding activities.

Approximately 3,418-cubic yards of excavated impacted soil were transported to the Environmental Plus, Inc. Landfarm for treatment. Clean native soil was obtained from the surrounding area and utilized to backfill the excavation. Upon completion of backfilling activities, the site was graded/contoured to promote natural drainage. Upon completion of remediation activities, the site was seeded with a seed blend suitable to the landowner

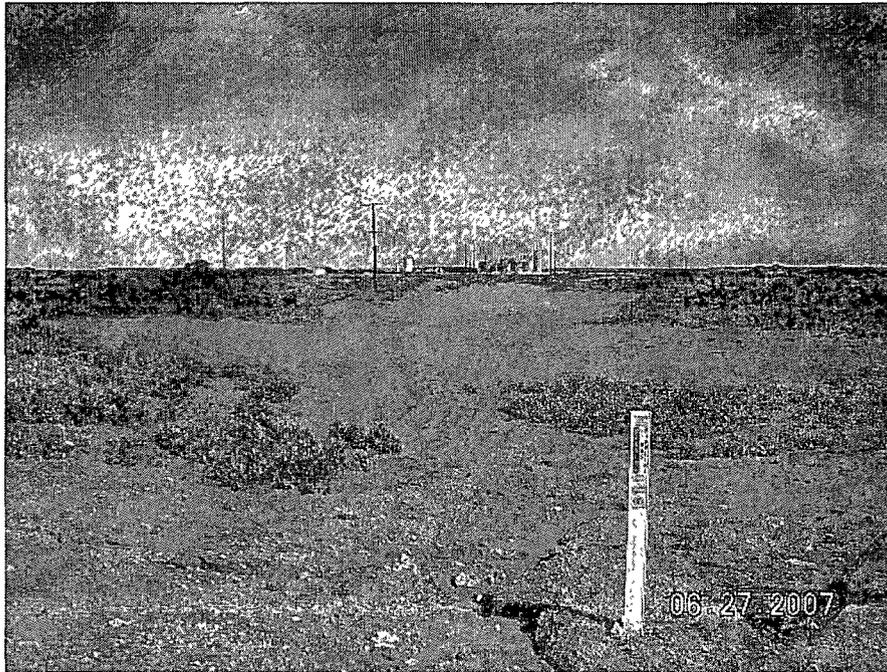
Photograph #7 – Looking northerly across southeast excavation after backfilling and seeding activities.

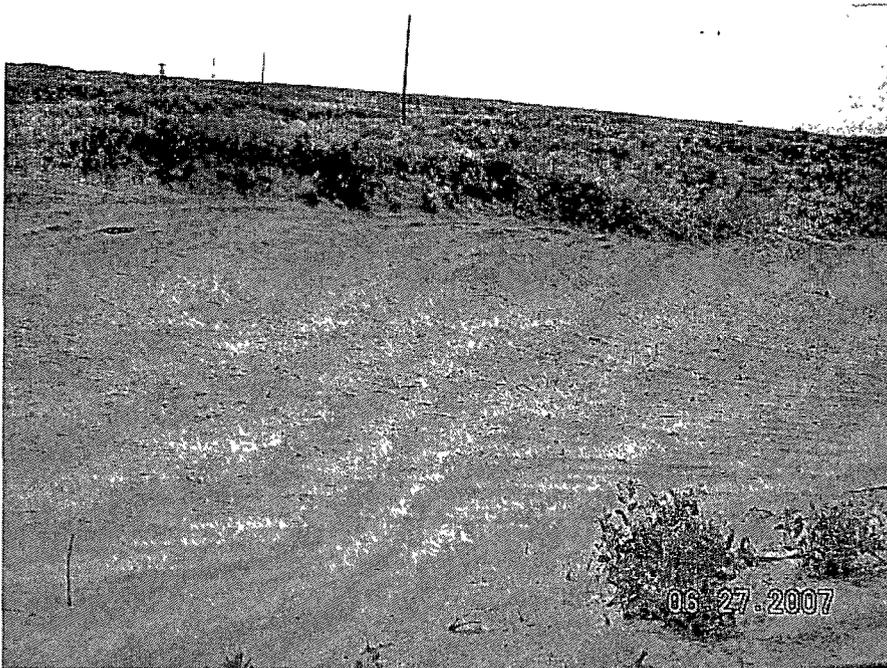
Photograph #8 – Looking southeasterly across southeast excavation after backfilling and reseeding activities.
