***STAGE 1 FINAL INVESTIGATION REPORT
AND CORRECTIVE ACTION PLAN***

EME JCT. K-6 SITE (AP-46)

**T20S, R37E, SECTION 6, UNIT LETTER K
LEA COUNTY, NEW MEXICO**

RICE Operating Company
**122 West Taylor
Hobbs, New Mexico 88240**

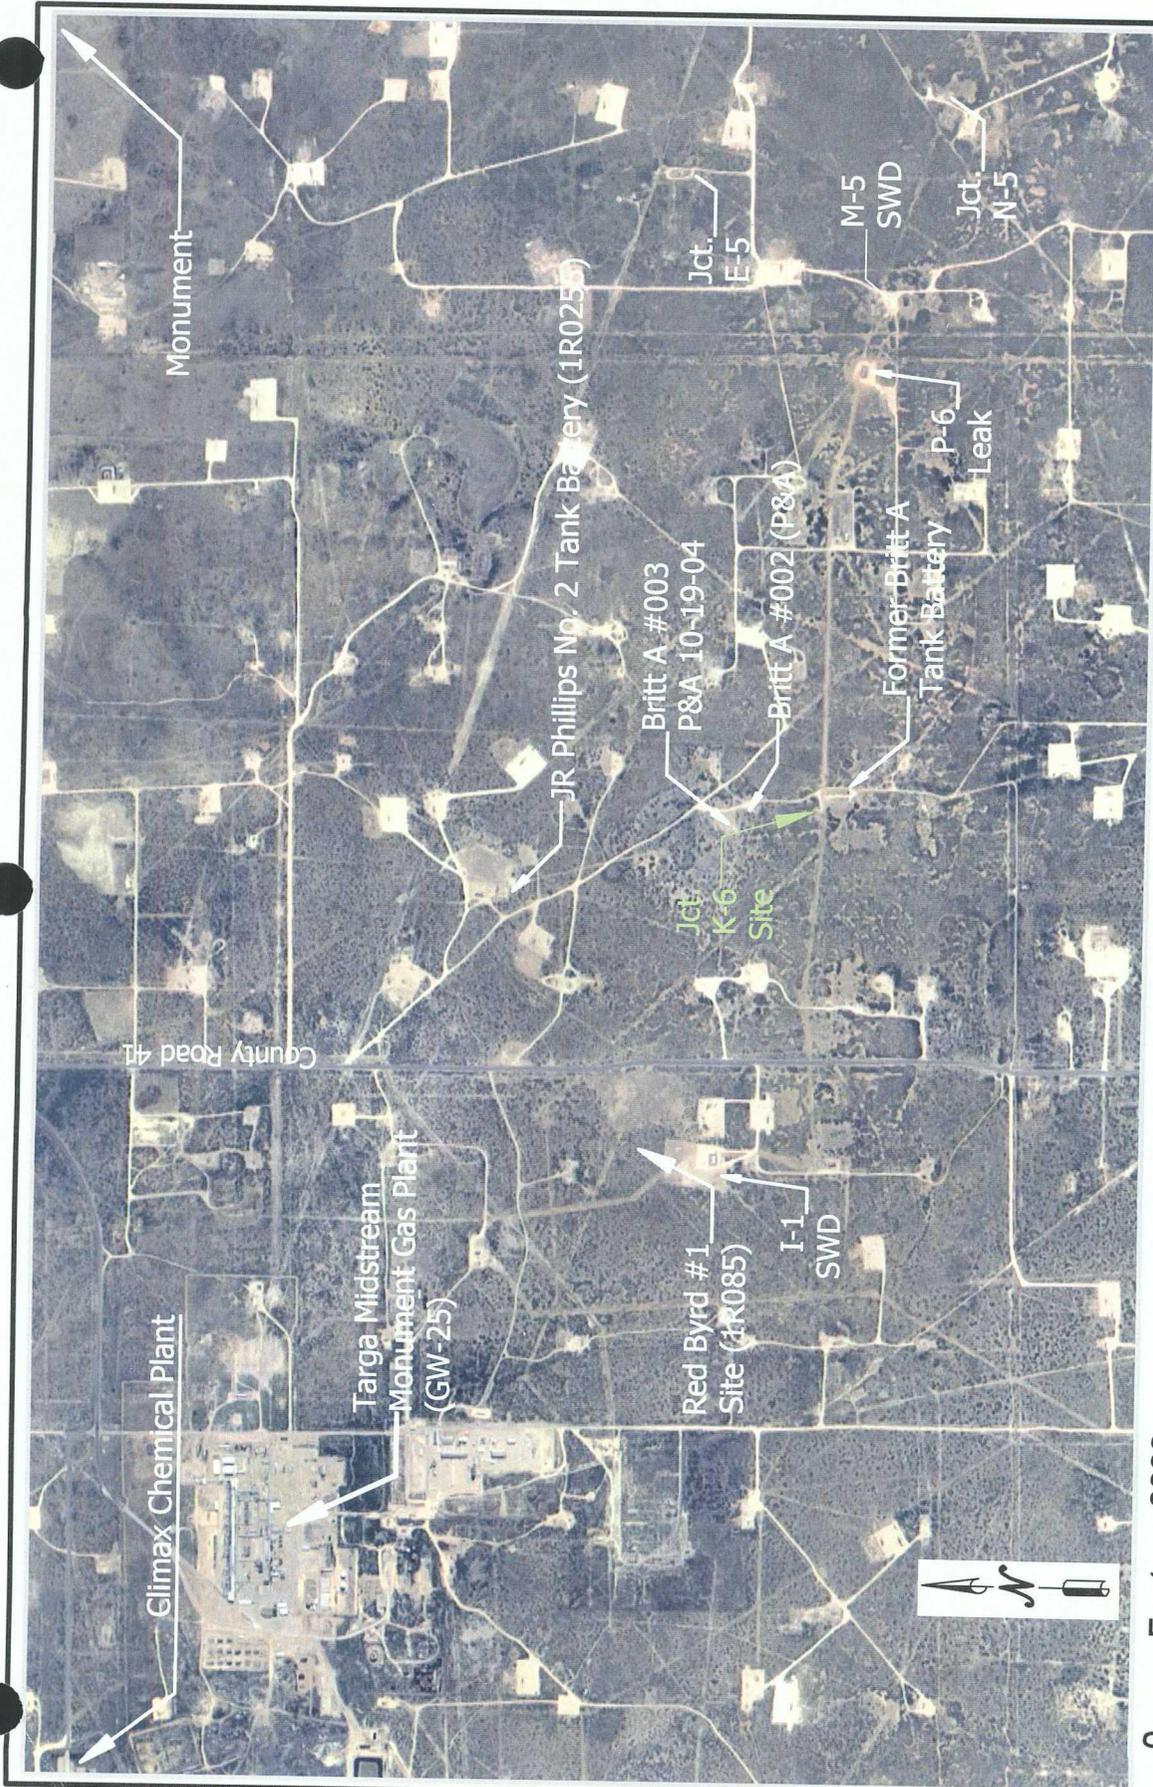
FIGURE 2
AERIAL PHOTO (2005)

- A high concentration of oil & gas wells (active and plugged) and associated structures (tank batteries, pits, pipelines, etc.) are located in this area of Monument. Many of these are obviously visible in Figure 2 (aerial photograph) including two plugged and abandoned oil wells located just north of the site (Figure 1).
- Review of a historical aerial photograph from the Lea County Soil Survey (published in 1974) indicates the presence of several contiguous pits covering an approximate area of 40,000 sq. ft. located less than 200 ft. southwest of Jct. K-6 and adjacent to the west side of the former tank battery. The former presence of these pits is also evident in recent aerial photographs as shown in the attached photodocumentaion in the appendices and Figure 2.

- Several contiguous pits covering an approximate area of 40,000 sq. ft. located less than 200 ft. southwest of Jct. K-6 and adjacent to the west side of the former tank battery are evident in the Lea County Soil Survey (based on 1955 and 1966 aerial photography). The former presence of these pits is also evident in recent aerial photographs as shown in the attached photodocumentaion in the appendices and Figure 2.

- The J. R. Phillips No. 2 Tank Battery site (NMOCD Case No. 1R0255) operated by Chevron is located less than ½ mile NNW of Jct. K-6 (Figures 2 and 5). Groundwater conditions are being monitored by Chevron on an annual frequency. Average chloride and TDS concentrations at the 8 monitoring wells are about 10,000 mg/L and 19,000 mg/L, respectively.

- The Monument Gas Plant operated by Targa Midstream Services, L.P. (Targa) is located approximately 1 mile northwest of the Jct. K-6 site (Figures 2 and 5). According to the Ground Water Discharge Plan (GW-025) this facility has two brine ponds and a network of 18 groundwater monitoring wells associated with it.

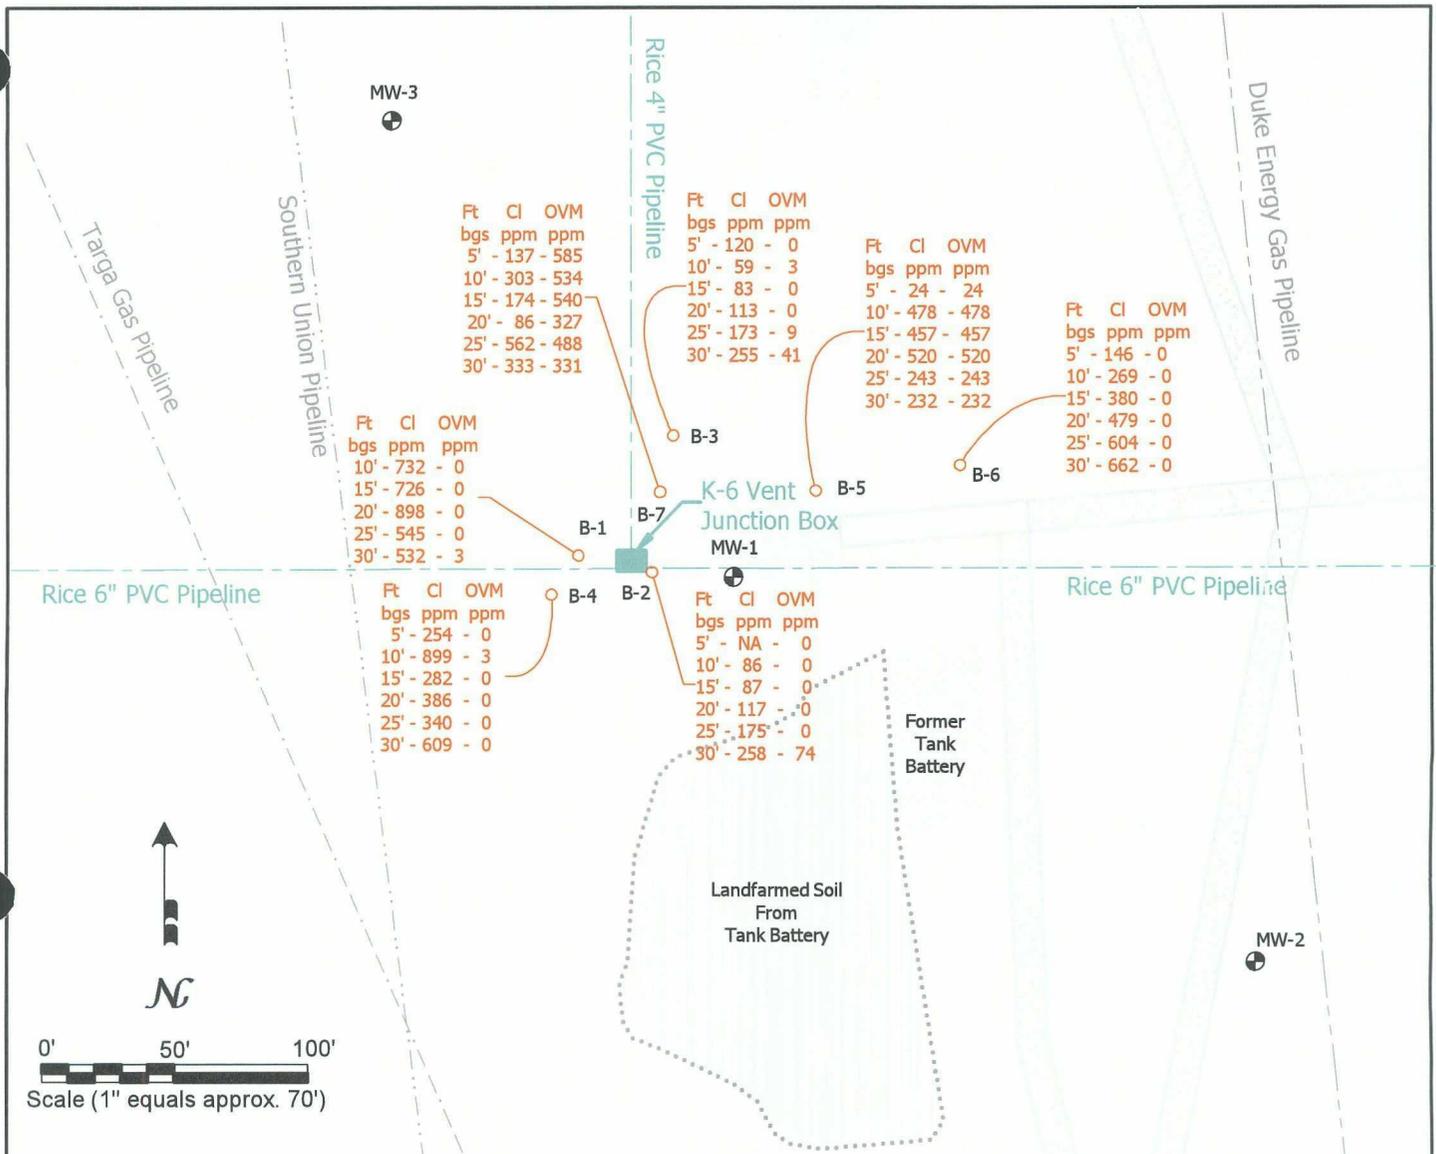
FIGURE 3
SOIL SAMPLE RESULTS
 JULY 18 and 19, 2006

Identification of soil and ground water impacts occurred during line replacement being performed as part of the approved Junction Box Upgrade Program. In January 2002, the subsurface soils at the Jct. K-6 site were investigated by trenching with a backhoe and field-tested for chloride and hydrocarbon levels and a monitoring well (MW-1) was installed within a few feet of the former junction box. On July 18 and 19, 2006, two additional monitoring wells (MW-2 and MW-3) and seven soil borings were installed in accordance with the Stage 1 Abatement Plan. A site map showing soil sample results for the on site borings at the Jct. K-6 site is depicted in Figure 3.

- A former tank battery and landfarmed area of hydrocarbon-impacted soil is located immediately adjacent to the south and southeast of Jct. K-6 (Figure 3). Soon after the plugging and abandonment of the Britt A #003 well on October 19, 2004, three 210-barrel tanks were removed in 2005, however the area with hydrocarbon-impacted soil is still present.

- A NNW-SSE trending gas pipeline marked as being owned by Southern Union is located about 100 feet west of Jct. K-6 (Figure 3).
- A NW-SE trending gas pipeline marked as being owned by Targa Resources is located about 160 feet west of Jct. K-6 (Figure 3).

- A north-south trending gas pipeline marked as being owned by Duke Energy Field Services is located about 240 feet east of Jct. K-6 (Figure 3).
- The J. R. Phillips No. 2 Tank Battery site (NMOCD Case No. 1R0255) operated by Chevron is located less than $\frac{1}{2}$ mile NNW of Jct. K-6 (Figures 2 and 5). Groundwater conditions are being monitored by Chevron on an annual frequency. Average chloride and TDS concentrations at the 8 monitoring wells are about 10,000 mg/L and 19,000 mg/L, respectively.

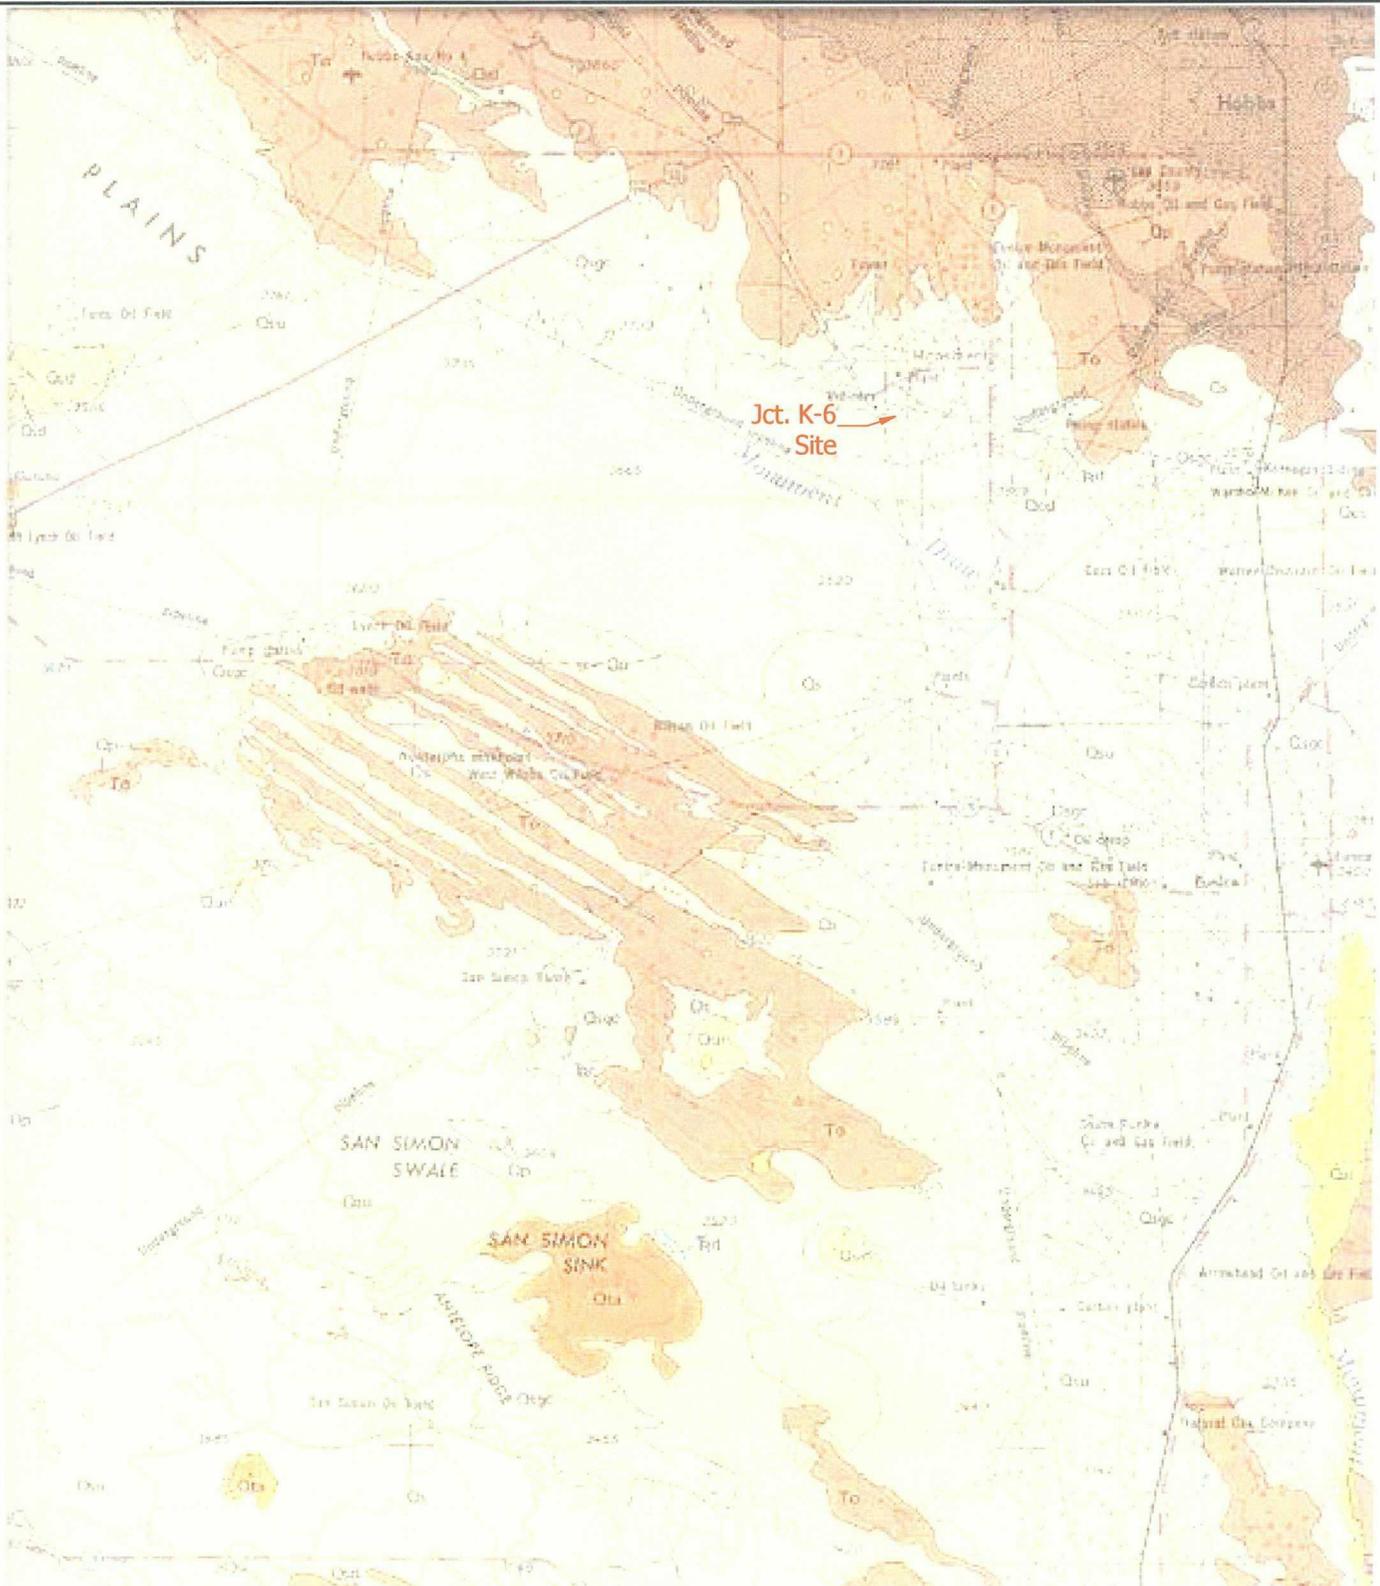
FIGURE 4
GEOLOGIC MAP

According to published information (Nicholson and Clebsch, 1961, Barnes, 1976, and Anderson, Jones, and Green, 1997) the site is underlain by Quaternary eolian and piedmont deposits composed of sand, silt, and gravel deposited by slopewash, and talus from the Ogallala Formation. The eolian and piedmont deposits are often calichified (indurated with cemented calcium carbonate) with caliche layers from 1 to 20 feet thick. The lithology of the eolian and piedmont deposits is very similar to that of the Ogallala since the Ogallala is the source of these re-deposited colluvial sediments. The nearest outcropping of the Ogallala Formation occurs approximately four miles north of Jct. K-6 along what is known as the Llano Estacado (caprock). The thickness of the colluvium deposits and Ogallala Formation at the Jct. K-6 site is estimated at 75 feet, however it varies locally as a result of significant paleo-topography at the top of the underlying Triassic Dockum Group. Since Cretaceous Age rocks in the region have been removed by pre-Tertiary erosion, the colluvial deposits and Ogallala Formation rest unconformably on the Triassic Dockum Group. The uppermost unit of the Dockum Group is the Chinle Formation, which primarily consists of micaceous red clay and shale but also contains thin interbeds of fine-grained sandstone and siltstone. The red clays and shale of the Chinle Formation act as an aquitard beneath the water bearing colluvial deposits and therefore limit the amount of recharge to the underlying Dockum Group. The thickness of the Dockum Group is estimated at approximately 300 feet in the site area although its thickness in southern Lea County varies from 0 to 1,270 feet thick (Nicholson and Clebsch, 1961). Figure 4 shows the surface geology of the site.

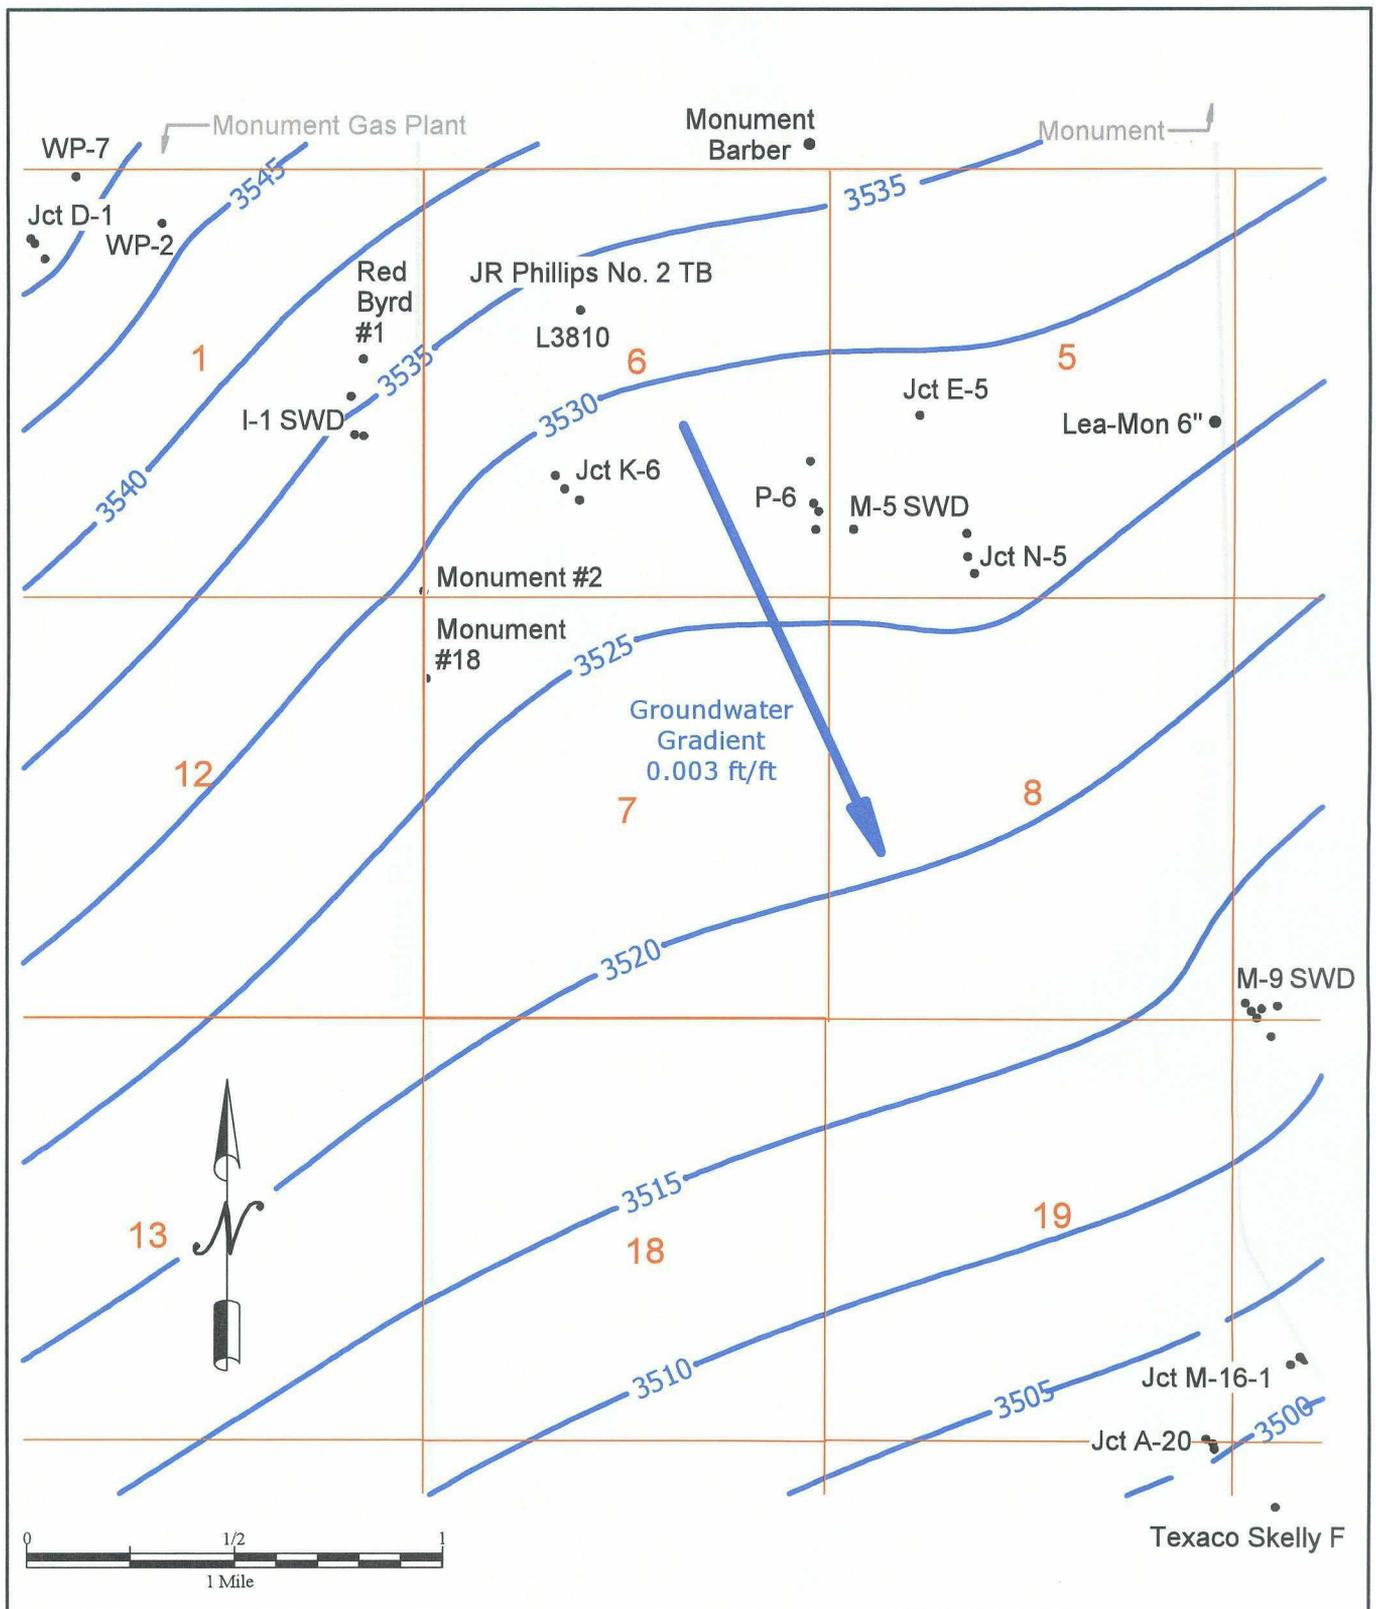
FIGURE 5
REGIONAL GROUNDWATER
GRADIENT MAP

- The Monument Gas Plant operated by Targa Midstream Services, L.P. (Targa) is located approximately 1 mile northwest of the Jct. K-6 site (Figures 2 and 5). According to the Ground Water Discharge Plan (GW-025) this facility has two brine ponds and a network of 18 groundwater monitoring wells associated with it.

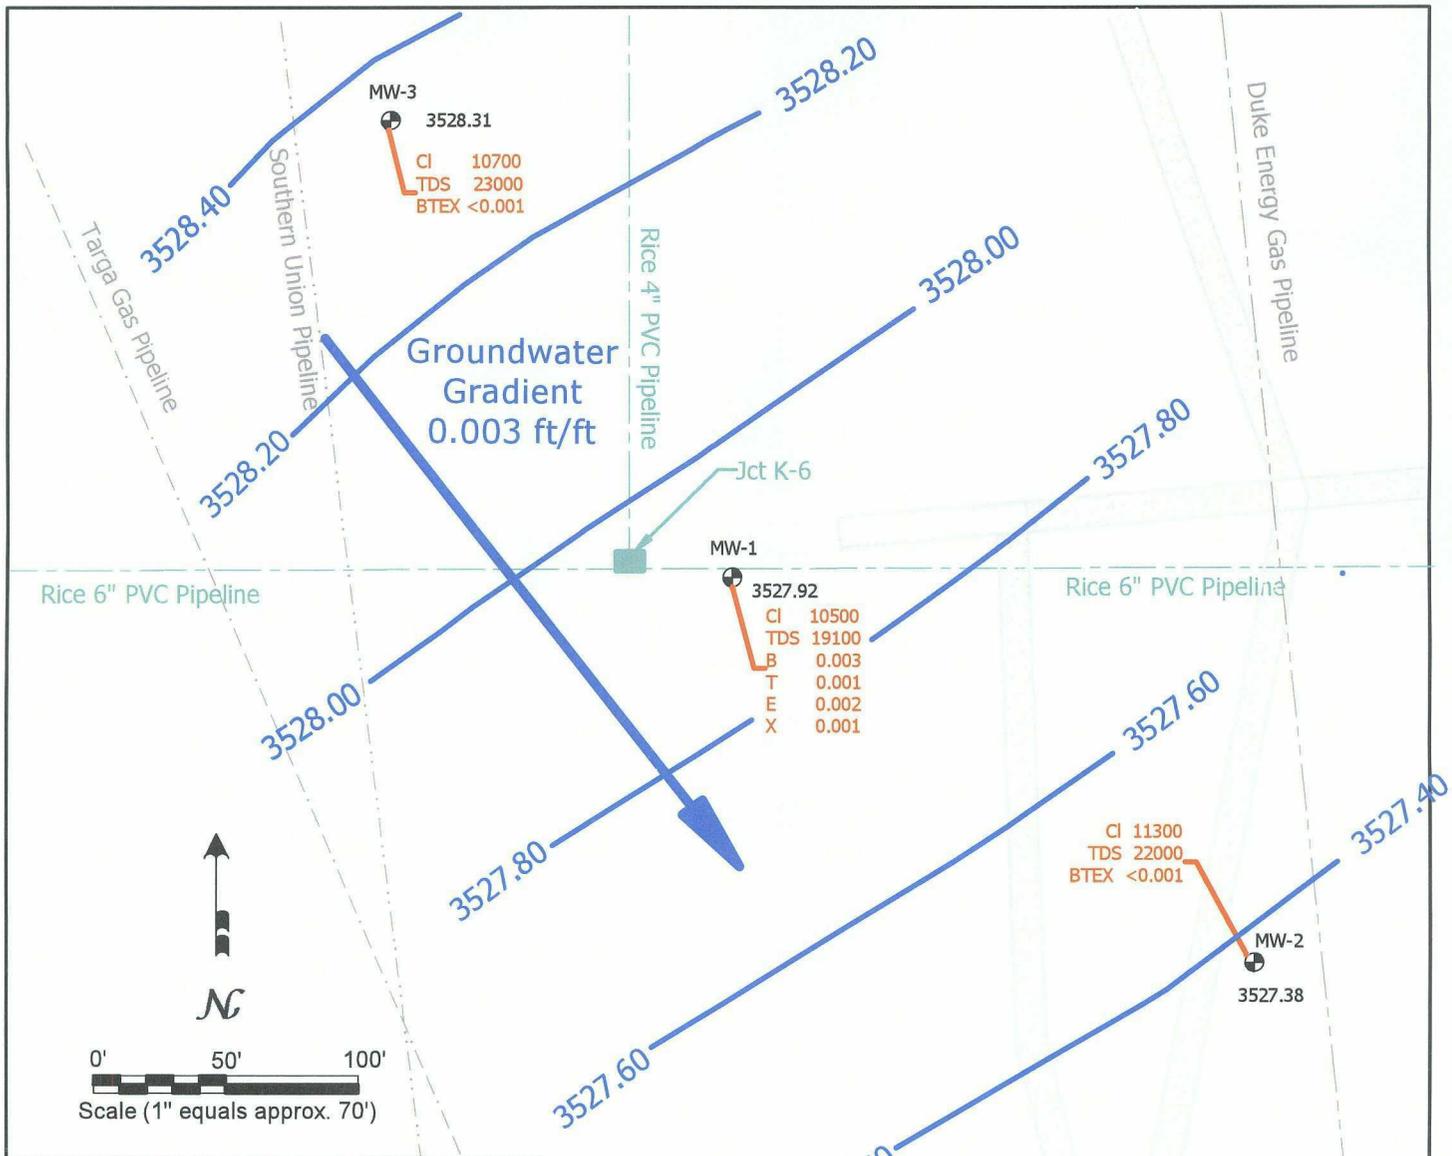
FIGURE 6
GROUNDWATER GRADIENT AND CHLORIDE, TDS, & BTEX CONCENTRATION MAP
AUGUST 22, 2006

Recent data from the three monitoring wells at Jct. K-6 shows that the water table slopes towards the southeast at a magnitude of approximately 0.003 ft/ft. The groundwater gradient at Jct. K-6 is consistent with those of several other groundwater monitoring sites in the Monument area and the regional gradient as cited in published reports (Nicholsen and Clebsch, 1961). A groundwater gradient map for the southwest portion of Monument is depicted in Figure 5. This more regionalized gradient map is based on measurements obtained during the third quarter of 2006 from several groundwater monitoring sites that are under the direction of ROC, Plains Petroleum, and Targa Midstream Services. The most recent groundwater gradient at the Jct. K-6 site is shown in Figure 6. Depth to ground water beneath the site area is approximately 34 feet bgs. There are no surface water bodies located within a mile of the site.

It has become clear that the upgradient monitoring well (MW-3) has higher concentrations of chlorides and total dissolved solids (TDS) than those observed near the junction box (MW-1), which indicates an upgradient source (north and/or northwest) for these constituents.

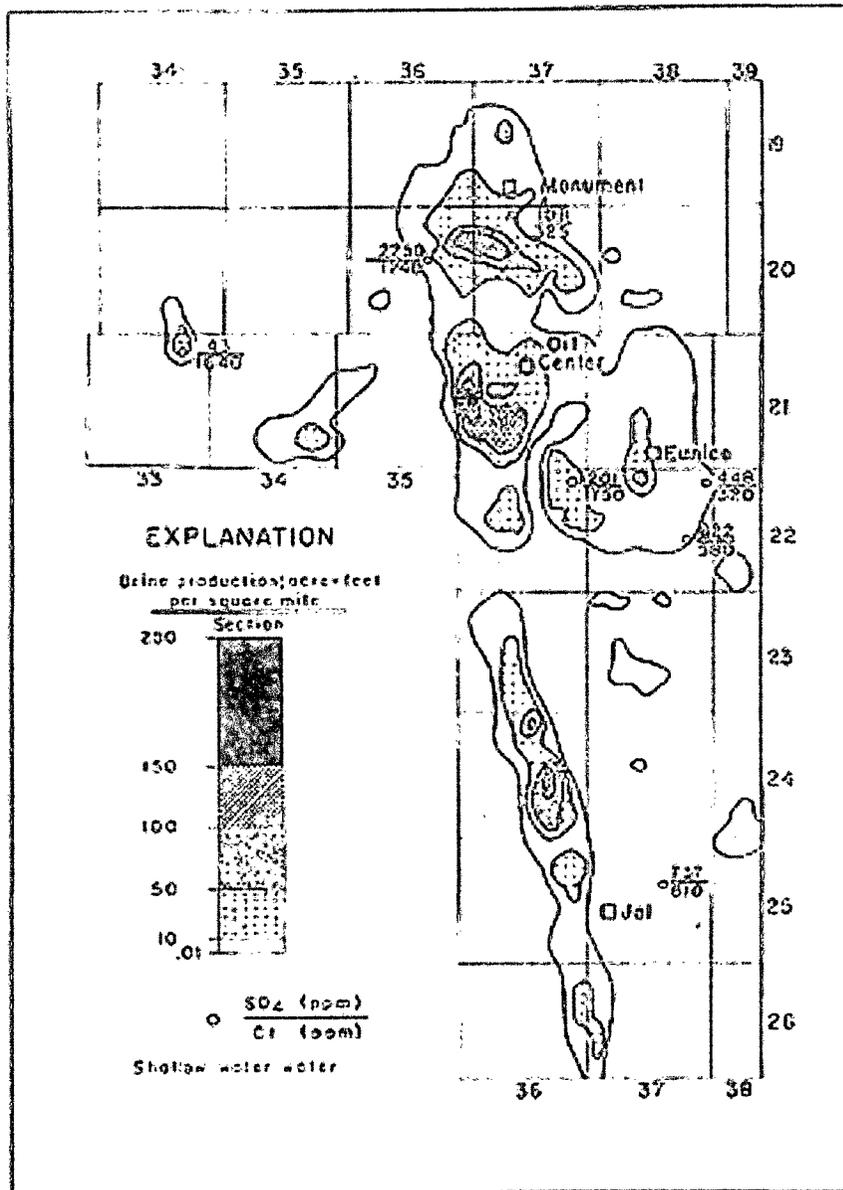
Figure 25

OIL-FIELD BRINE PRODUCTION IN SOUTHERN LEA COUNTY, N. MEX., 1952
 Showing locations of selected water wells that have been contaminated by brine. Upper figure adjacent to well symbol is sulfate concentration; lower figure is chloride concentration.

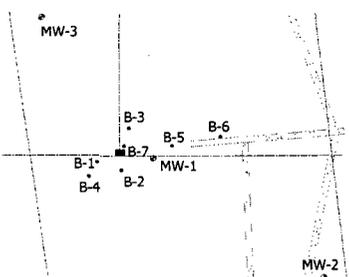
BOREHOLE NO.: B-2 TOTAL DEPTH: 30 Feet
 SITE ID: EME Jct. K-6 CLIENT: RICE Operating Company
 CONTRACTOR: Harrison & Cooper, Inc. COUNTY: Lea
 DRILLING METHOD: Air Rotary STATE: New Mexico
 START DATE: 07/18/06 LOCATION: T20S-R37E-Sec 6-Unit K
 COMPLETION DATE: 07/18/06 FIELD REP.: G. Van Deventer
 COMMENTS: Boring located 18 feet south of junction box.

Sample	Depth	Time	Type	Chloride (ppm)	PID (ppm)	USCS	LITHOLOGIC DESCRIPTION:
							LITHOLOGY, COLOR, GRAIN SIZE, SORTING, ROUNDING, CONSOLIDATION, DISTINGUISHING FEATURES
			Surface				Light brown (5 YR 6/4) sandy loam, dune sand, fine-grained, well-sorted, subrounded grains, unconsolidated, dry
	5						
	1536		Split Spoon		0	SW	Light brown (5 YR 5/6), pale yellowish brown (10 YR 6/2) and dark yellowish brown (10YR 6/6) fine-grained sand, well-sorted, subrounded grains, unconsolidated, dry
	10	1538	Cuttings	86	0		Hard caliche layer (too hard for split spoon)
	15						
	1542		Split Spoon	87	0	SM/CAL	Grayish orange (10YR 7/4) fine-grained sand with some very pale orange calcium carbonate (10 YR 8/2) in matrix. Sand grains are moderately well-sorted, subrounded, unconsolidated, dry.
	20						
	1544		Split Spoon	117	0		Grayish orange (10YR 7/4) fine-grained sand with some very pale orange calcium carbonate (10 YR 8/2) in matrix. Sand grains are moderately well-sorted, subrounded, unconsolidated, dry.

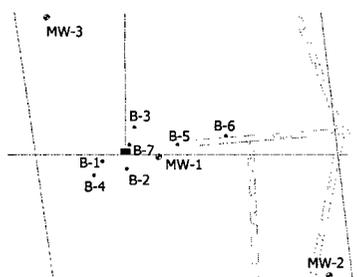
BOREHOLE NO.: <u>B-3</u>	TOTAL DEPTH: <u>30</u> Feet
SITE ID: <u>EME Jct. K-6</u>	CLIENT: <u>RICE Operating Company</u>
CONTRACTOR: <u>Harrison & Cooper, Inc.</u>	COUNTY: <u>Lea</u>
DRILLING METHOD: <u>Air Rotary</u>	STATE: <u>New Mexico</u>
START DATE: <u>07/18/06</u>	LOCATION: <u>T20S-R37E-Sec 6-Unit K</u>
COMPLETION DATE: <u>07/18/06</u>	FIELD REP.: <u>G. Van Deventer</u>
COMMENTS: <u>Boring located 25 feet north-northeast of junction box.</u>

Depth	Sample		Chloride (ppm)	PID (ppm)	USCS	LITHOLOGIC DESCRIPTION: LITHOLOGY, COLOR, GRAIN SIZE, SORTING, ROUNDING, CONSOLIDATION, DISTINGUISHING FEATURES
	Time	Type				
		Surface			SW	Light brown (5 YR 6/4) sandy loam, dune sand, fine-grained, well-sorted, subrounded grains, unconsolidated, dry
5						
1630		Split Spoon	120	0	SM/CAL	Pale olive (10Y 6/2) fine-grained sand with some very pale orange calcium carbonate (10 YR 8/2) in matrix. Sand grains are moderately well-sorted, subrounded, unconsolidated, dry.
10						
1632		Split Spoon	59	3		Pale olive (10Y 6/2) fine-grained sand with some very pale orange calcium carbonate (10 YR 8/2) in matrix. Sand grains are moderately well-sorted, subrounded, unconsolidated, dry.
15						
1635		Split Spoon	83	0		Light brown (5 YR 6/4) fine-grained sand with some very pale orange calcium carbonate (10 YR 8/2) in matrix. Sand grains are moderately well-sorted, subrounded, unconsolidated, dry.

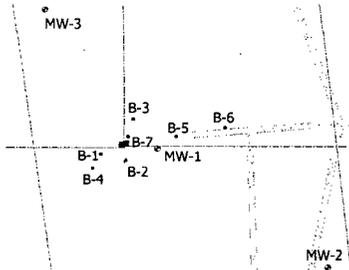
BOREHOLE NO.: B-4
 SITE ID: EME Jct. K-6
 CONTRACTOR: Harrison & Cooper, Inc.
 DRILLING METHOD: Air Rotary
 START DATE: 07/19/06
 COMPLETION DATE: 07/19/06
 COMMENTS: Boring located 52 feet southwest of junction box.

TOTAL DEPTH: 32 Feet
 CLIENT: RICE Operating Company
 COUNTY: Lea
 STATE: New Mexico
 LOCATION: T20S-R37E-Sec 6-Unit K
 FIELD REP.: G. Van Deventer

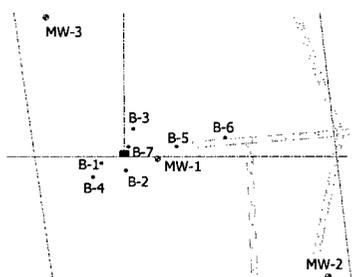
BOREHOLE NO.: <u>B-5</u>	TOTAL DEPTH: <u>32</u> Feet
SITE ID: <u>EME Jct. K-6</u>	CLIENT: <u>RICE Operating Company</u>
CONTRACTOR: <u>Harrison & Cooper, Inc.</u>	COUNTY: <u>Lea</u>
DRILLING METHOD: <u>Air Rotary</u>	STATE: <u>New Mexico</u>
START DATE: <u>07/19/06</u>	LOCATION: <u>T20S-R37E-Sec 6-Unit K</u>
COMPLETION DATE: <u>07/19/06</u>	FIELD REP.: <u>G. Van Deventer</u>
COMMENTS: <u>Boring located 54 feet east of junction box.</u>

Depth	Sample		Chloride (ppm)	PID (ppm)	USCS	LITHOLOGIC DESCRIPTION: LITHOLOGY, COLOR, GRAIN SIZE, SORTING, ROUNDING, CONSOLIDATION, DISTINGUISHING FEATURES
	Time	Type				
		Surface			SW	Moderate yellowish brown (10YR 5/4) fine-grained sand.
5						
0900		Split Spoon	181	24		Moderate yellowish brown (10YR 5/4) fine-grained sand.
10						
0905		Split Spoon	365	478		Grayish olive (10Y 4/2) fine-grained sand. Strong hydrocarbon odor and dark staining.
15					SM/CAL	
0910		Split Spoon	168	457		Pale olive (10Y 6/2) fine-grained sand with some very pale orange calcium carbonate in matrix. Strong hydrocarbon odor and moderate staining.
20						
0915		Split Spoon	165	520		Dusky yellow (5Y 6/4) fine-grained sand with some very pale orange calcium carbonate in matrix. Strong hydrocarbon odor and moderate staining.
25						
0920		Split Spoon	121	243		Moderate yellowish brown (10YR 5/4) fine-grained sand, moderately well-sorted, subrounded, unconsolidated, dry. Moderate hydrocarbon odor.

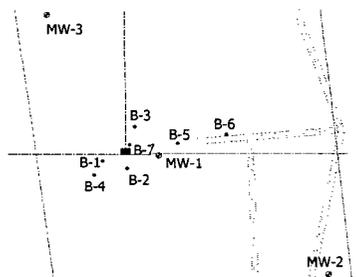
BOREHOLE NO.: <u>B-6</u>	TOTAL DEPTH: <u>32 Feet</u>
SITE ID: <u>EME Jct. K-6</u>	CLIENT: <u>RICE Operating Company</u>
CONTRACTOR: <u>Harrison & Cooper, Inc.</u>	COUNTY: <u>Lea</u>
DRILLING METHOD: <u>Air Rotary</u>	STATE: <u>New Mexico</u>
START DATE: <u>07/19/06</u>	LOCATION: <u>T20S-R37E-Sec 6-Unit K</u>
COMPLETION DATE: <u>07/19/06</u>	FIELD REP.: <u>G. Van Deventer</u>
COMMENTS: <u>Boring located 108 feet north-northeast of junction box.</u>

Depth	Sample		Chloride (ppm)	PID (ppm)	USCS	LITHOLOGIC DESCRIPTION: LITHOLOGY, COLOR, GRAIN SIZE, SORTING, ROUNDING, CONSOLIDATION, DISTINGUISHING FEATURES
	Time	Type				
		Surface				Light brown (5 YR 6/4) sandy loam, dune sand, fine-grained, well-sorted, subrounded grains, unconsolidated, dry
5					SW	
0945		Split Spoon	146	0		Grayish orange (10YR 7/4) fine-grained sand, moderately well-sorted, subrounded, unconsolidated, dry.
10					SM	
0950		Split Spoon	269	0		Light brown (5Y 6/4) fine-grained sand with some pale yellowish brown (10YR 6/2) calcium carbonate in matrix. Sand grains are moderately well-sorted, subrounded, unconsolidated, dry.
15					SM/CAL	
0955		Split Spoon	380	0		Grayish orange (10YR 7/4) fine-grained sand with some very pale orange calcium carbonate (10 YR 8/2) in matrix. Sand grains are moderately well-sorted, subrounded, unconsolidated, dry.
20					SW	
1000		Split Spoon	479	0		Light brown (5Y 6/4) and pale yellowish brown (10YR 6/2) fine-grained sand, moderately well-sorted, subrounded, unconsolidated, dry.

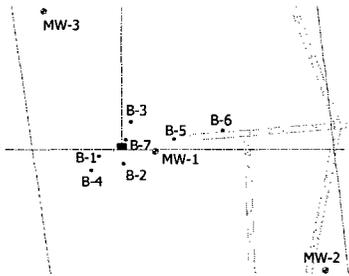
BOREHOLE NO.: B-7 TOTAL DEPTH: 32 Feet
 SITE ID: EME Jct. K-6 CLIENT: RICE Operating Company
 CONTRACTOR: Harrison & Cooper, Inc. COUNTY: Lea
 DRILLING METHOD: Air Rotary STATE: New Mexico
 START DATE: 07/19/06 LOCATION: T20S-R37E-Sec 6-Unit K
 COMPLETION DATE: 07/19/06 FIELD REP.: G. Van Deventer
 COMMENTS: Boring located adjacent to northeast corner east of junction box.

Depth	Sample		Chloride (ppm)	PID (ppm)	USCS	LITHOLOGIC DESCRIPTION: LITHOLOGY, COLOR, GRAIN SIZE, SORTING, ROUNDING, CONSOLIDATION, DISTINGUISHING FEATURES
	Time	Type				
		Surface			SW	Moderate yellowish brown (10YR 5/4) fine-grained sand.
5						
1025		Split Spoon	137	585		Pale olive (10Y 6/2) and dark yellowish orange (10YR 6/2) fine-grained sand with calcium carbonate in matrix. Strong hydrocarbon odor and dark staining.
10						
1030		Split Spoon	303	534		Greenish gray (5GY 6/1), medium dark gray, and black fine-grained sand with calcium carbonate in matrix. Strong hydrocarbon odor and dark staining.
15						
1035		Split Spoon	174	540	SM/CAL	Olive gray (5Y 4/1) and yellowish gray (5Y 8/1) fine-grained sand with some calcium carbonate in matrix. Strong hydrocarbon odor and moderate staining.
20						
1040		Split Spoon	86	327		Light olive gray (5Y 6/1) fine-grained sand with some very pale orange calcium carbonate in matrix. Strong hydrocarbon odor and moderate staining.

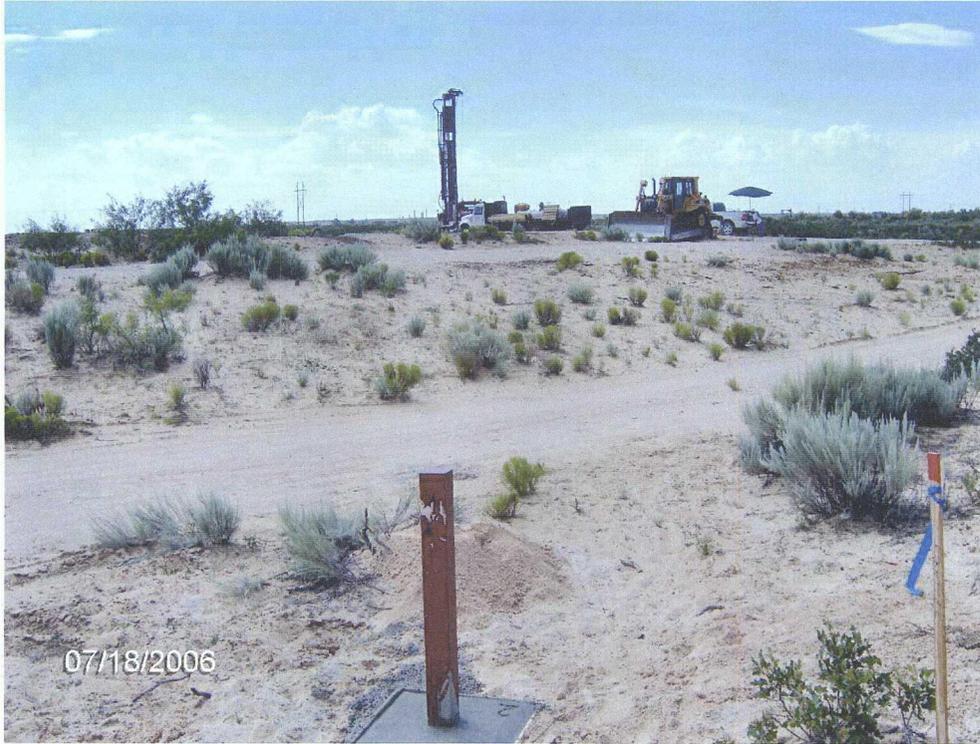
View facing northwest showing completed MW-2 (foreground) and drilling activities at boring B-3 (background) near Jct. K-6.

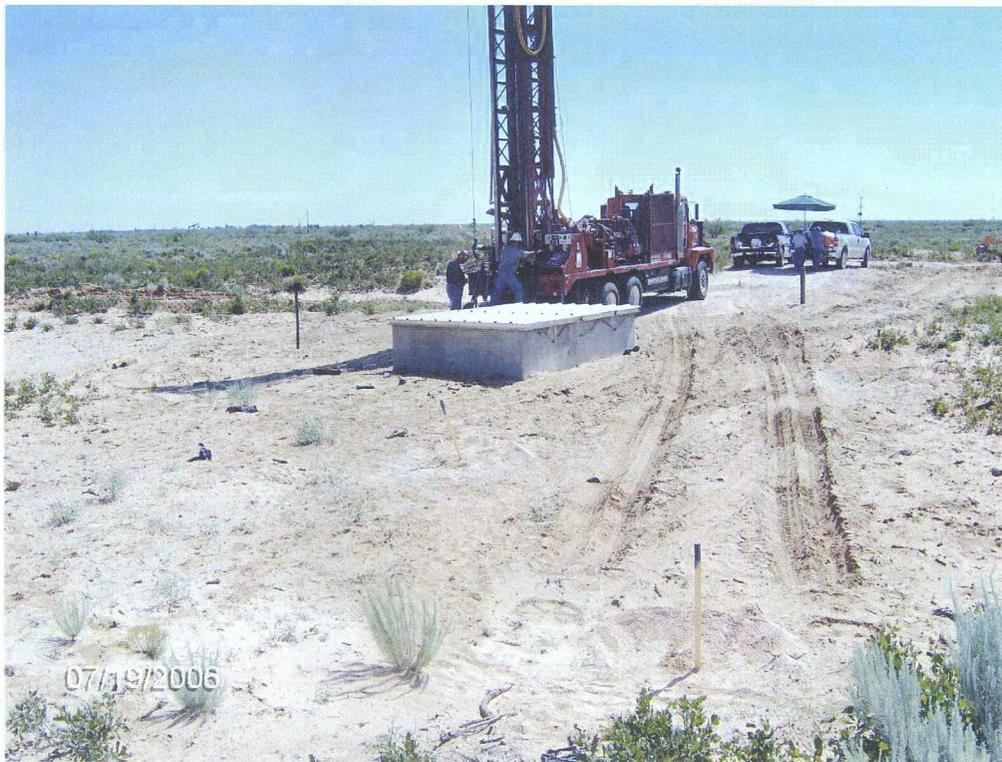
View facing east showing drilling activity at boring B-7 near Jct. K-6.

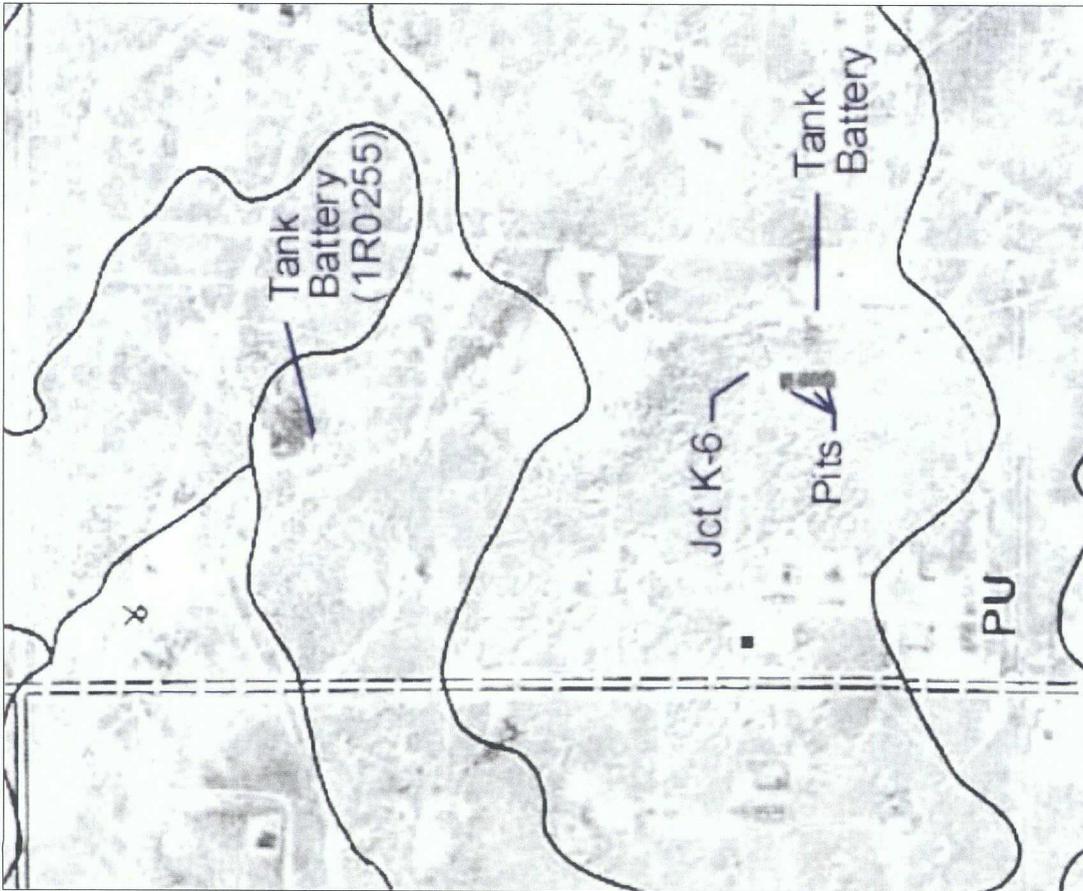
USDA-SCS soil survey (published 1974) showing Jct K-6 site relative to nearby pits, tank batteries, and other oil and gas facilities (photobase from 1955 and 1966 aerial photography).

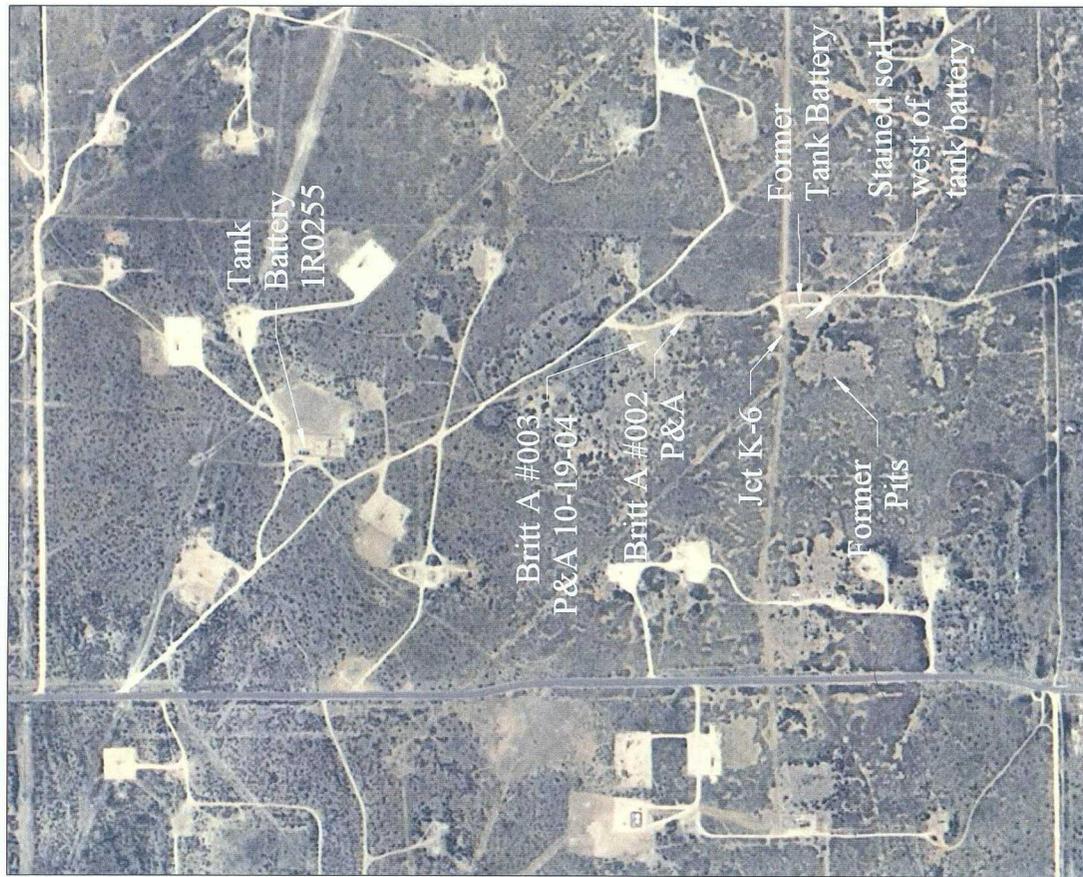
USGS aerial photograph showing Jct K-6 site relative to nearby pits, tank batteries, and other oil and gas facilities (photo taken July 2005).
