**3R - 347**

**MONITORING  
REPORT**

RE: WILMERDING # 1M DEHY PIT REMEDIATION AND CLOSURE REPORT

# Wilmerding 1M - T31N, R13W, S10, Unit C

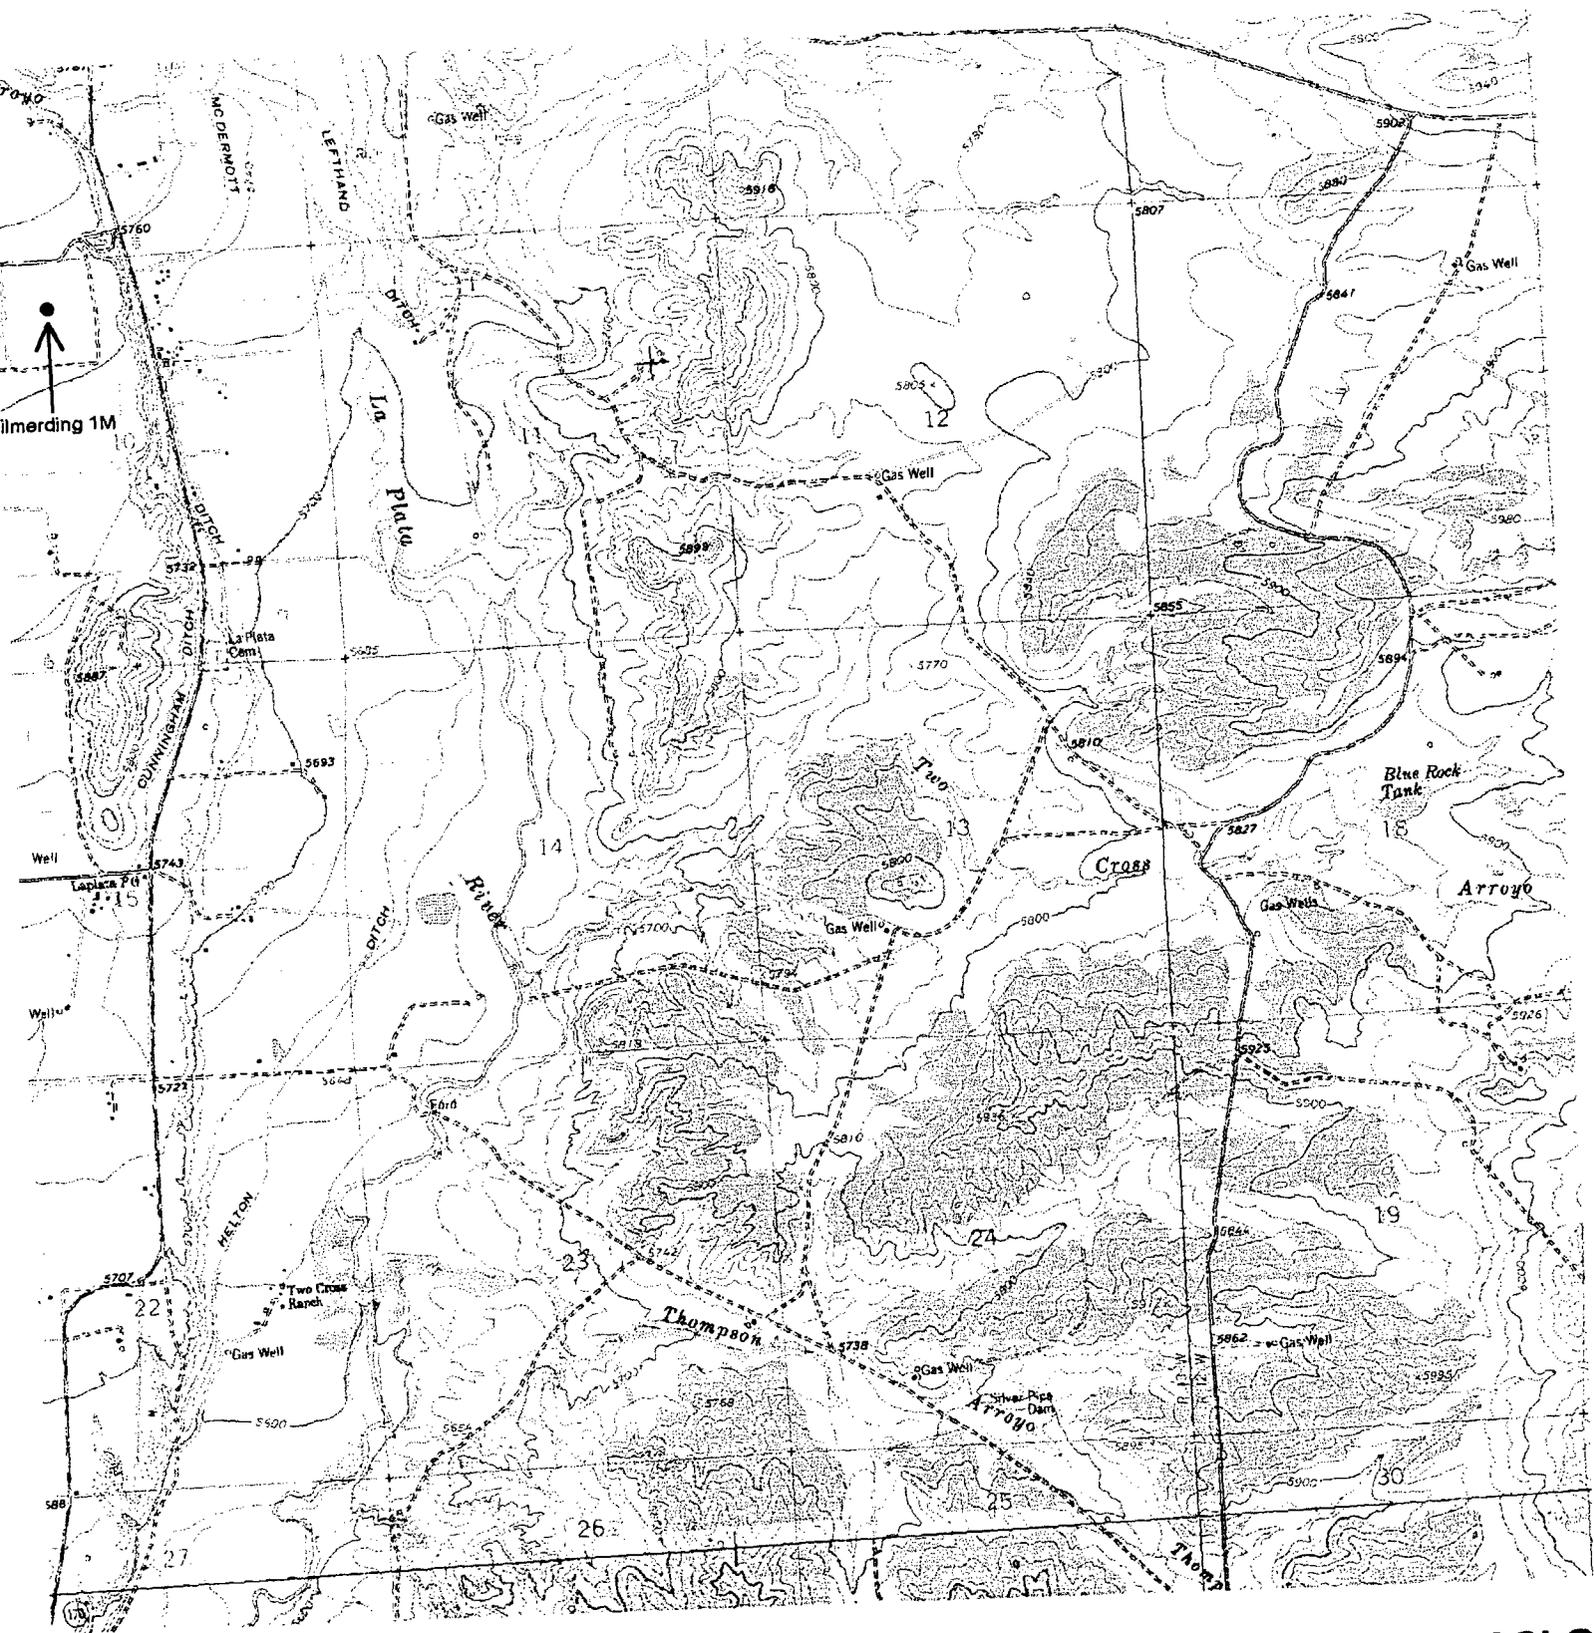
LA PLATA, N. MEX.- COLO.

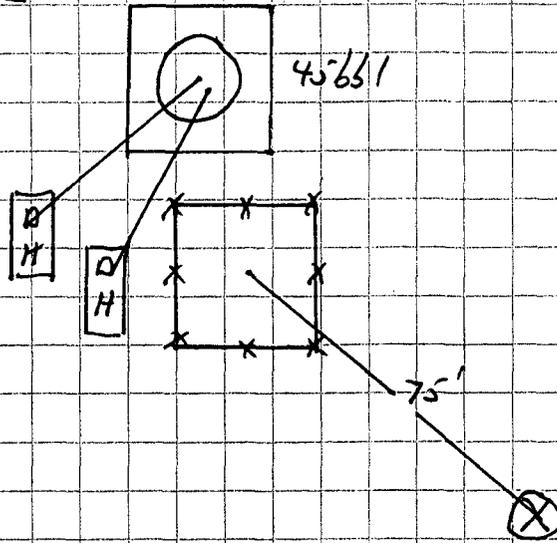
5/21/98

NO SOIL SAMPLES DUE TO RAPID INFILTRATION OF GROUND WATER
