**3R - 337**

**MONITORING  
REPORT**

RE: O'SHEA # 1M DEHY PIT REMEDIATION AND CLOSURE REPORT

**PIT REMEDIATION AND CLOSURE REPORT**

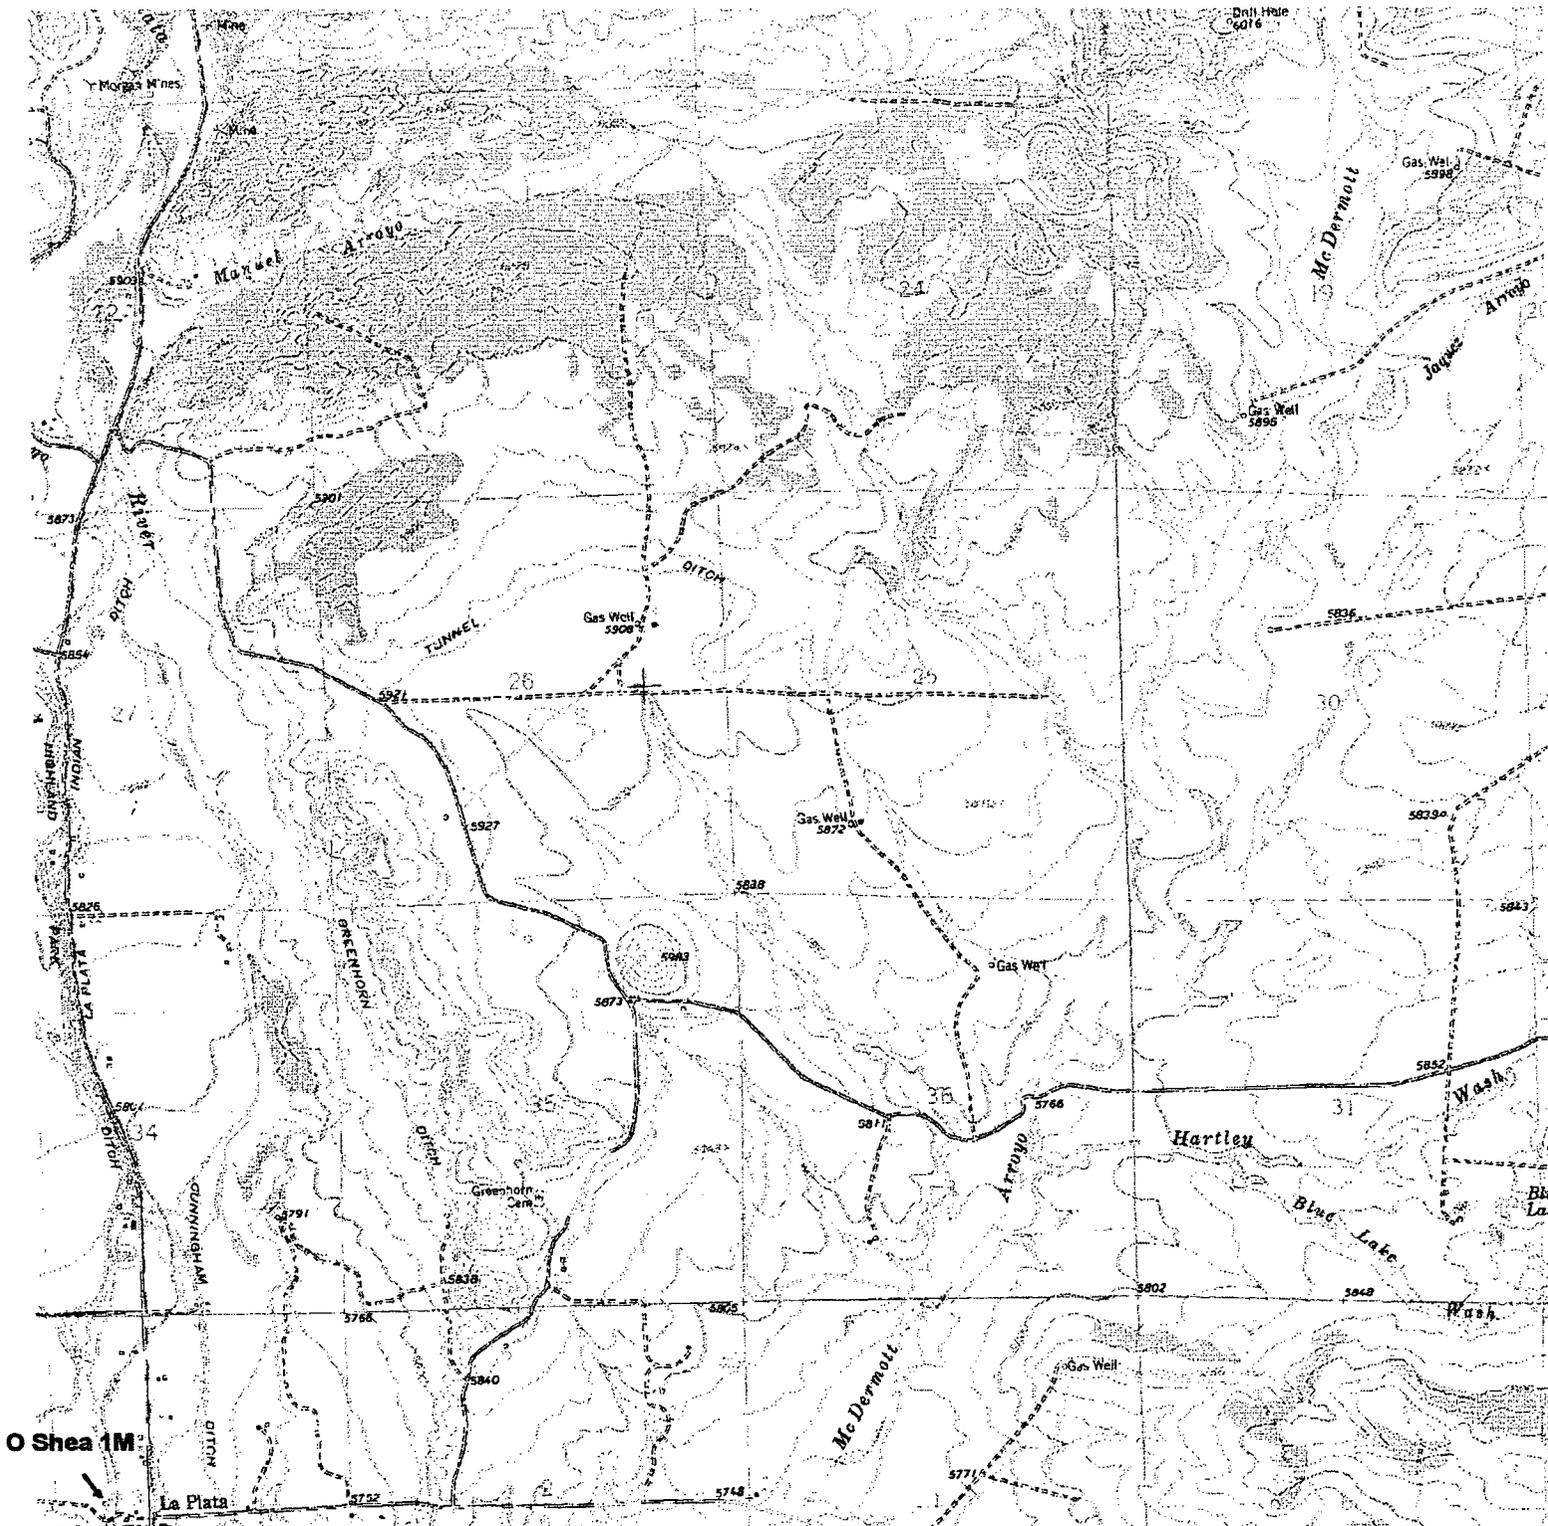
# O Shea 1M T31N, R13W, S3, Unit F

LA PLATA, N. MEX.- COLO.

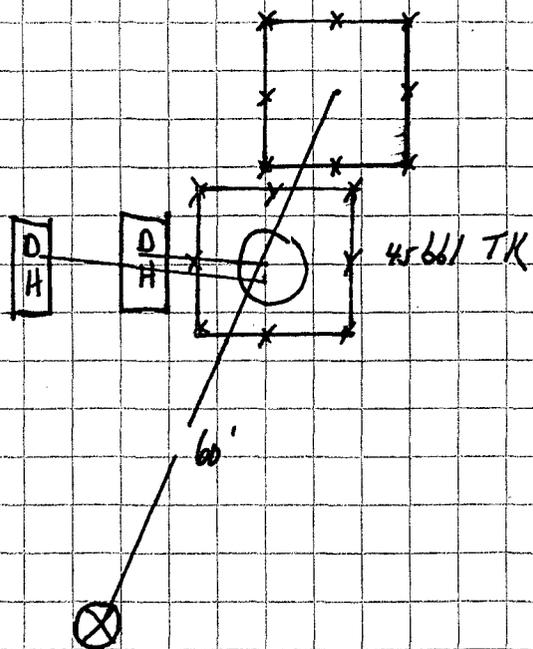
6-2-98

Comments: No PID reading. Have water running into pit after first bucket full of dirt. Cobbles. Operator tank just east of PNM pit floating in water. Water at first probably due to irrigation. At 6' depth hit water and cobbles with Blk/Grn color. Soil was BRN with PID reading of 30-90 ppm before 6' level.

Dug test hole east side of operator equip. edge of roadway & it is hot, in fact appears dirtier than our pit. Will grab H<sub>2</sub>O sample (east test hole # 9806021605) over

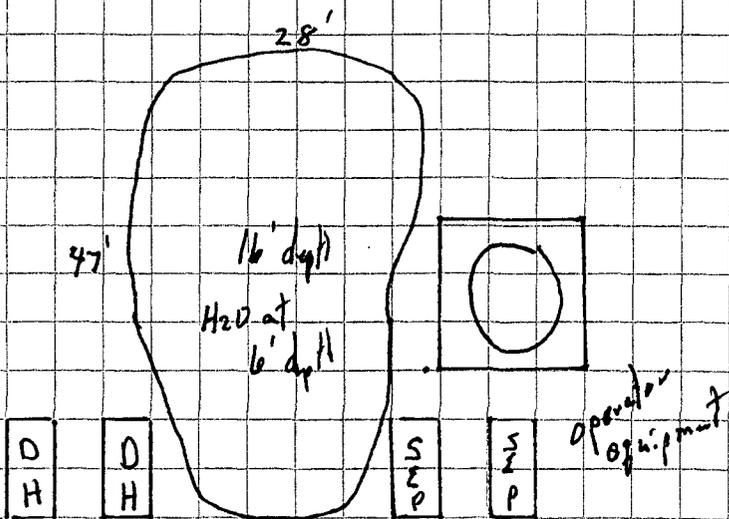
End of excavation:

Date 6-2-98		Vertical Extent			
Well Name O'Shea #1M	Operator Chateau Oil	S 3	T 31N	R 13W	UI F
Pit Dimensions at Start 20 X 20 X 3		Excavation Dimensions at End 28 X 47 X 16			
Excavated Cu. Yds. 780	Overburden Cu. Yds. 0		Spoil Cu. Yds. 780

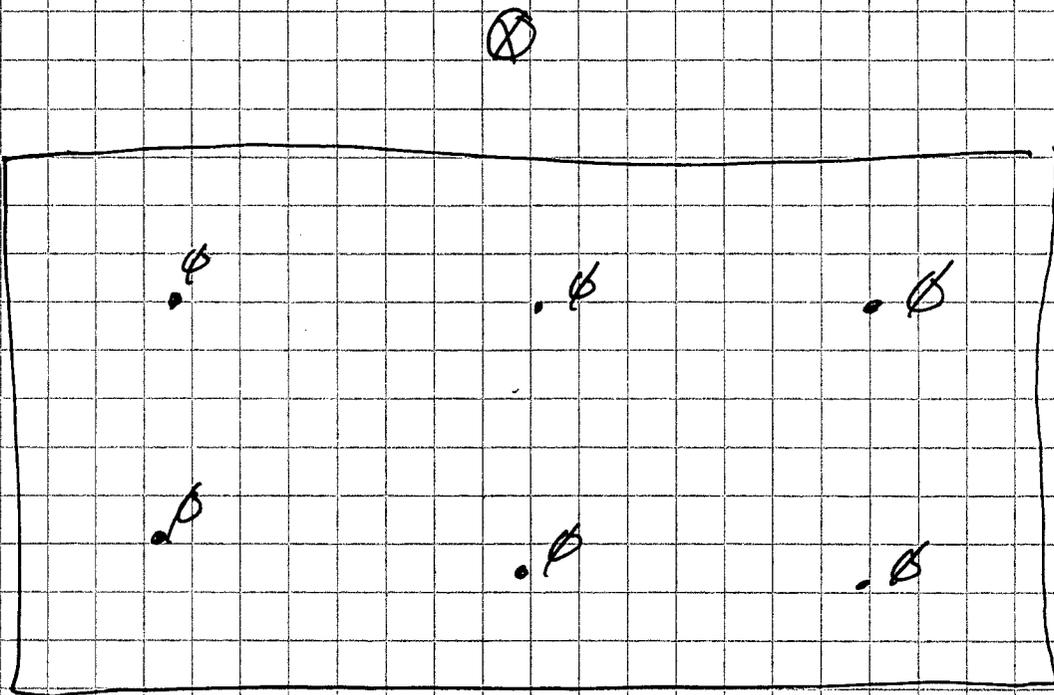
Land farm:

780 ya-ds

9806301230  
2"-12" depth

soil vapor headspace =  $\phi$  ppm

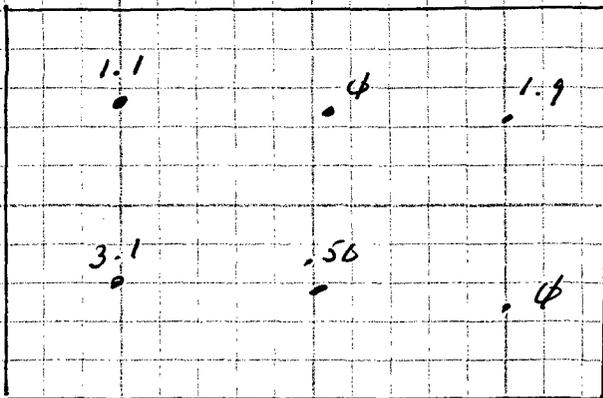
Landfarm: On location

2"-12" depth

9807211130
