Enclosed, please find a copy of the closure report for the Devon Dickinson Project. Additional copies of the report are being forwarded to your Hobbs office and to the landowner, Darr Angell.

**B.C. Dickinson
Remediation Project
Closure Report**

Executive Summary

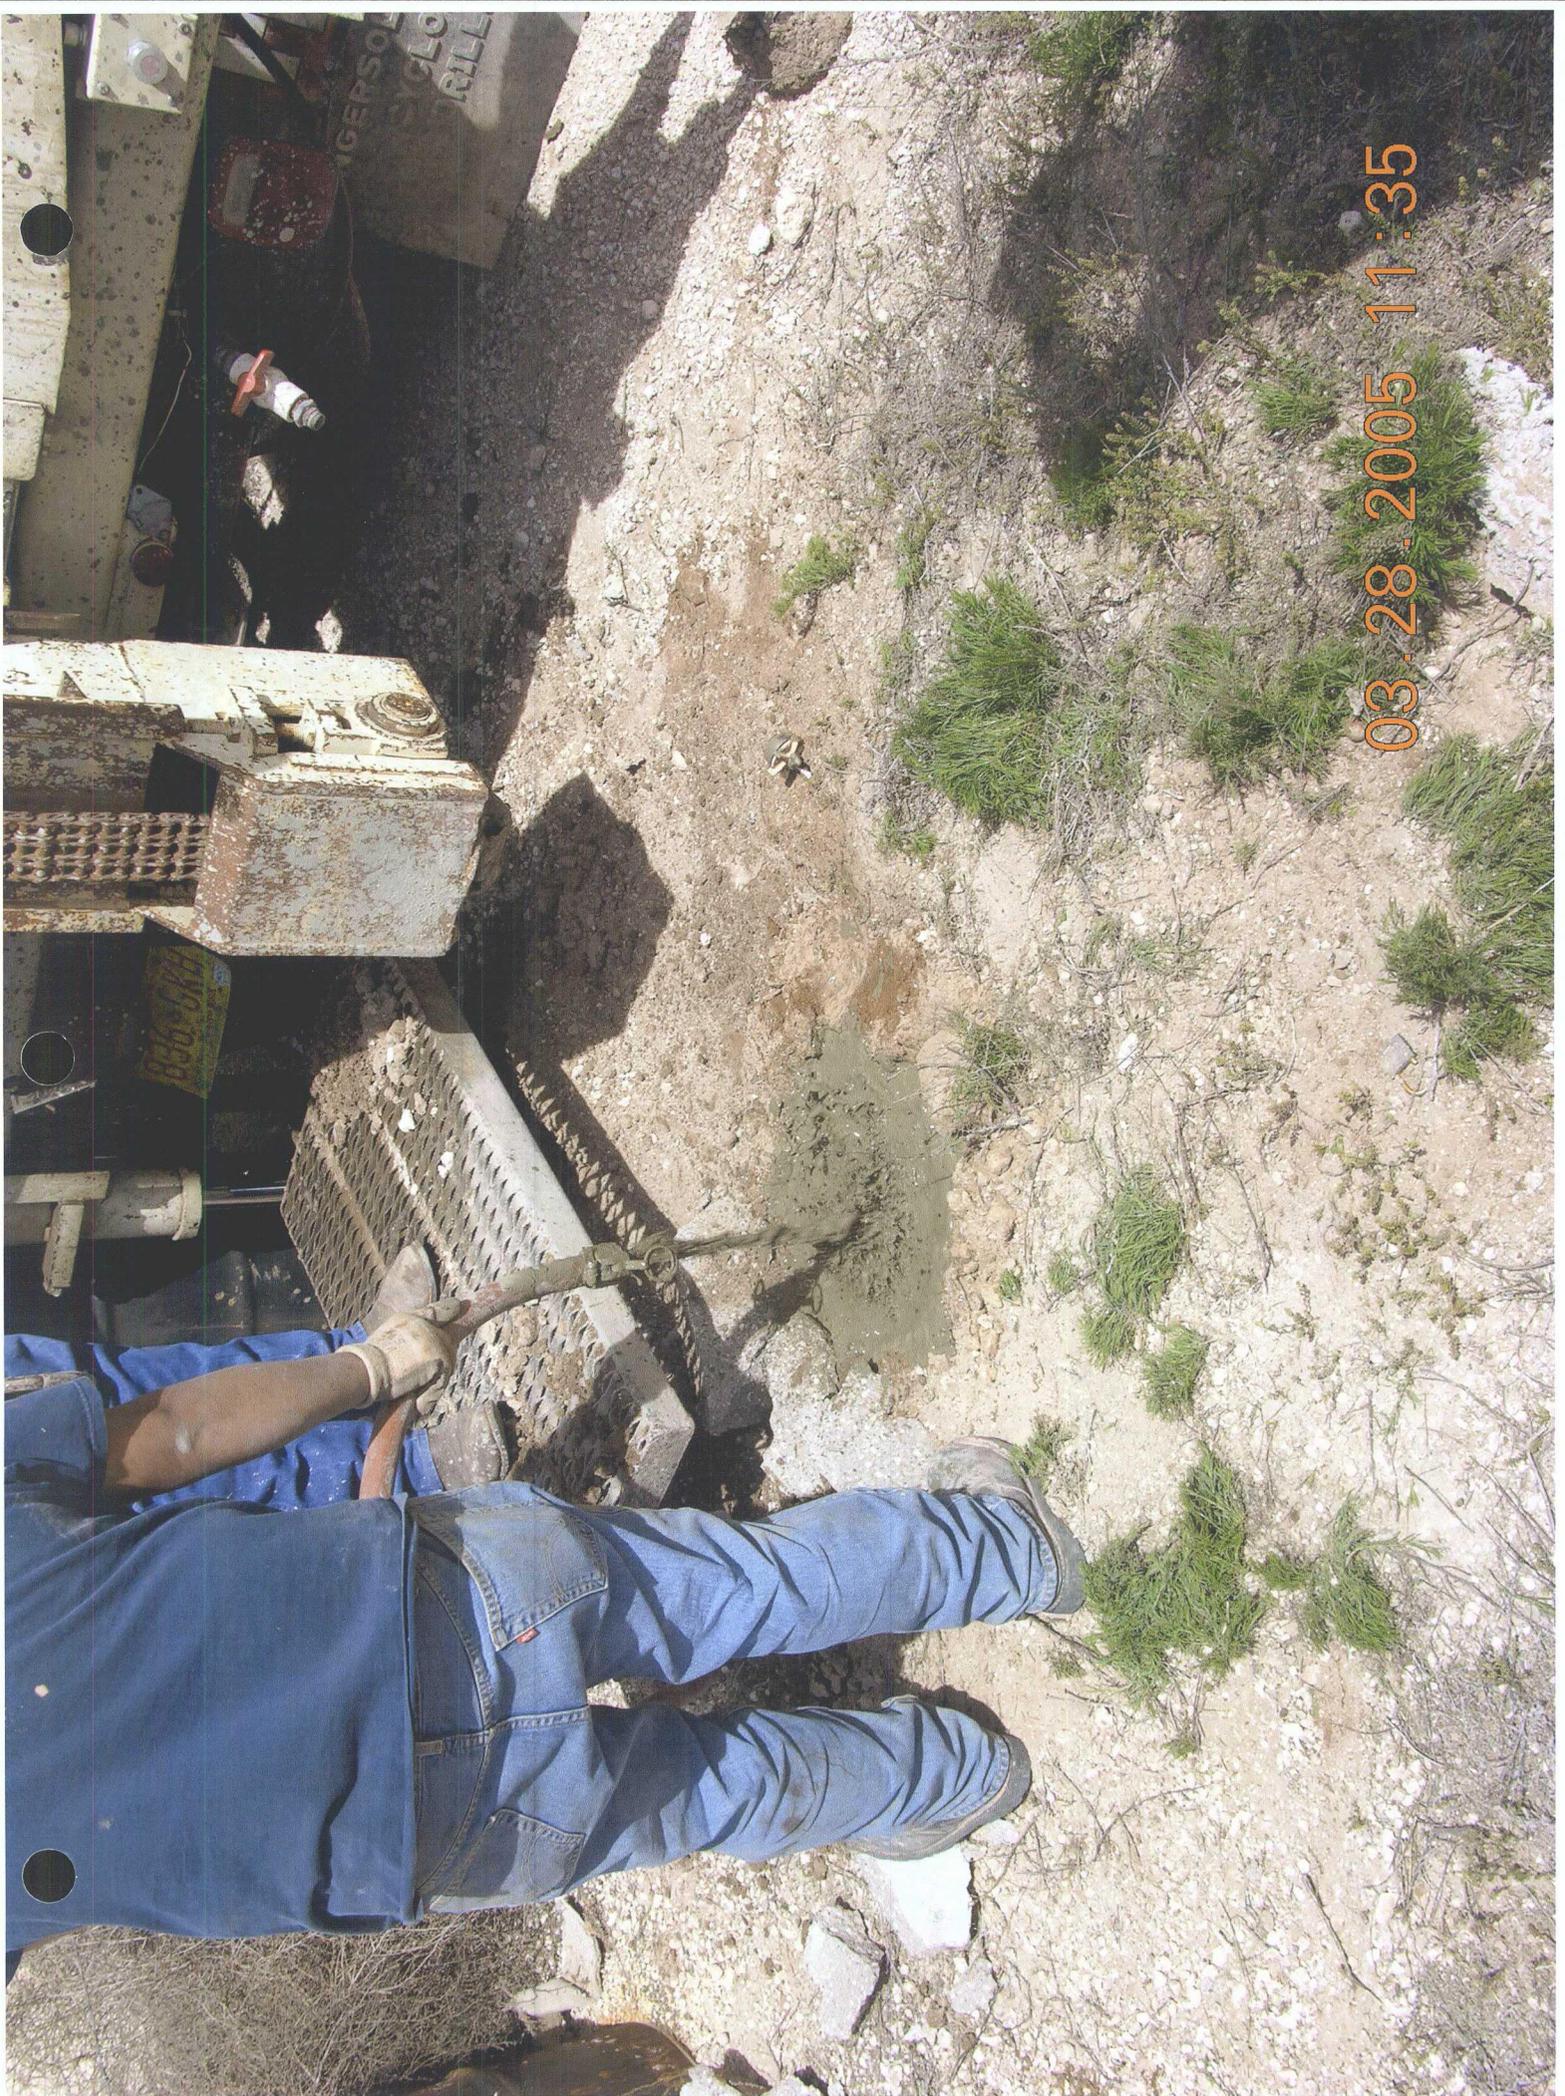
03-28-2005 11:35

Log of Boring Monitor Well 2 East

Depth in Feet	GRAPHIC	USCS	Sample	DESCRIPTION	MW-2 East
0				Plug and abandon Monitor Well #2 East located on Devon/Darr Angell Ranch at the Dickerson Lease, Lovington, NM.	
5				Water Level 62.0' ground level Total Depth 72.48' ground level	
10				Was not able to pull the casing from well. Grouted well through the casing. 47 gallons of grout used at ±10 lbs. per gallon.	
15					
20					
25					
30					
35					
40					
45					
50					
55					
60					
65					
70					
75

Monitor well no. 2 was situated within the battery area had to be plugged and removed prior to excavation activities. The metal surface box and all accessible plastic casing were removed. The bore hole was then grouted from bottom to surface with cement. (See exhibits 10-11)

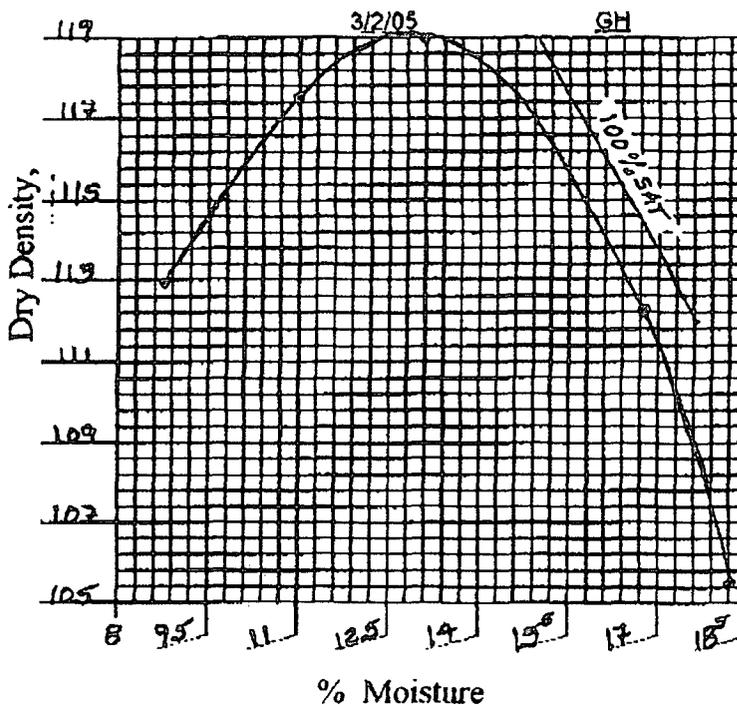
U.S. Standard Sieve No.	Cumulative % Retained	Cumulative % Passing	Specs
3"	0%	100%	
1 1/2"	0%	100%	
1"	0%	100%	
3/4"	0%	100%	
3/8"	0%	100%	
#4	0%	100%	
#10	9%	91%	
#40	19%	81%	
#200	44.7%	55.3%

Material Classification (field) Sandy Clay

0% Gravel
45% Sand
55% Fines

A two foot layer of clay was placed within the excavation and compacted to achieve a coefficient of permeability of 1.7×10^{-7} . (See exhibits 16-18).

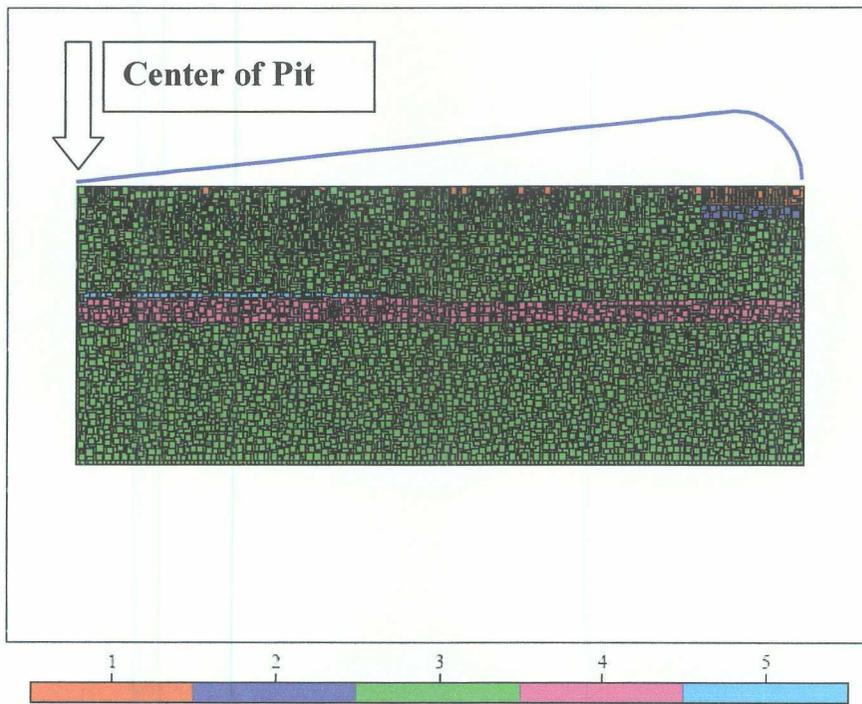
Figure 1. Diagram of distribution of soil materials after remediation of the pit. The vertical cross section represents a slice of the circular pit and surroundings with a radius of 165 feet and a depth of 62 feet. Soil surface at top, ground water at bottom. Material 1 (red) is the top soil; material 2 (dark blue) is the calcic horizon; material 3 (green) is the sand; material 4 (pink) is the sandstone; material 5 (light blue) is the clay cap.

In this report we evaluate the optimal remediation strategy as designed by WEE. The contaminated site has been excavated to a depth of approximately 25 feet. The impaired geological layers below 25 feet have been left in place. The impaired excavated soil has been mixed with uncontaminated soil to prepare fill material with a soil chloride concentration not higher than the legal limit of 250 ppm, i.e. 250 mg of chloride per 1 kg of moist soil. A 2 feet thick clay cap has been placed on the bottom of the pit in order to prevent deep percolation water to enter the impaired formations below. The pit has been filled with approximately half the volume of fill material, the remaining fill material has been buried around the site to a maximum depth of 10 feet. Figure 1 shows all soil materials after completion of the remediation project.

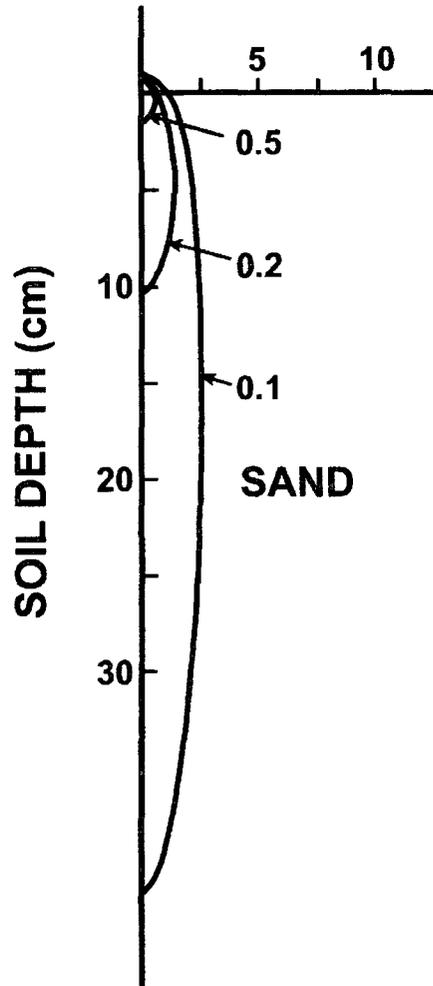
Figure 2. Limiting soil water content profiles as time goes to infinity during infiltration from a line source. Numbers on the curves represent values of degree of saturation. (After Jury & Horton, 2004).

The flow of water from the edge of the clay cap into the underlying sand can be evaluated by considering what is know about infiltration from a line source. Theoretical and experimental evidence^{22,23} predict that the wetting front of the water infiltrating from a line source into a sand

will become elongated with time since gravitational forces in the sand dominate the capillary forces (Figure 2). The same will happen over time with the water flowing over the edge of the clay cap into the sand layer. As a matter of fact during excavation of the pit we have observed a distinct vertical “wetting front” in the sand layer above the sandstone (Figure 3). This “wetting front” resulted from the infiltration of BTEX contaminated brine from the tank battery into the soil. Its vertical elongated shape is exactly what is predicted by the theory in this sand layer. Since the sand layer underneath the clay cap is similar to the one above, the same infiltration pattern will occur.

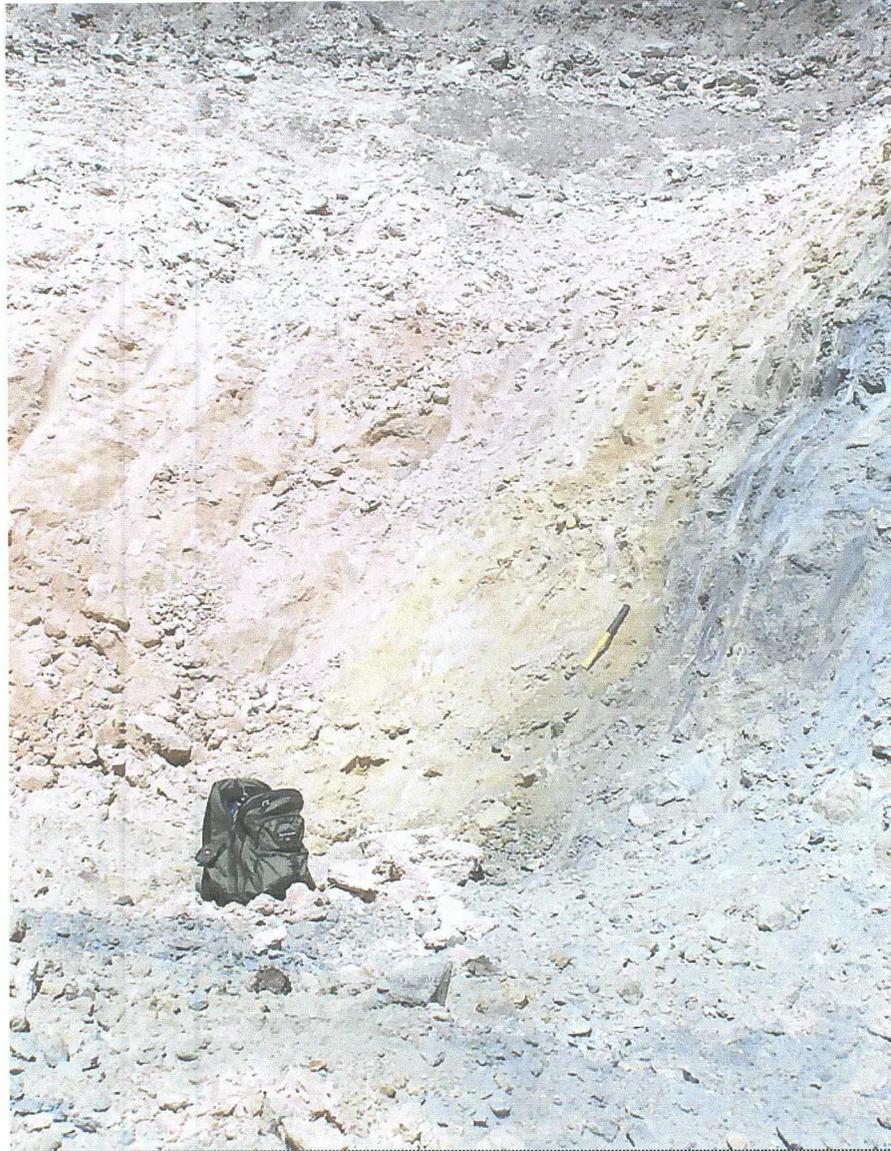
Figure 3. Soil profile inside the excavated pit. The dark area to the right has been darkened due to infiltration of BTEX and brines; the light area at the left has not been affected. The sharp vertical boundary between the dark and light areas is evidence of the limiting soil water content profiles typical for sand soils during three-dimensional infiltration from the tank battery.

On March 30, 2005, the excavated pit was inspected and sampled. The pit is located at UTM coordinates 671980 East and 3657376 North (Zone 13 North, datum WGS84). The soil profile in the pit consists of 3 feet of a silty clay loam topsoil underlain by a caliche layer of 4 feet. The caliche layer is fractured and full of fine roots. Beneath the caliche layer a 17 feet thick sand layer rests on 6 feet of indurated sandstone. The sand layer consists of fine sand with some one to two inch diameter stones. The bottom of the pit was located on the indurated sandstone. The soil bore logs presented in a report by Environmental Technology Group, Inc.² clearly indicate that the sand layers underneath the sandstone are very similar to the one above the sandstone. This finding is corroborated by several geological reports on the Ogallala Aquifer in Eastern New Mexico^{3,4}.

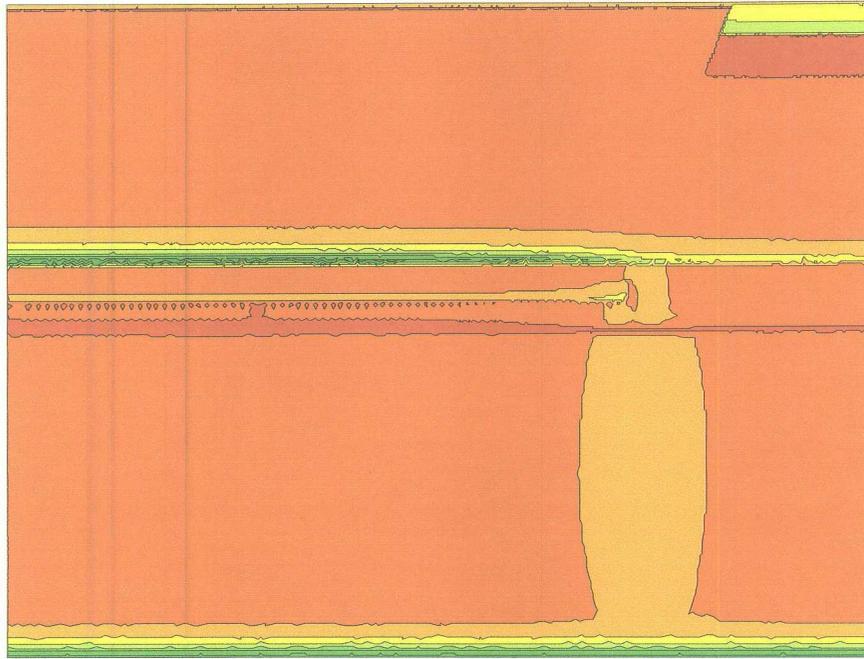
Figure 4. Soil water content distribution at the remediated site ten years after installation of the clay cap. The elongated shape with higher water contents is a result of infiltration from the edge of the clay cap. The impaired soil volume to the left of the infiltrating water is not affected by the higher water contents. See also detail in Figure 5.

The model HYDRUS2D was used to simulate how far water would be wicked into the impaired volume. After ten years of simulation an approximately steady water content distribution developed (Figure 4) with a wetting front similar to the one predicted by the theory (Figure 2) and observed in the field (Figure 3). The wetting front wicks some water towards the impaired volume over a distance of about 7 feet. The diameter of the impaired volume is 120 feet; the clay cap has a diameter of 140 feet and, thus, extends 10 feet away from the contaminated sand. Since the wicking action of the sand is less than 10 feet, the chloride in the impaired volume will not be affected. This can be seen clearly in Figure 5 where the water flow velocity vectors are plotted for the area just below and surrounding the edge of the clay pan.

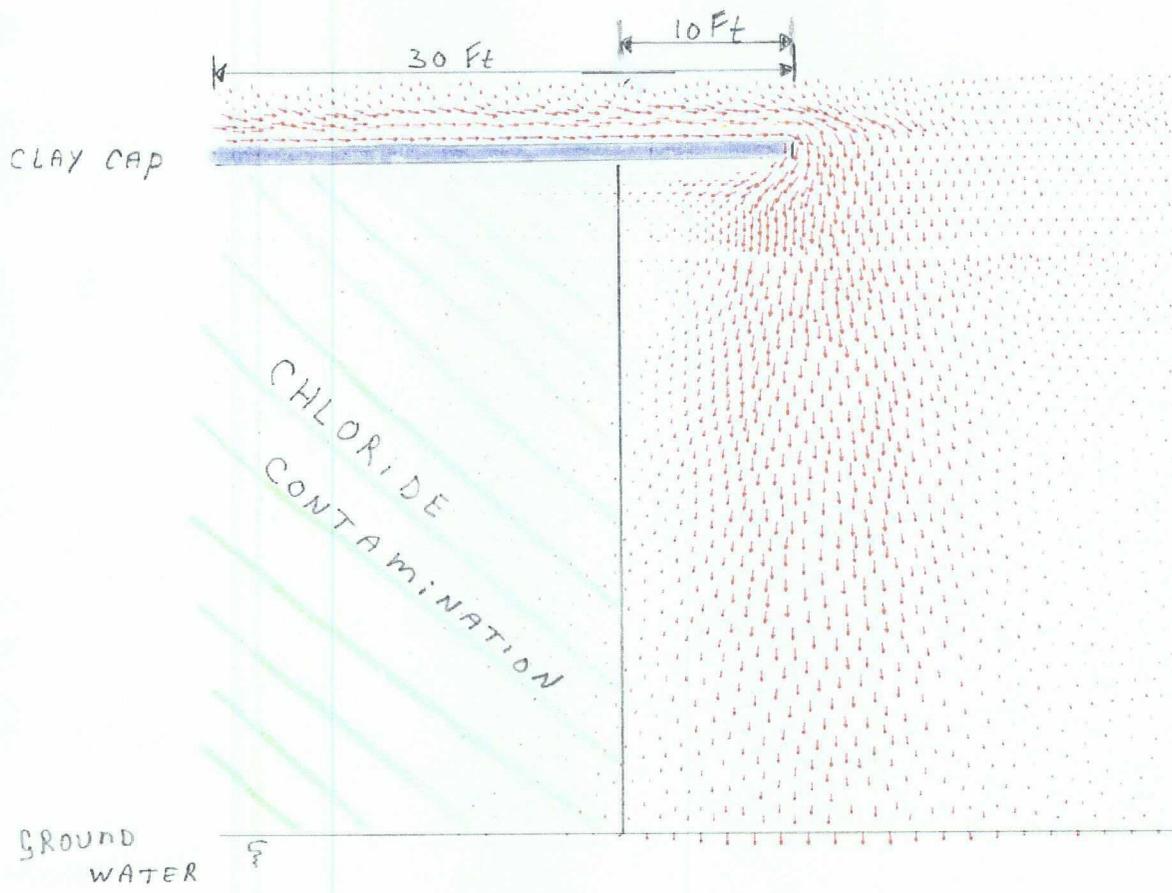
Figure 5. Water flow velocity vectors near the edge of the clay pan simulated with HYDRUS2D ten years after installation of the clay pan. The larger the vector, the more water flow. Note (i) the lateral flow on top of the clay cap and (ii) the absence of vectors inside the impaired soil volume with chloride contamination.

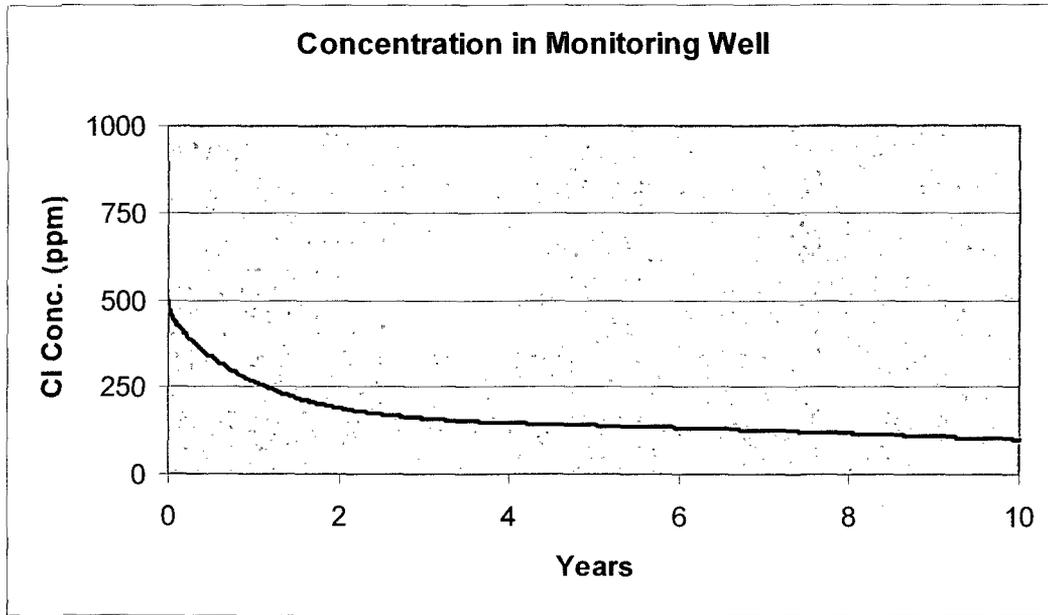
Figure 6. The chloride concentration in a down-gradient monitoring well as a function of time after clay cap installation.

In order to evaluate the decrease of chloride flux with time we have simulated chloride and water dynamics underneath the clay cap using HYDRUS1D. Initial conditions are taken from the HYDRUS2D simulation of the performance of the clay cap. The top boundary condition is set at a very small flux of 0.001 cm/day equal to the saturated hydraulic conductivity of the clay cap. The chloride content in the impaired volume is conservatively taken as 874 ppm, i.e. 974 mg of chloride per 1 kg of moist soil, as explained in section “*Remediation Approach*”. The chloride content in the aquifer at the time of the installation of the clay cap is conservatively taken as 496 ppm which is the highest concentration measured in monitoring well MW1. Figure 6 presents the chloride concentrations simulated in a 10 feet deep monitoring well placed at the edge of the impaired soil volume after installation of the clay cap. In about one year the chloride concentration in the monitoring well drops below 250 ppm. Since the simulated chloride concentrations in Figure 6 are based on uncertain estimates of chloride concentrations in the impaired soil volume and in the impaired ground water, actual chloride measurements in the future may be somewhat different. However, Figure 6 clearly demonstrates how effective the clay cap will be for the reduction of future chloride concentrations in the monitoring well.

installation of the clay cap. Figure 7 shows that the simulated chloride concentrations are higher than the ones presented in Figure 6. Nevertheless, in about four years the chloride concentration will be less than 250 ppm, even after the most catastrophic event that could happen at the site after installation of the clay cap. Therefore, we conclude that a sudden rise of ground water level will affect the concentrations in the monitoring well but its effect will be mitigated within only a few years.

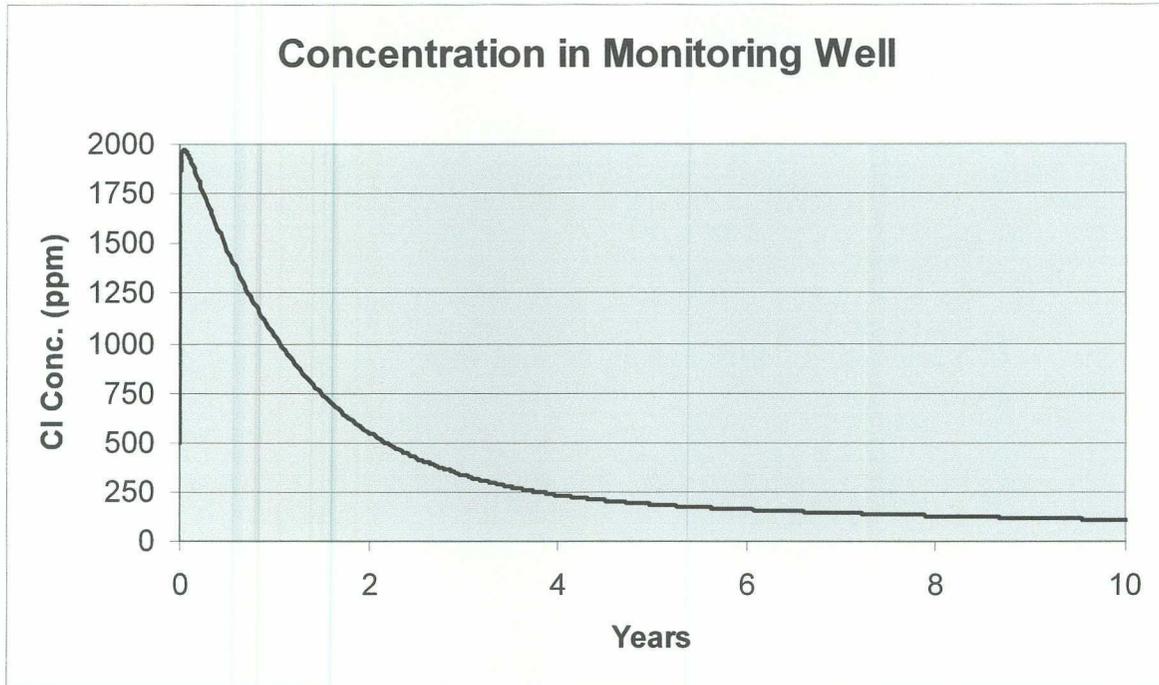
Figure 7. The chloride concentration in a down-gradient monitoring well as a function of time after a sudden 4 feet rise of ground water level immediately after installation of the clay cap.
