**RE: NOTIFICATION OF GROUNDWATER IMPACT**  
**BD P-26-1 vent, #1R0426-106**  
**Unit P, Sec. 26, T21S, R37E**

# SOIL BORING LITHOLOGIC LOG

# LITHOLOGIC LOG AND MONITORING WELL CONSTRUCTION DIAGRAM

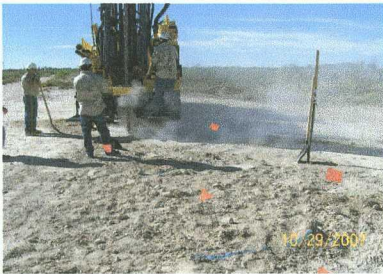
BOREHOLE NO.: B-1 TOTAL DEPTH: 45 Feet  
 SITE ID: BD Jct. P-26-1 Vent CLIENT: RICE Operating Company  
 CONTRACTOR: Harrison & Cooper, Inc. COUNTY: Lea  
 DRILLING METHOD: Air Rotary STATE: New Mexico  
 START DATE: 10/29/07 LOCATION: T21S-R37E-Sec 26-Unit P  
 COMPLETION DATE: 10/29/07 FIELD REP.: G. Van Deventer  
 COMMENTS: Boring located 14 feet west-southwest of former junction box (plate marker)  
Photo at left shows drilling of B-1 (facing west). Orange pin flagging identifies active brine water lines.

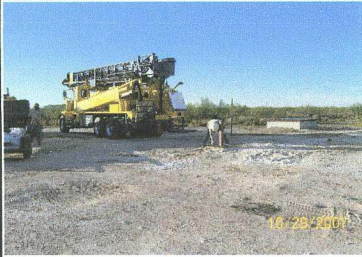
MONITORING WELL NO.: MW-1 TOTAL DEPTH: 55 Feet  
 SITE NAME: BD Jct. P-26-1 Vent Site CLIENT: RICE Operating Company  
 CONTRACTOR: Harrison & Cooper, Inc. COUNTY: Lea  
 DRILLING METHOD: Air Rotary STATE: New Mexico  
 START DATE: 10/29/07 LOCATION: T21S-R37E-Sec 26 - Unit P  
 COMPLETION DATE: 10/29/07 FIELD REP.: G. Van Deventer  
 COMMENTS: Located approximately 12 feet southeast of former junction box (plate marker).  
Photo at left shows completed MW-1 (facing northwest) and new junction box (right-center).
