**STAGE 1 & 2
WORKPLAN**

RE: Samson Livestock "30" Reserve Pit, T21S, R35E, Section 30, Unit P;
NMOCD Case: Abatement Plan 62

**Stage 1/Stage 2
Abatement Plan
Samson Livestock 30
T21S-R35E-Section 30**

**Prepared for:
Samson Resources Inc**

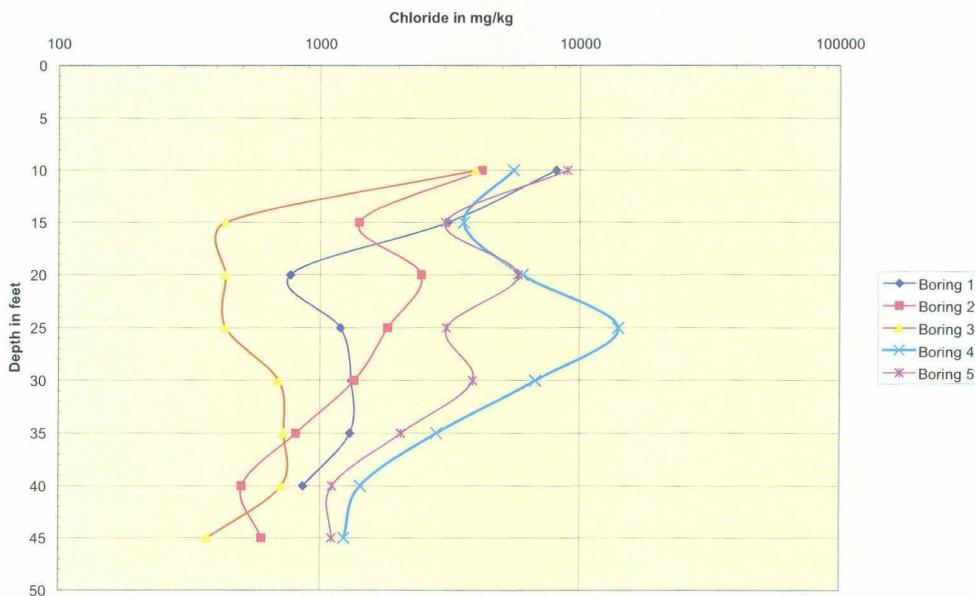
Figure 3: Chloride Concentration in Soil at the Livestock Site

Figure 3 shows the chloride concentrations v. depth for the boreholes within the excavation associated with the former reserve pit. The maximum field chloride concentration of 14,080 mg/kg is from B-4 at a depth of 25 feet bgs. The deepest samples above the capillary fringe (about 35 feet bgs) suggest that chloride did not materially impact the lower vadose zone in the northern portion of the former pit (borings 2 and 3). In the central and southern portion of the former pit, chloride concentrations above the capillary fringe are 1,298 mg/kg (B-1), 2,799 mg/kg (B-4) and 2,031 mg/kg (B-5). The fact that borehole #4 exhibits the highest chloride concentrations may not be surprising, given the fact that this borehole characterizes the area of the former reserve pit where accumulated cuttings would not restrict any loss from a lack of liner integrity. Figure 3 presents two schematic cross sections showing chloride concentrations from north to south and from east to west.

The results of the soil sampling are summarized in Table 1. In all of the four borings located outside of the pit area (B-6 through B-9) chloride concentrations in soil were less than 250 mg/kg. Twelve of 39 samples showed chloride concentrations less than the 1,000 mg/kg ground water protection limit suggested by highly-conservative simulation modeling conducted by NMOCD as being protective of ground water (see NMOCD Exhibits to the Surface Waste Management Rule Hearing).

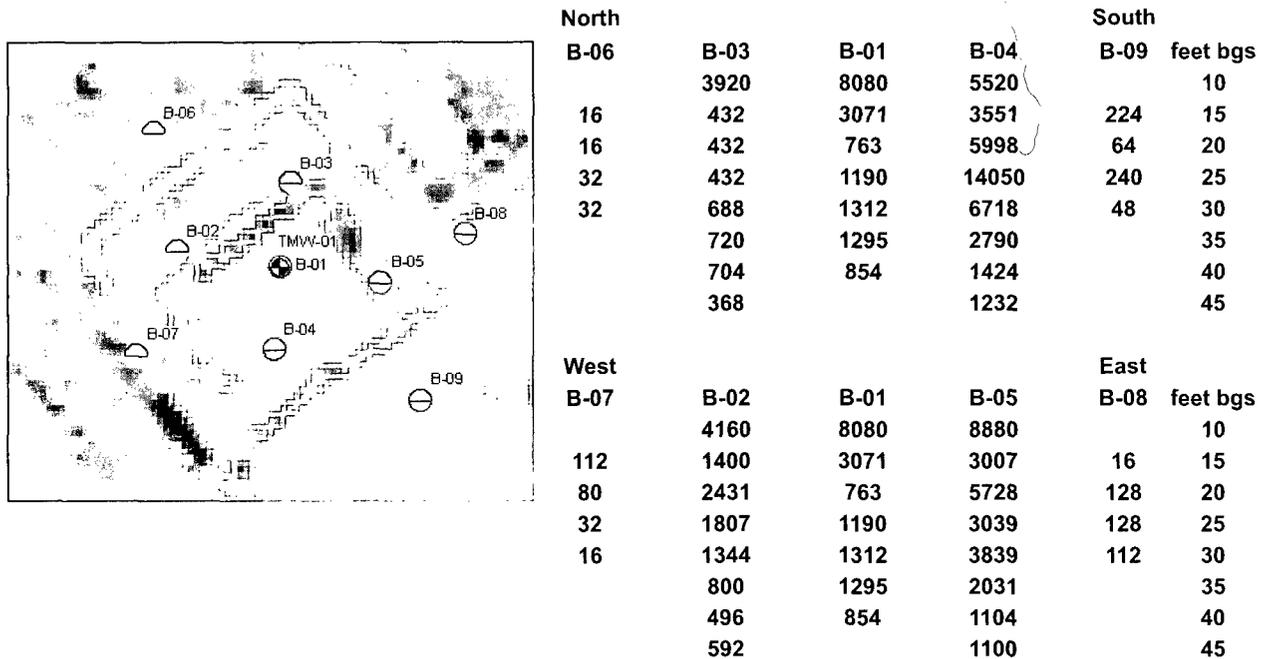
Figure 4: Schematic Cross Section of Chloride Concentrations

As Figure 4 shows, the center of chloride mass resides in boreholes B-01, B-04, B-05 and B-02. This strongly suggests that the inner horseshoe (brine) section of the reserve pit was the source of leakage and chloride.

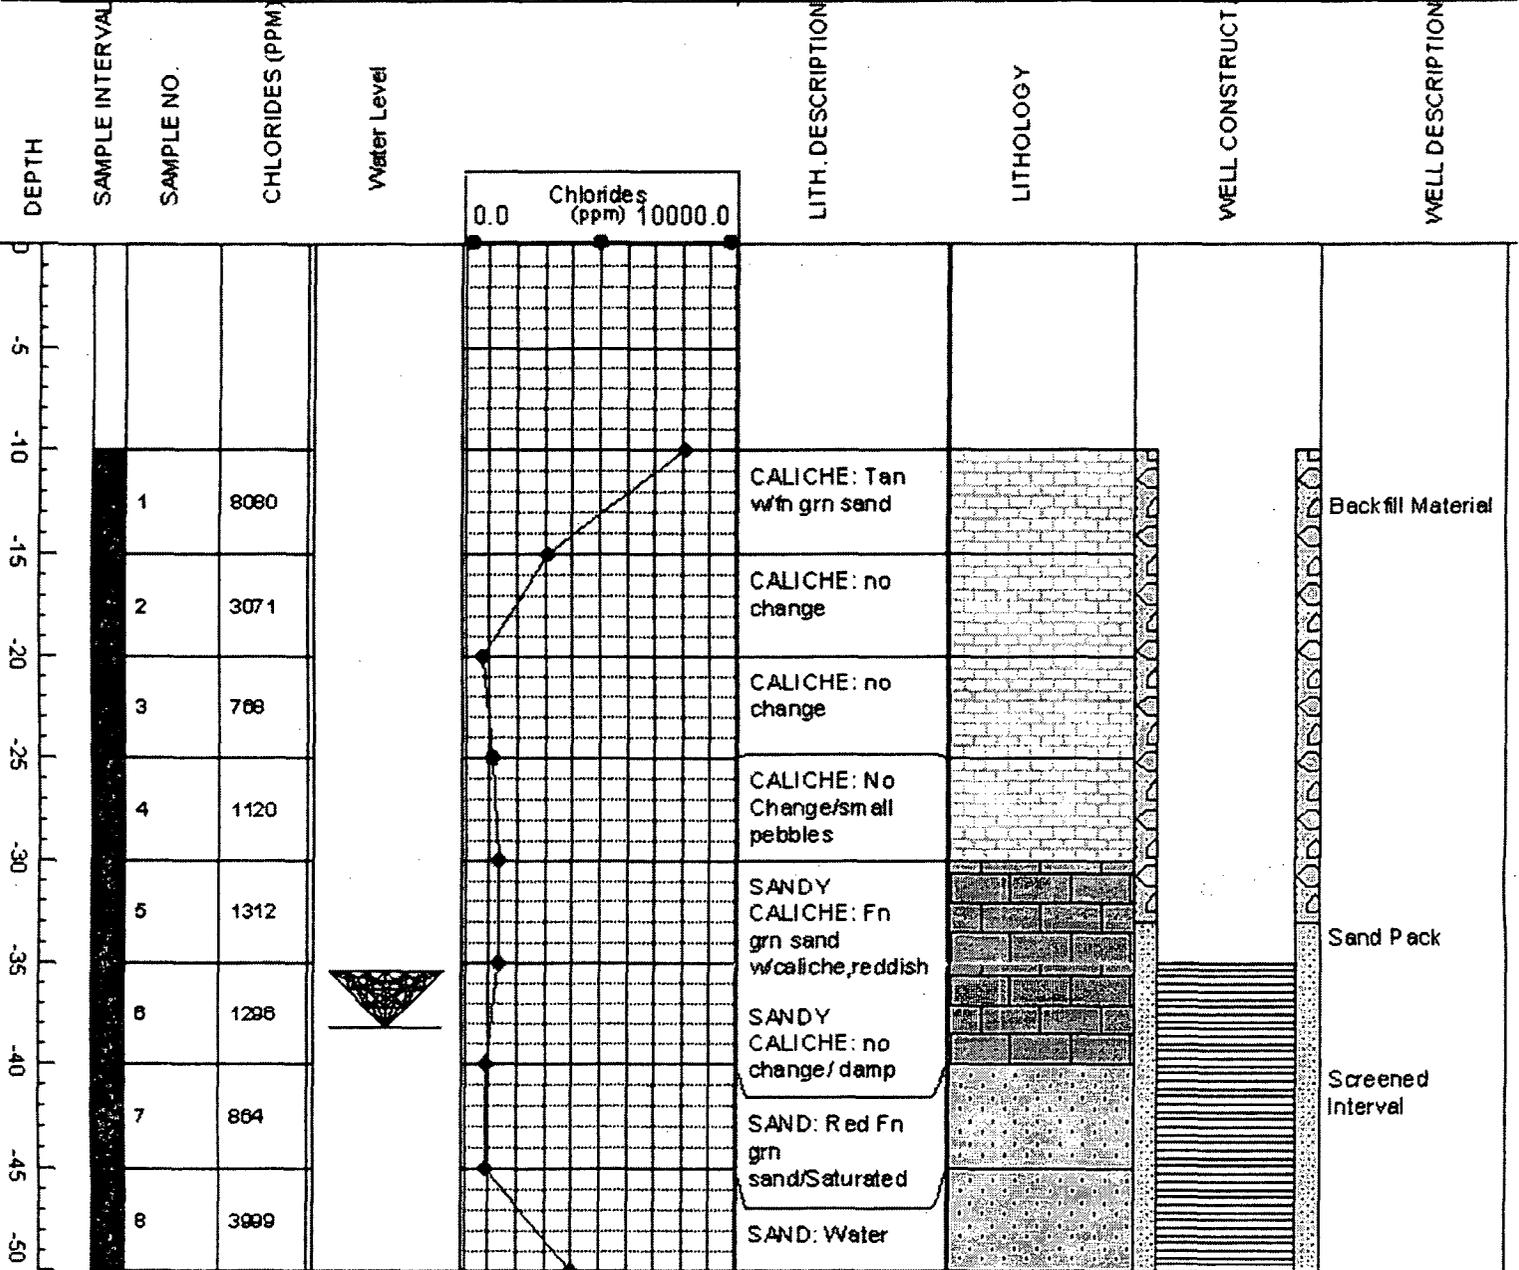
*** Chloride value at -45' bgs is an arbitrary number.....(No sample was taken)

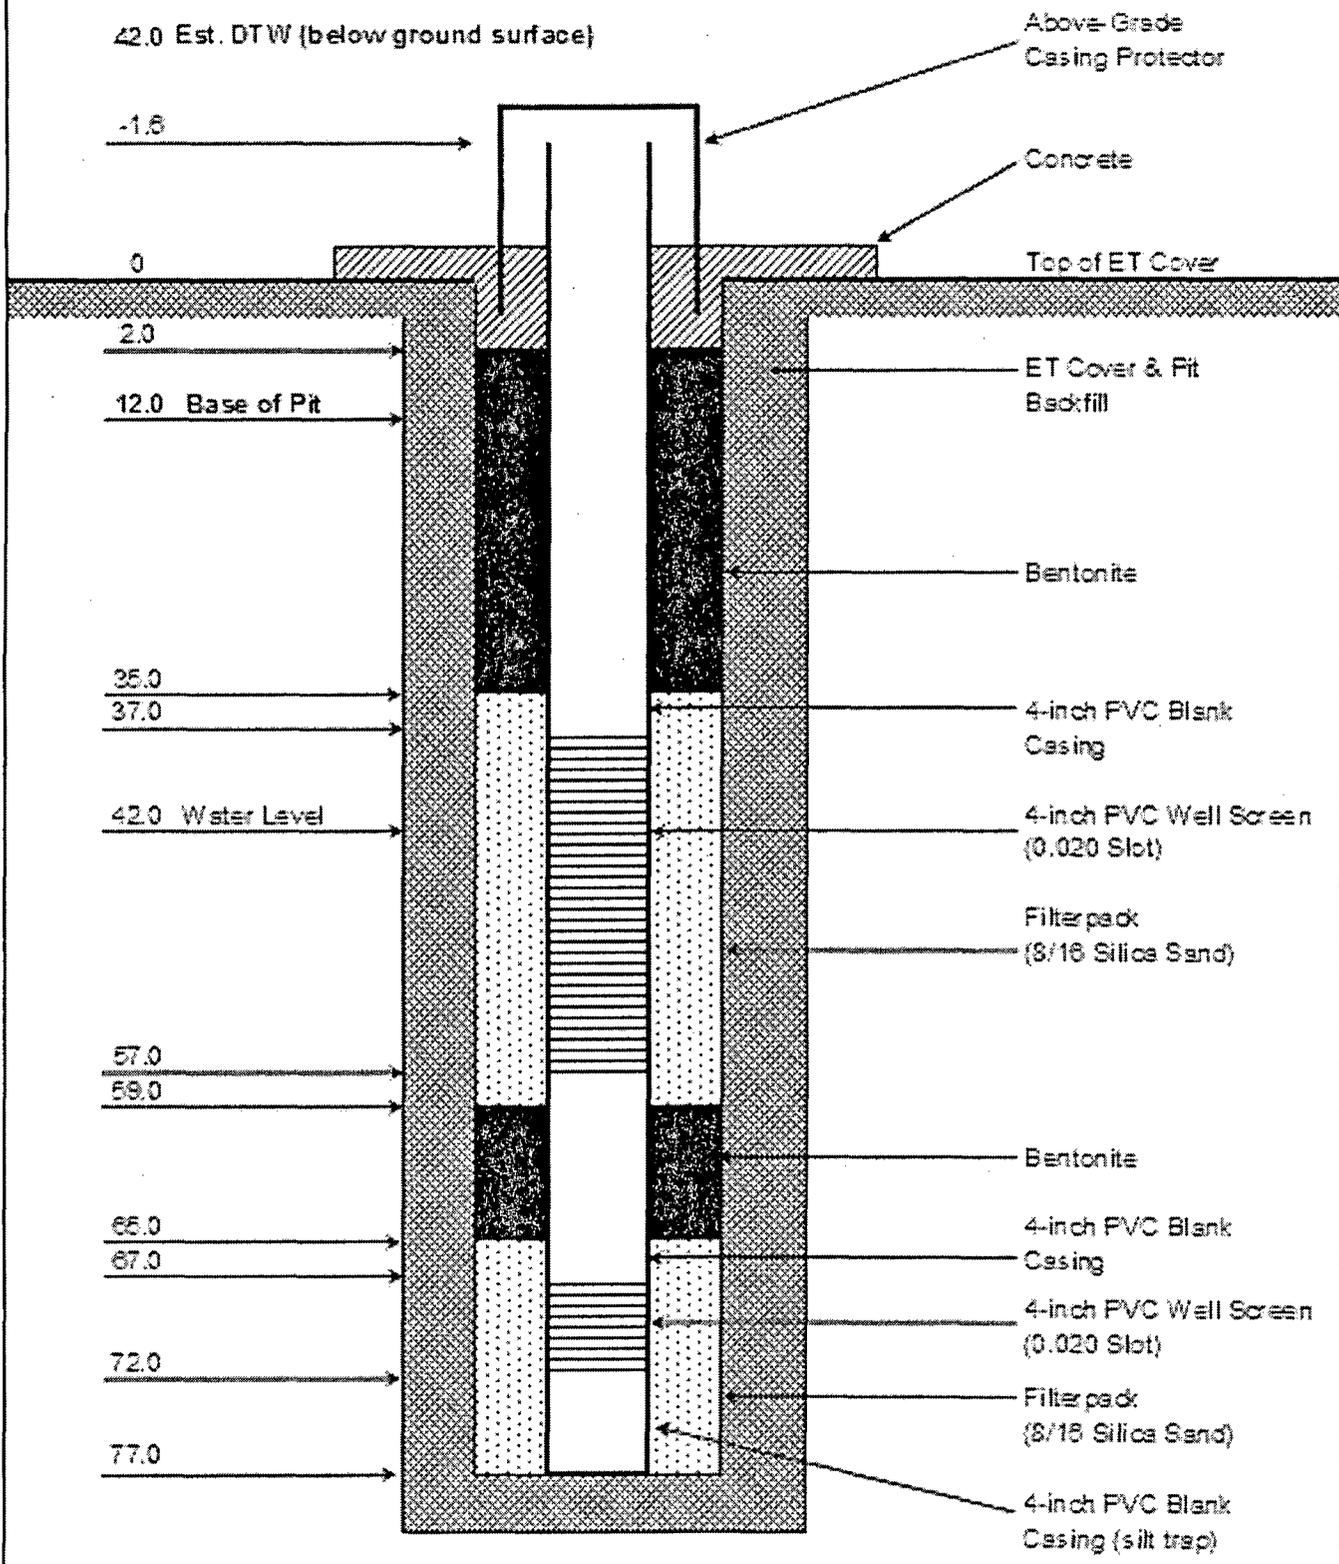
E.T. PIT COVER MONITORING WELL CONSTRUCTION DIAGRAM

42.0 Est. DTW (below ground surface)

RT Hicks Consultants Ltd	SITE: Samson Livestock "30" Site		E.T. Pit Cover Proposed Monitoring Well
	DATE: 9/6/05	REV. NO.: 1	
	AUTHOR: DTL	TECH: DTL

Following the construction of the modified monolithic ET barrier but prior to seeding the surface, a single 4-inch ground water recovery/monitoring well will be installed through the ET barrier, at the approximate location of TMW-1, using a hollow-stem auger. Once completed and properly developed the well will be equipped with a water pump powered by the appropriate solar panels and voltage switching or a portable generator. Ground water from the well will be pumped to the existing 500-bbl fiberglass storage tank associated with the Livestock "30" gas well. It should be noted that the gas well produced water to the fiberglass tank for only a short period of time following the initial stimulation. Currently the water tank is not being used for oil field operations. Appendix D provides the proposed design for the recovery well.
