APPLICATION FOR WASTE MANAGEMENT FACILITY

Land Farm Permit Application

7 Rivers Landfarm
Carlsbad, New Mexico

Project:
7 Rivers Landfarm
Eddy County, New Mexico

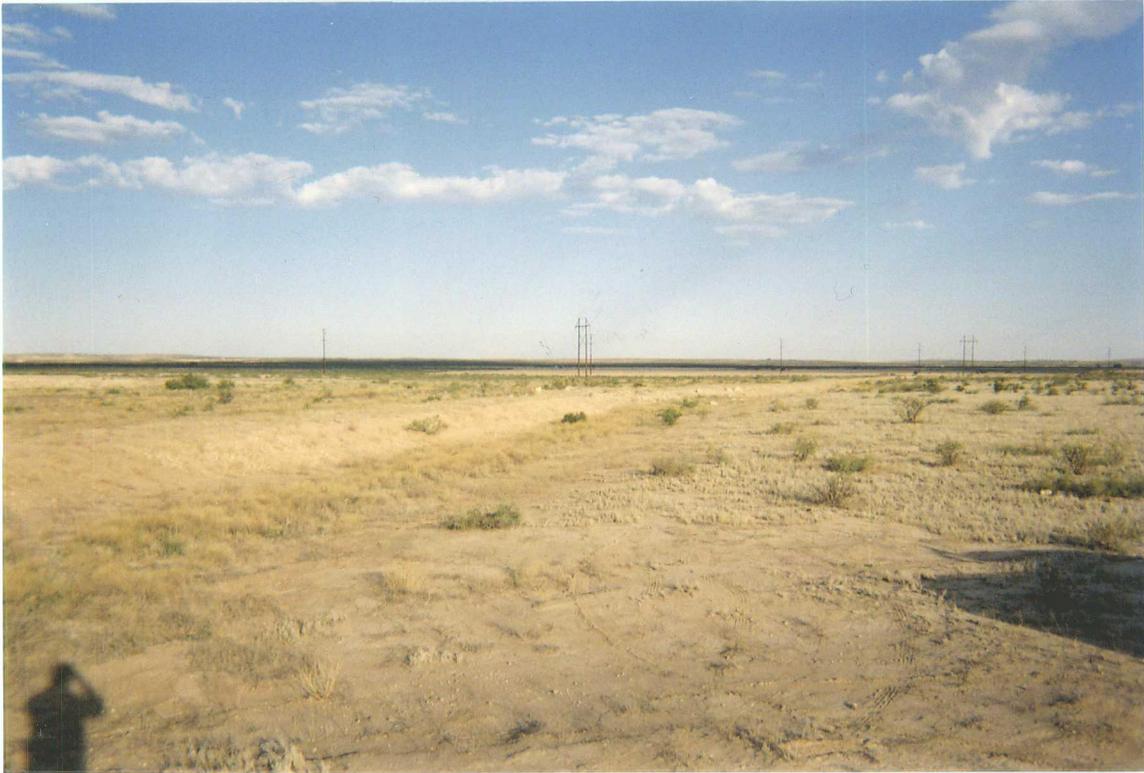
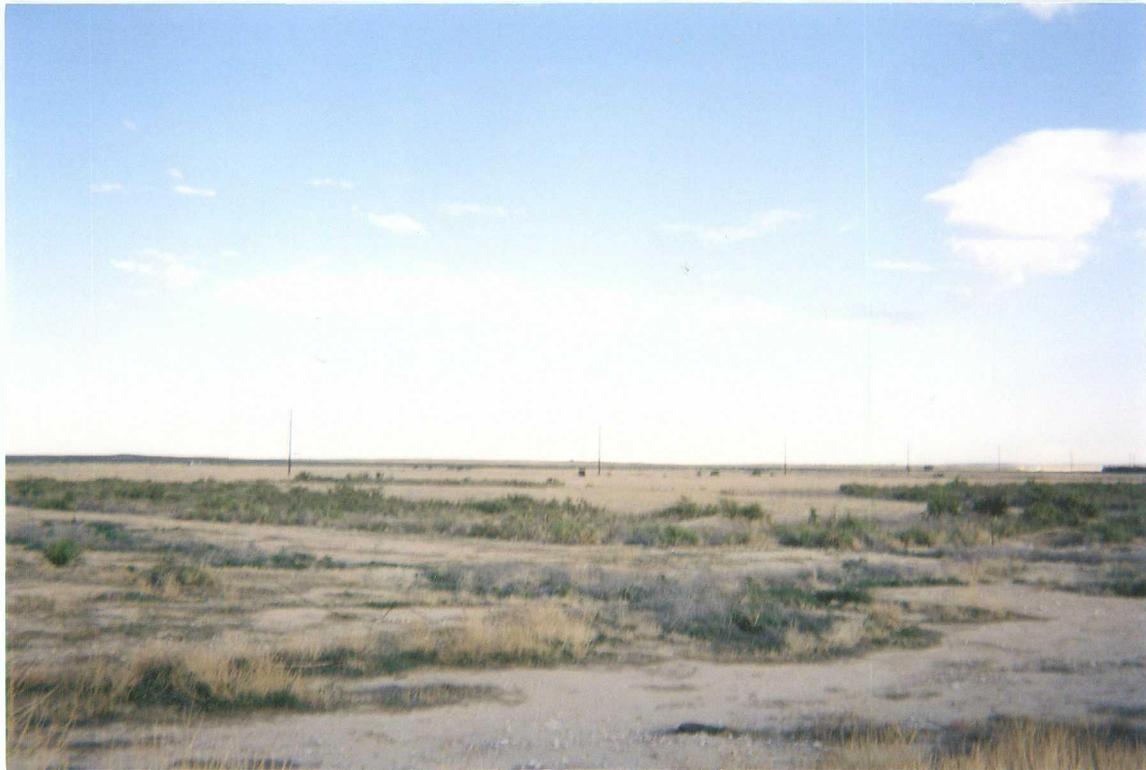
Area where diverted water will run during large rain event

Canals and ponds on land farm proposed site

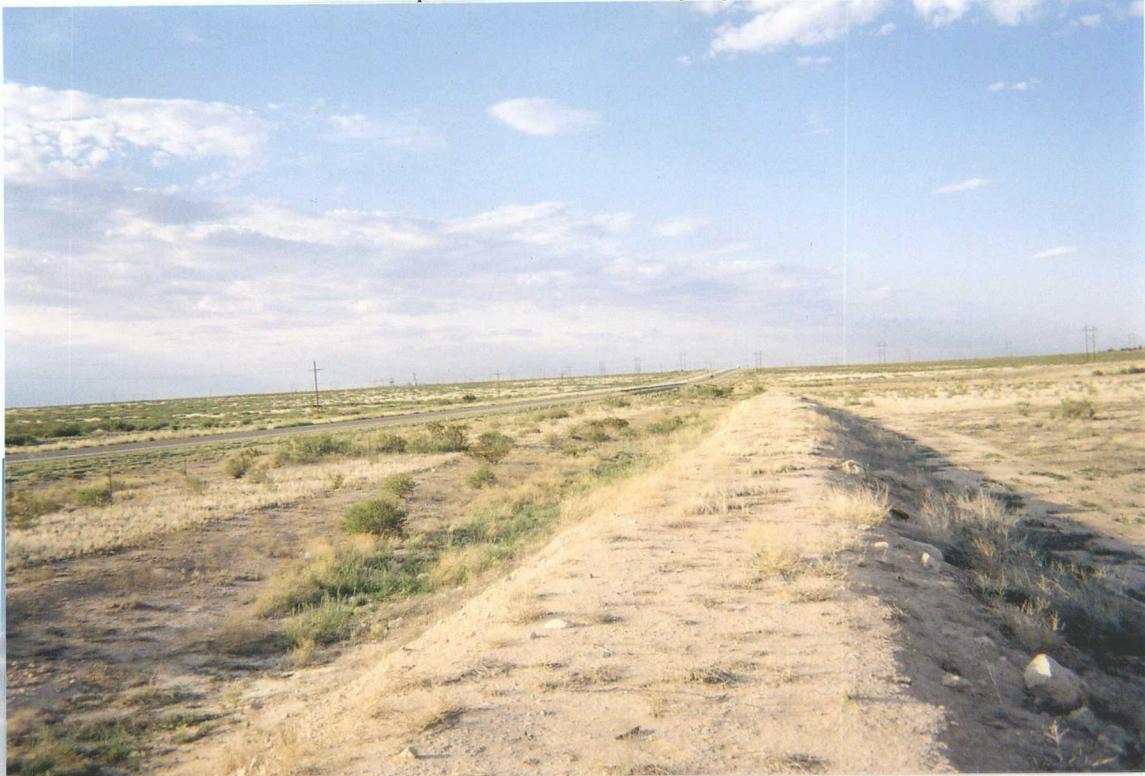
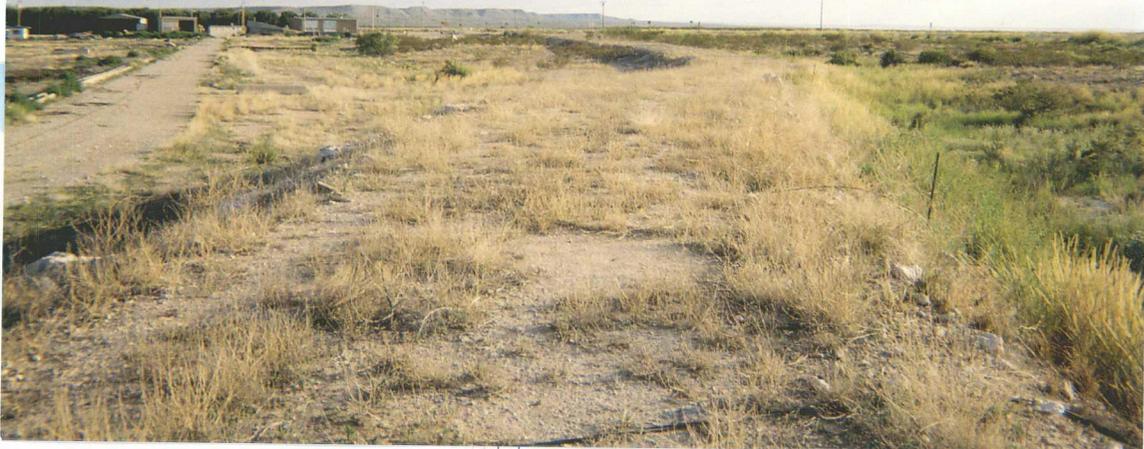
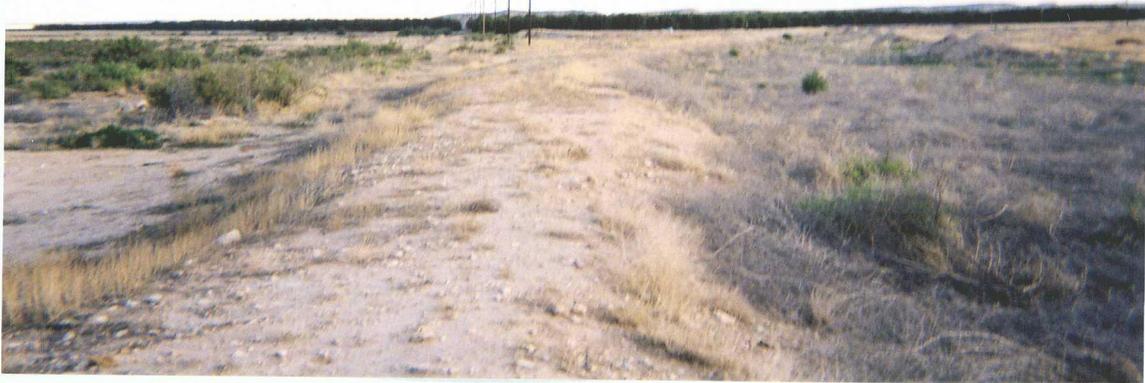
These canals surround the land farm the water will be diverted to Brantley State Park

Three large holding ponds

This site was selected for the biomass facility because the New Mexico solid waste division in Santa Fe recommended. This site was recommended by solid waste personnel due to the engineering located on the property. With 600 tons of manure being processed, and thousands of tons of manure would have to be stored, this facility offers the best site. The entire property is surrounded by diversion canals that divert all outside runoff away from the property to the state park located east of the proposed land farm. All rain falling on the property is channeled into three large holding ponds. The entire facility is engineered for a 25 year rain event.

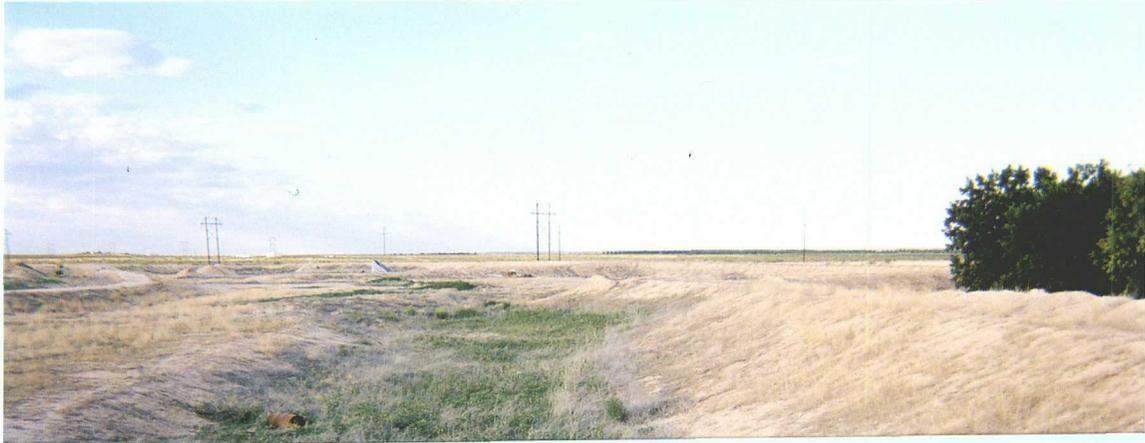
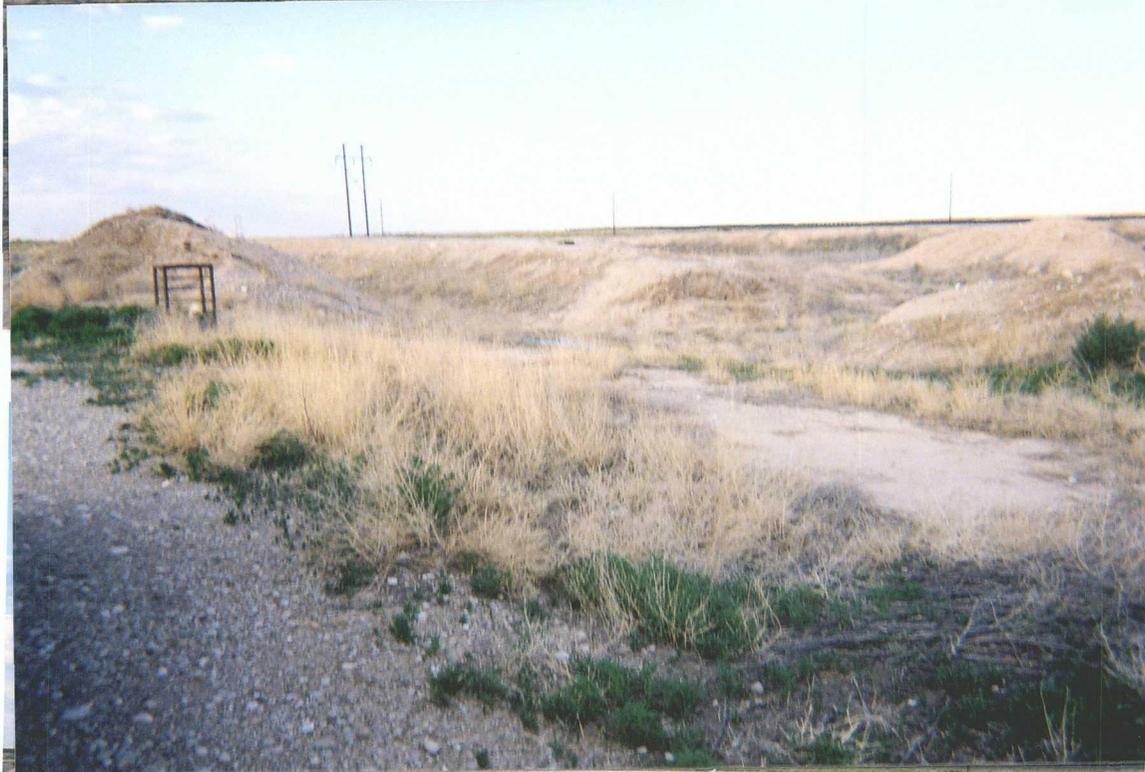
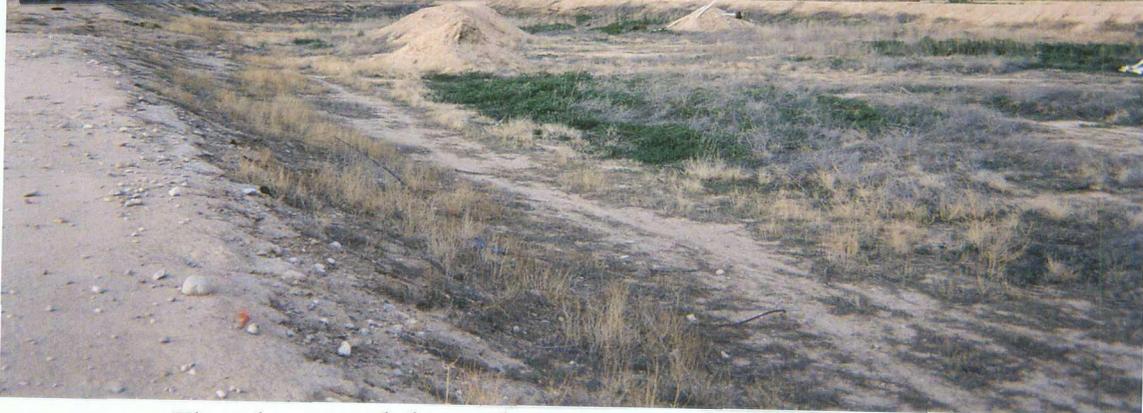
Three large ponds have adequate storage for 25 year rain event

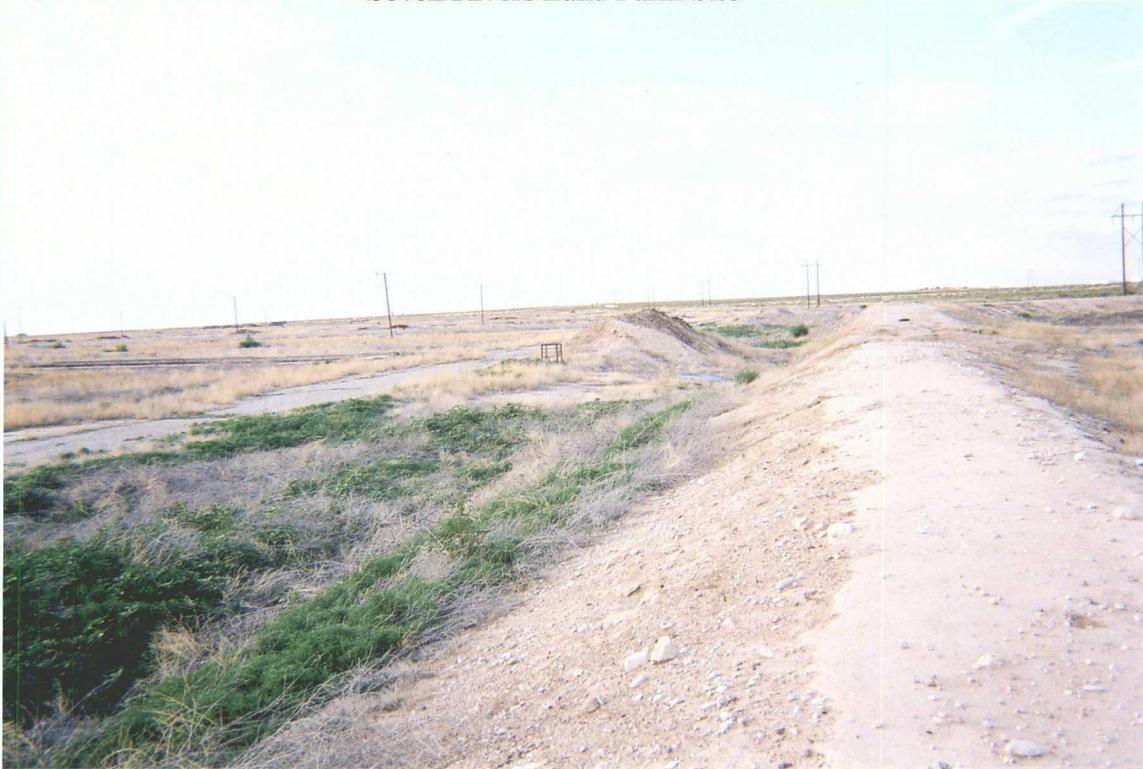
This large canal empties into three holding ponds

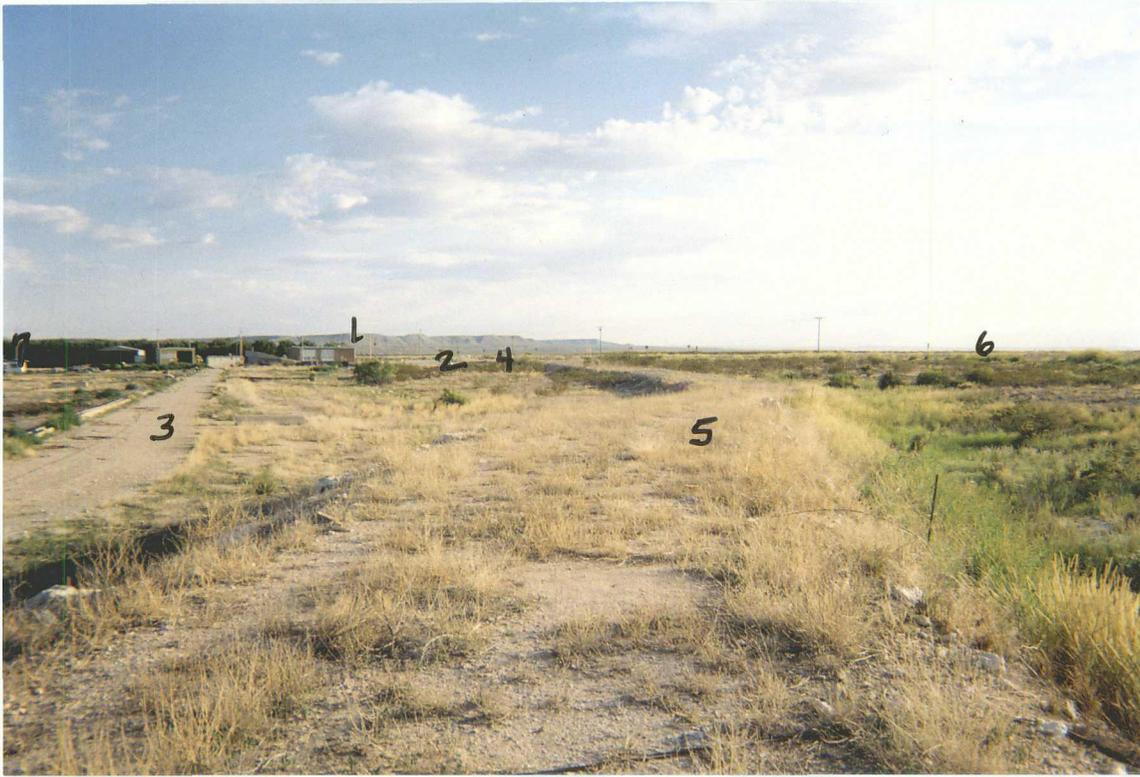
Land farm site Seven Rivers

No. 1- Proposed office facility

No. 2- Scales are located here

No. 3- Graveled road leading to cells

No. 4- Gate entrance

No. 5- Canal diverting water around the site

No. 6- Hwy 285 four lanes

No. 7- Dakota Packaging facility

There is only one entrance into the facility, the office and scales are located right at this entrance. All loads received will be weighed and documented through our office. Once the paperwork is completed the contaminated soil will be placed in the designated cell assigned. The contaminated soil will be spread as it is unloaded. Once the cell is covered the process of tilling and watering begins in order to further aid in the bacterial growth. Once the cell has reached its lift capacity which is 6 to 8 inches, it will be tilled
