VacJct P-27

CLOSURE

RICE OPERATING COMPANY
JUNCTION BOX FINAL REPORT

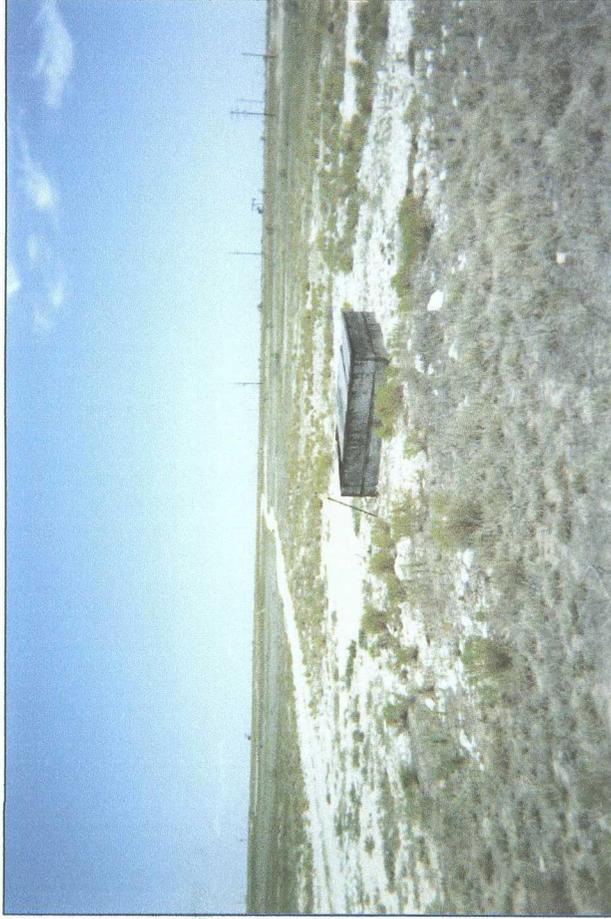
8/22/2005

undisturbed junction box

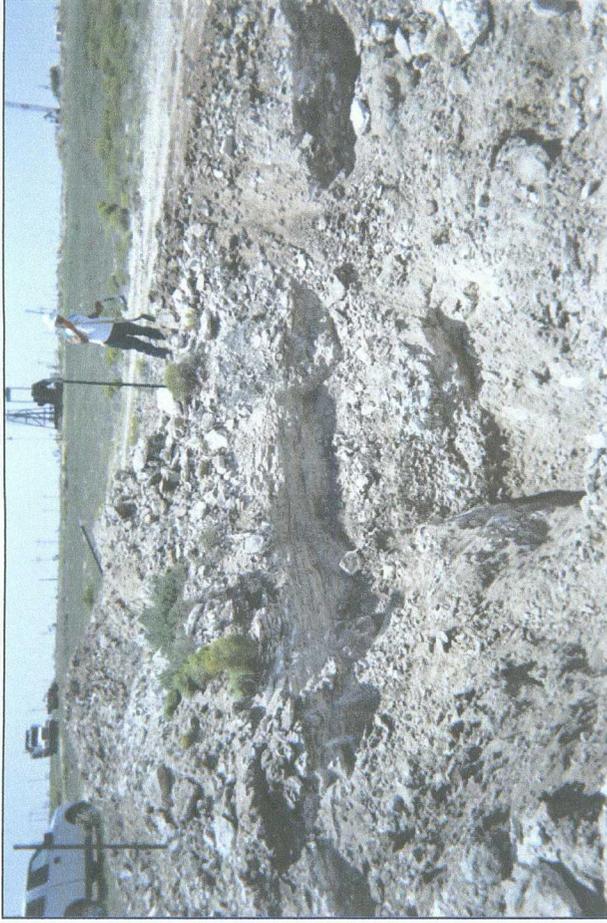
8/21/2007

9-ft delineation trench prior to backfill

This junction box was addressed as part of the Vacuum SWD System abandonment. After the box lumber was removed and the pipelines were capped, a delineation trench was made at the site to collect soil samples. Excavation was difficult due to hard caliche rock but the trench was extended to 9 ft BGS. Chloride field tests were conducted on the samples and yielded very low concentrations. Organic vapors were measured and also yielded very low concentrations. The grab samples from the deepest part of the trench (9 ft) was sent to a laboratory for confirmation and TPH analysis. TPH results meet NMOCD guidelines. The excavated soil was returned to the trench and the remainder of the hole (from removal of the junction box) was backfilled with clean, imported soil which was also spread on the surface to encourage regrowth. The surface was seeded with a blend of native vegetation on 8/29/2007 and is expected to return to productive capacity at a normal rate.

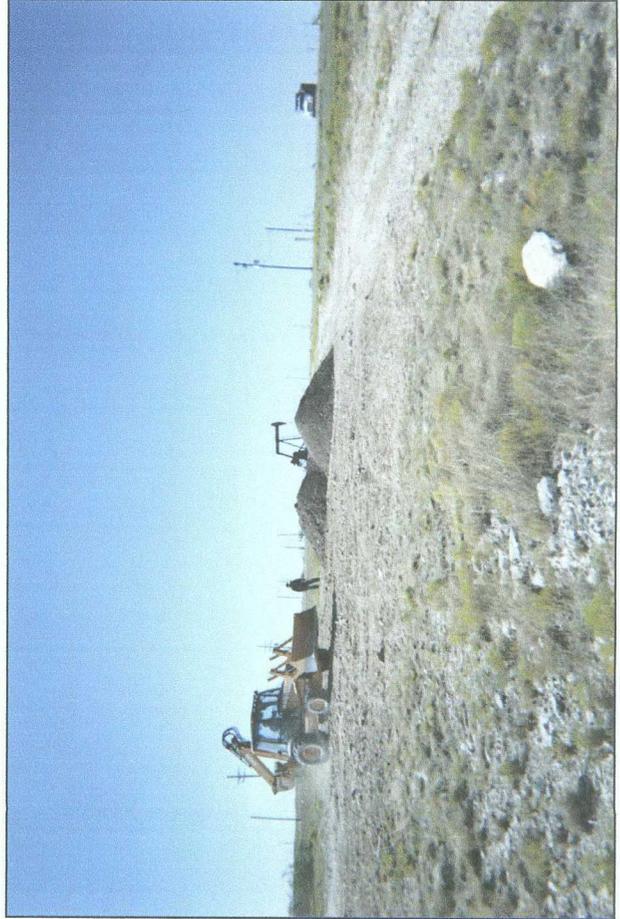
8/29/2007

spreading imported soil

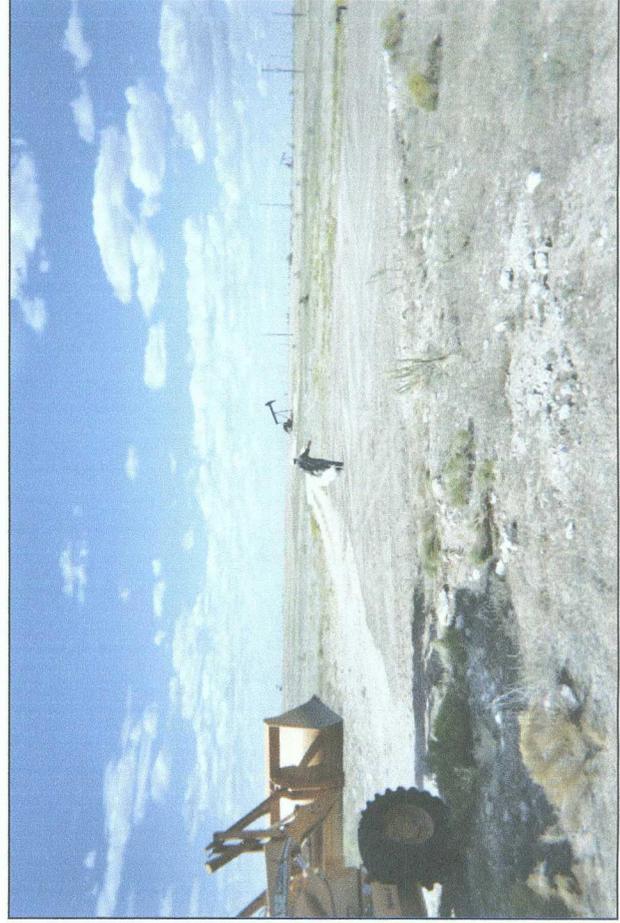
8/29/2007

seeding
