RICE OPERATING COMPANY
JUNCTION BOX DISCLOSURE* REPORT

SWD SYSTEM	JUNCTION	UNIT	SECTION	TOWNSHIP	RANGE	COUNTY	NEW BOX DIMENSIONS - FEET		
							Length	Width	Depth
Vacuum	jct. M-5	M	5	18S	35E	Lea	no box--System Abandonment

Vacuum jct. M-5

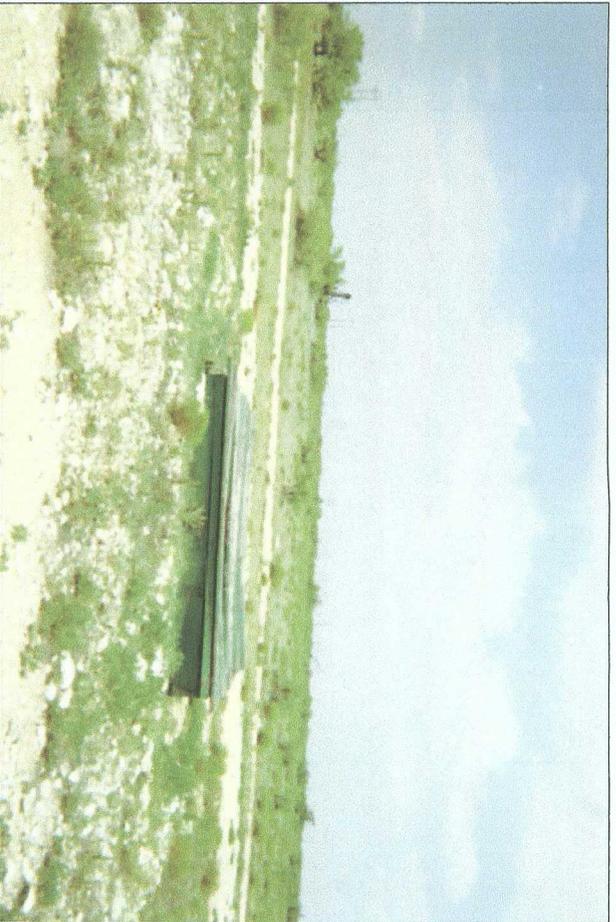
7/12/2005

undisturbed junction box

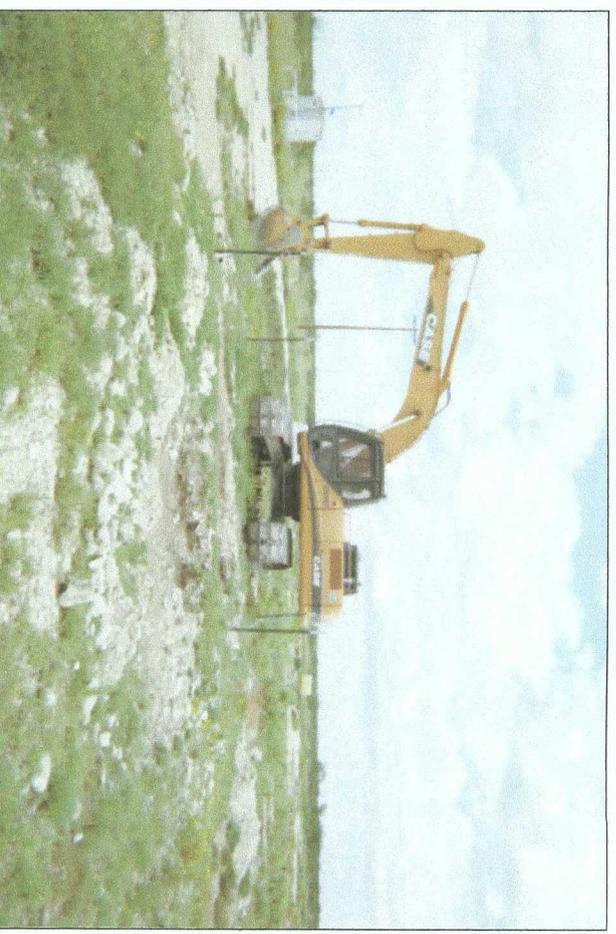
9/14/2005

preparing for initial trackhoe delineation trench

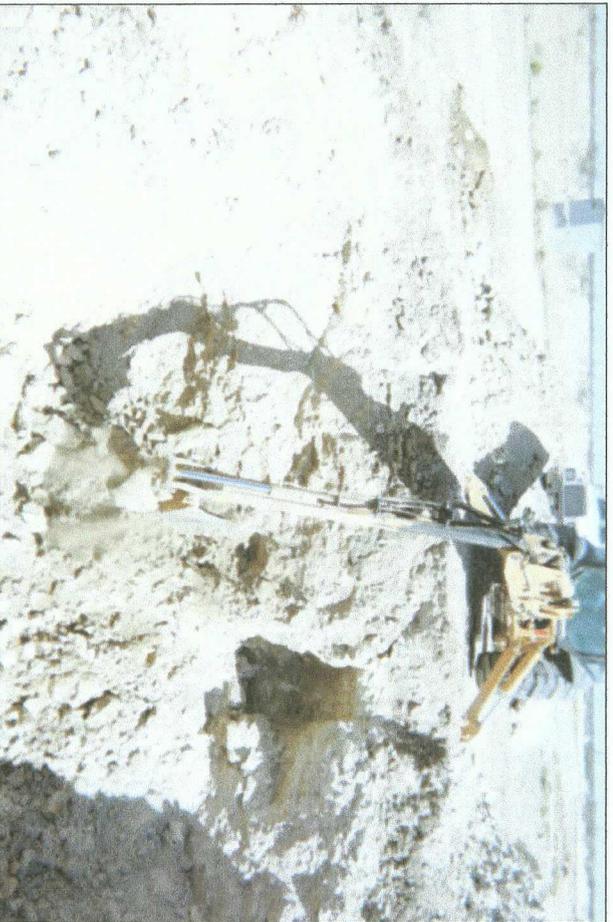
2/20/2007

delineation & excavation with backhoe

This junction box site was addressed as part of the Vacuum SWD System abandonment. After the box lumber was removed, the site was delineated by collecting soil samples at regular intervals using a backhoe to produce a 30 x 30 x 12-ft-deep excavation. Chloride field tests revealed concentrations that were generally consistent laterally and vertically. Organic vapors were tested in the field using a photo-ionization detector. Composite samples were collected for laboratory analysis to confirm field results; TPH concentrations meet OCD guidelines. The excavated soil was blended on site and backfilled into the hole to 6 ft BGS. At 6 ft, a clay barrier was installed to inhibit infiltration of remaining chloride. The remaining spoils were backfilled on top of the clay and contoured to the surrounding surface. The disturbed surface was seeded with a blend of native vegetation and is expected to return to productive capacity at a normal rate. An identification plate has been placed on the surface of the site to mark the presence of clay below and also the former junction box for future environmental considerations. OCD was notified of potential groundwater impact at this site on 8/15/2007.

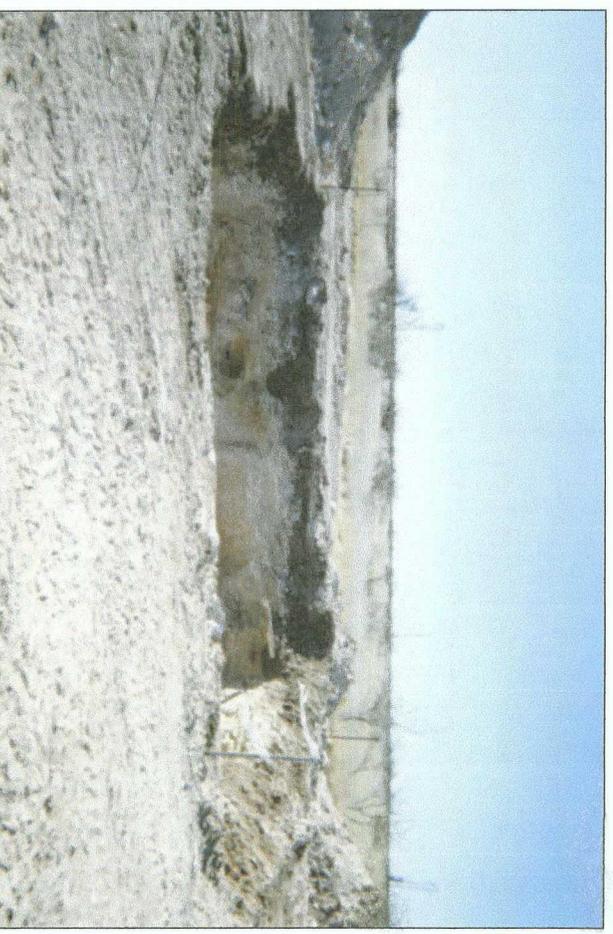
2/21/2007

final 30 x 30 x 12-ft-deep excavation

Soil Excavated 400 cubic yards Excavation Length 30 Width 30 Depth 12 feet

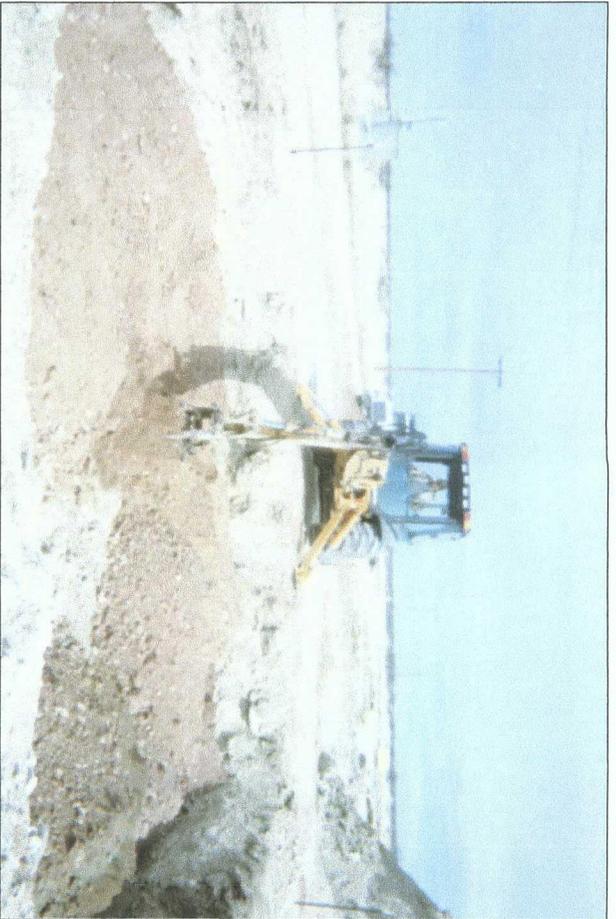
2/23/2007

installing clay barrier at 6 ft

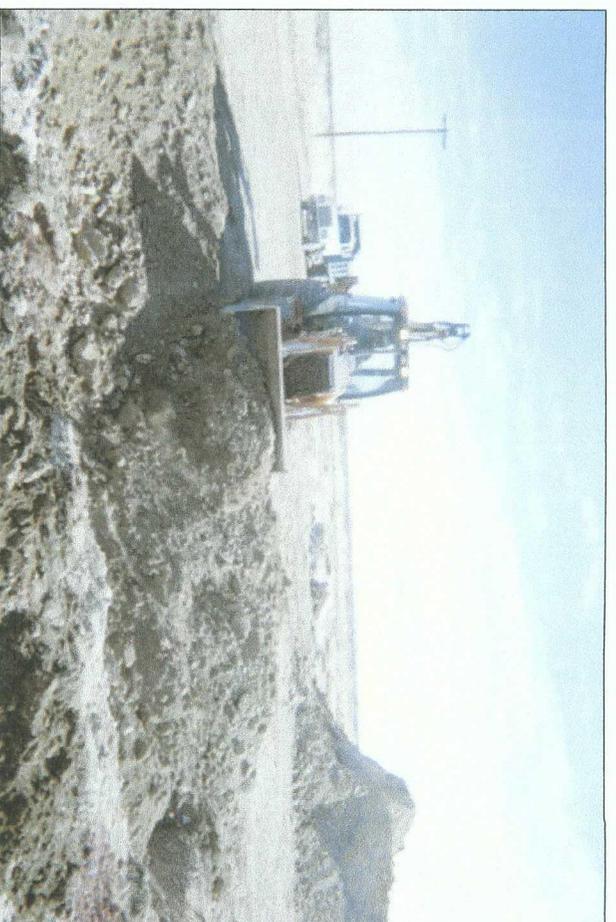
2/23/2007

backfilling excavation

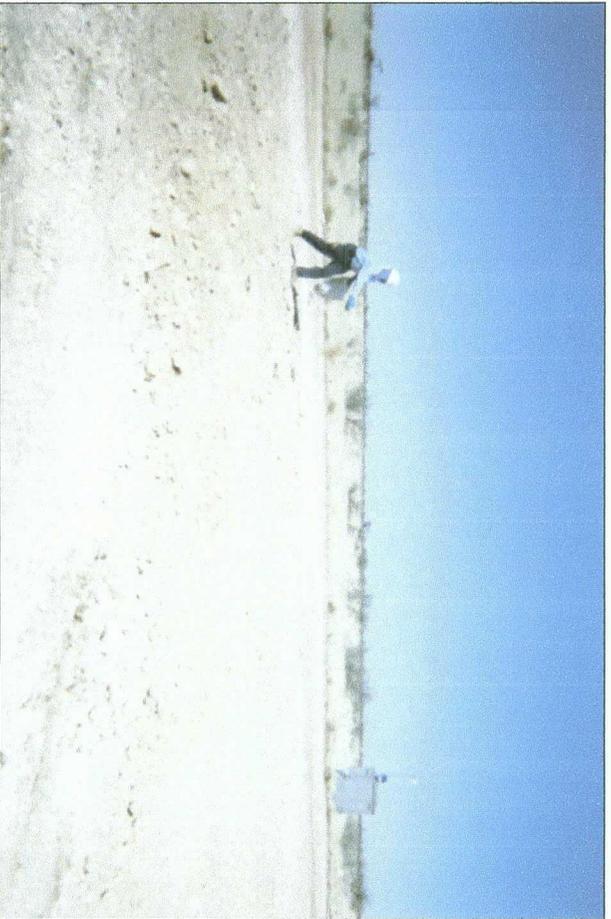
3/23/2007

seeding disturbed area of backfilled site

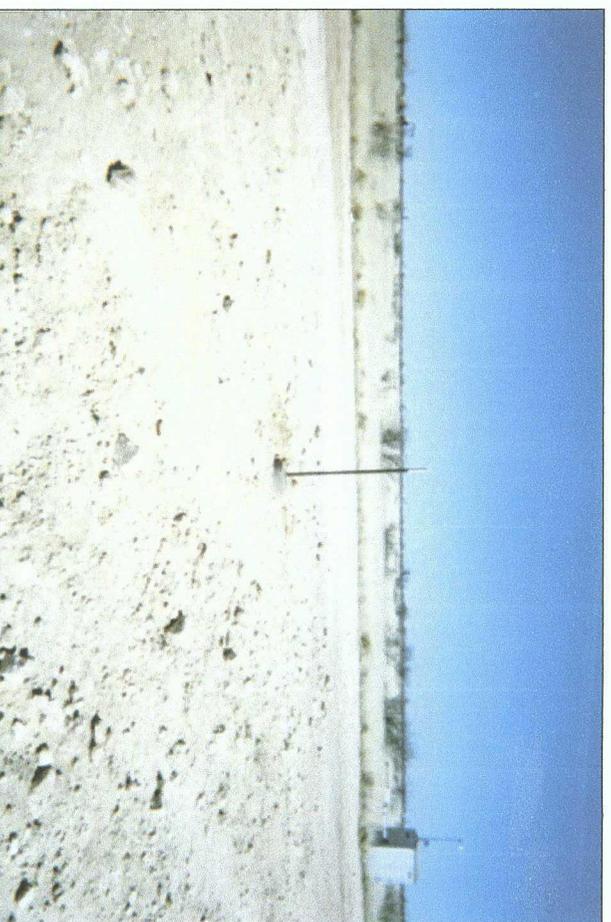
identification plate at backfilled site marking clay barrier below
and former junction box 3/26/2007

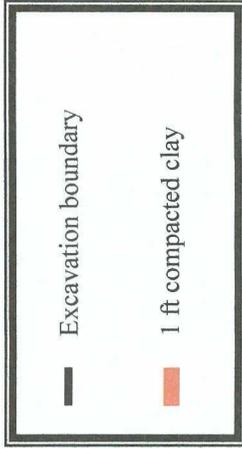
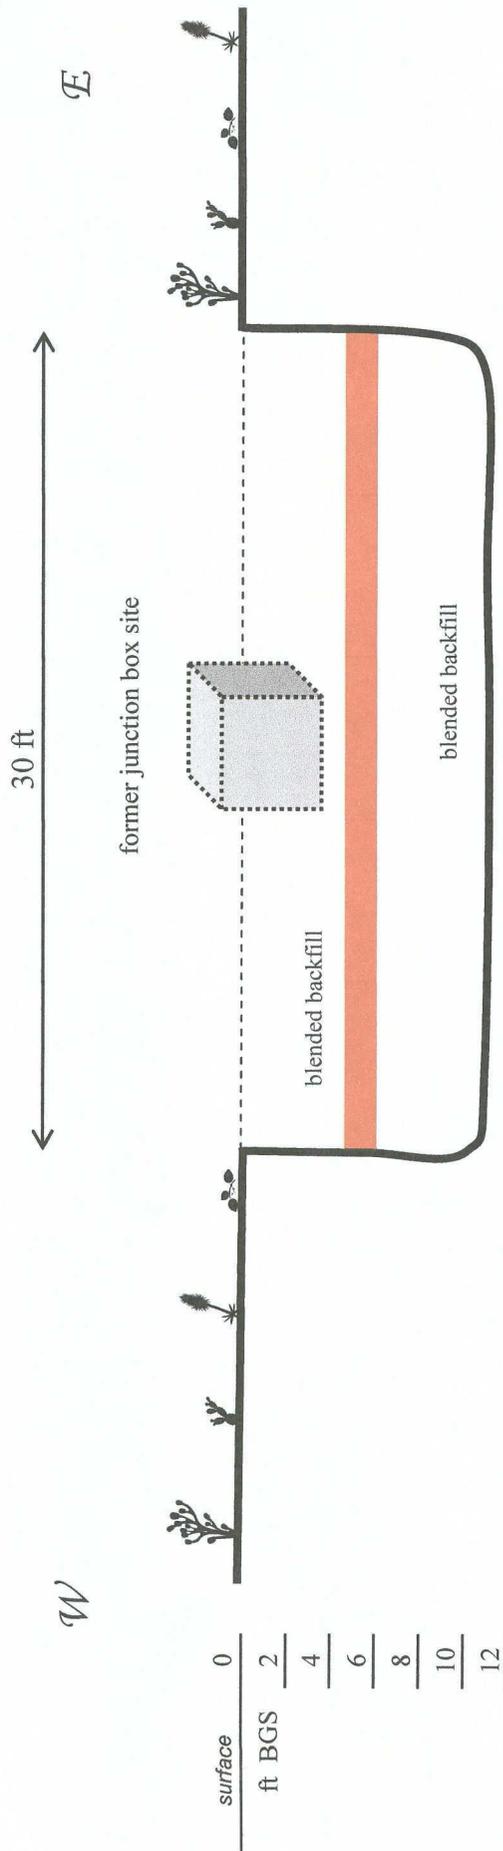
Excavation Cross-Section

30 x 30 x 12-ft-deep

surface	0
ft BGS	2
	4
	6
	8
	10
	12

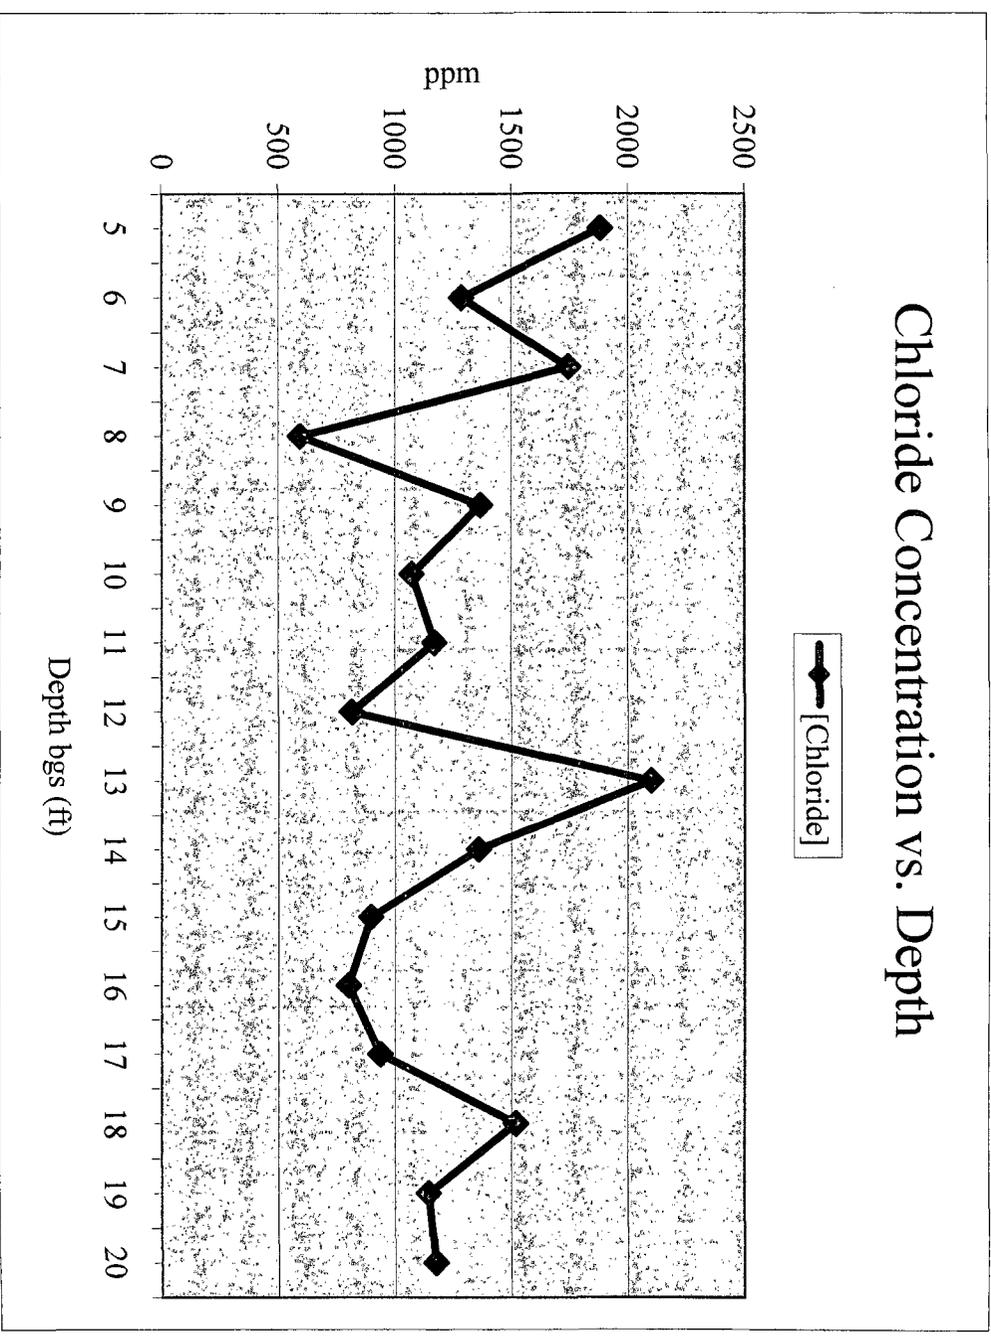
5 ft East of former junction

Depth bgs (ft)	[Cl] ppm
5	1882
6	1285
7	1745
8	594
9	1367
10	1072
11	1170
12	815
13	2099
14	1360
15	896
16	800
17	935
18	1519
19	1143
20	1175

Groundwater = 77 ft

LOCATION	DEPTH (ft)	ppm	
5 ft EAST of former junction box site	5	1882	
	6	1285	
	7	1745	
	8	594	
	9	1367	
	10	1072	
	11	1170	
	12	815	
	13	2099	
	14	1360	
	15	896	
	16	800	
	17	935	
	18	1519	
	19	1143	
	20	1175	
	4-wall comp.	n/a	921
	bottom comp.	12	1039
	backfill comp.	n/a	573
