RE: Groundwater Investigation Report  
Smith and Marrs SLJU  
Jal, New Mexico

Smith and Marrs, Inc.  
South Langlie Jal Unit  
Jal, New Mexico

**Groundwater Investigation**  
**Abatement**

Prepared by  
*Eddie Seay Consulting*  
December 2005

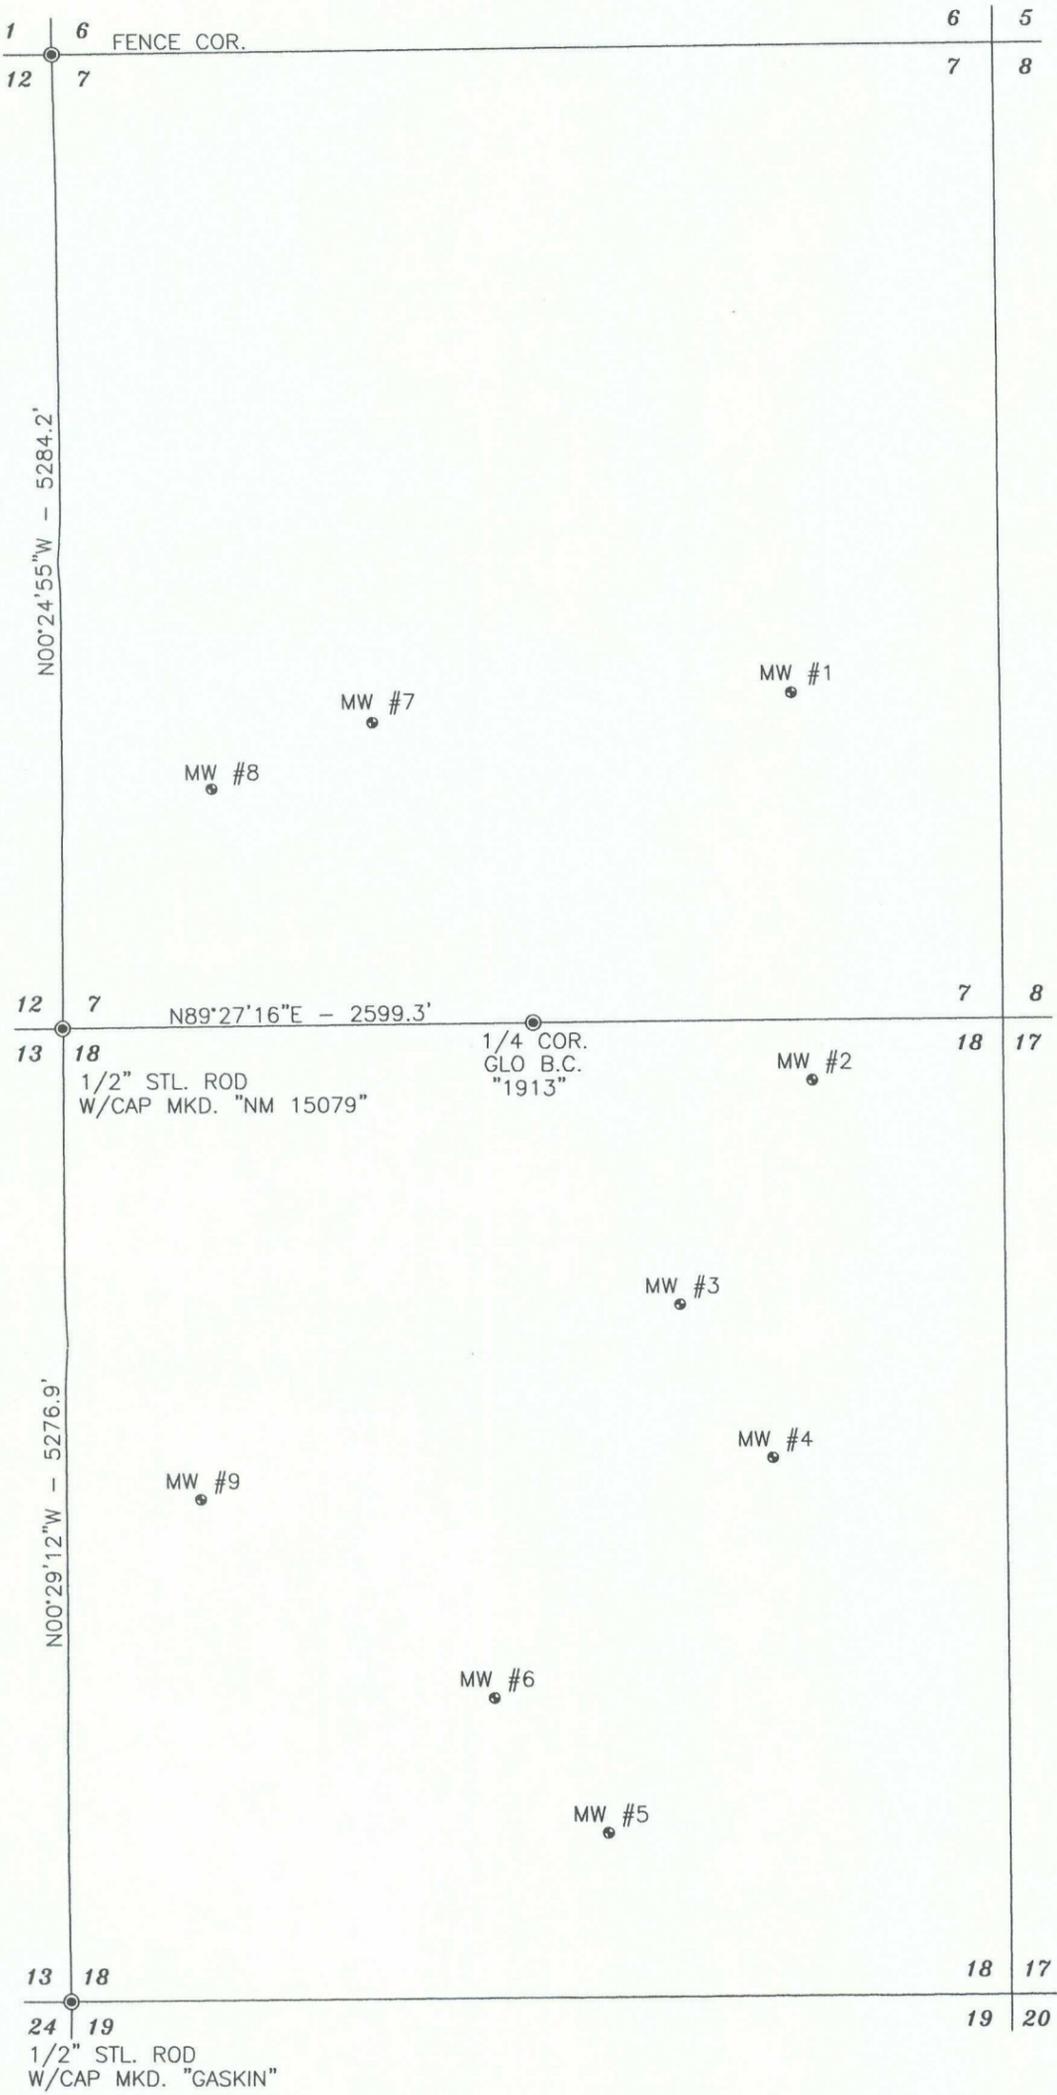
SURVEY TO LOCATE MONITOR WELLS IN  
SECTIONS 7 & 18, TOWNSHIP 25 SOUTH, RANGE 37 EAST,  
N.M.P.M., LEA COUNTY, NEW MEXICO

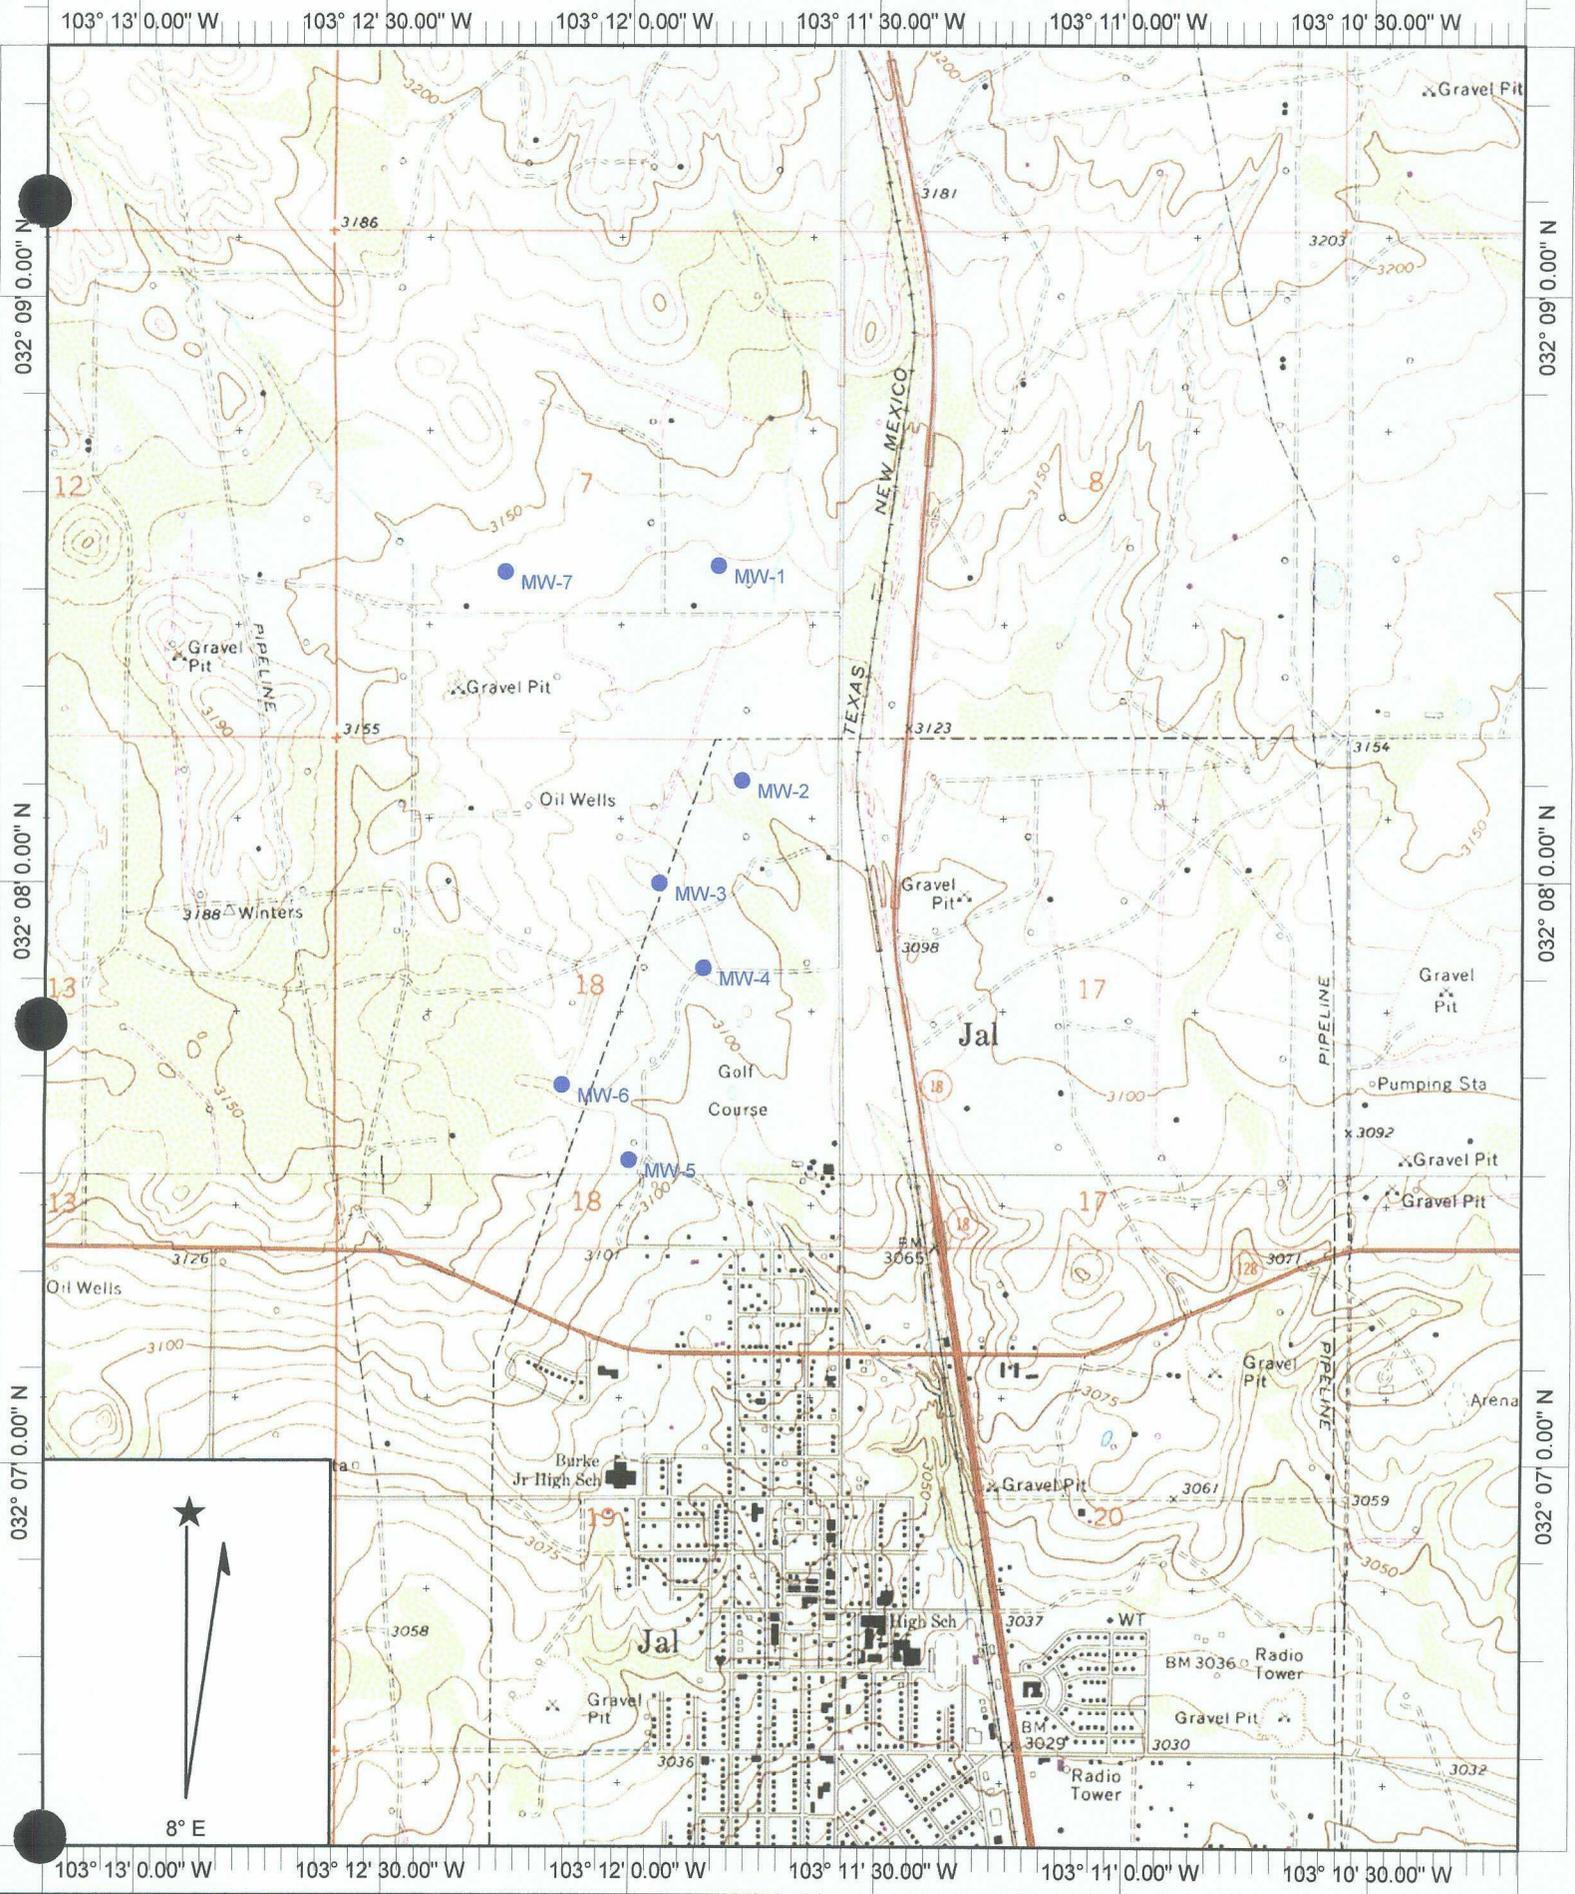
Location: 032° 07' 53.32" N 103° 11' 41.48" W  
 Caption: SLJU, Monitor Well Locations  
 Sections 7, 8, 17, 18 T25S,R37E  
 Lea County, New Mexico

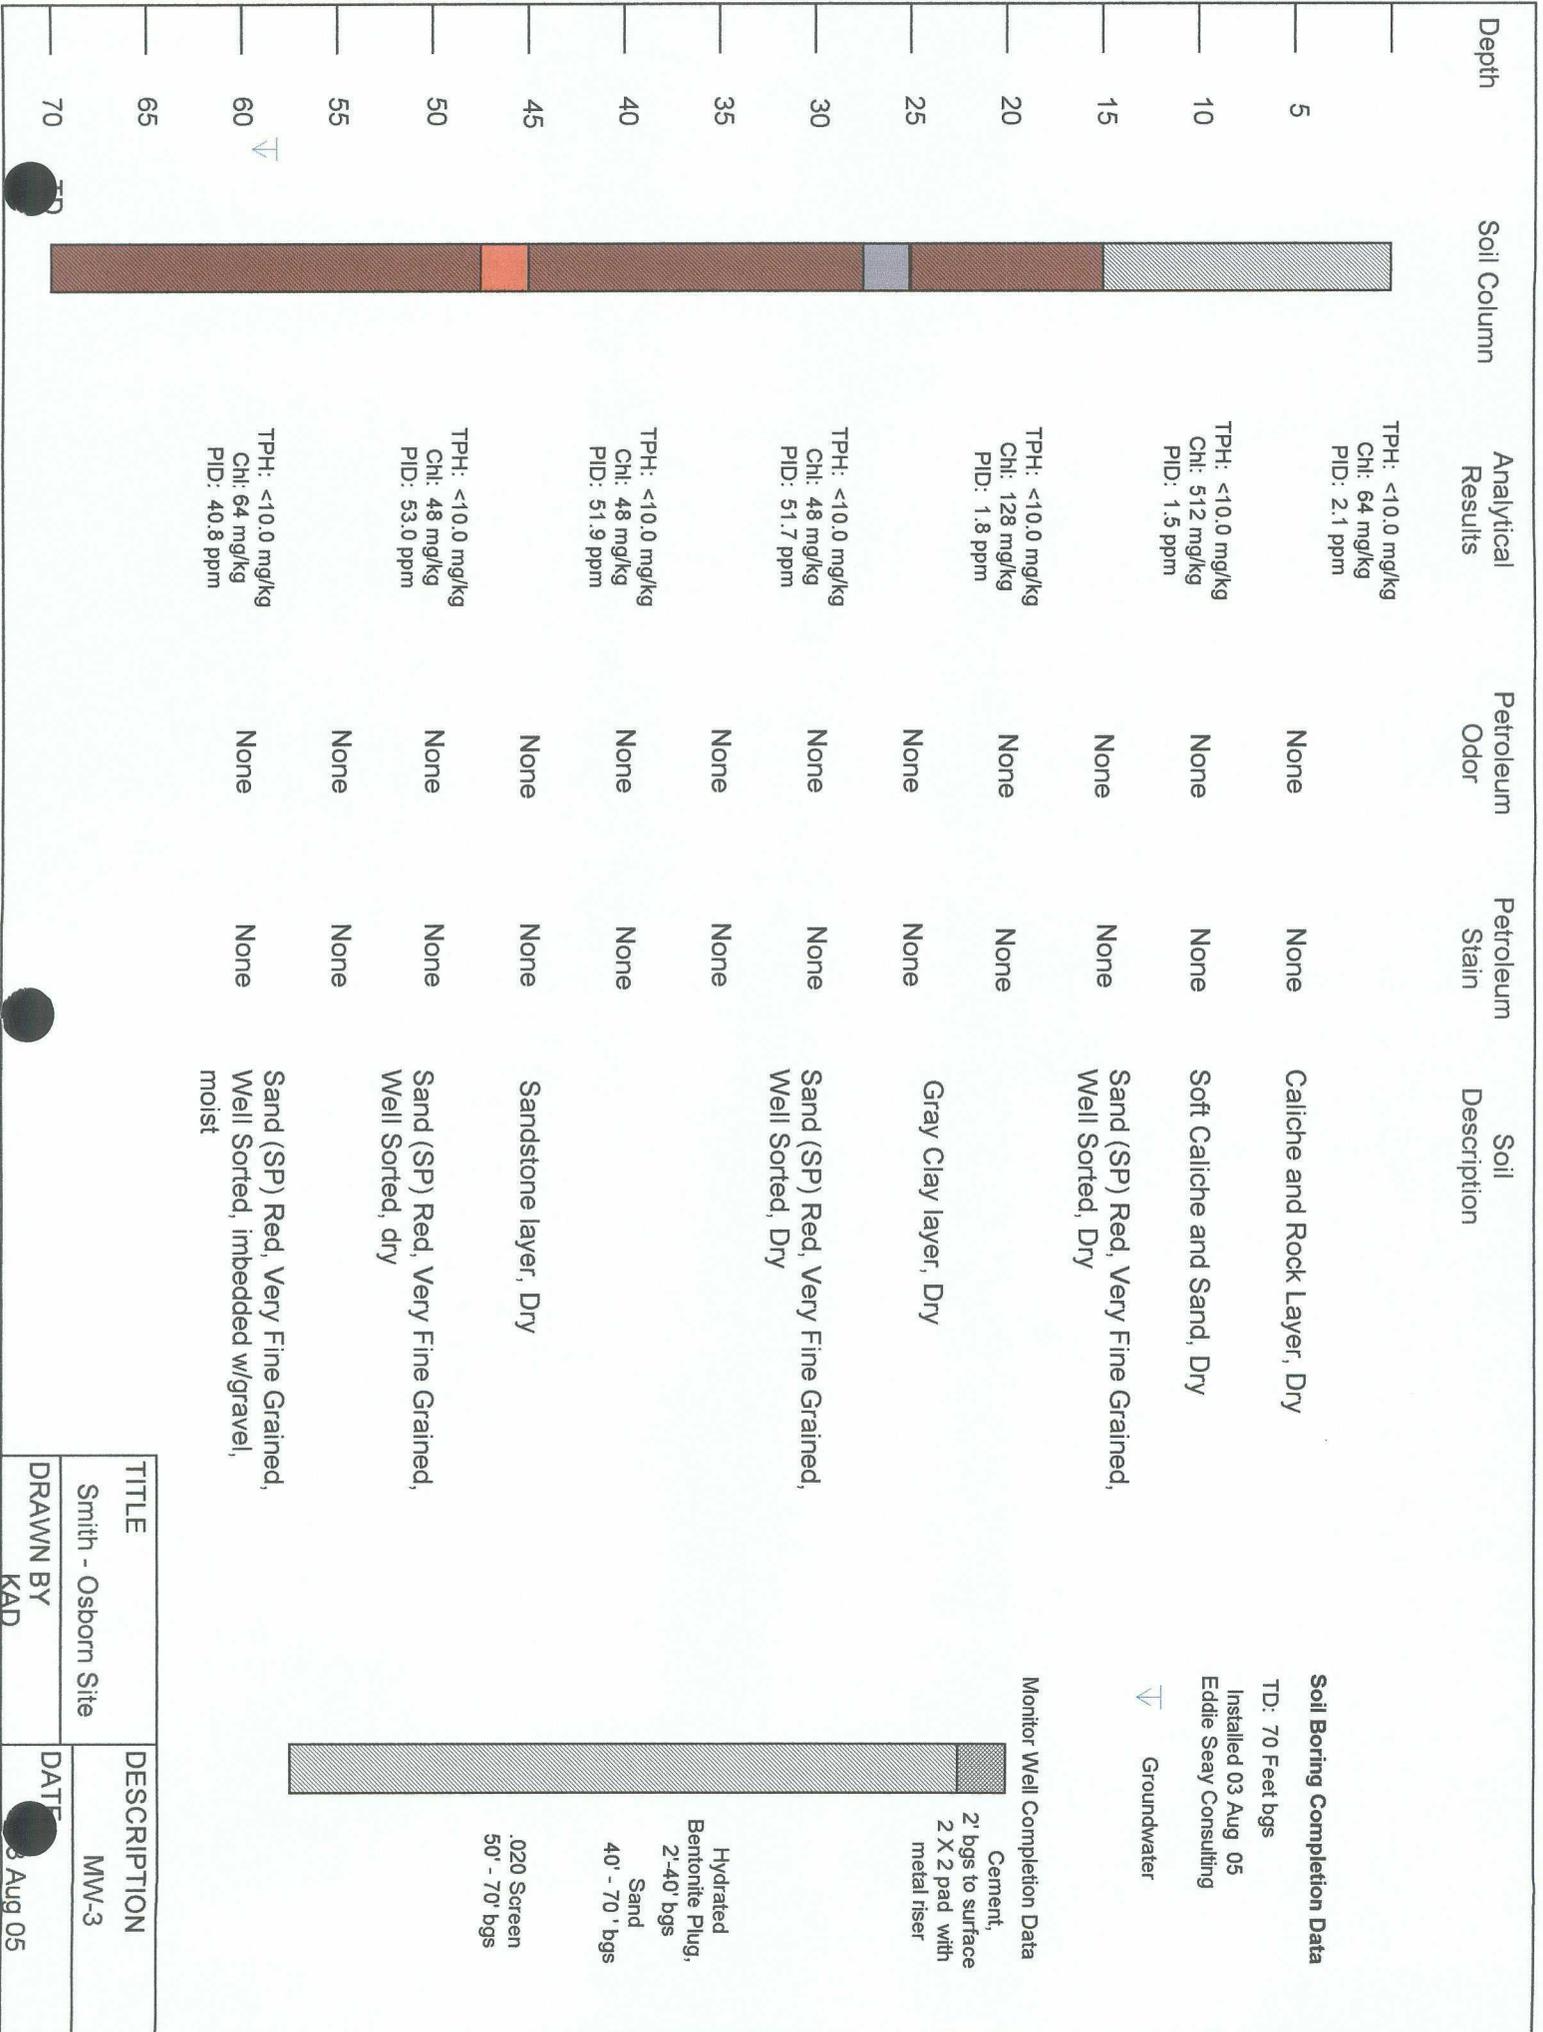
TITLE		DESCRIPTION	
Smith - Osborn Site		MW-3	
DRAWN BY	DATE		
KAD	8 Aug 05

Depth	Soil Column	Analytical Results	Petroleum Odor	Petroleum Stain	Soil Description
5		TPH: 17.4 mg/kg Chi: 64 mg/kg PID: 2.1 ppm	None	None	Sand (SP) Red, Very Fine Grained, Well Sorted, Dry
10		TPH: <10.0 mg/kg Chi: 64 mg/kg PID: 1.6 ppm	None	None	Soft Caliche and Sand, Dry
15		TPH: <10.0 mg/kg Chi: 368 mg/kg PID: 1.6 ppm	None	None	Sand (SP) Red, Very Fine Grained, Well Sorted, Dry
25		TPH: <10.0 mg/kg Chi: 160 mg/kg PID: 1.2 ppm	None	None	Soft Caliche and Sand, Dry
30		TPH: <10.0 mg/kg Chi: 48 mg/kg PID: 1.5 ppm	None	None	Sand (SP) Red, Very Fine Grained, Well Sorted, Dry
35			None	None	
40			None	None	
45			None	None	Sandstone layer, Dry
50		TPH: <10.0 mg/kg Chi: 64 mg/kg PID: 0.7 ppm	None	None	Sand (SP) Red, Very Fine Grained, Well Sorted, dry
55		TPH: <10.0 mg/kg Chi: 96 mg/kg PID: 0.6 ppm	None	None	Sand (SP) Red, Very Fine Grained, Well Sorted, imbedded w/gravel, moist
60			None	None	
65					
70

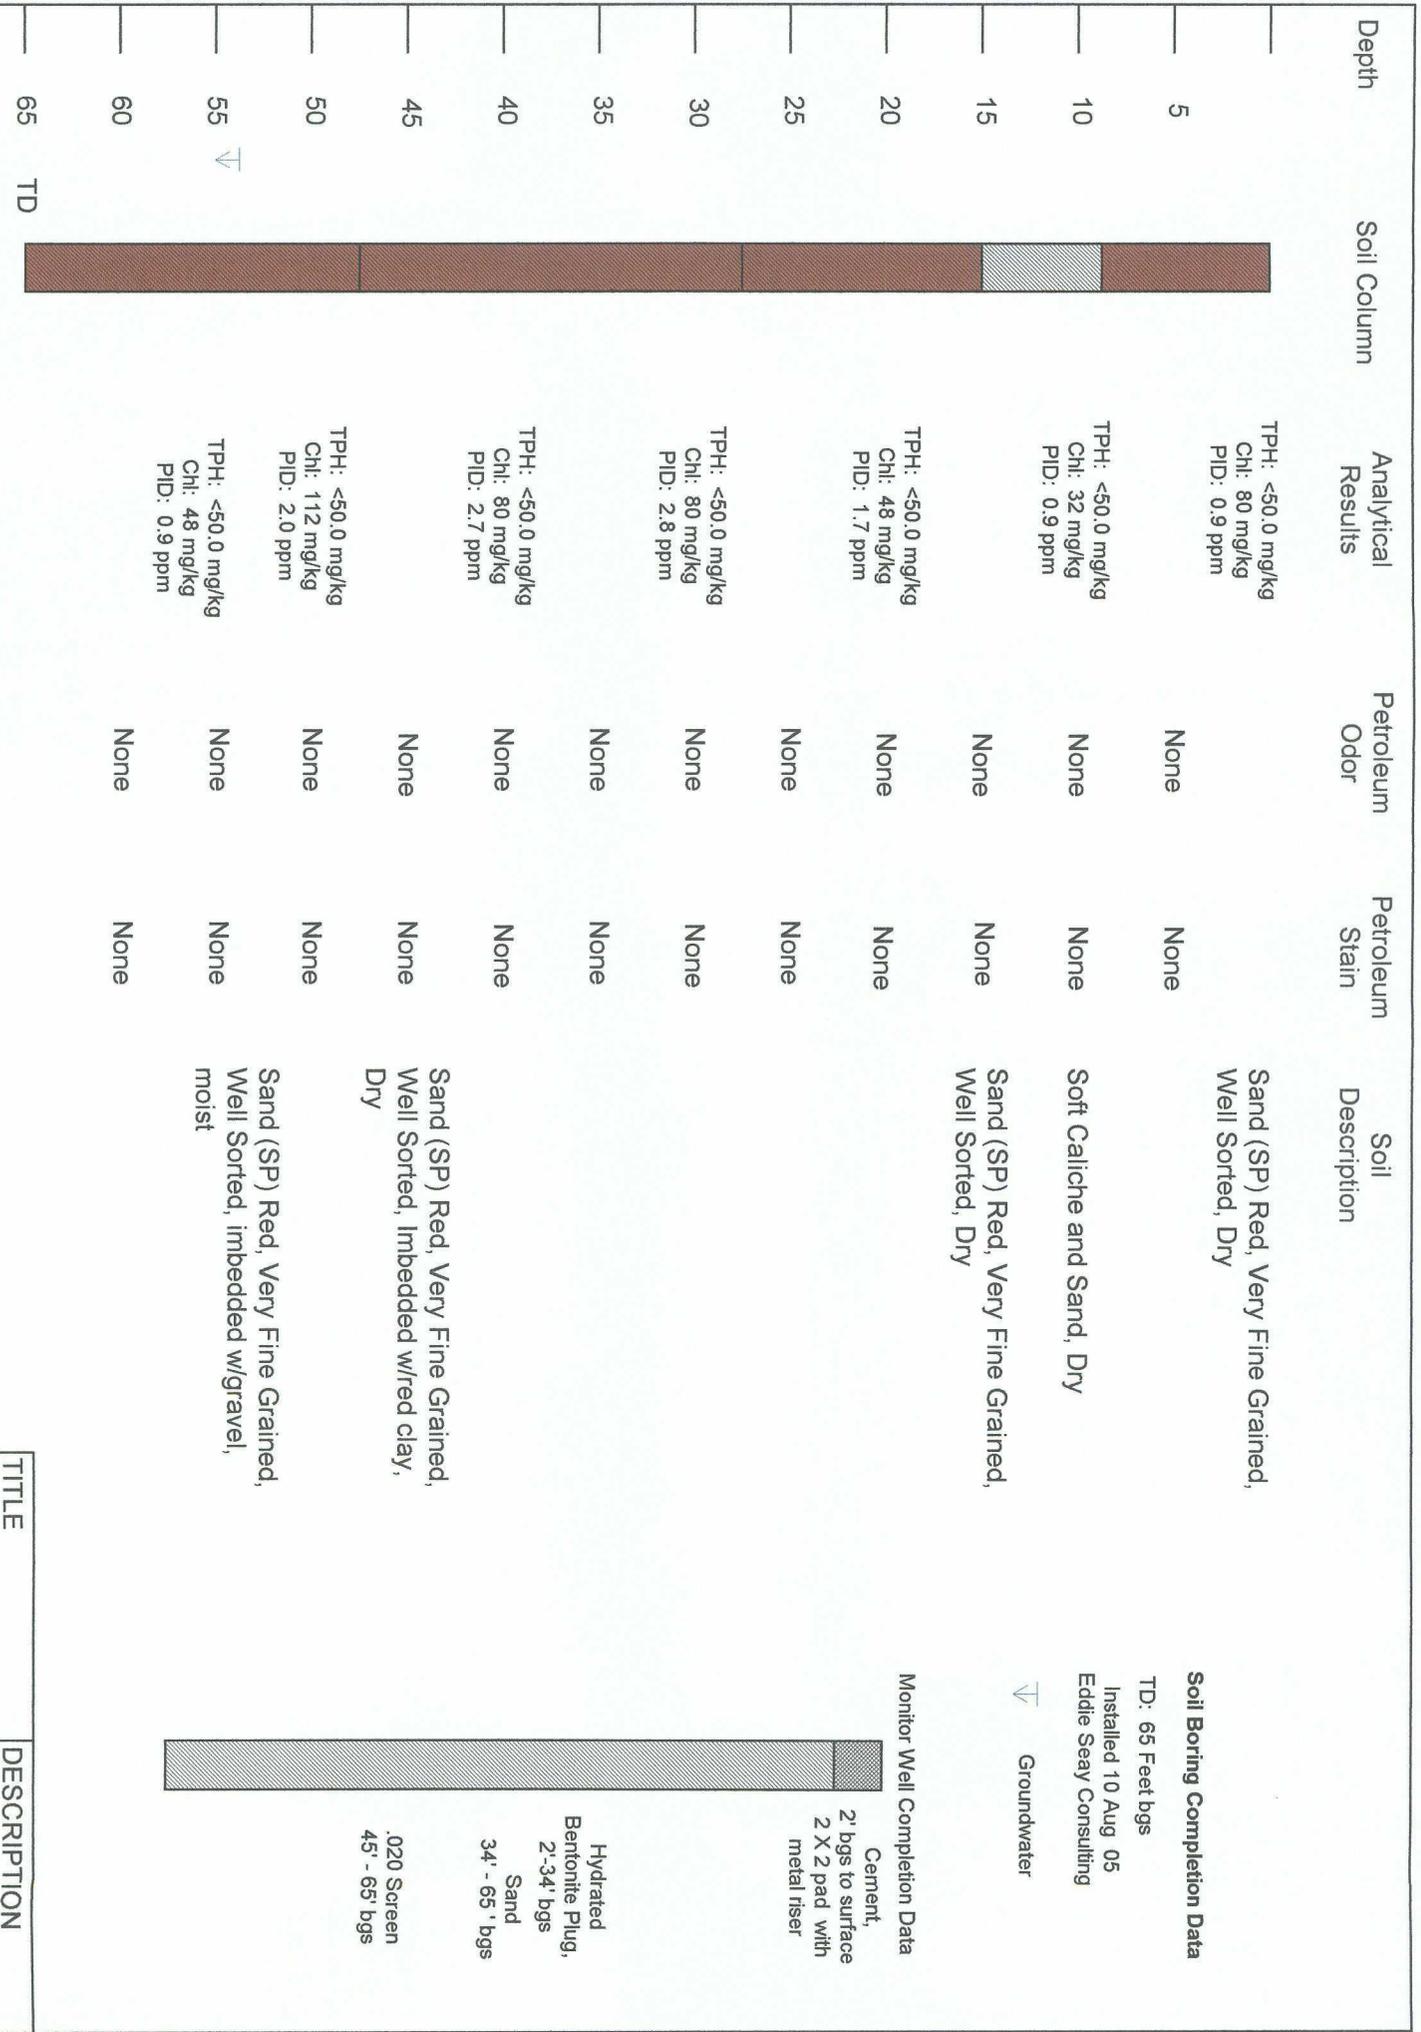
**Soil Boring Completion Data**

TD: 65 Feet bgs  
 Installed 10 Aug 05  
 Eddie Seay Consulting

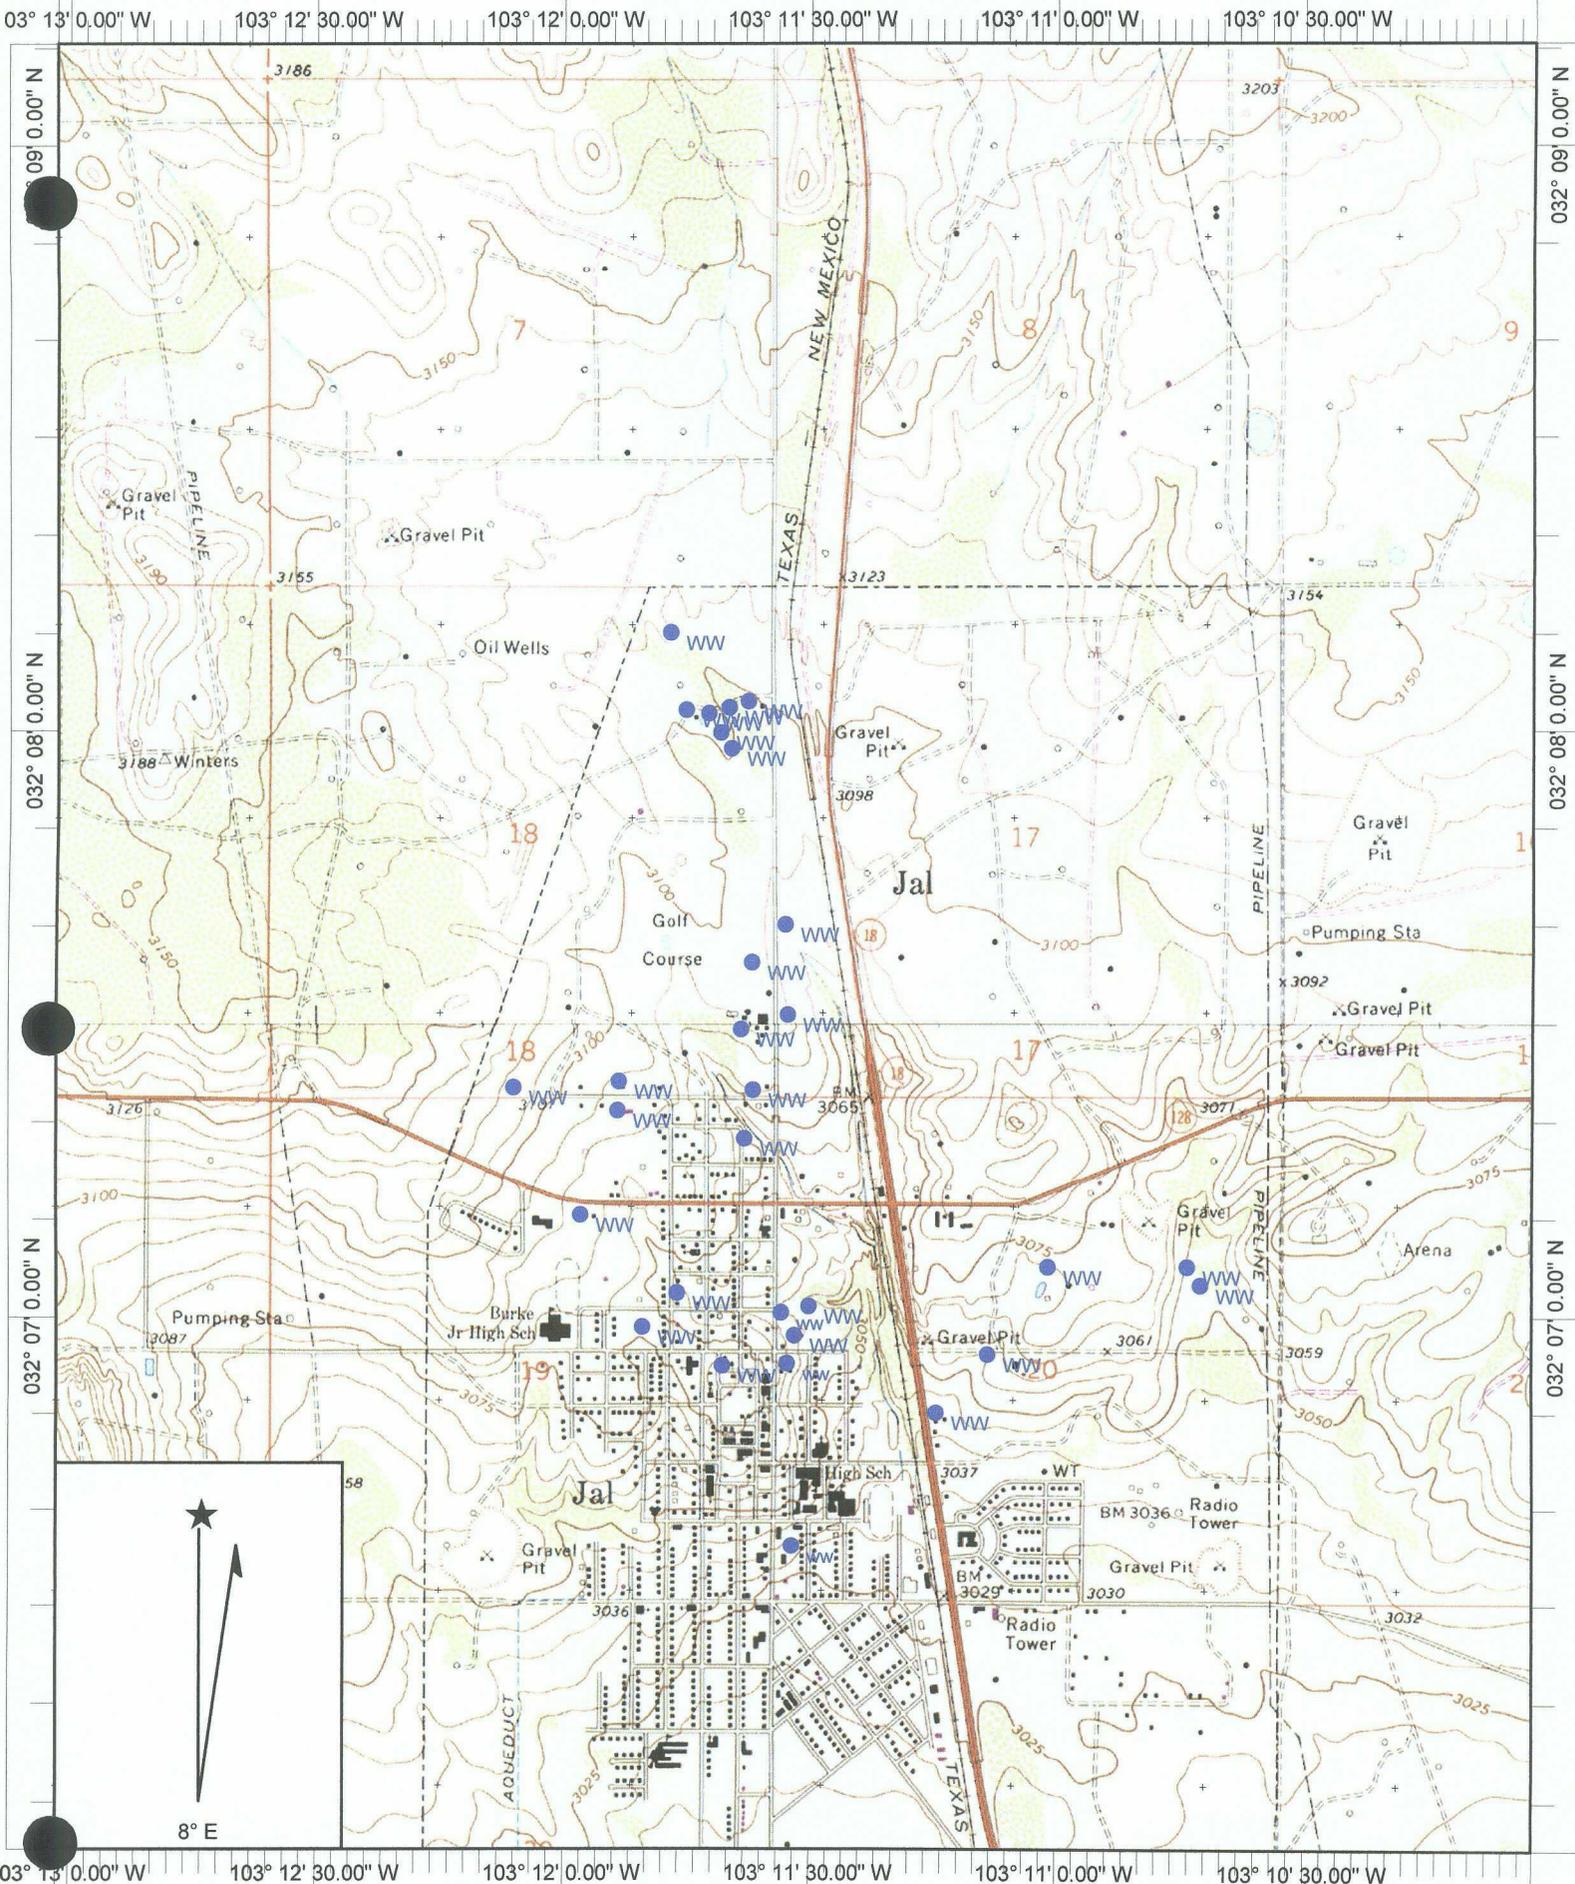
Location: 032° 07' 37.85" N 103° 11' 31.97" W  
 Caption: Jal, New Mexico  
 Water Well Locations  
 NM State Engineers Database

As part of the investigation requirements, a listing of all water wells within 1 mile of the SLJU was conducted. A review of the State Engineers list of known water wells is included in Appendix 6, State Engineer Data. The list includes wells that have been drilled over the past several years, but does not give exact location or, if wells are in operation or plugged. Many of the wells were found, but were not in operation. We sampled the wells that were available and operational. (See Appendix 8, Photos, Appendix 6, Analysis, and Appendix 6, Location Map) Along with this information is a report and sample results from the New Mexico Environmental Department, which sampled the Osborn wells per the landowners request in 2001. (Appendix 6, Additional Research )
