BD F-23 Vent

**RICE OPERATING COMPANY
JUNCTION BOX FINAL REPORT**

Unit F, Section 23, T21S, R37E

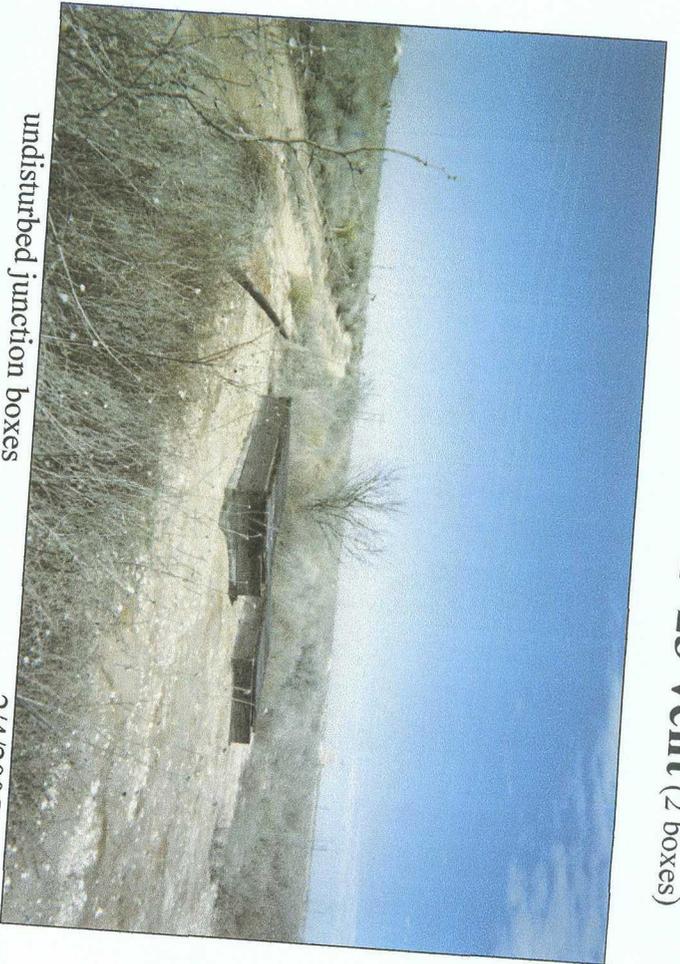
2/4/2005

undisturbed junction boxes

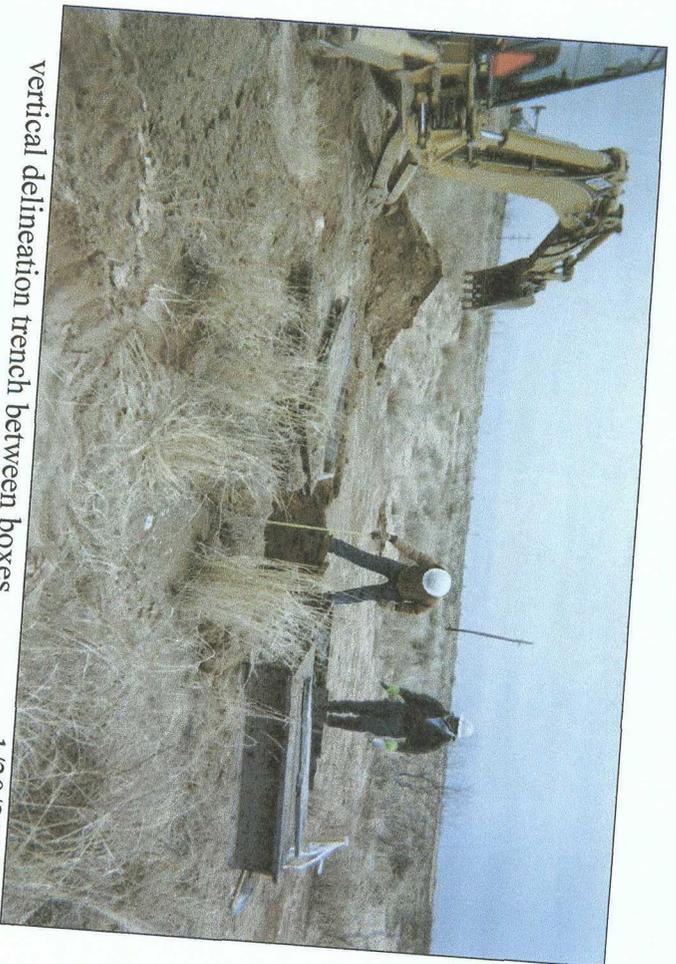
1/30/2007

vertical delineation trench between boxes

boxes that were eliminated as part of the pipeline replacement/upgrade program. After the boxes were removed, the site was delineated using a backhoe to collect soil samples at regular intervals to produce a 25 x 25 x 12-ft-deep excavation. Chloride field tests were performed on each sample and concentrations were generally low and exhibited a trend of decline with depth. Organic vapors were also measured using a PID and yielded low concentrations as well. Representative composite samples were collected for laboratory confirmation. The excavated soil was blended on site and returned to the excavation. The remaining excavation was backfilled with clean, imported soil. On 3/1/2007, the disturbed area was seeded with a blend of native vegetation and is expected to return to productive capacity at a normal rate. Remaining TPH concentrations will naturally attenuate and are not threatening to groundwater.

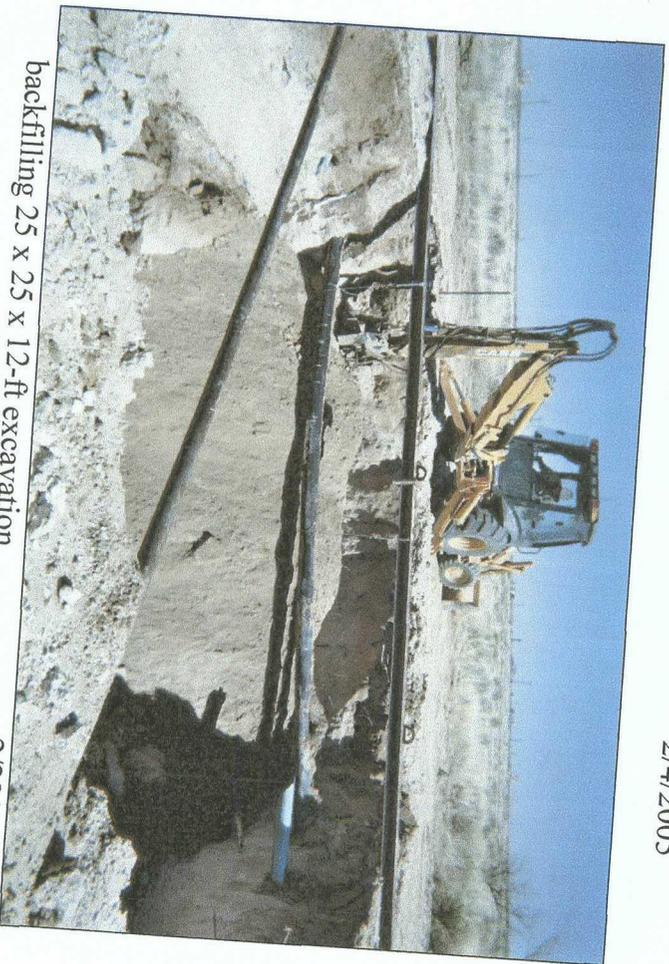
2/28/2007

backfilling 25 x 25 x 12-ft excavation

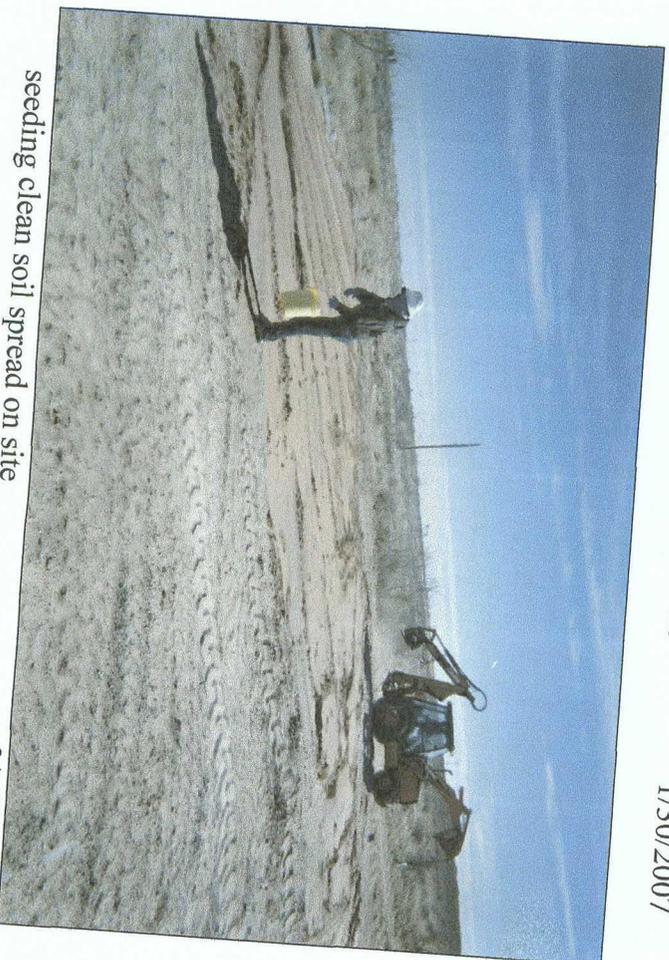
3/1/2007

seeding clean soil spread on site

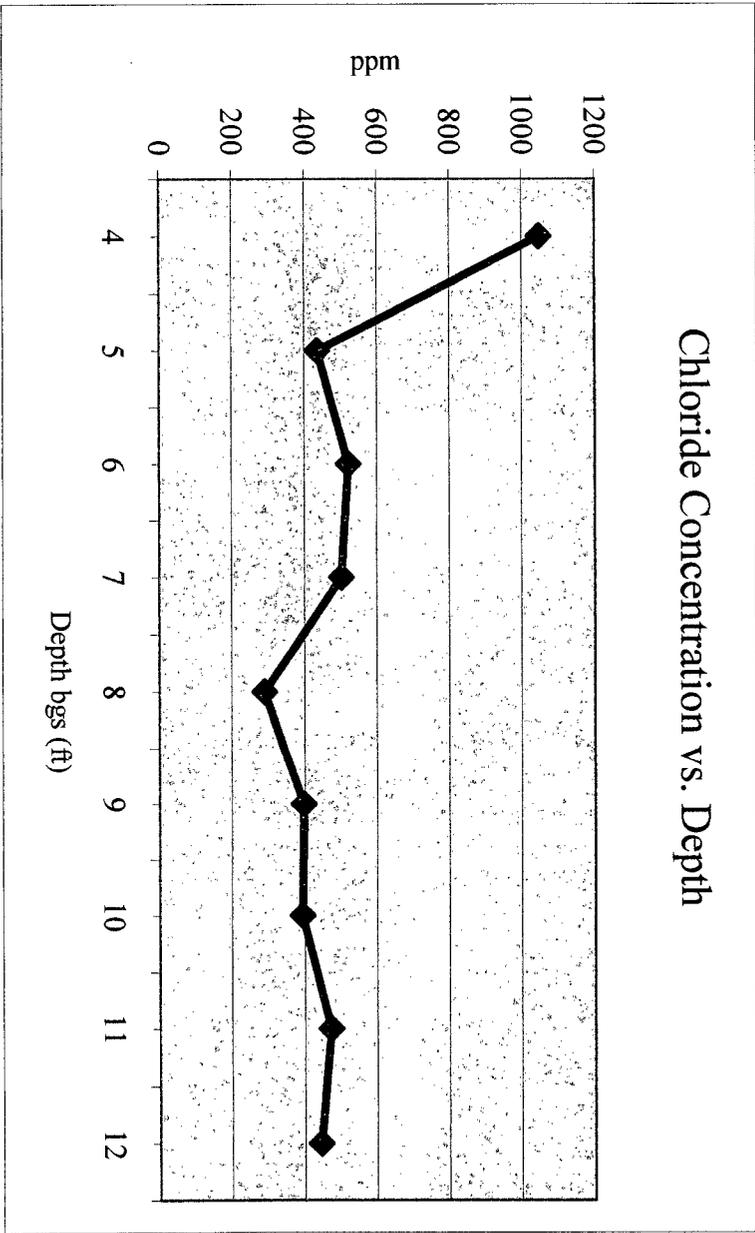
BD F-23 vent (2 boxes)

15 ft WEST of former junction

Depth bgs (ft)	[Cl ⁻] ppm
4	1047
5	436
6	521
7	502
8	290
9	397
10	394
11	472
12	445

Groundwater = 50 ft
