**RICE OPERATING COMPANY  
JUNCTION BOX FINAL REPORT**

SWD SYSTEM	JUNCTION	UNIT	SECTION	TOWNSHIP	RANGE	COUNTY	NEW BOX DIMENSIONS - FEET		
							Length	Width	Depth
Blinebry-Drinkard (BD)	jct. J-4-1	J	4	22S	37E	Lea	moved 30 ft West

# BD jct. J-4-1

Unit J, Section 4, T22S, R37E

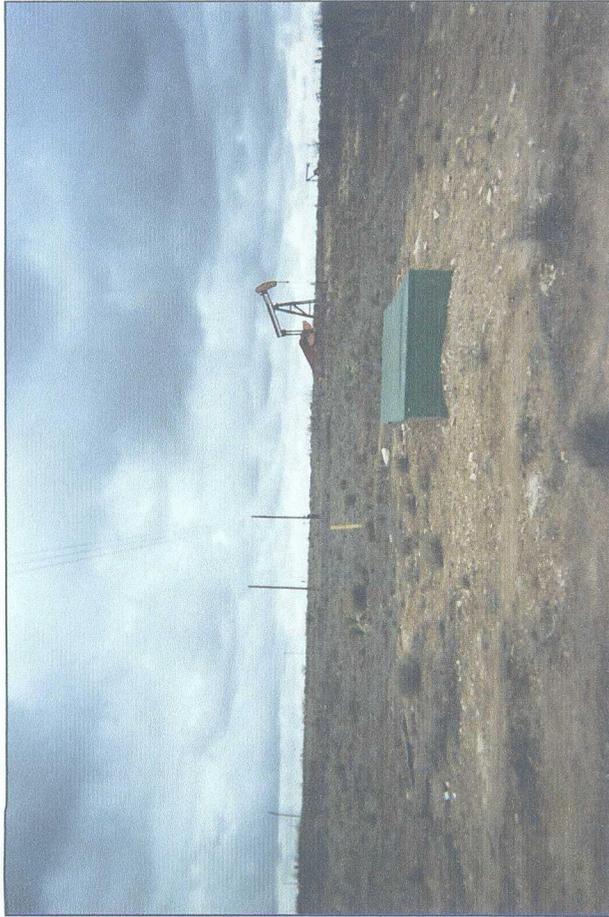
2/23/2004

undisturbed junction box (facing North)

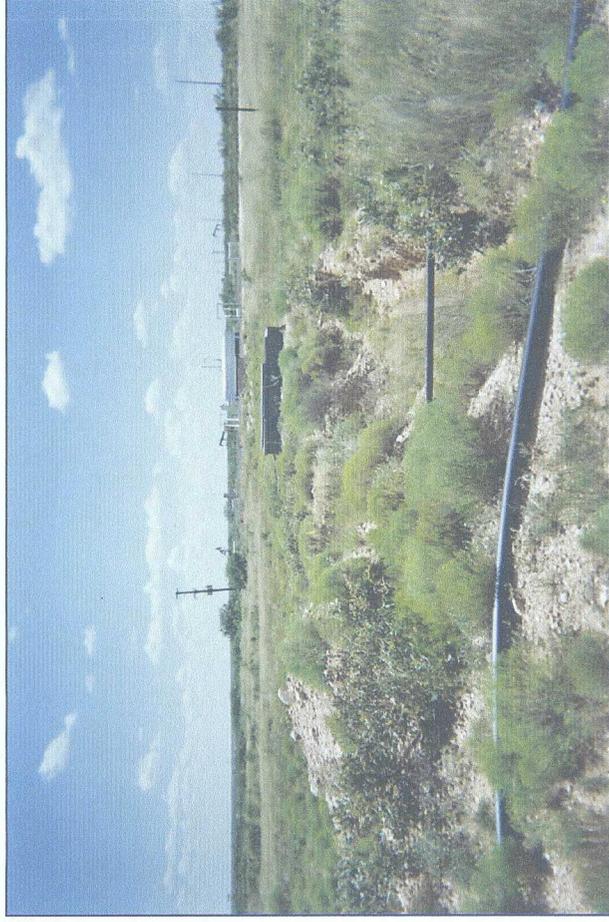
7/23/2007

former junction site in foreground (facing West)

This junction was moved 30 ft west where a new, watertight box was built as part of the pipeline replacement/upgrade program. After the box lumber was removed from the former site, the site was inspected and the surrounding soils did not exhibit any signs of adverse impact from the junction. Soil samples were collected using a hand auger and chloride field tests were conducted on them. All samples yielded low chloride concentrations similar to that of the background sample. Organic vapors were also measured which resulted in very low concentrations as well. The deepest sample (6 ft bgs) collected below the junction was analyzed at a commercial laboratory for confirmation of field tests. Results indicate that neither TPH nor chloride were present within the laboratory's detection limit. The hole from the former junction box was backfilled with clean, imported soil and contoured to the surrounding surface. The surface was seeded with a blend of native vegetation on 9/21/2007 and is expected to return to productive capacity at a normal rate.

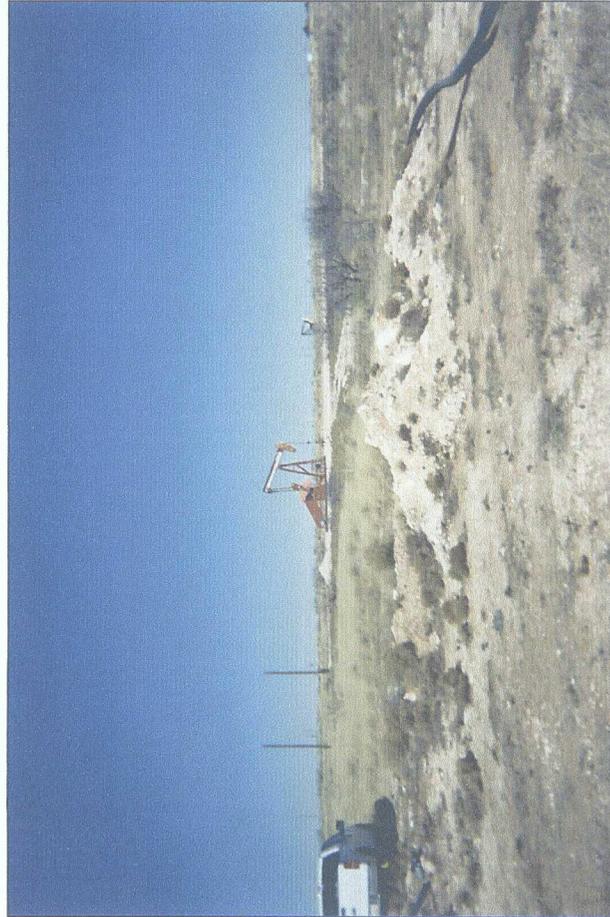
1/30/2006

junction box removed (facing North)

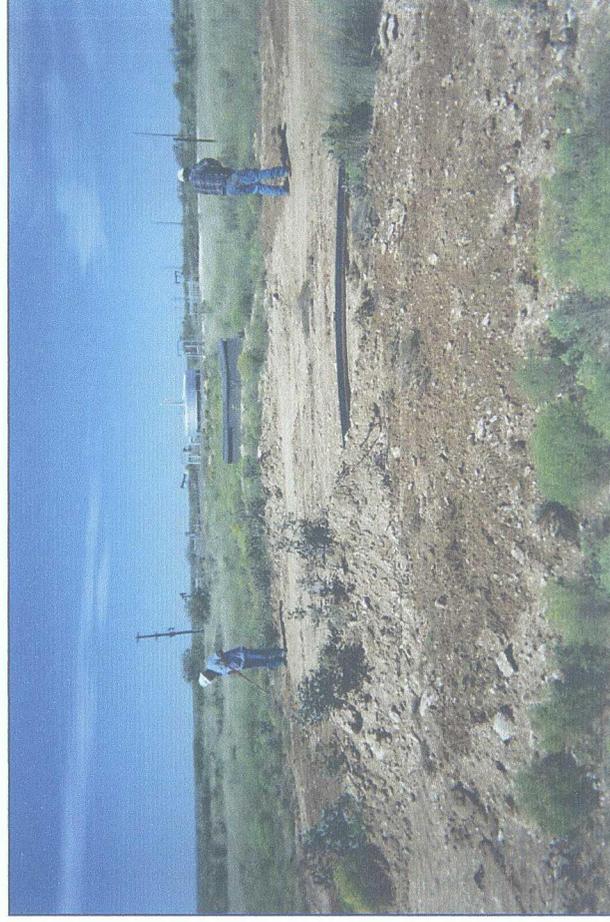
9/21/2007

seeding backfill; new junction 30 ft West in background
