CLOSURE

**RICE OPERATING COMPANY
JUNCTION BOX FINAL REPORT**

BD jct. K-18-2

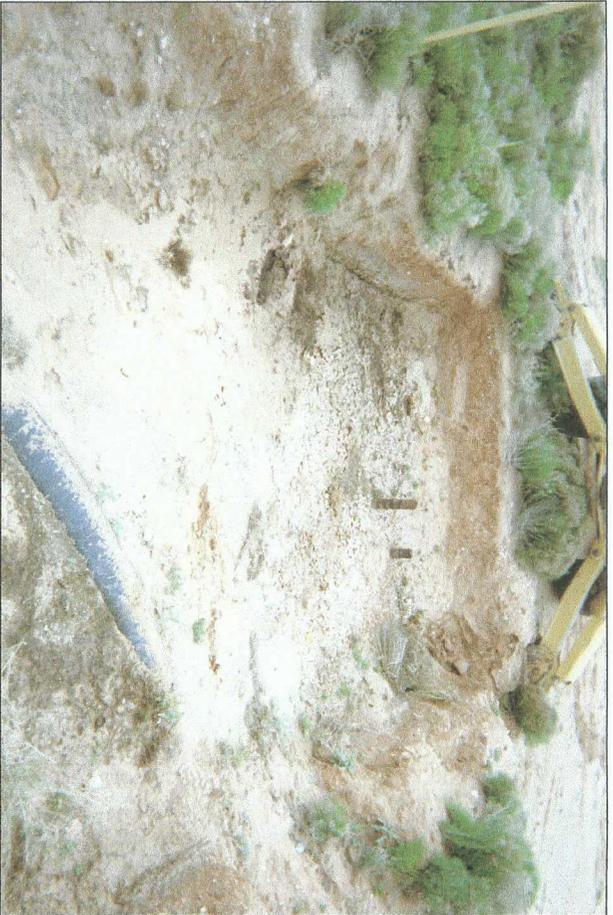
former junction box site prior to backhoe delineation 4/4/2007

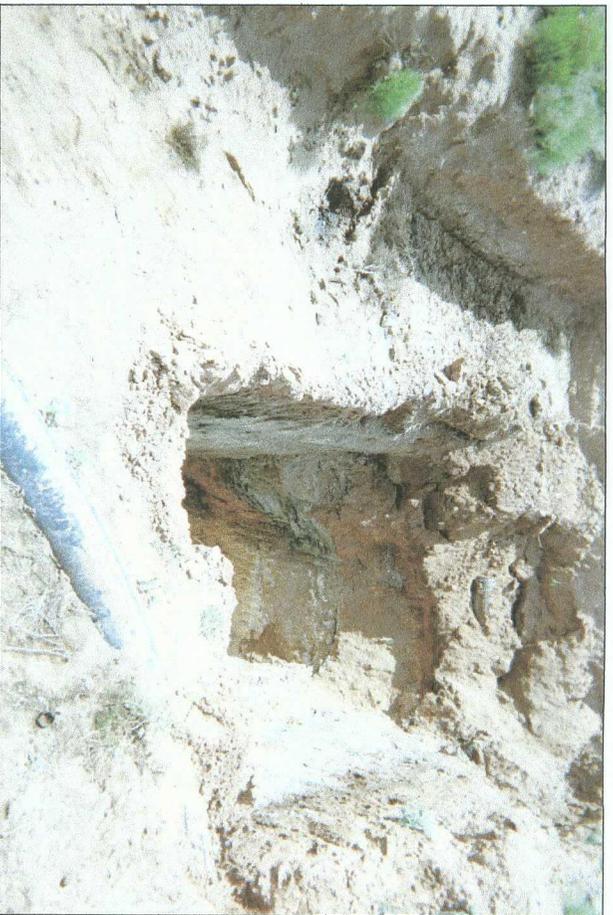
delineation trench at former junction box site 4/5/2007

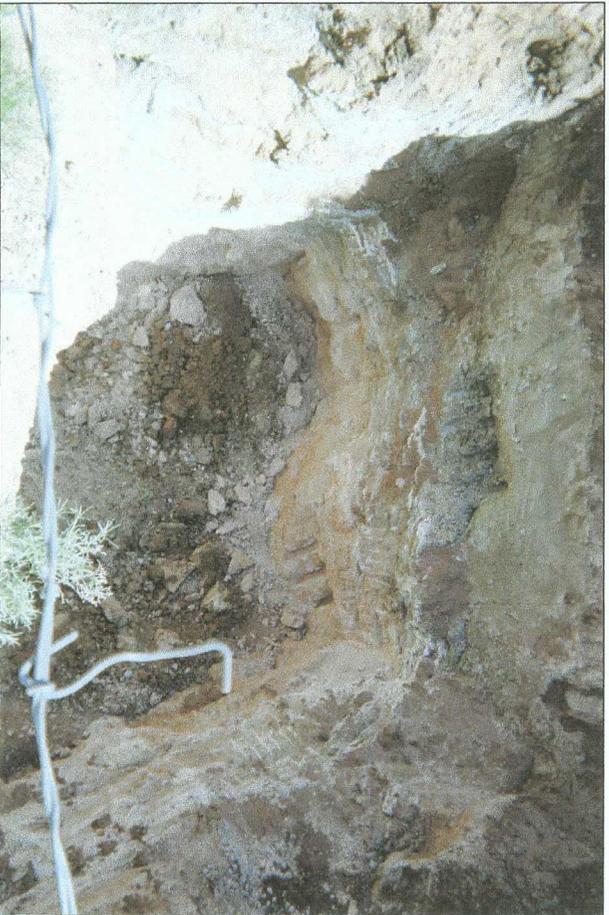
final 10 x 10 x 12-ft-deep excavation 4/12/2007

This junction was eliminated with the pipeline replacement/upgrade program. After the pipeline was replaced and the box lumber removed, soil samples were collected at regular intervals using a backhoe to produce a 10 x 10 x 12-ft-deep hole. Chloride field tests were conducted on each sample and yielded low concentrations throughout. Organic vapors were also measured in the field using a PID and also yielded low concentrations. Composite samples were collected for laboratory analysis and confirmed the field readings. The excavated soil was blended on site and returned to the excavation. Additional fill was needed so 24 cubic yards of clean, imported topsoil was added to complete the backfill and contour the site to the surrounding surface. The disturbed surface was seeded with a blend of native vegetation and is expected to return to productive capacity at a normal rate.

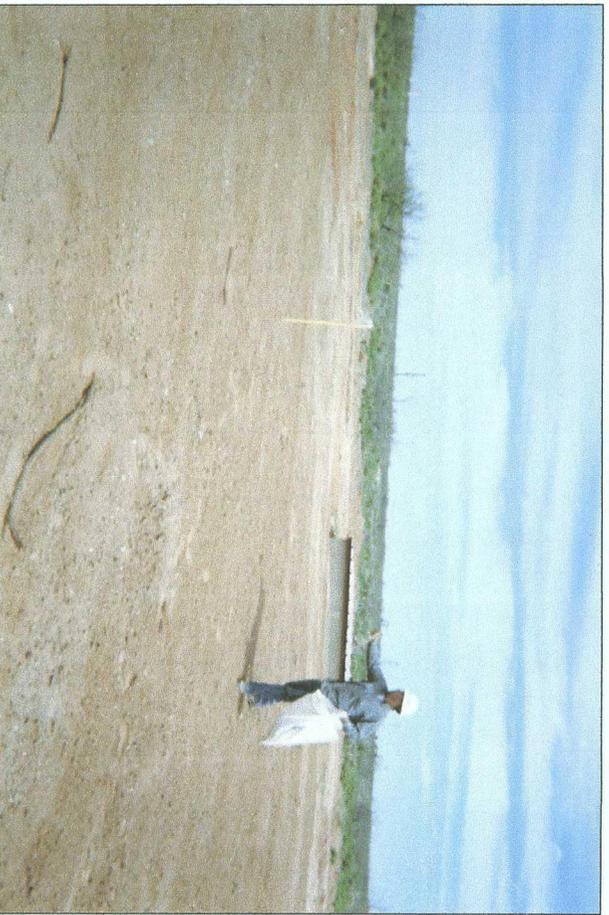
seeding surface of backfilled site (former jct. marked by flagged stake) 4/26/2007
