CLOSURE

**RICE OPERATING COMPANY  
JUNCTION BOX FINAL REPORT**

# BD jct. L-30-3

Unit L, Section 30, T21S, R37E

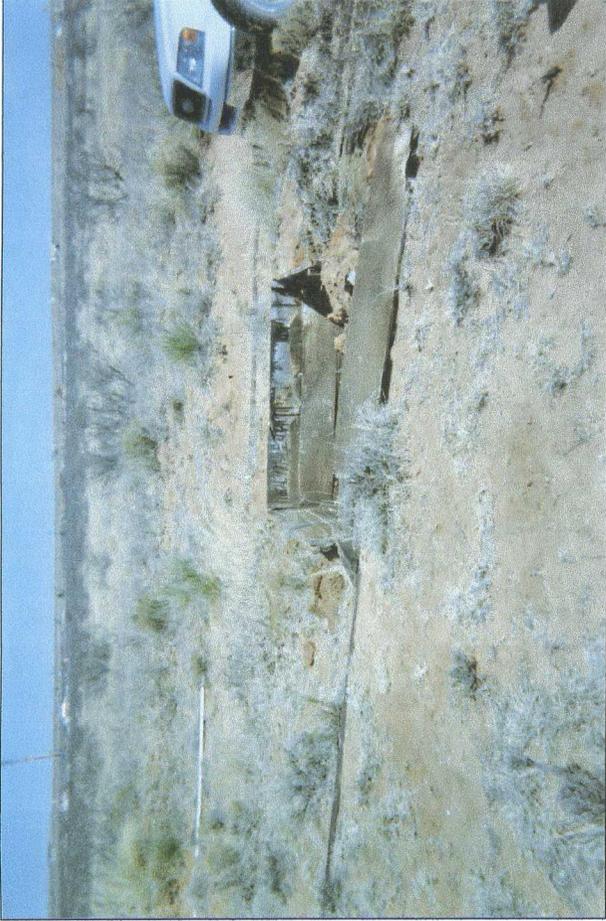
2/22/2006

deconstructing old junction box

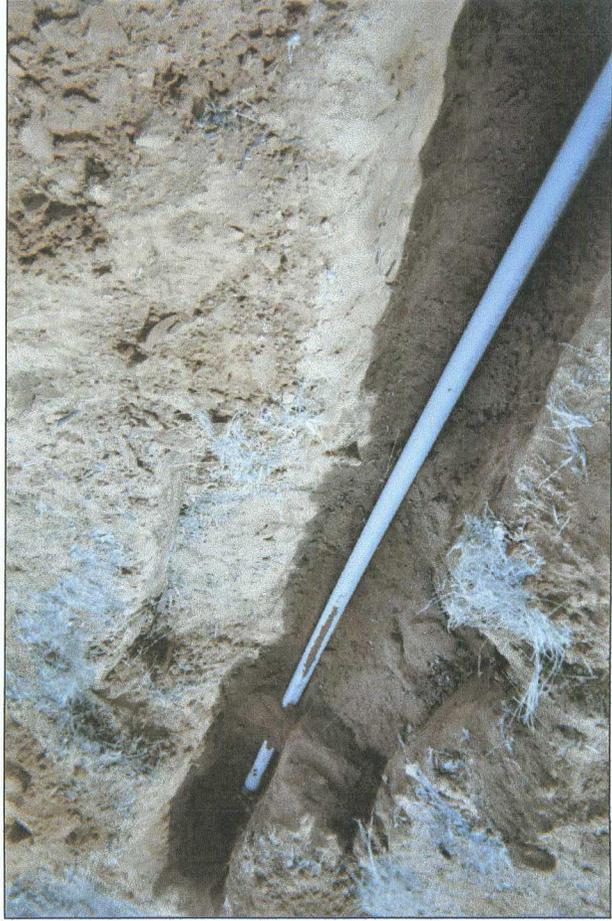
2/23/2006

junction eliminated; new pipeline

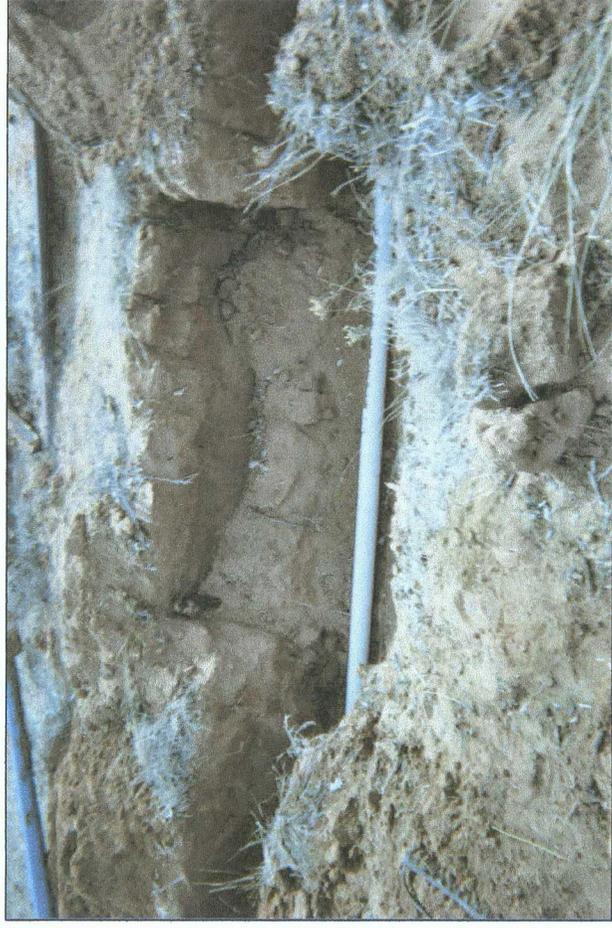
2/23/2006

junction eliminated; new pipeline
