BD Jct K-7-1

RICE OPERATING COMPANY

JUNCTION BOX FINAL REPORT

Unit K, Section 7, T22S, R37E

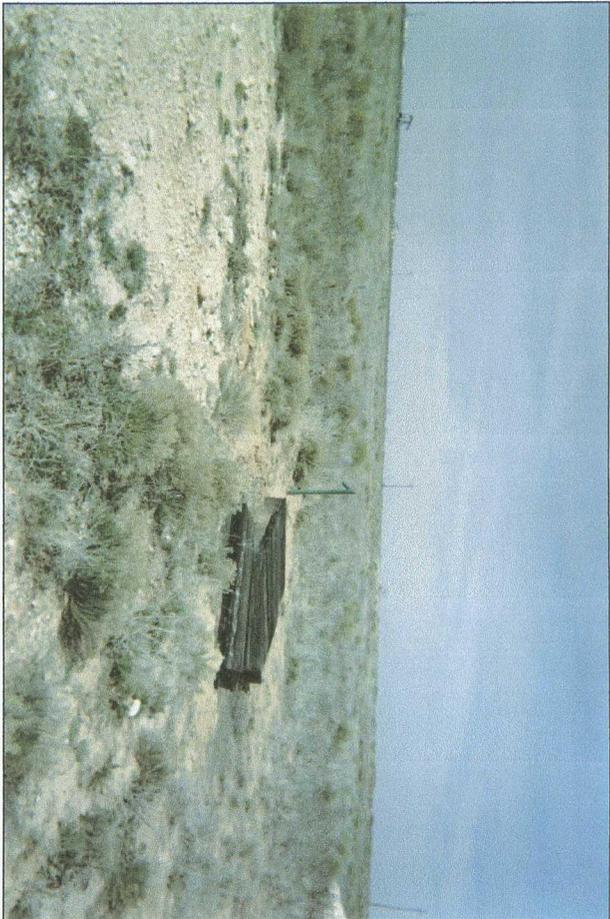
2/9/2005

undisturbed junction box

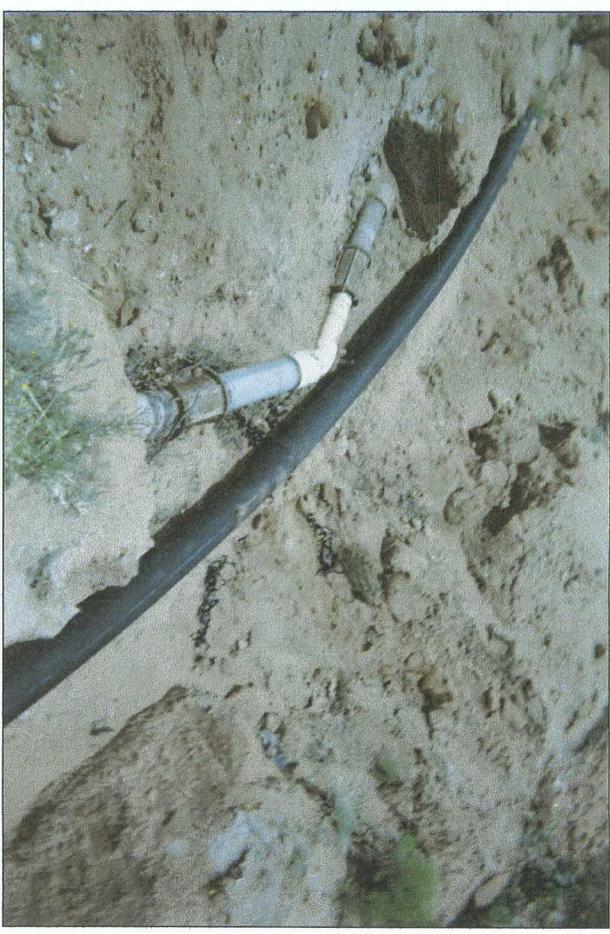
9/20/2007

former junction site; pipeline replaced

This junction was eliminated with the

pipeline replacement/upgrade program. After the box lumber was removed, the site was inspected and the surrounding soils did not exhibit any signs of adverse impact from the junction. Soil samples were collected using a hand auger and chloride field tests were conducted on them.

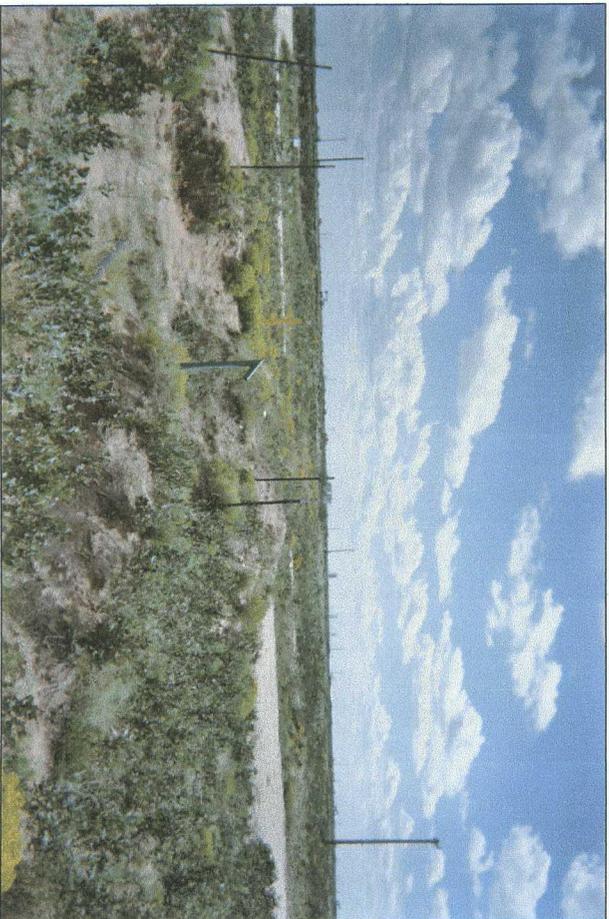
9/20/2007

box removed; site of hand auger samples

All samples yielded low chloride concentrations similar to that of the background sample. Organic vapors were also measured which resulted in very low concentrations as well. The deepest sample (8 ft bgs) collected below the junction was analyzed at a commercial laboratory for confirmation of field tests. Results indicate that neither TPH nor chloride were present within the laboratory's detection limit. The hole from the former junction box was backfilled with clean, imported soil and contoured to the surrounding surface. The surface was seeded with a blend of native vegetation on 11/30/2007 and is expected to return to productive capacity at a normal rate.
