BD BEC Corp Owen 'A' EOL

**RICE OPERATING COMPANY
JUNCTION BOX FINAL REPORT**

BD BEC Corp. Owen 'A' EOL

Unit E, Sec. 3, T22S, R37E

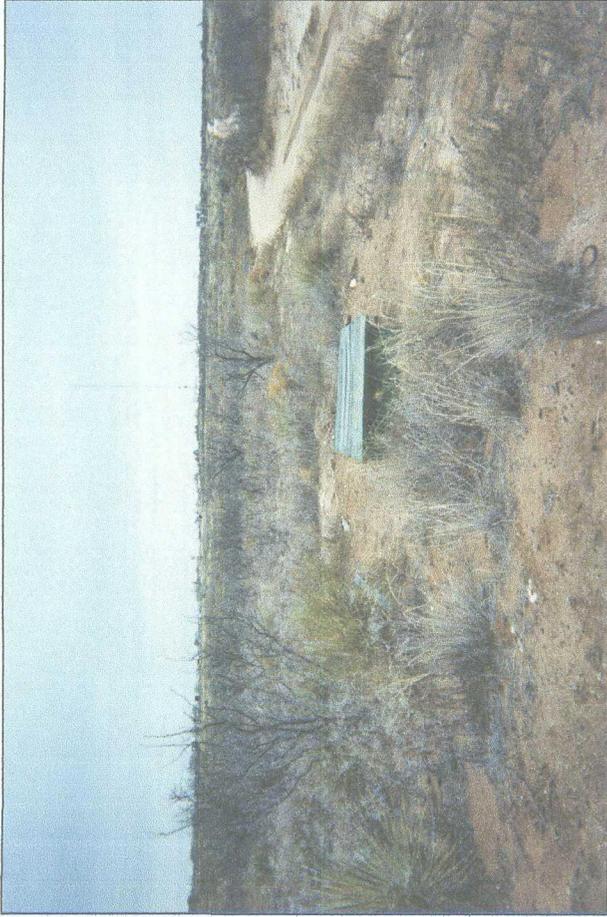
2/14/2006

undisturbed junction box

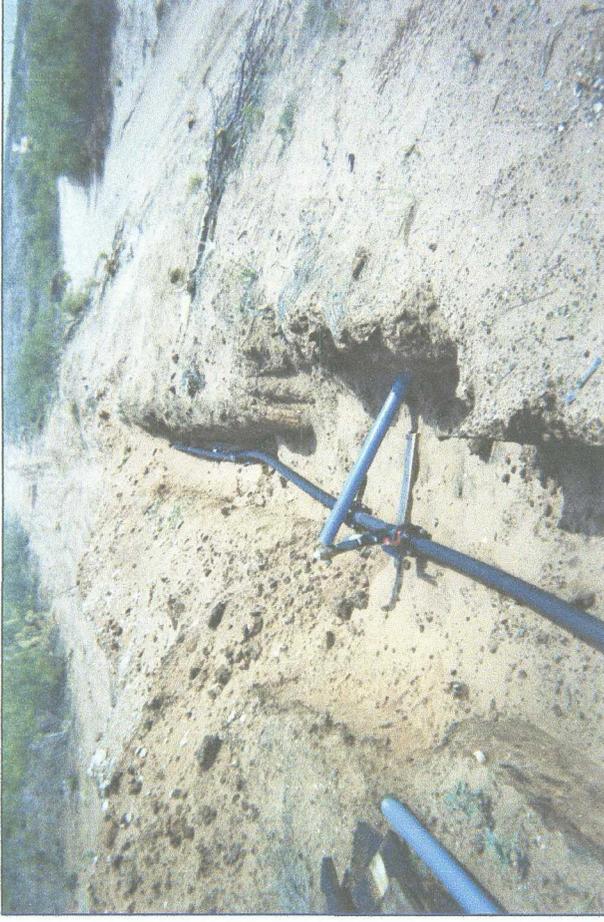
new junction box site 10 ft north of former; new poly pipeline

This end-of-line (EOL) junction box was moved/upgraded as part of the pipeline replacement program. Once the box lumber was removed from the former site, the location was inspected for chloride and hydrocarbon impact. The soils at the site were of a red sand type and did not exhibit any staining or other signs of adverse impact. The surrounding surface has a healthy vegetation cover which does not appear to be stressed. Field tests on the soil samples confirmed that chloride and hydrocarbon concentrations were very low. A confirmation composite sample was analyzed at a certified laboratory. The former box hole was backfilled with 12 yd³ of clean, imported soils and the disturbed surface area was seeded with a blend of native vegetation on 8/8/2007 and is expected to return to productive capacity at a normal rate. A new, watertight junction box was built 10 ft north of this former location.

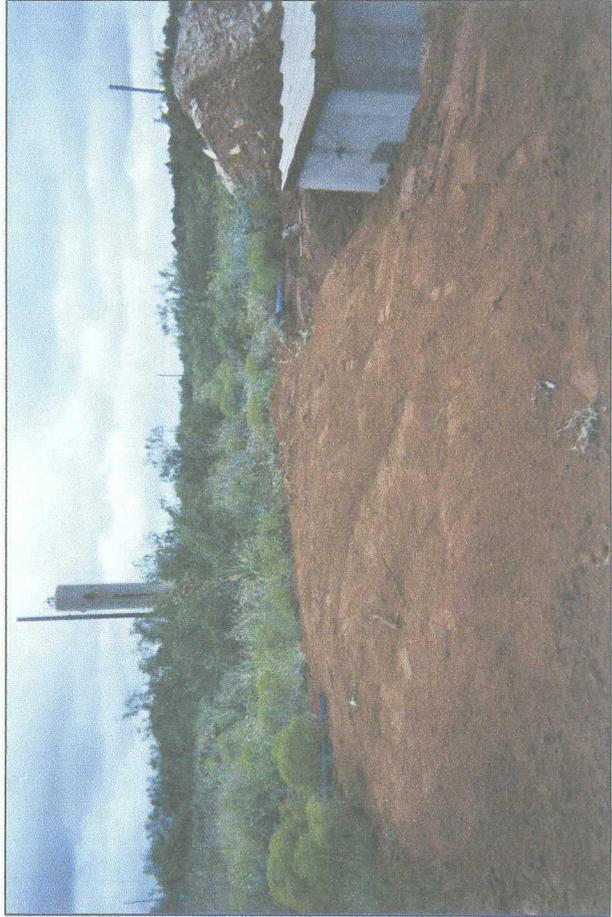
8/2/2007

former junction box hole filled with clean, imported soil

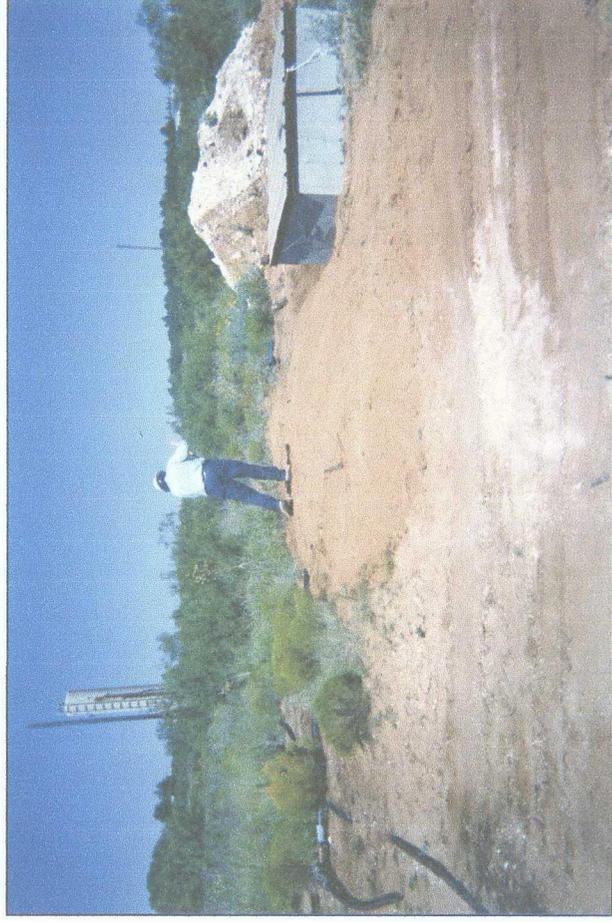
8/8/2007

seeding former box site; new box on the left
