BD ~~S~~C-4-1 Vent

RICE OPERATING COMPANY
JUNCTION BOX FINAL REPORT

SWD SYSTEM	JUNCTION	UNIT	SECTION	TOWNSHIP	RANGE	COUNTY	NEW BOX DIMENSIONS - FEET		
							Length	Width	Depth
Blinebry-Drinkard (BD)	C-4-1 vent	C	4	22S	37E	Lea	no box--junction eliminated

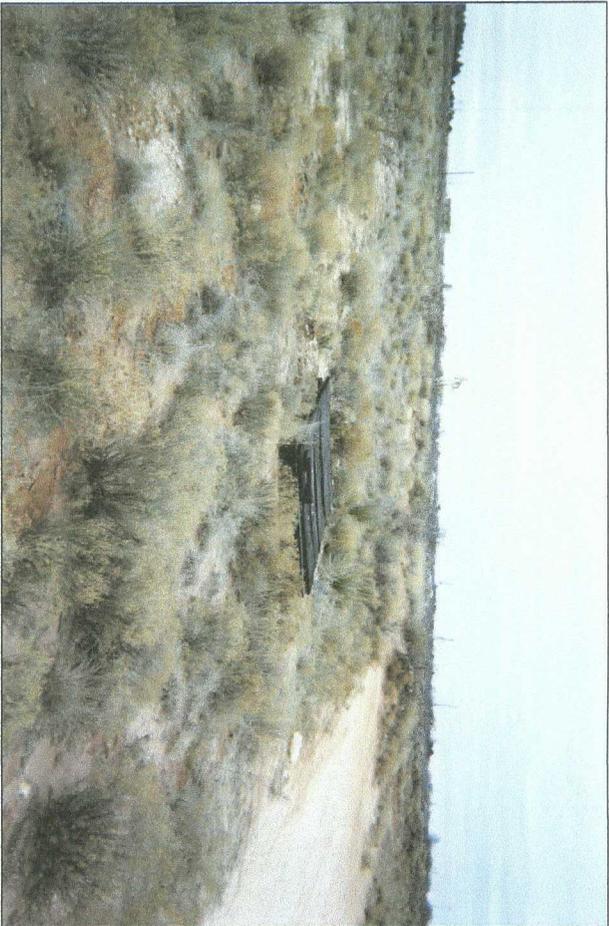
BD C-4-1 vent

undisturbed junction box

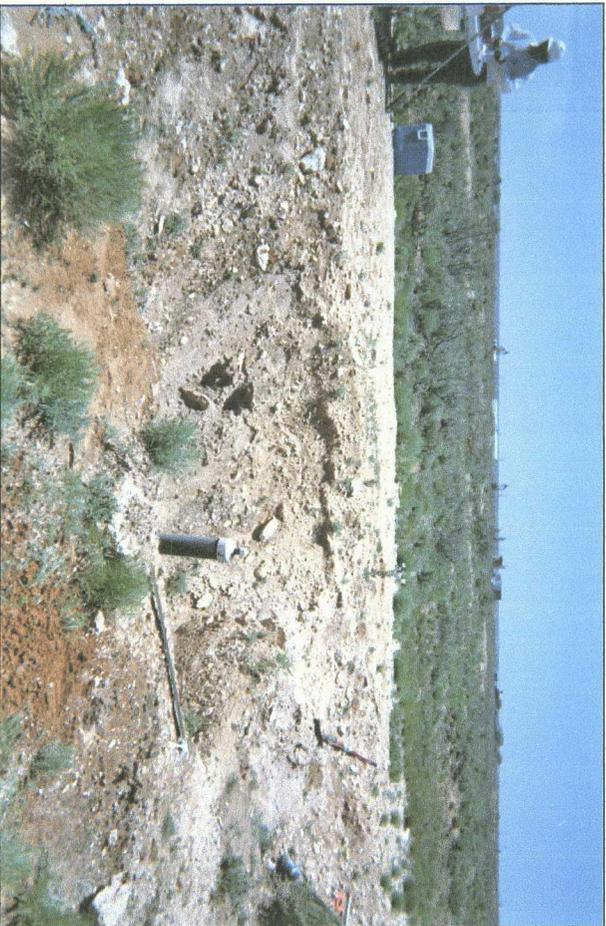
collecting samples from site: pipeline replaced and box removed

This junction was eliminated with the pipeline replacement/upgrade program. After the box
lumber was removed, the site was evaluated using a hand auger to collect soil samples. Field chloride tests revealed chloride concentration at the site to
be similar to background concentration. Hydrocarbon concentrations were investigated using a photoionization detector and yielded low concentrations.
Representative samples were collected for laboratory analysis and results confirmed chloride field tests. TPH concentrations were also low, meeting
NMOCD guideline concentrations. The 7 x 7 x 3-ft-deep area was backfilled with clean, imported fill dirt and contoured to the surrounding area.
The disturbed surface was seeded with a blend of native vegetation and is expected to return to productive capacity at a normal rate.

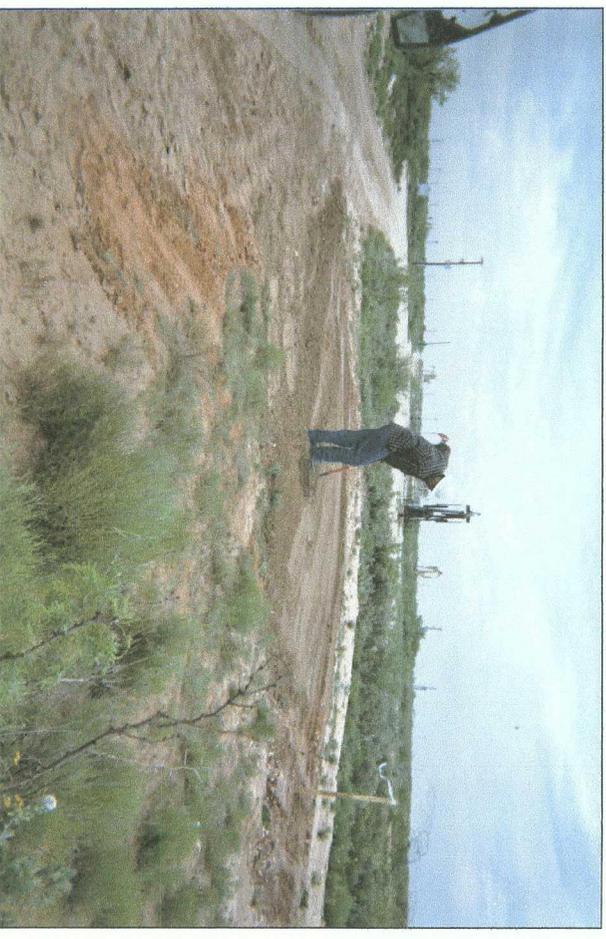
seeding imported topsoil of backfilled site
