**RICE OPERATING COMPANY
JUNCTION BOX FINAL REPORT**

SWD SYSTEM	JUNCTION	UNIT	SECTION	TOWNSHIP	RANGE	COUNTY	NEW BOX DIMENSIONS - FEET		
							Length	Width	Depth
Blinebry-Drinkard (BD)	B.C. Operating EOL	A	24	21S	36E	Lea	moved 150 ft South

B.C. Operating FOI

Unit A, Section 24, T21S, R36E

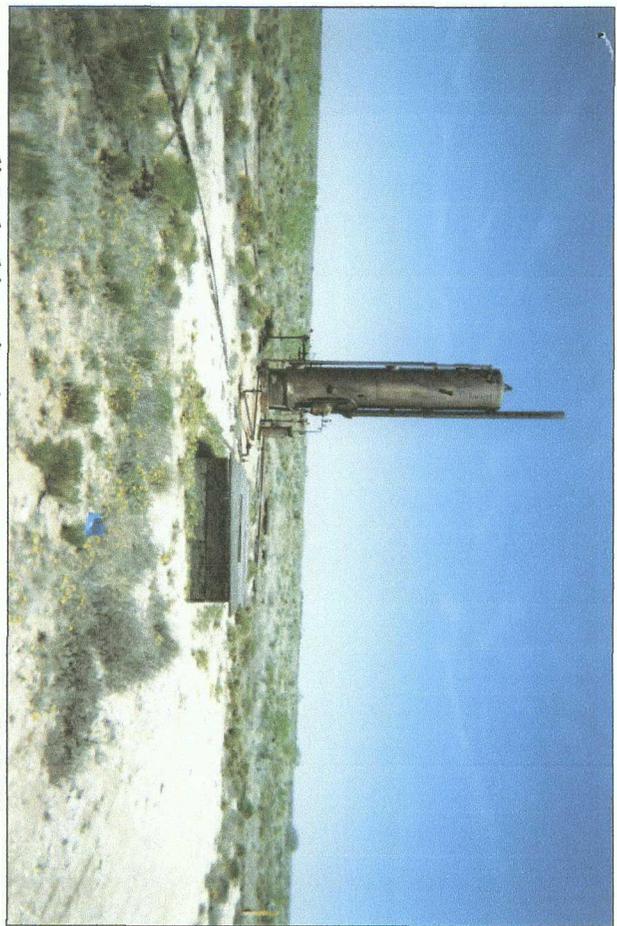
6/2/2003

undisturbed junction box

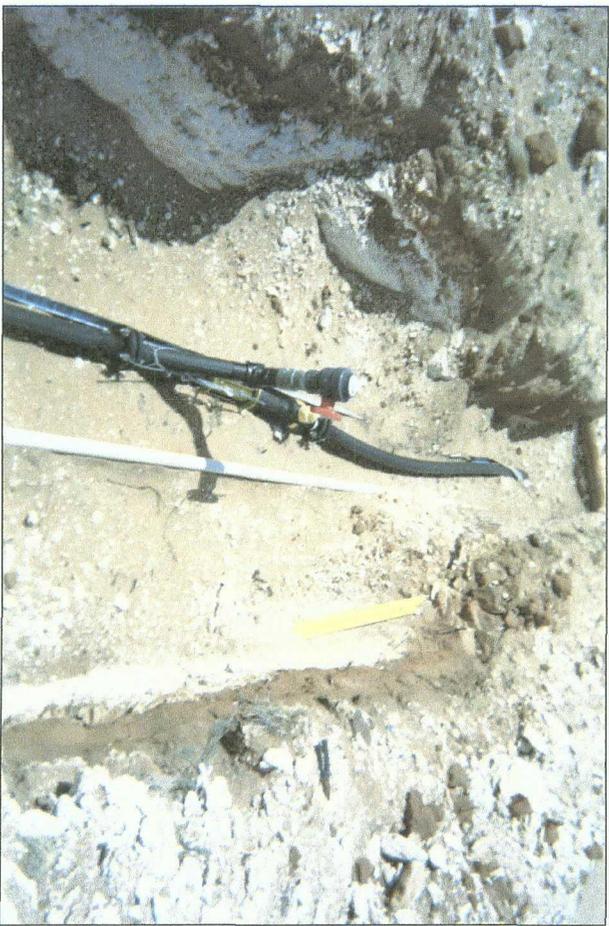
7/25/2003

new pipeline and junction at new location 150 ft south

This junction was moved as part of the pipeline replacement/upgrade program. A new junction box was built 150 ft south of the former box site. The former site was cleared of NORM and the box lumber was removed before it was inspected for physical signs of adverse effects from the junction; none were observed. A delineation trench was made at the former junction site to collect soil samples to 9 ft BGS. Chloride field tests were conducted on each sample and yielded very low concentrations. Organic vapors were also screened using a PID and revealed low concentrations as well. The deepest sample (9 ft) was collected for laboratory analysis and confirmation of field tests. TPH was not present within the laboratory's detection limits, meeting NMOCD guidelines. Clean, imported soil was used to backfill the trench and to spread onto the disturbed surface. The area was seeded with a blend of native vegetation on 7/19/2007 and is expected to return to productive capacity at a normal rate.

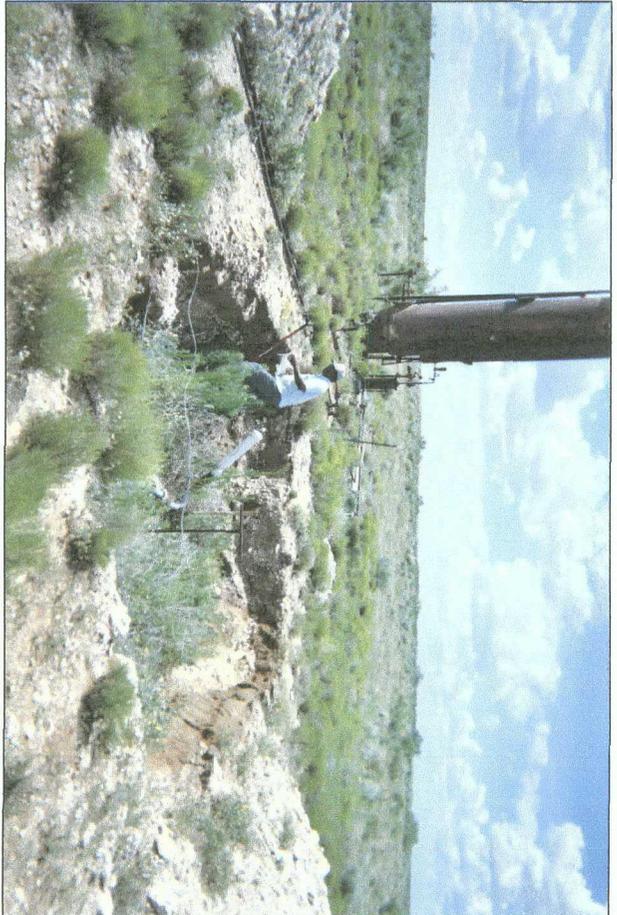
7/16/2007

initial inspection and evaluation

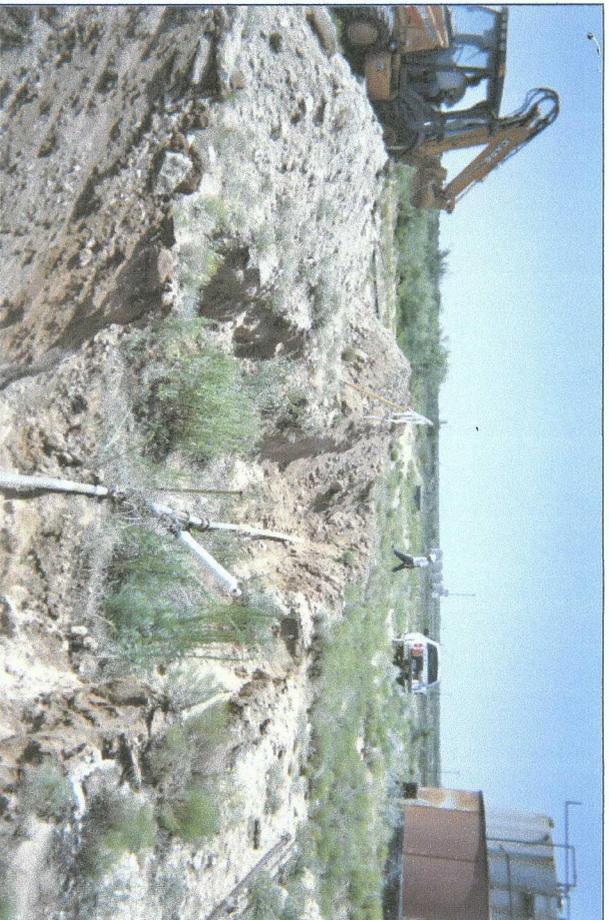
7/16/2007

former box site; new box in background

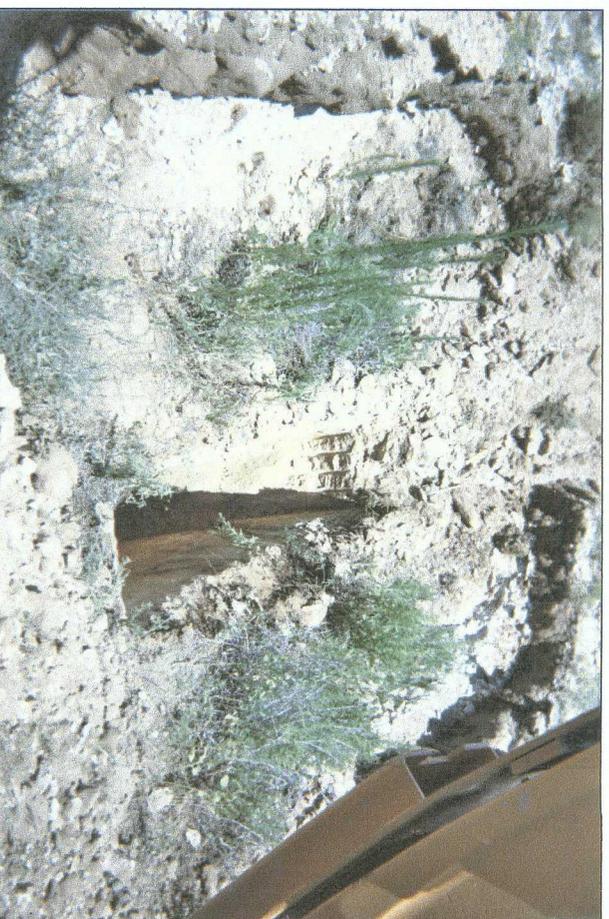
7/16/2007

LOCATION	DEPTH (ft)	ppm
delineation trench at junction	6	138
	7	196
	8	129
	9	220

delineation trench at former junction site

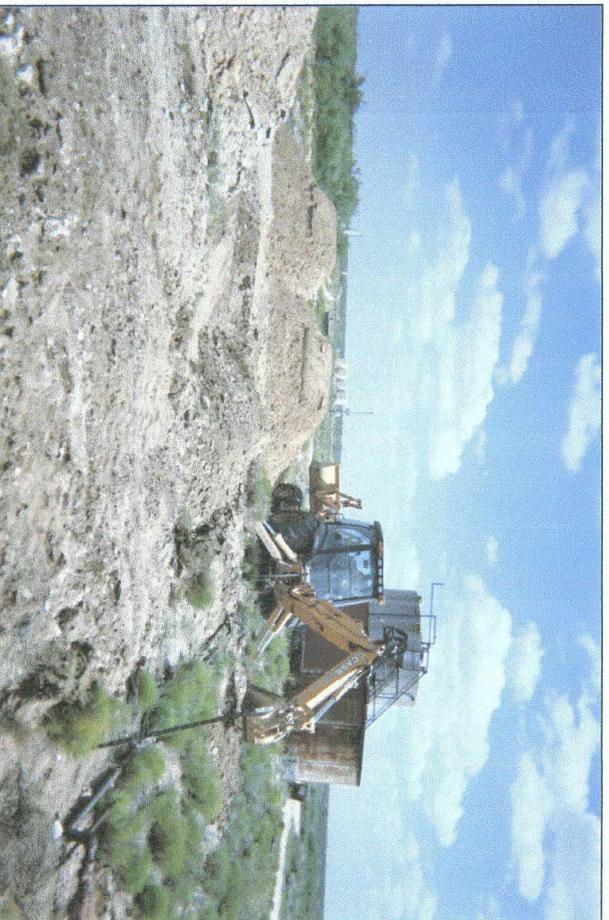
7/18/2007

preparing to backfill and spread imported soil

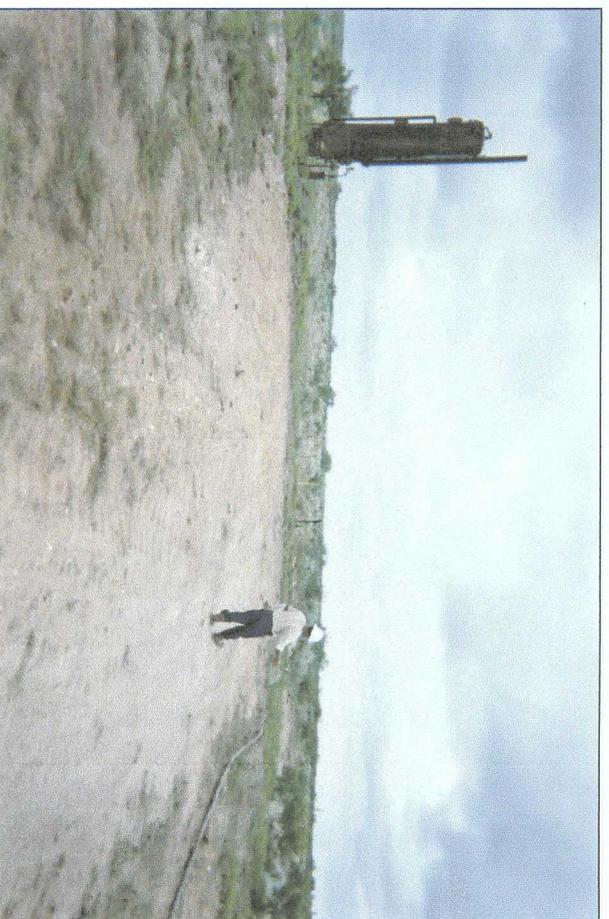
7/19/2007

seeding disturbed surface
