BD Jct E-20-1

CLOSURE

RICE OPERATING COMPANY
JUNCTION BOX FINAL REPORT

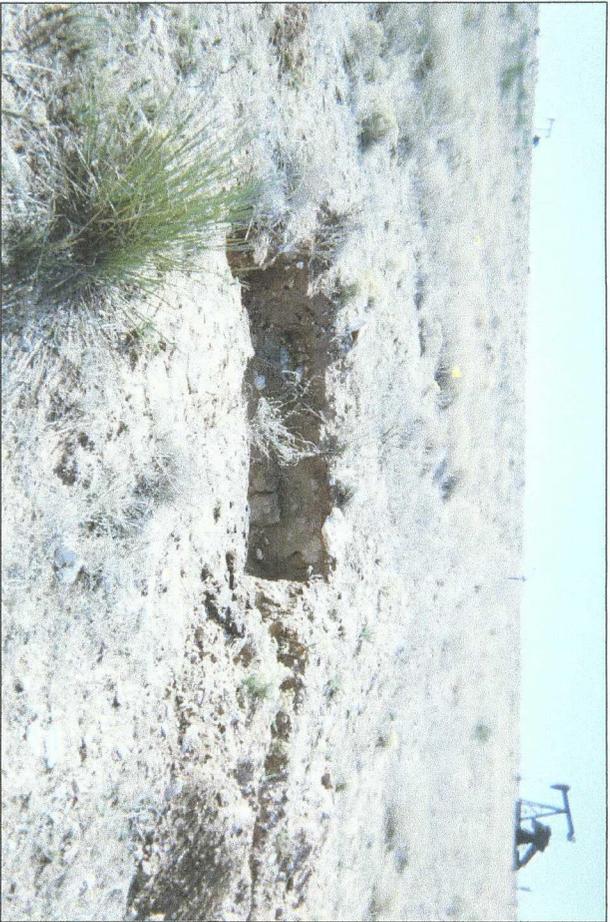
2/27/2007

box removed; before excavation

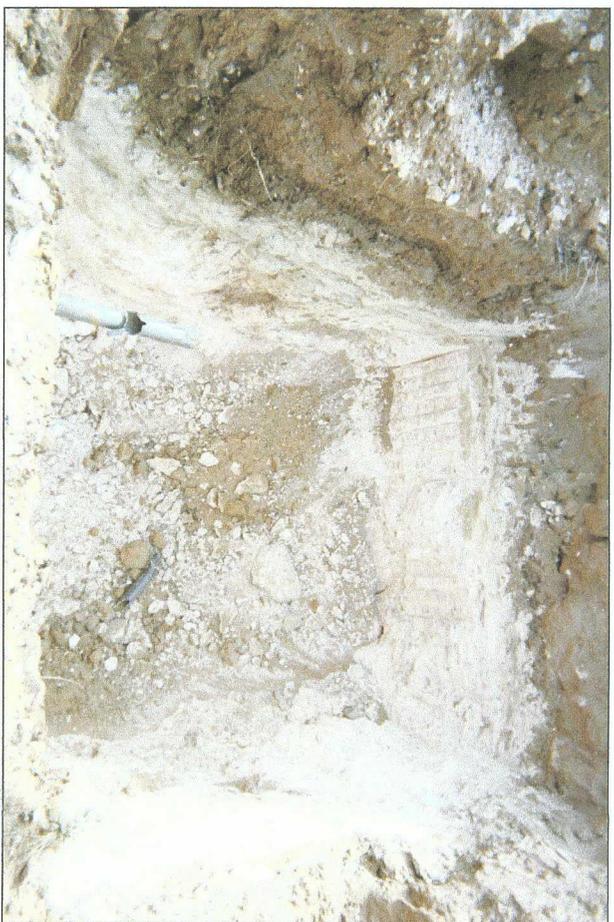
2/28/2007

final 10 x 8 x 7-ft-deep excavation

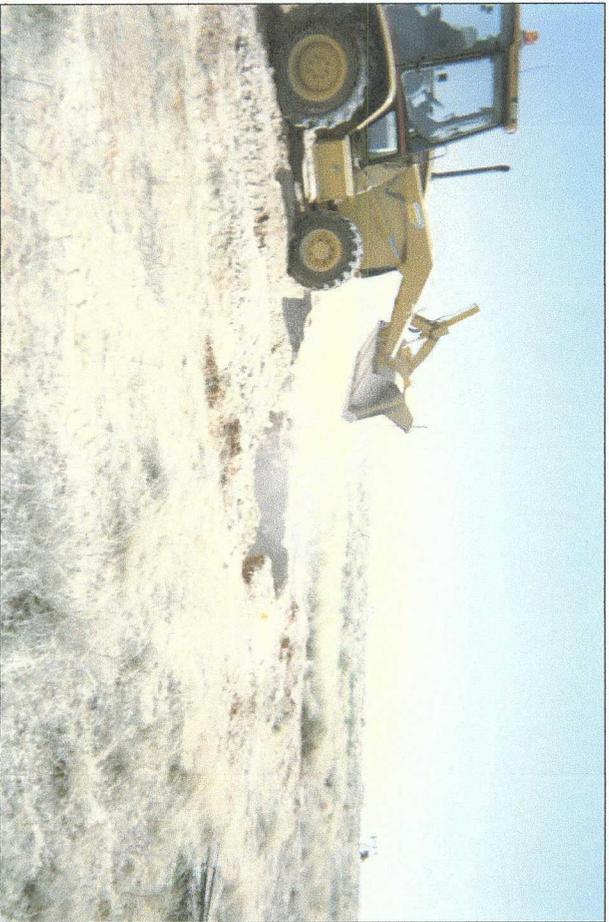
3/6/2007

backfilling

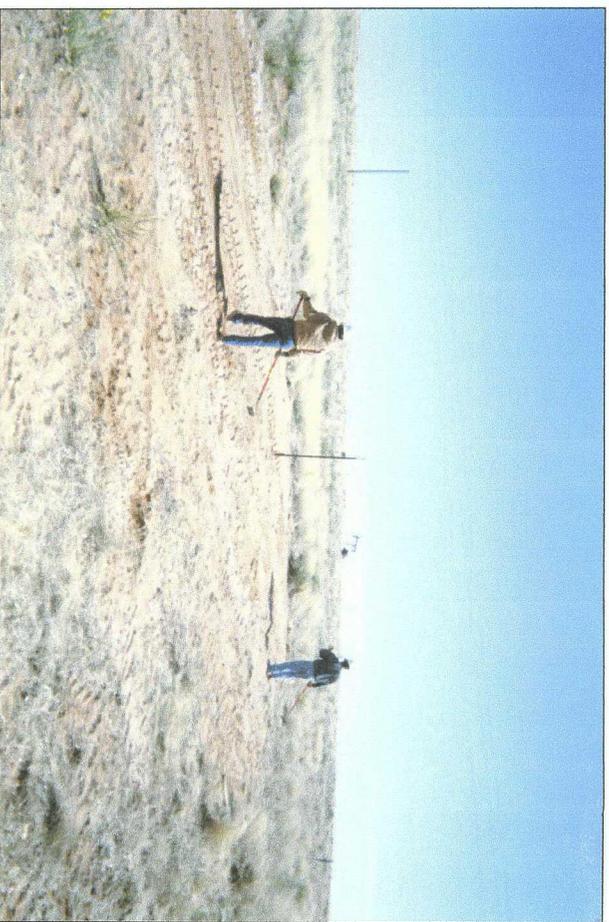
3/6/2007

seeding surface of backfilled site
