RE: **CORRECTIVE ACTION PLAN**
EME I-1 SWD OFFSITE ENCROACHMENT SITE
NMOCD CASE No.: 1R0464 336
T20S-R37E-SECTION 1, UNIT LETTER I
LEA COUNTY, NEW MEXICO

RICE Operating Company (ROC) retained Trident Environmental to address potential environmental concerns at the above-referenced site. An Investigation and Characterization Plan (ICP), submitted to the OCD Hobbs District office on February 25, 2005, is attached to this Corrective Action Plan (CAP) with the NMOCD approval. This Corrective Action Plan (CAP) incorporates the findings from the Investigation & Characterization Plan (ICP) and proposes recommendations for corrective action.

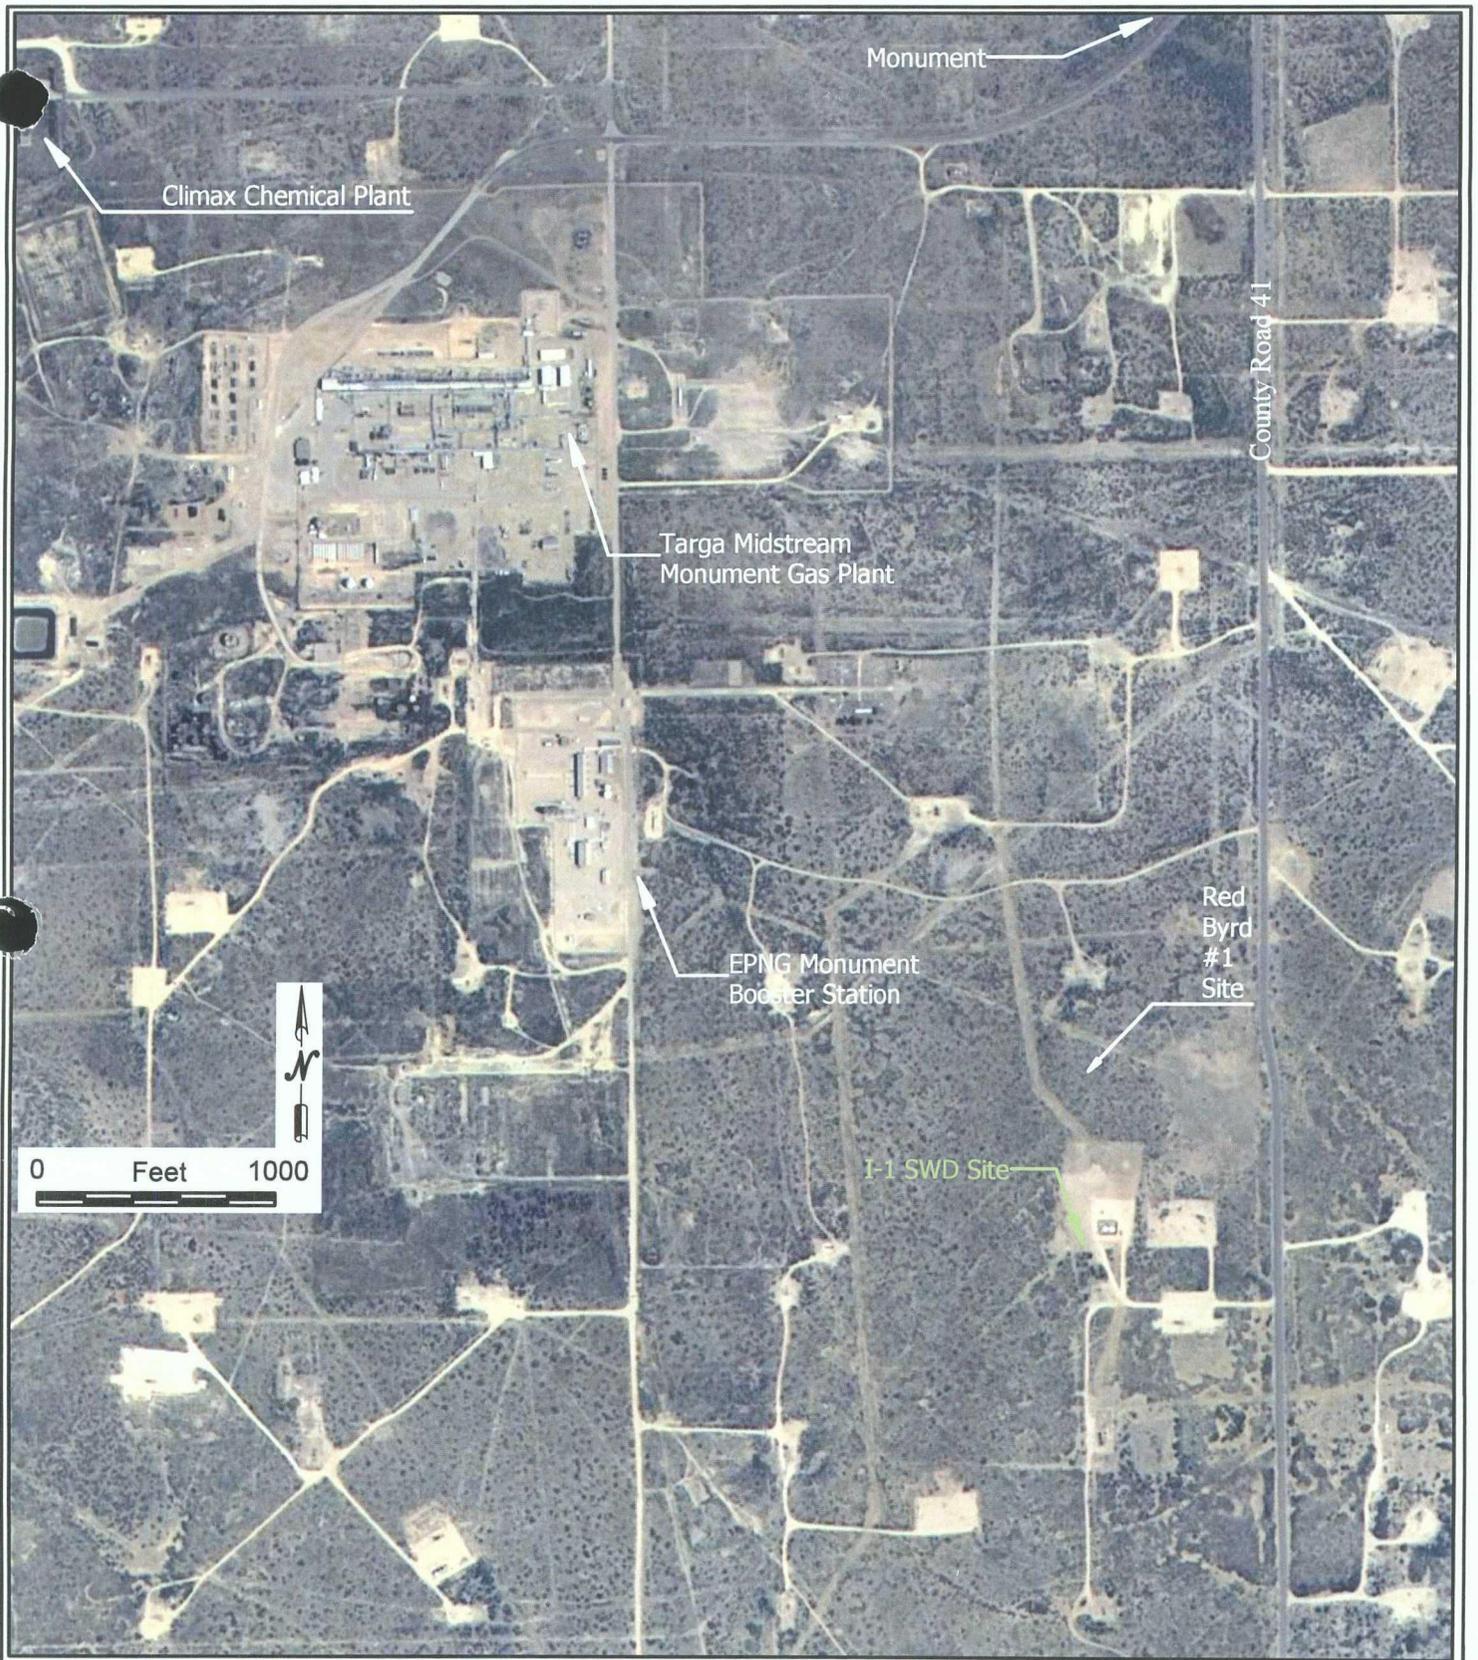
FIGURE 2
AERIAL PHOTO (2005)

- A high concentration of oil & gas wells (active and plugged) and associated structures (tank batteries, pits, pipelines, etc.) are located in this area of Monument. Many of these are obviously visible in Figure 2 (aerial photograph).

- A crude oil pipeline operated by Plains Petroleum is located approximately 700 feet north of the SWD well where a groundwater monitoring site (Red Byrd #1) has been undergoing investigation and remediation since February 2000 (NMOCD Case # 1RP-85) with a network of approximately 15 groundwater monitoring wells (Figure 2).

- The El Paso Natural Gas (EPNG) Monument Booster Station is located approximately ½ mile northwest of the I-1 SWD site (Figure 2).
- The Monument Gas Plant operated by Targa Midstream Services, L.P. (Targa) is located approximately ¾ mile northwest of the I-1 SWD site. According to the Ground Water Discharge Plan (GW-025) this facility has two brine ponds and a network of 18 groundwater monitoring wells associated with it (Figure 2).

- An abandoned hydrochloric acid manufacturing plant (DLD Resources, formerly Climax Chemical Company) is located about one-mile northwest of the I-1 SWD site. There are several groundwater monitoring wells associated with this facility however no active regulatory directives towards further investigation and remediation of this facility are known to be in progress (Figure 2).

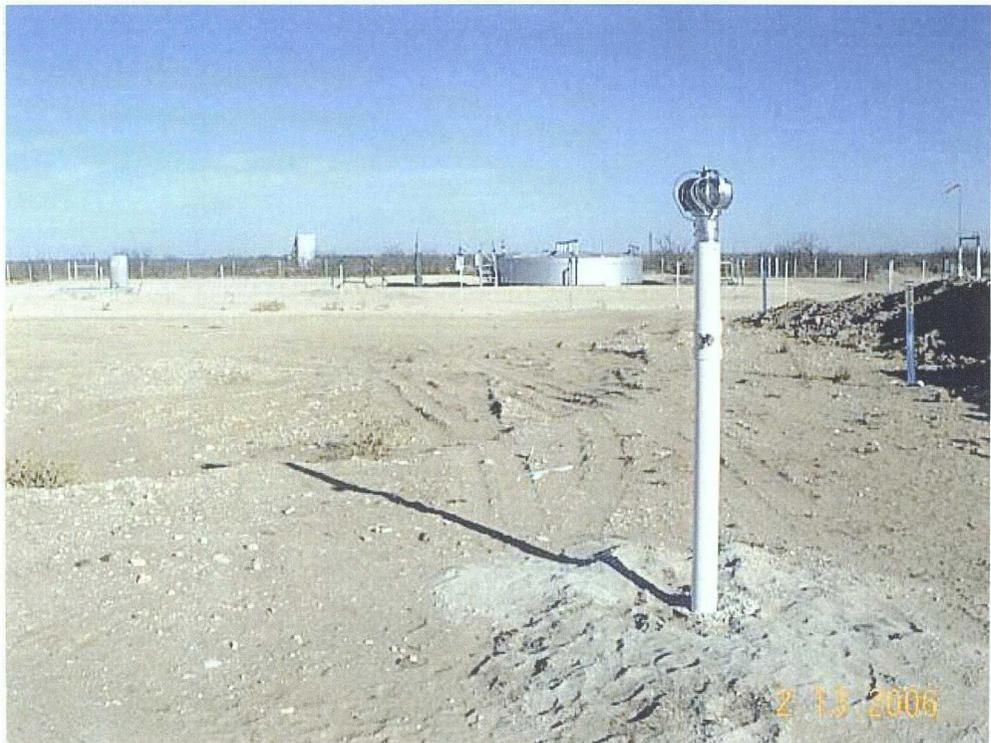
View facing east showing passive vapor extraction well at location of boring B-1.

There was no indication of hydrocarbon impact to the vadose zone in any of the samples, with the exception of boring B-1. PID readings in boring B-1 ranged from 458 ppm to 539 ppm in the upper 17 ft bgs, but quickly diminished to levels at or below 15 ppm to the bottom of the boring at 32 ft bgs. Laboratory analysis of hydrocarbon constituents of concern (benzene, BTEX, and TPH) in boring B-1 indicate impact is limited to the upper 15 to 20 feet of the vadose zone as summarized in Table 1. Boring B-1 was advanced immediately adjacent to the southwestern edge of the excavated area and represents very localized impact. To mitigate potential migration of volatile organic compounds (VOCs) boring B-1 was converted into a passive vapor extraction well which consists of 4-inch diameter PVC, screened across the 5 to 20 ft interval, and fitted with a wind-powered ventilating turbine.

Boring B-1 represents a small localized area impacted by hydrocarbons within the upper 15 to 20 feet of the vadose zone. This impact is localized because no evidence of hydrocarbon impact was observed in the surrounding borings (B-4 and MW-1), and the area to the north was excavated during the closure of the former redwood tanks. Previous remedial actions by ROC (excavation, backfilling, and lining of the former redwood tank area) and conversion of the boring B-1 into a passive vapor extraction well has minimized the risk for potential migration of VOCs into groundwater; therefore, no further mitigation is proposed with the exception of leaving the passive vapor extraction well in place.

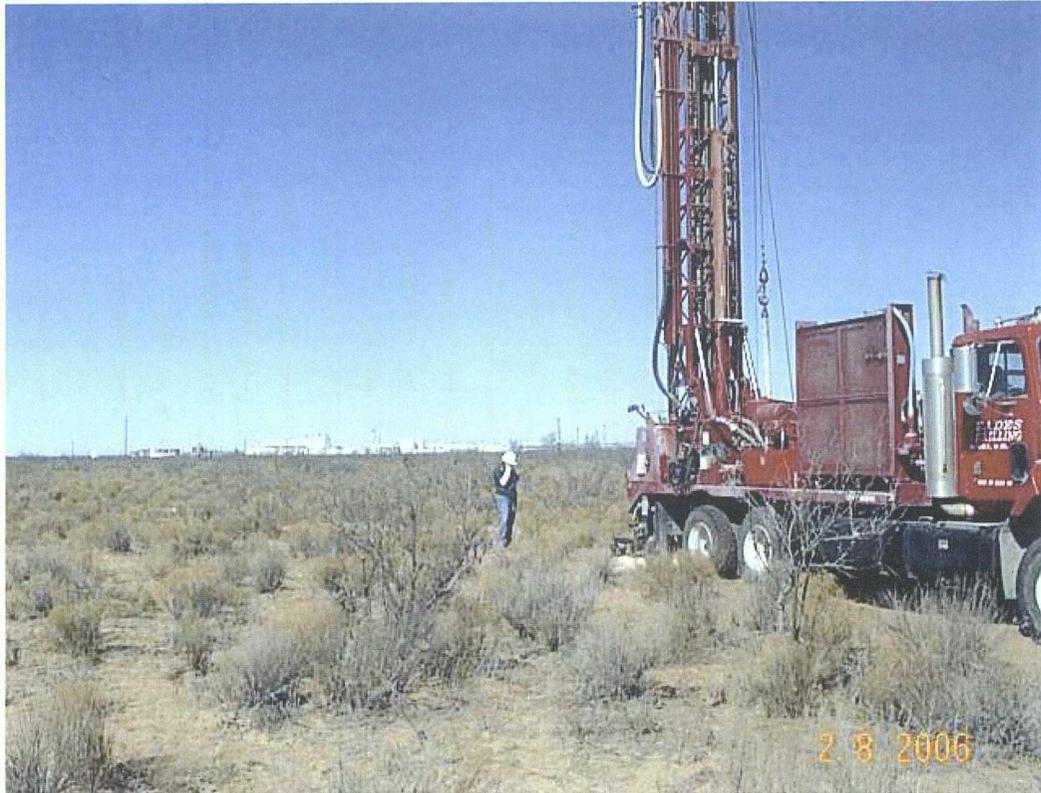
View facing north showing drilling activities at monitoring well MW-2.

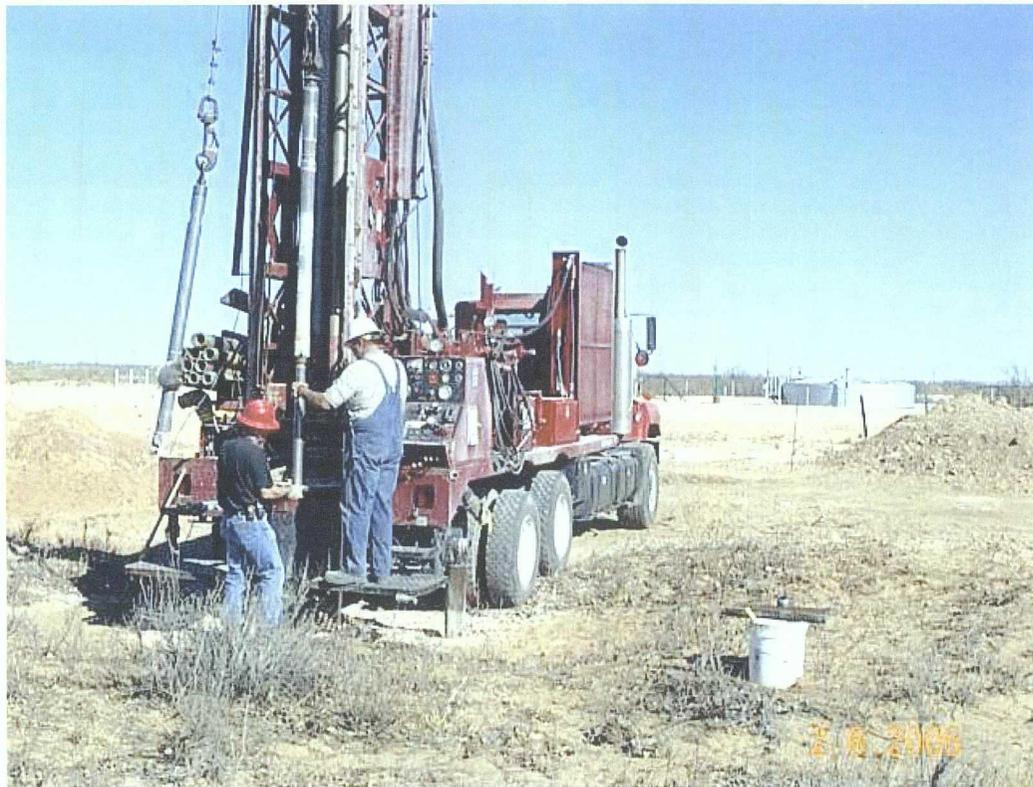
View facing east showing split spoon sampling activity at boring B-4.
