EME Cooper 'E' EOL

1R427-233

CLOSURE

RICE OPERATING COMPANY
JUNCTION BOX FINAL REPORT

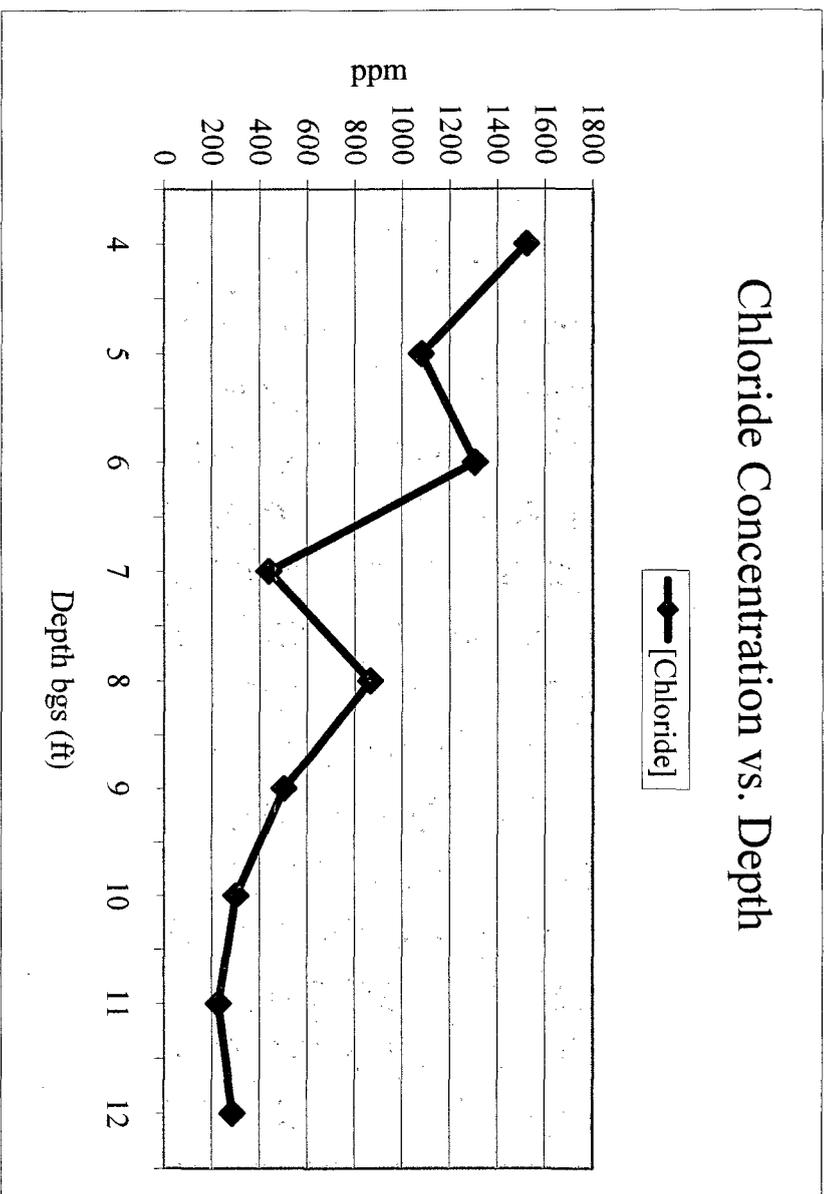
15 ft NORTH of junction

Depth bgs (ft)	[Cl ⁻] ppm
4	1524
5	1082
6	1307
7	440
8	865
9	503
10	302
11	229
12	287

Groundwater = 27 ft

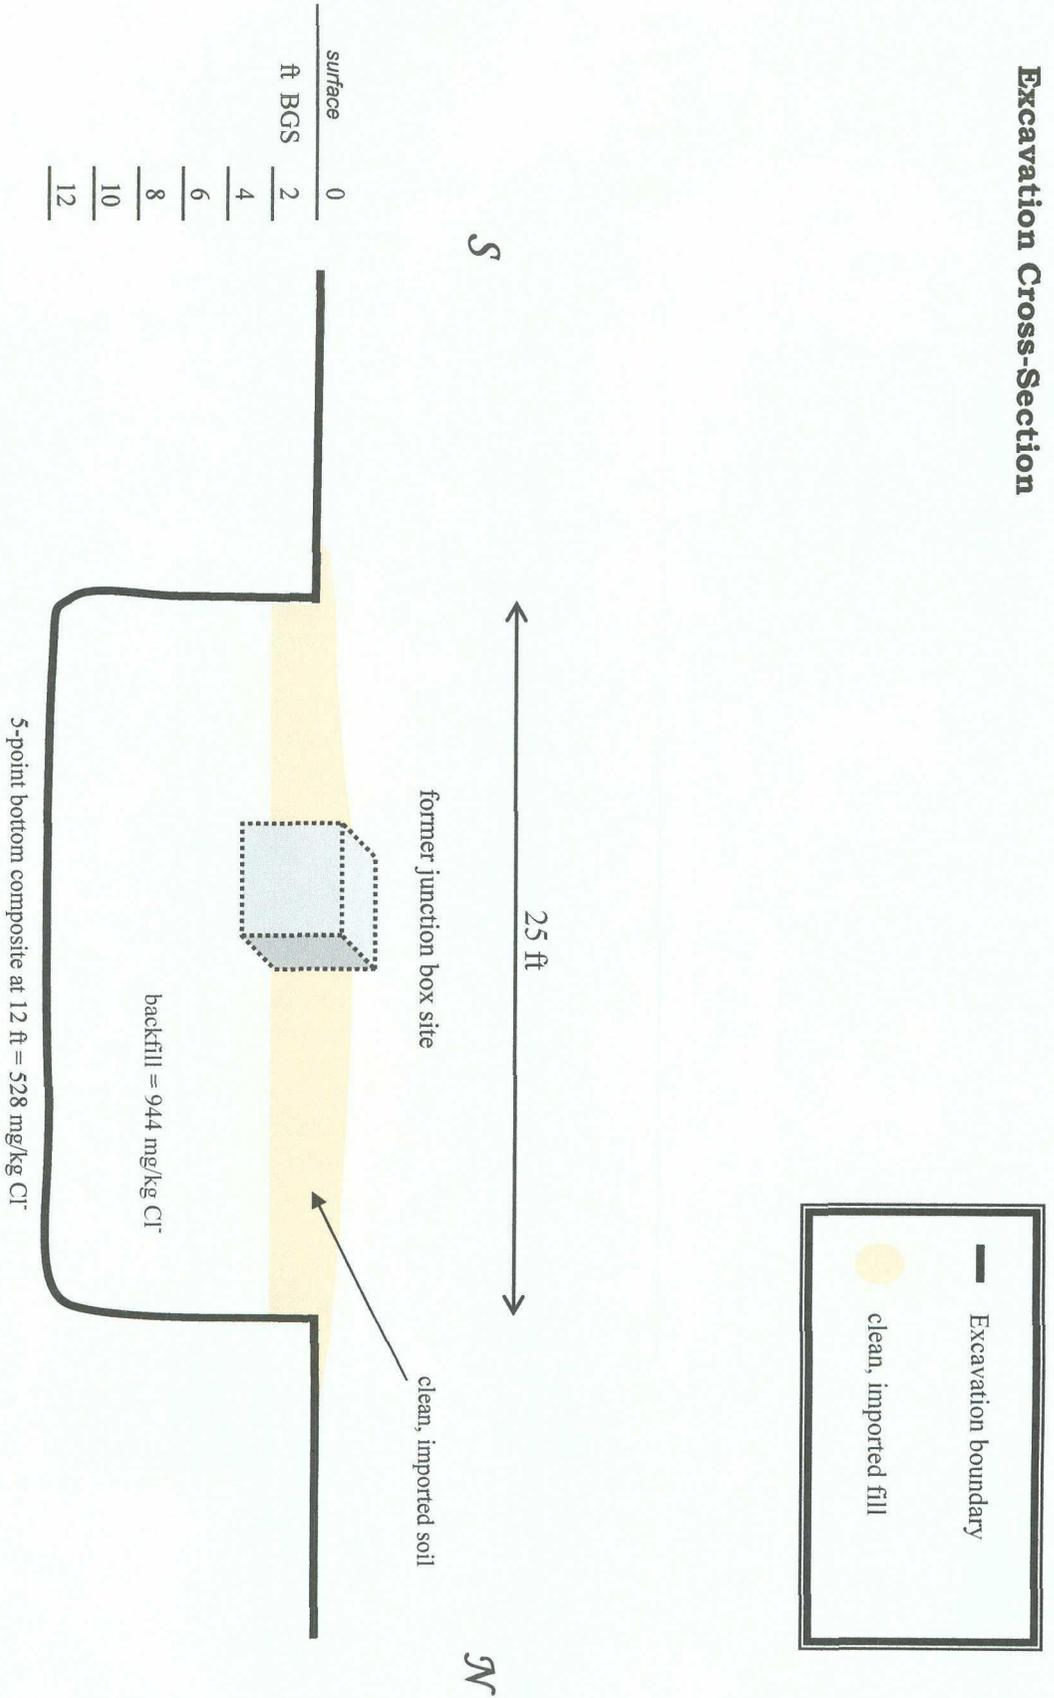
Excavation Cross-Section

25 x 20 x 12-ft-deep

This junction was eliminated with the pipeline replacement program. After the box lumber was removed, a backhoe was used to collect soil samples at regular intervals. Chloride field tests and organic vapor readings using a PID were performed on each sample throughout the 25 x 20 x 12-ft-deep excavation. Composite samples from the final excavation were collected for laboratory analysis and confirmed that hydrocarbon was not detected. Chloride concentrations exhibited a trend of decline with depth. The excavated soil was blended on site and returned to the excavation. 36 cubic yards of clean topsoil was imported to fill the remaining 2 ft of the excavation. The topsoil was contoured to the surrounding terrain and seeded with a blend of native vegetation. The seed has been watered and will be monitored for growth.

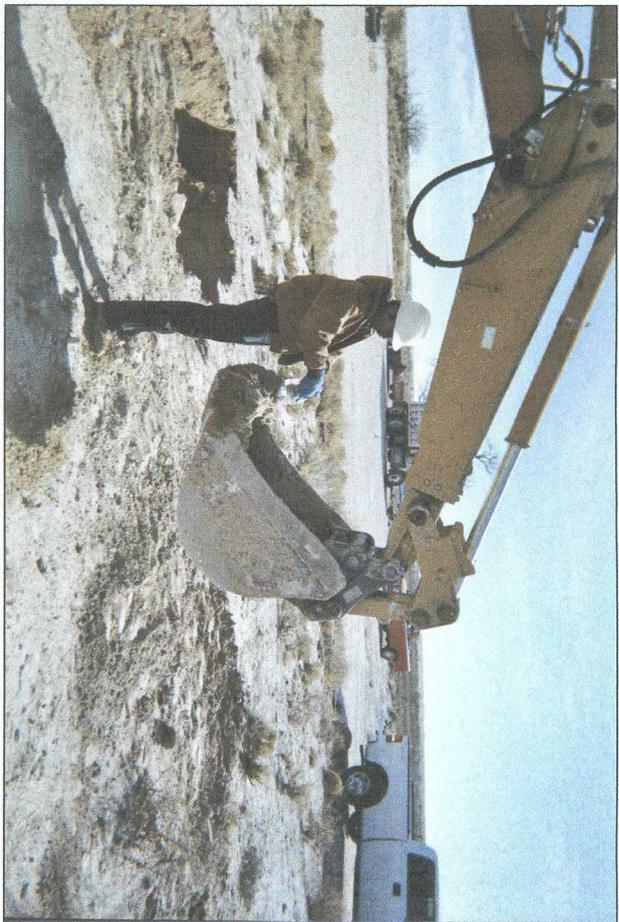
beginning backhoe sample collection at former box site 12/27/2006

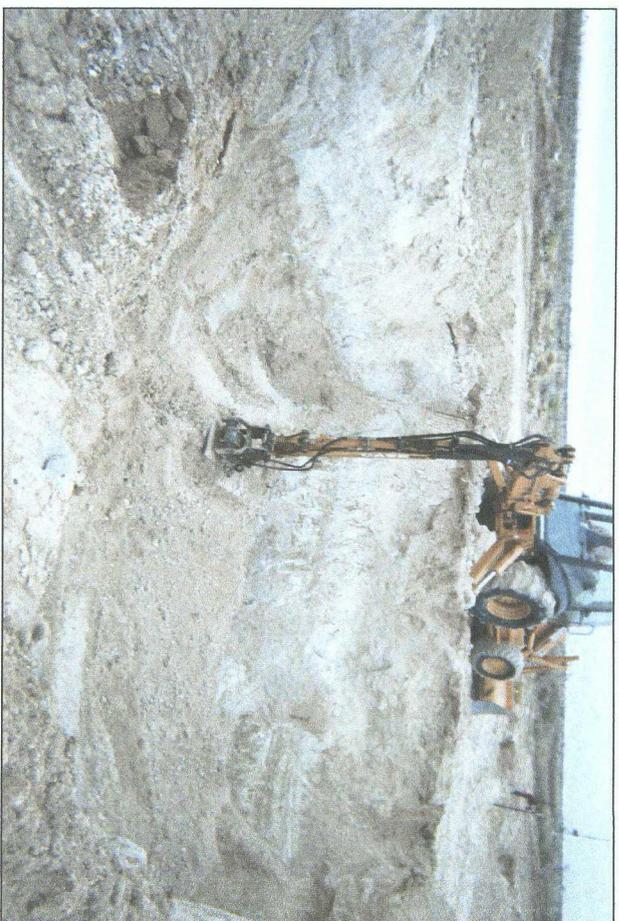
compacting backfill in 25 x 20 x 12 ft excavation 1/29/2007

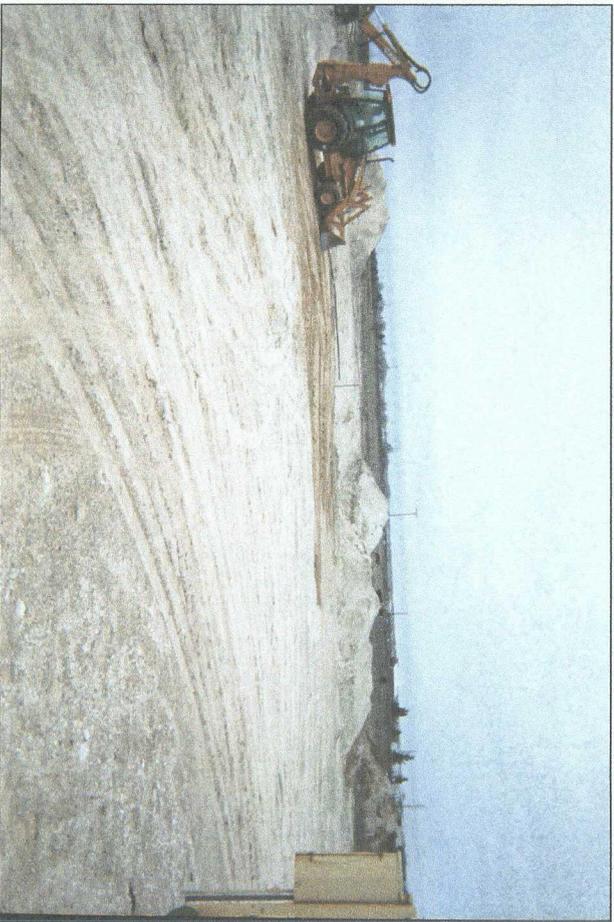
spreading clean, imported soil on top of backfilled site 1/30/2007

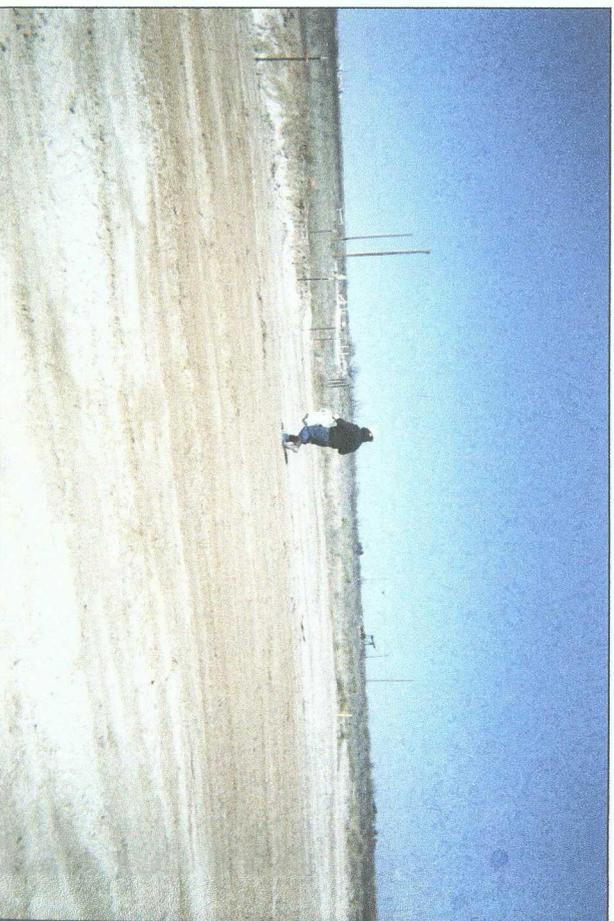
seeding disturbed surface of backfilled site 2/2/2007
