**CLOSURE**

**RICE OPERATING COMPANY  
JUNCTION BOX FINAL REPORT**

# EMIE jct. P-8

Unit P, Sec. 8, T20S, R37E

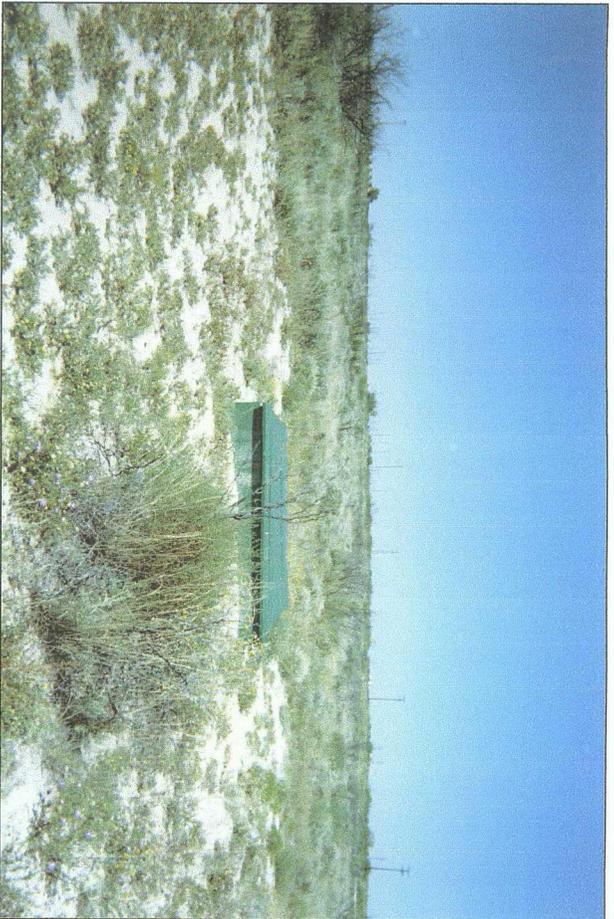
9/2/2004

undisturbed junction box

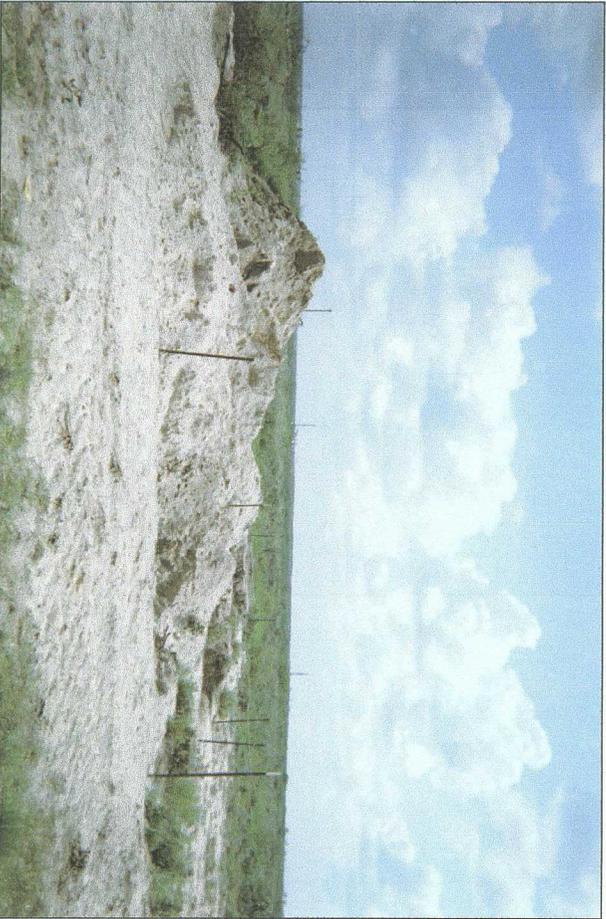
2/14/2005

box removed; NORM decontamination complete

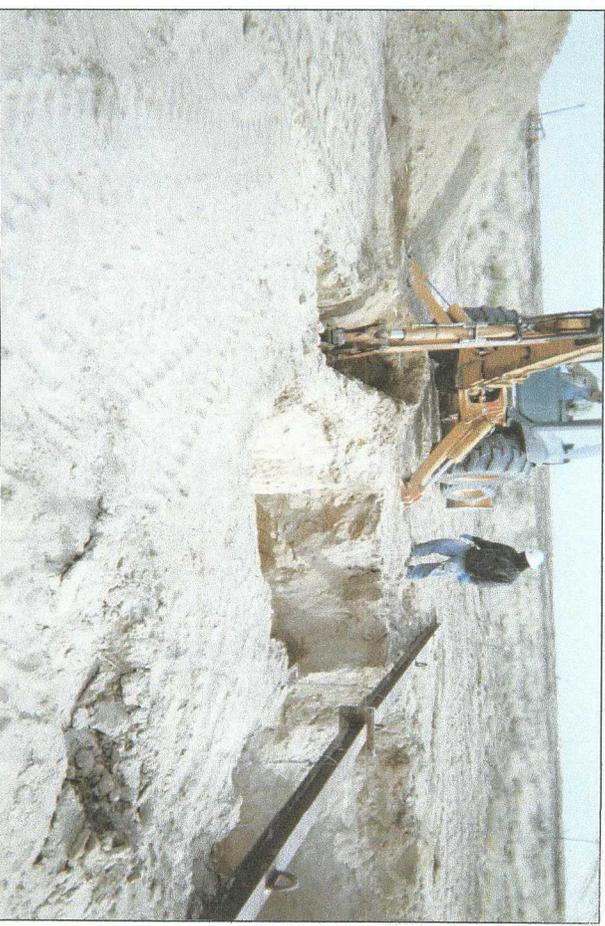
1/9/2007

delineation & excavation

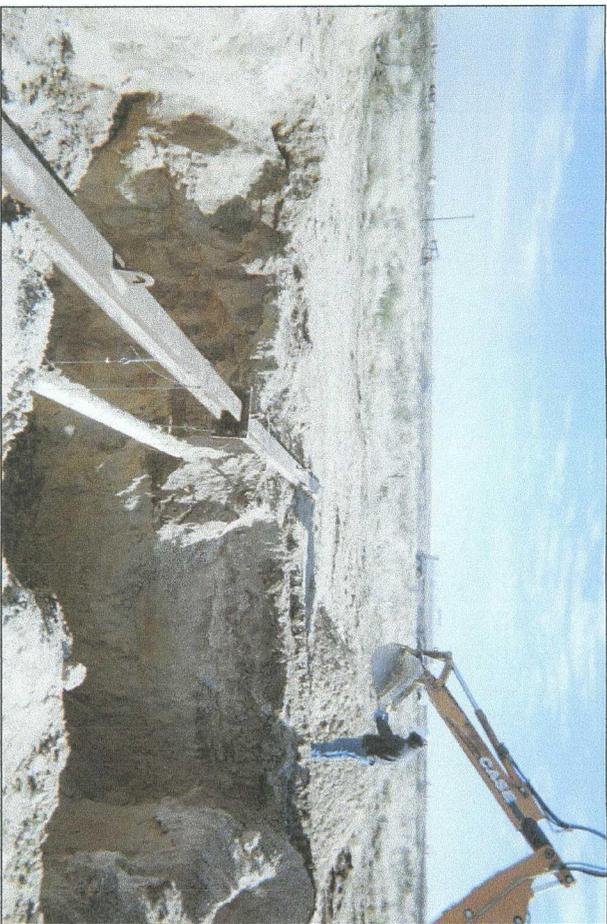
1/10/2007

collecting soil samples from backhoe

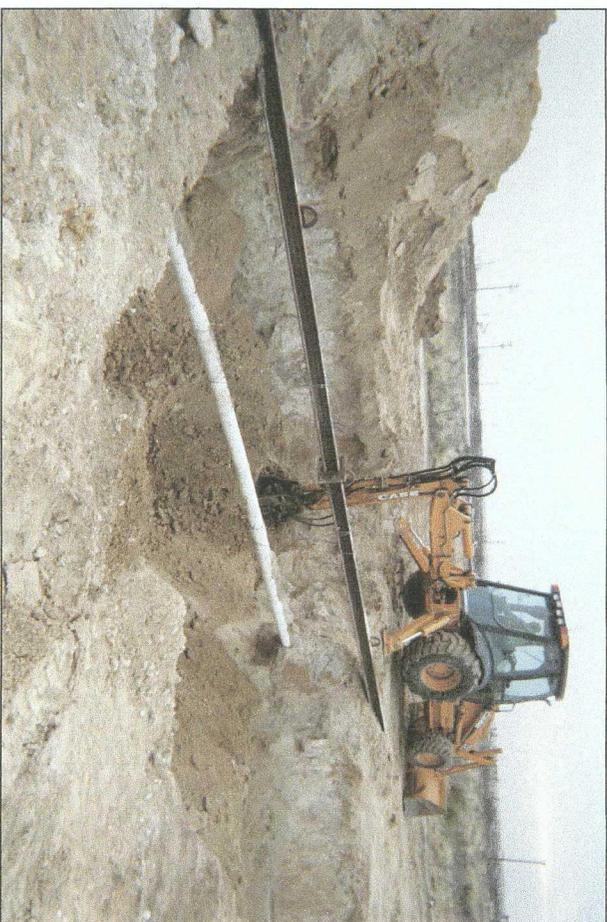
1/22/2007

backfilling 30 x 30 x 12 ft excavation

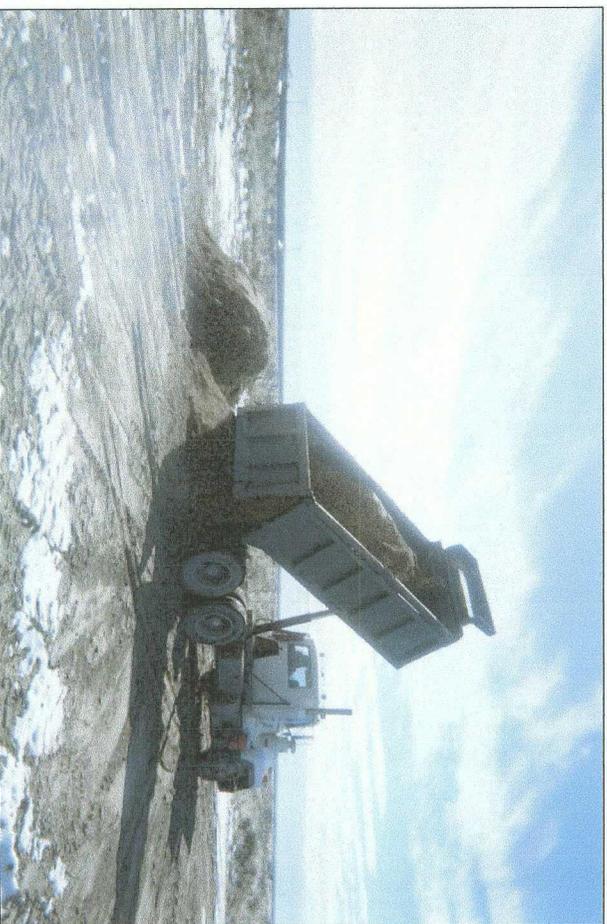
1/24/2007

unloading imported topsoil

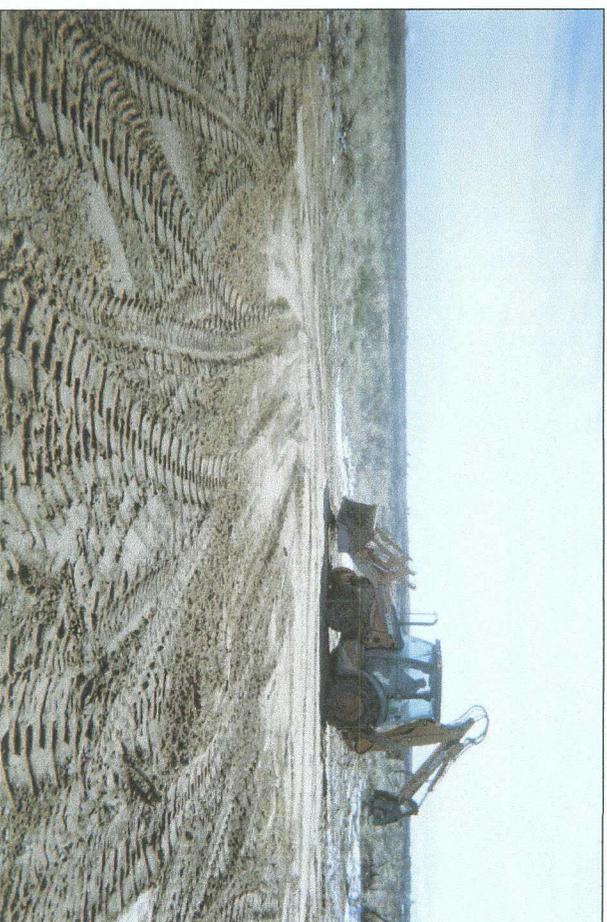
1/24/2007

spreading topsoil on backfilled site
