EME Jct D-18

CLOSURE

RICE OPERATING COMPANY  
JUNCTION BOX FINAL REPORT

Unit D, Section 18, T19S, R37E

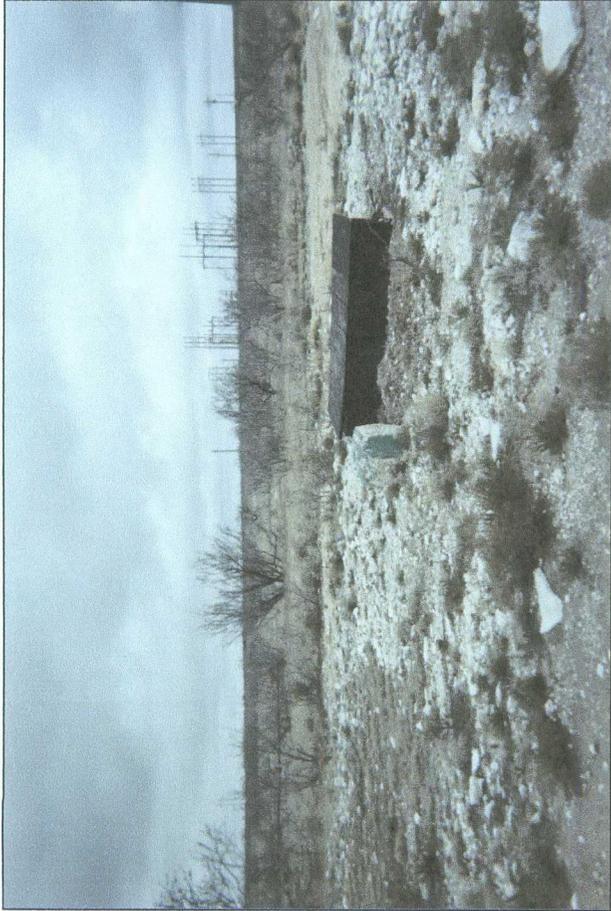
1/31/2005

undisturbed junction box

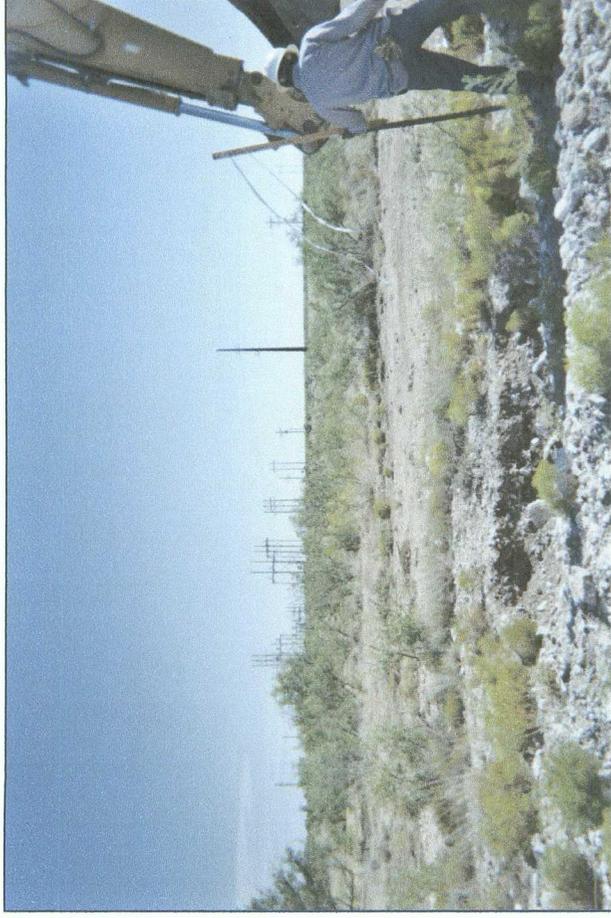
8/29/2007

delineation trench at former box site

for physical indications of impact; none were observed. Vegetation surrounding the site was healthy and abundant. A backhoe was used to collect soil

samples directly below the junction site. Soil at the site is characterized by shallow sand and hard caliche from 3-12 ft BGS. Chloride field tests were

conducted on each sample to 12 ft and yielded very low concentrations throughout the trench. Organic vapors were also measured from each sample using

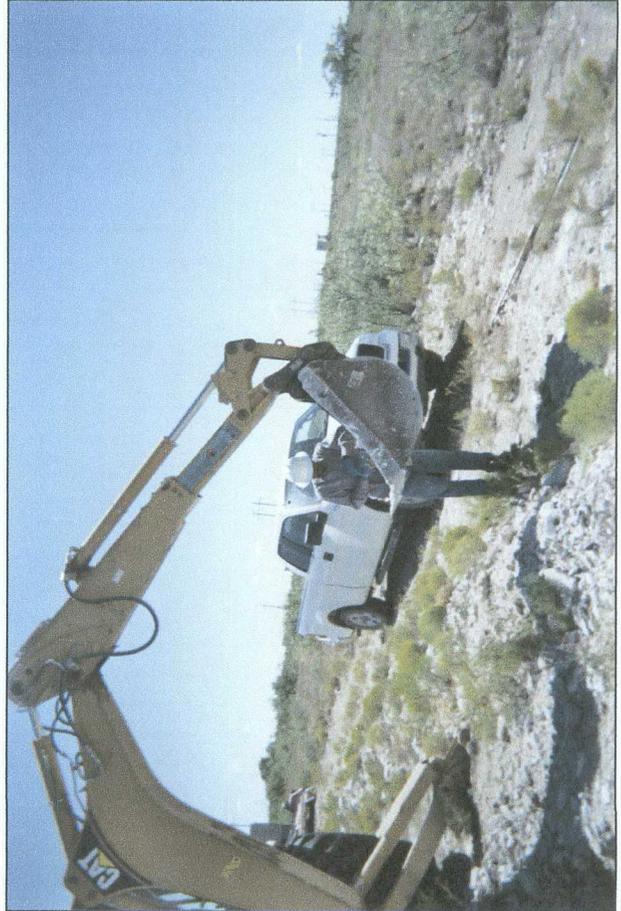
8/29/2007

collecting samples from backhoe bucket

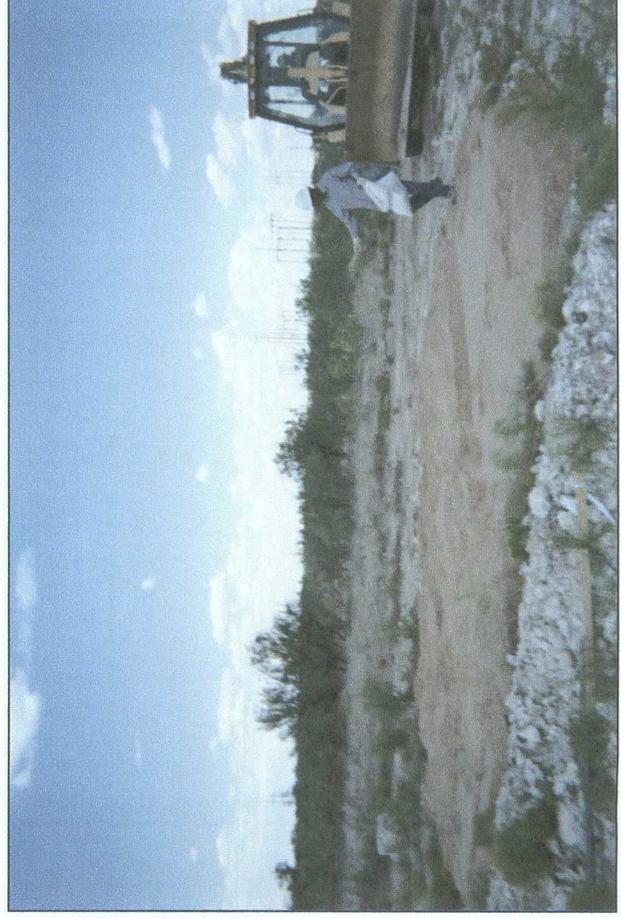
backfilled trench; clean soil spread; seeding

The delineation trench was backfilled with the excavated soil and 6 cubic yards of clean, imported soil was spread on top of the site. The surface area was

seeded with a blend of native vegetation on 8/29/2007 and is expected to return to productive capacity at a normal rate.
