EME Jct P-27-1

1R-427-218

**RICE OPERATING COMPANY
JUNCTION BOX FINAL REPORT**

SWD SYSTEM	JUNCTION	UNIT	SECTION	TOWNSHIP	RANGE	COUNTY	NEW BOX DIMENSIONS - FEET		
							Length	Width	Depth
EME	jct. P-27-1	P	27	19S	36E	Lea	no box; junction eliminated

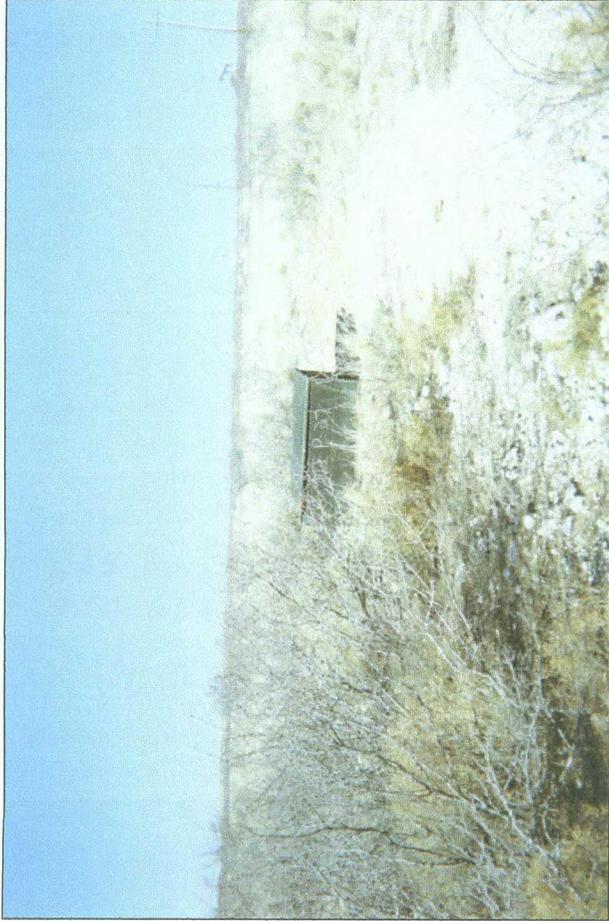
2/6/2006

undisturbed junction box

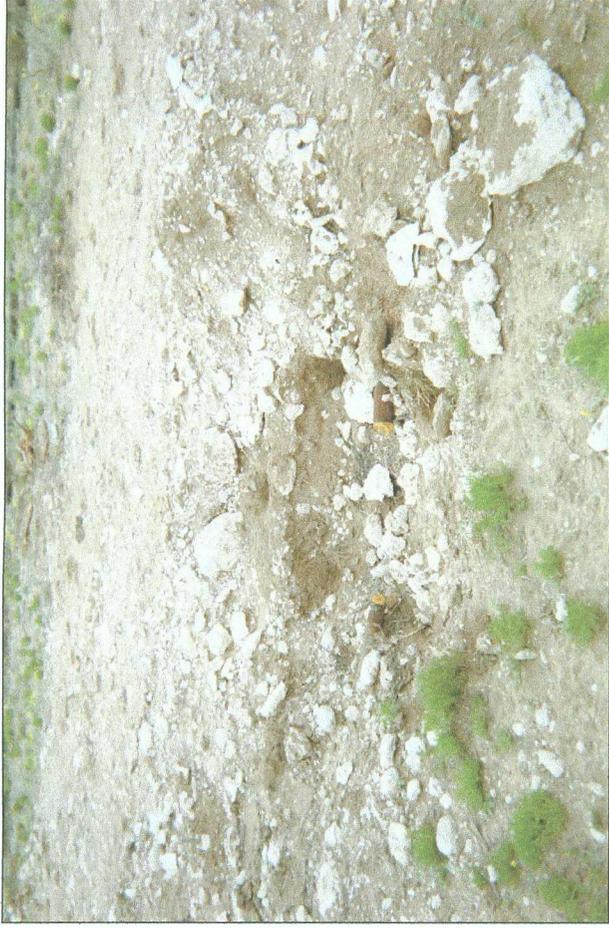
3/9/2007

box removed from site and pipelines capped

This junction was eliminated with the pipeline replacement/upgrade program. After the box lumber was removed, an investigation was conducted and a hand auger was used to collect soil samples at and around the former box site. Chloride field tests were performed on each sample and all of them yielded concentrations similar to background levels. Organic vapors were measured from each sample as they were collected and yielded very low concentrations as well. Laboratory analysis confirmed the field results and neither TPH nor chloride was present within the laboratory's detection limits. There were no physical indications of impact to the soil at or around the former box site so the hole was backfilled. Additional clean fill was imported to backfill and contour the remainder. On 4/18/2007 the disturbed surface was seeded with a blend of native vegetation and is expected to return to productive capacity at a normal rate.

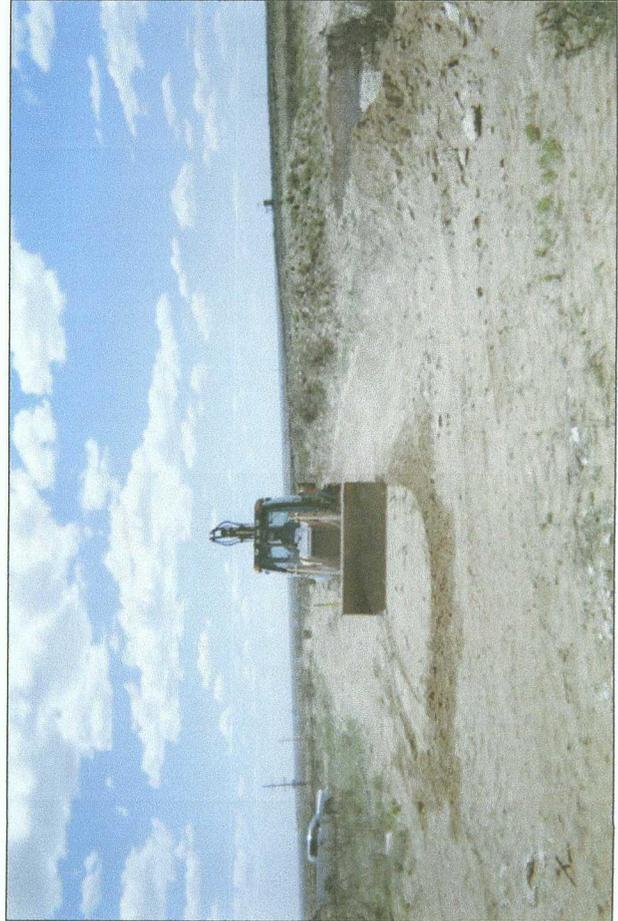
4/17/2007

spreading clean, imported soil over backfilled site

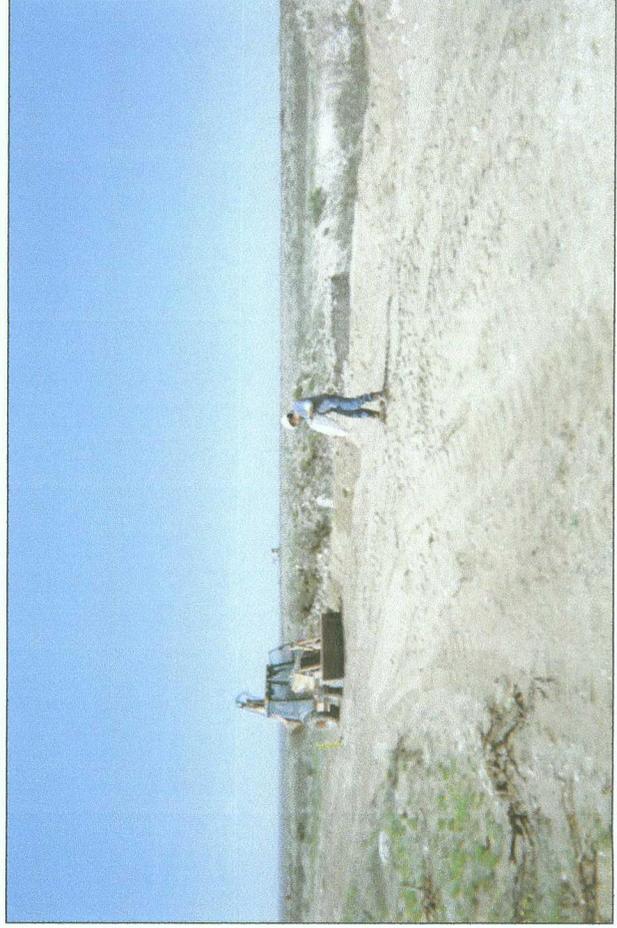
4/18/2007

seeding disturbed area
