EME Jct A-4

**CLOSURE**

RICE OPERATING COMPANY  
JUNCTION BOX FINAL REPORT

# EME jct. A-4

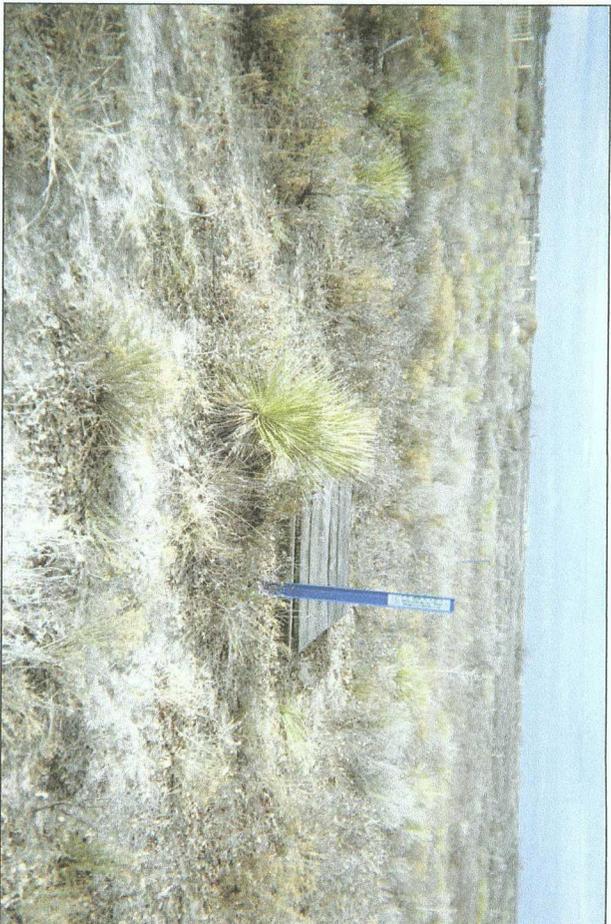
2/2/2006

undisturbed junction box

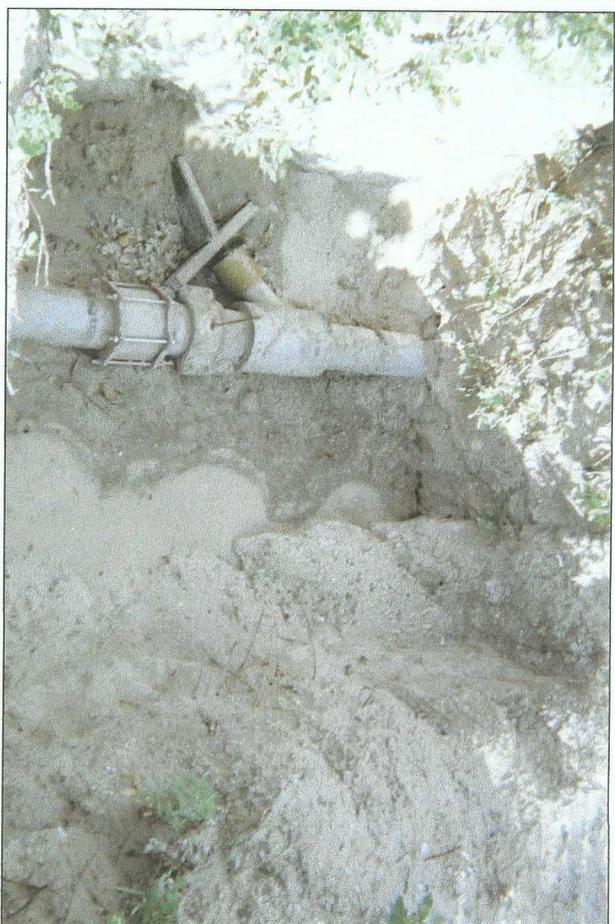
close-up of junction after box was removed; before excavation

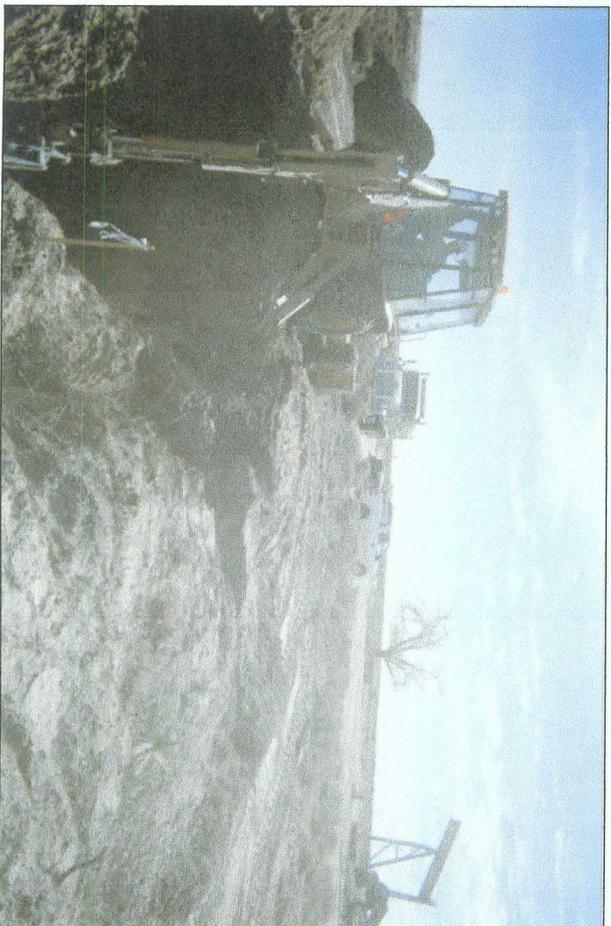
1/10/2007

delineation and excavation

This junction was eliminated with the pipeline replacement/upgrade program. After the box lumber was removed, soil samples were collected a regular intervals using a backhoe to produce a 10 x 10 x 12-ft-deep hole. Chloride field tests conducted on each sample revealed very low concentrations throughout, similar to background level (262 ppm). Organic vapors were also measured on each sample using a PID which yielded very low concentrations as well. Confirmation samples were collected for laboratory analysis which confirmed all field results. The excavated soil was blended on site and then returned to the excavation and contoured to the surrounding surface. On 3/5/2007, the disturbed surface was seeded with a blend of native vegetation and is expected to return to productive capacity at a normal rate.

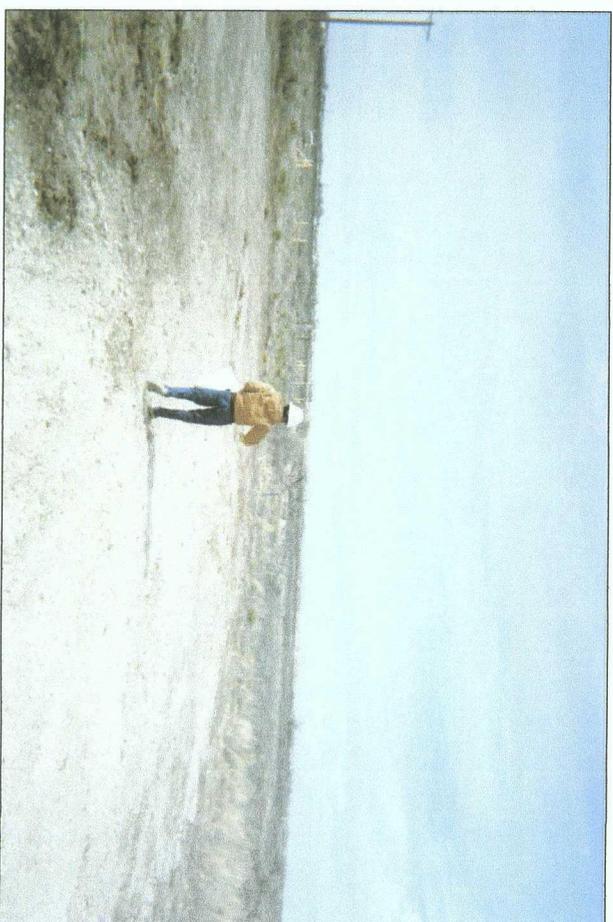
3/5/2007

seeding disturbed area of backfilled site
