Antelope Ridge Unit #2 Flow line
(Located in SECTION 4, T24S, R34E of Lea County, NM)
(GPS Reading of 32°-15'-24.9"-N & 103°-27'-55.3"-W)
(API # 30-025-20444)

Spill Remediation Report

Bold Energy, LP
415 W. Wall Ste. 500
Midland, Texas 79701

Phoenix Environmental, LLC.
P.O. Box 1856
Hobbs, New Mexico 88240

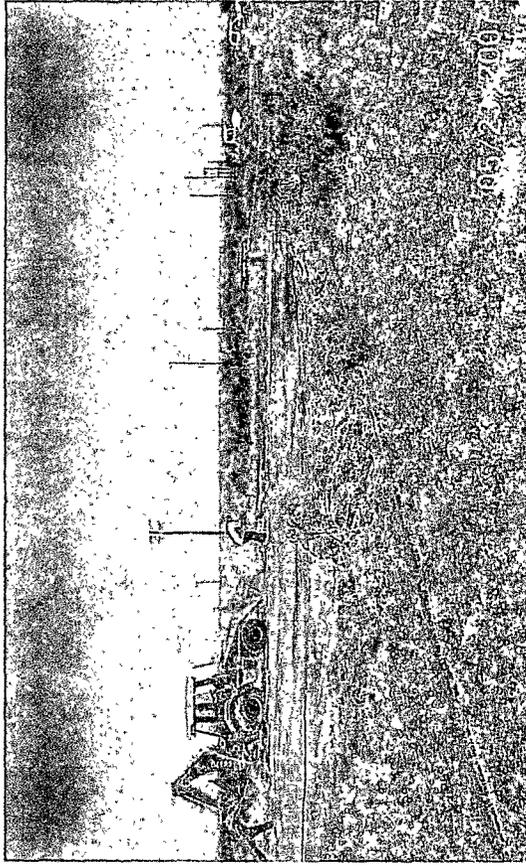
Photo #6 Placing Liner for Stockpiling of Impacted Soils

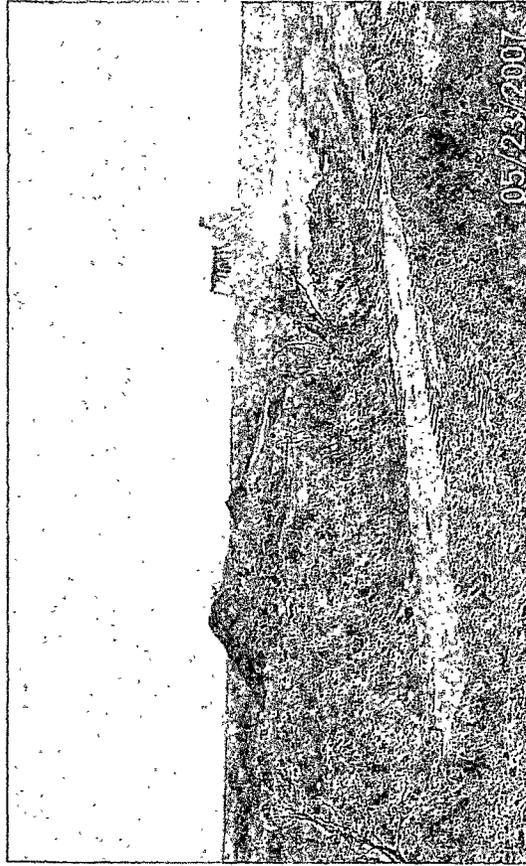
Photo #8 Cleaning up Impacted Soils and Placing on Liner

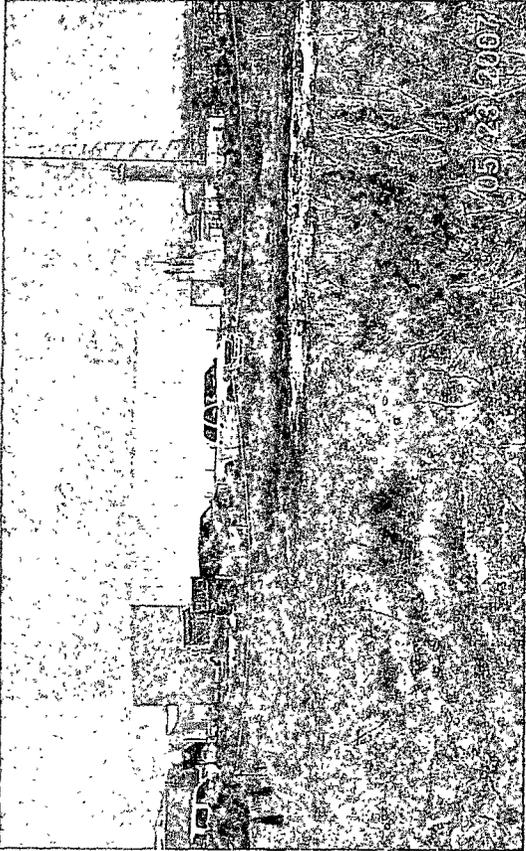
Photo #5 Mobilizing Equipment on Location

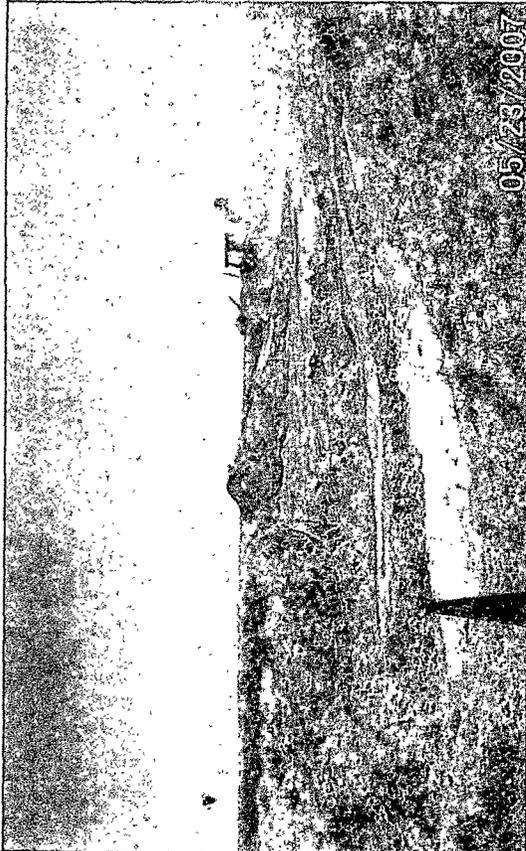
Photo #7 Starting Clean up of Blowout Area

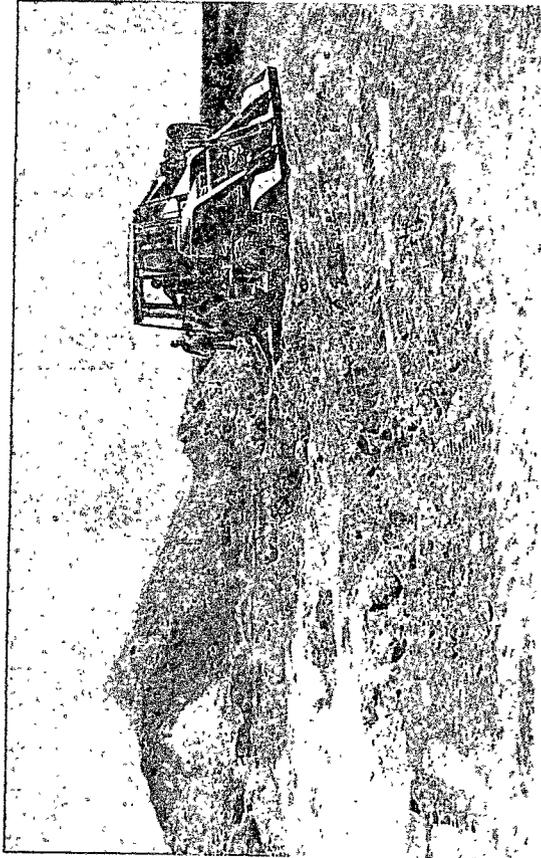
Photo #9 Crew Digging out Flow Line

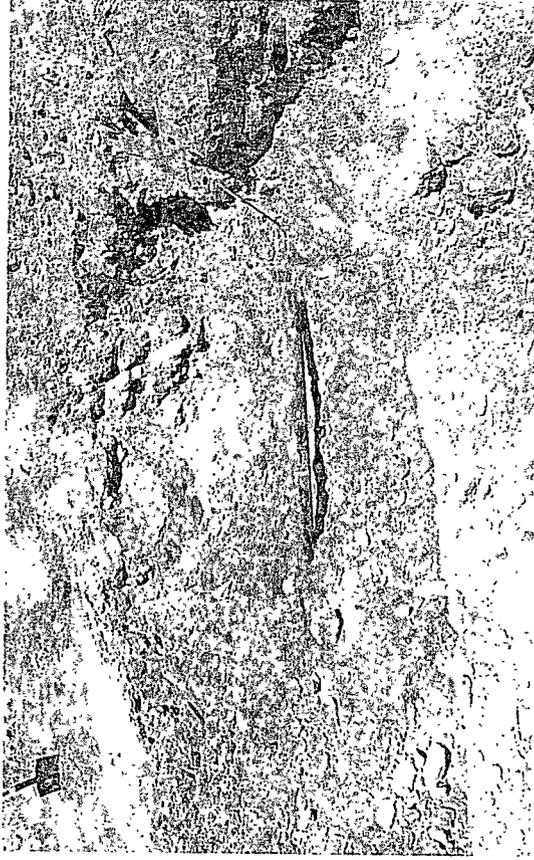
Photo #10 Beginning of Flow Line being Exposed

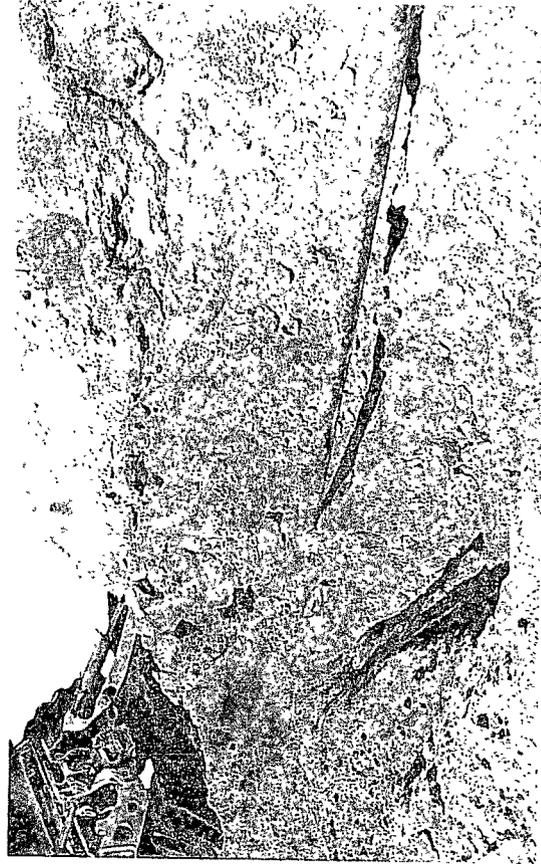
Photo #11 Clearing Soil from Flow Line

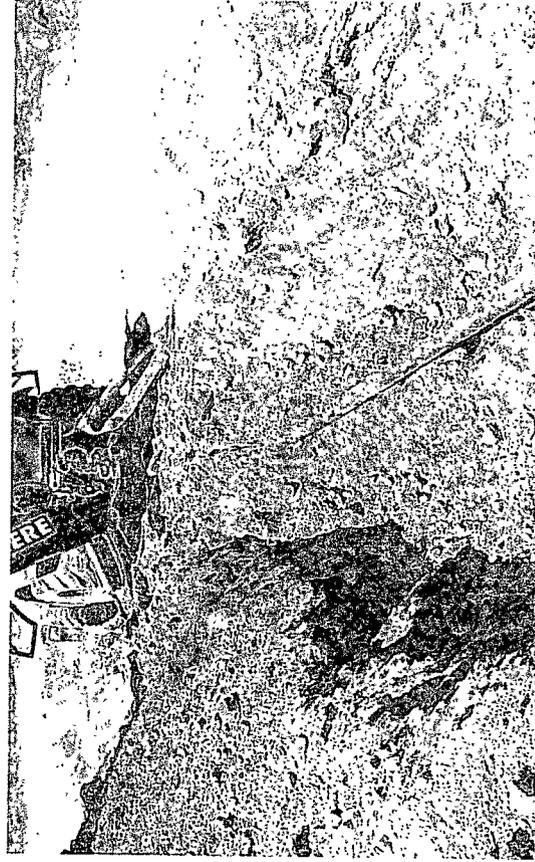
Photo #12 Clearing Soil from Flow Line

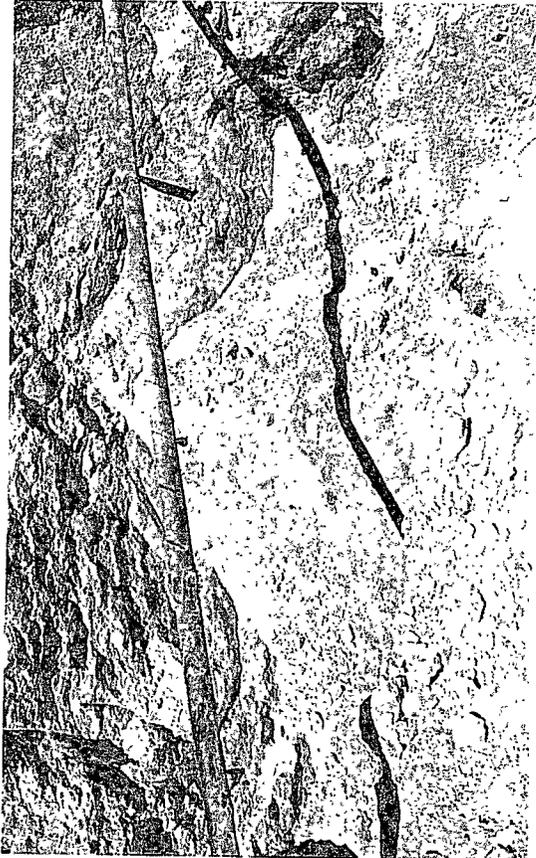
Photo #13 Digging out Impact Soils around Flow Line

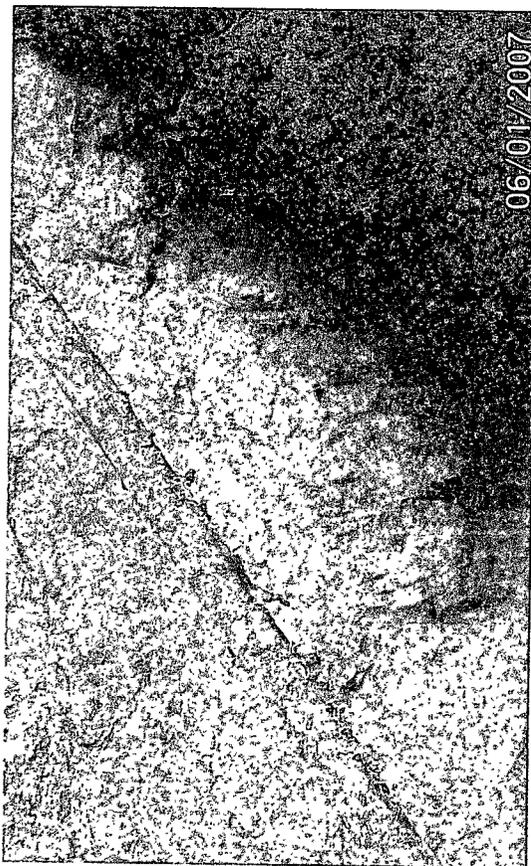
Photo #15 Digging out Impact Soils around Flow Line

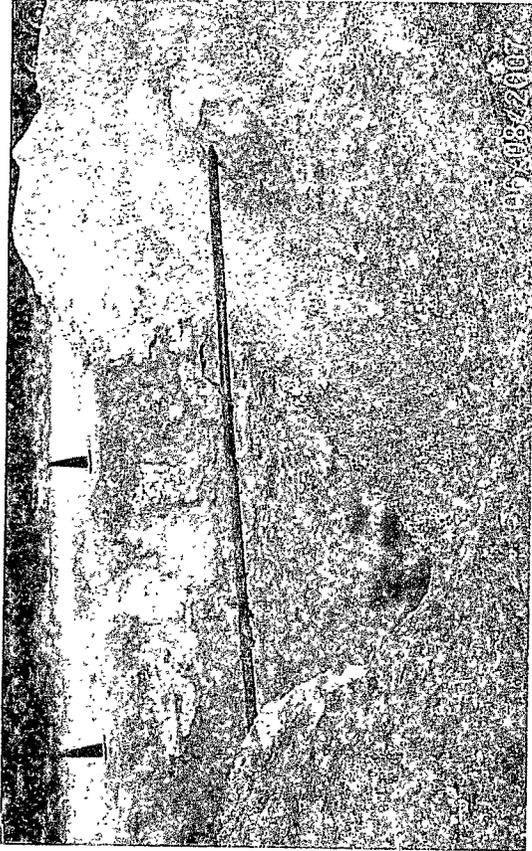
Photo #17 Backfilling Flow Line Blowout Excavation Area

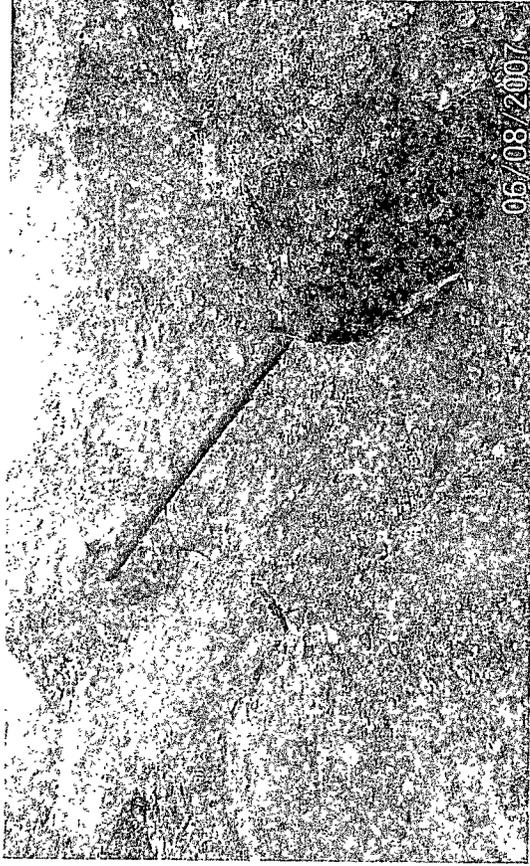
Photo #18 Backfilling Flow Line Blowout Excavation Area

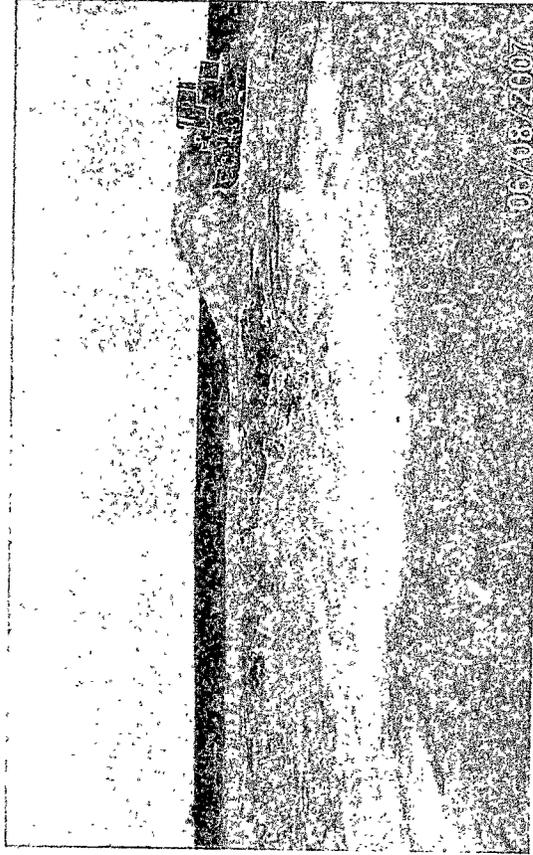
Photo #19 Backfilling Flow Line Blowout Excavation Area

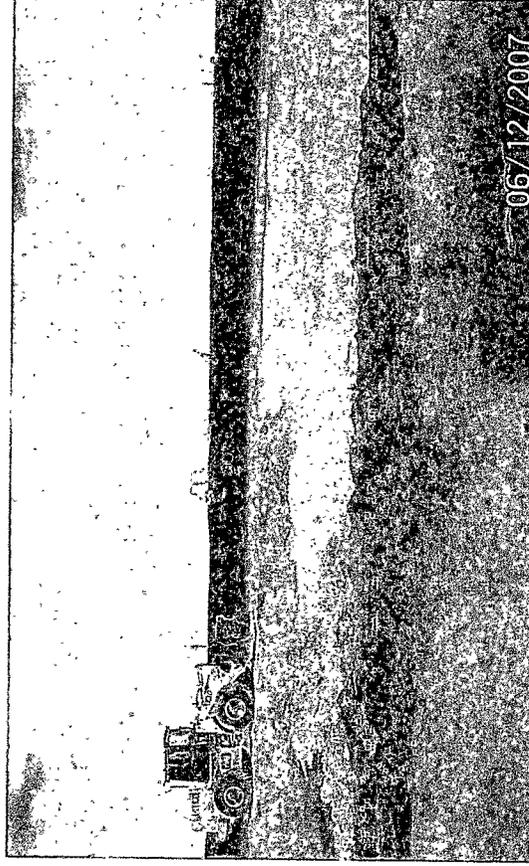
Photo #20 Backfilling Flow Line Blowout Excavation Area

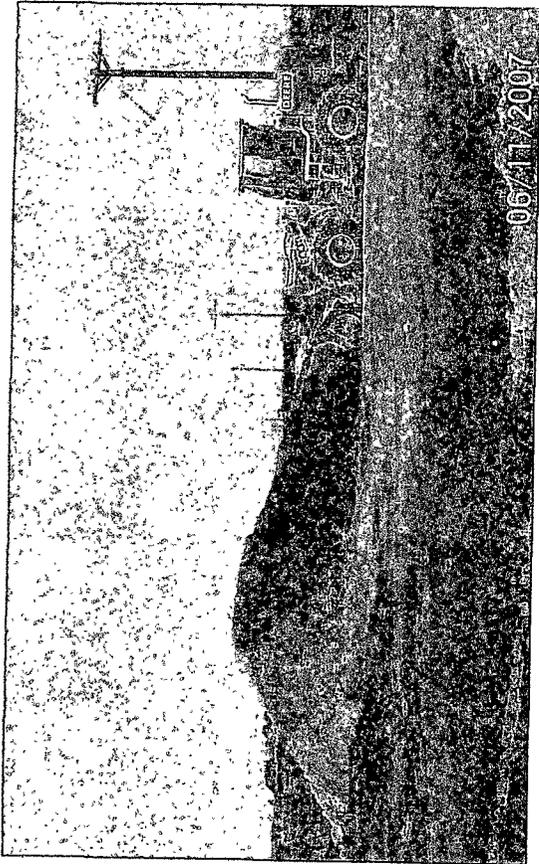
Photo #21 Backfilling and Dressing Location
