**Release Notification and Corrective Action**

Name of Company: Rice Operating	Contact: Tony Grieco
Address: 122 W. Taylor St., Hobbs, NM 88240	Telephone No.: (575) 393-9174
Facility Name: BD	Facility Type: Salt Water Gathering System

# BD H-1 LEAK SITE

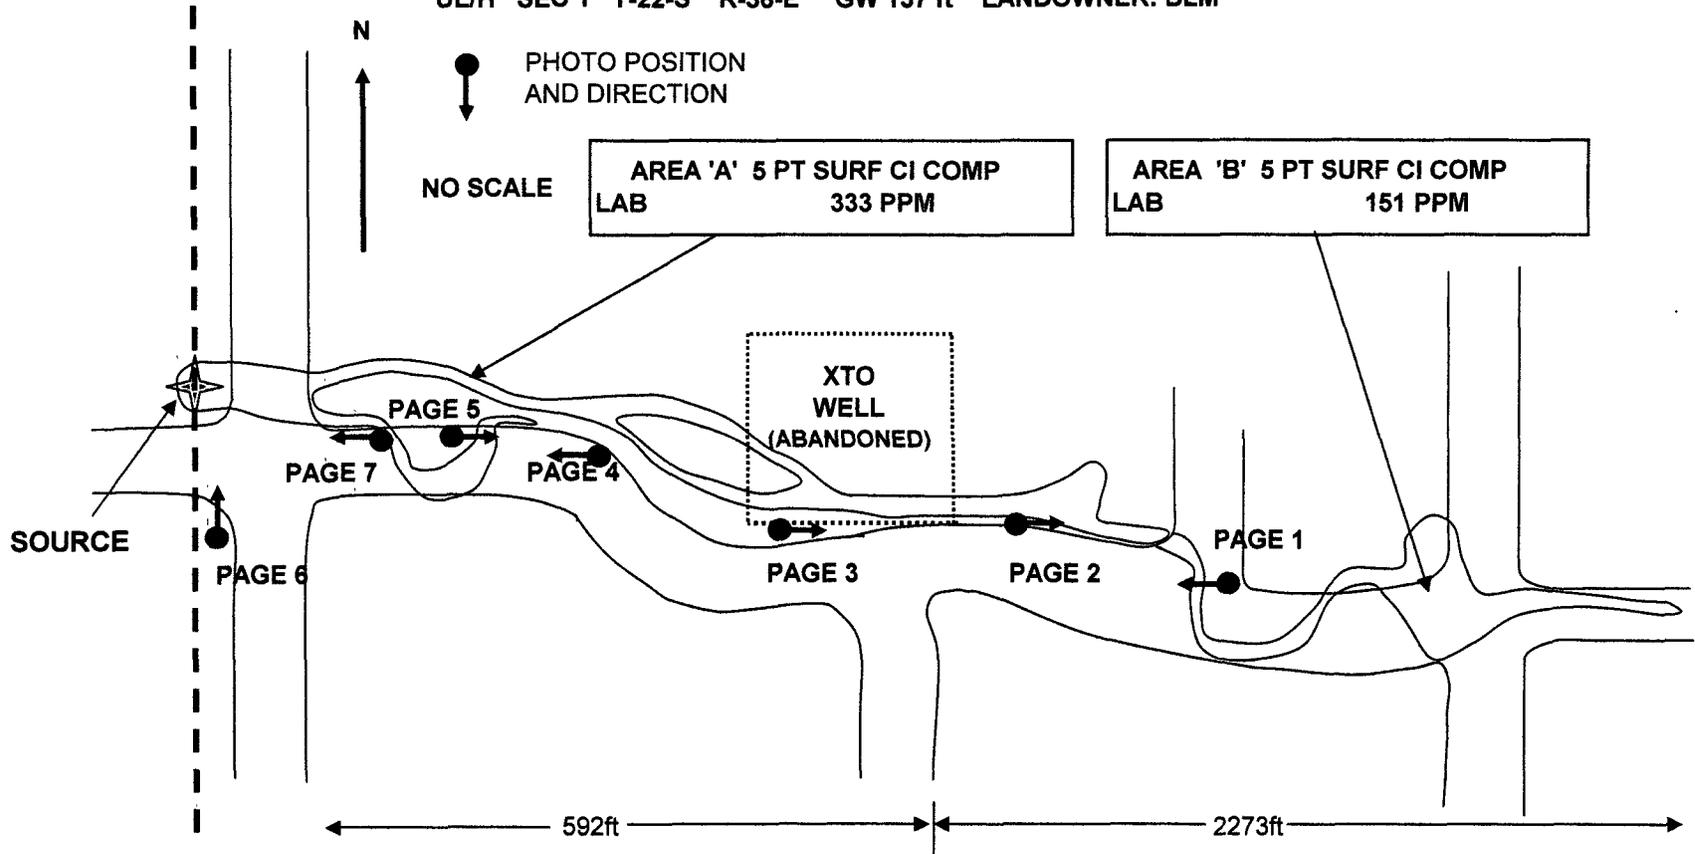
SURFACE CHLORIDES AFTER SCRAPING (4in)

UL/H SEC 1 T-22-S R-36-E GW 137 ft LANDOWNER: BLM

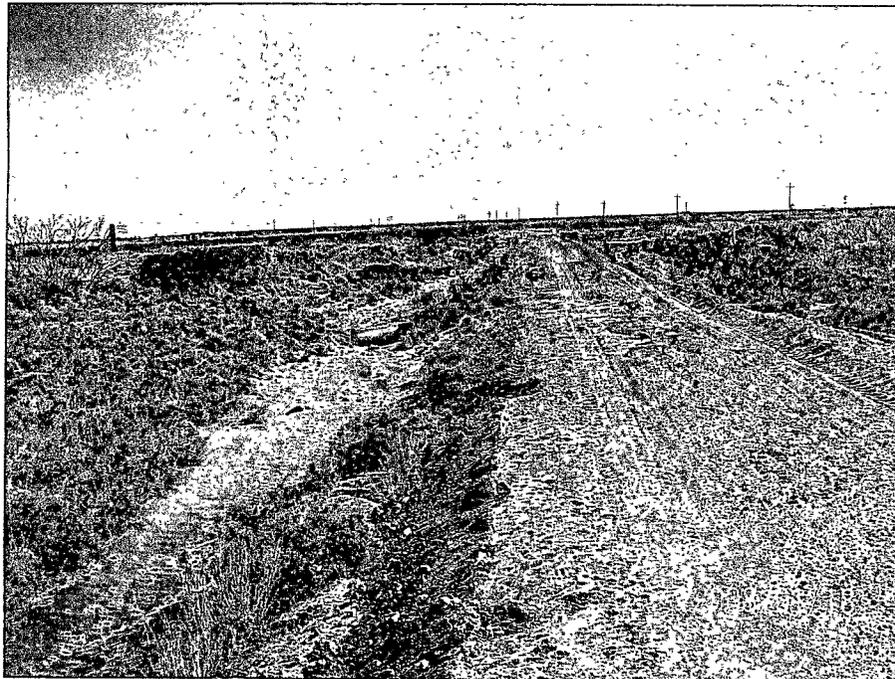
**FACING EAST, FROM THE SOUTHEAST CORNER OF THE XTO WELL PAD**

**AFTER REMEDIATION**

The affected area was approximately 11,460 sq ft. On 1/31/05 and 3/10/06 hand auger samples were taken and field tested for chlorides. ROC discovered a layer of impermeable caliche 6 in to 2 ft below the surface throughout the entire spill area. The ditch next to the roadway was where most of the release gathered and was contained. The surface of the roadway is caliche, but there is historic asphaltic material present beneath it. On 11/8/06 the entire area was scraped to a depth of 4 in and 12 yds of impacted soil was removed to Sundance disposal facility. On 11/9/06 24 yds of base coarse and 24 yds of blowsand were imported and spread. On 1/17-18/08, 180 yds of caliche were imported and used to repair the eroded lease road and build up the area around the leak source. The pasture area was seeded on 1/18/08 with 4 lbs of BLM #2 mix. BLM was notified and consulted for each event and concurs that remediation is complete.

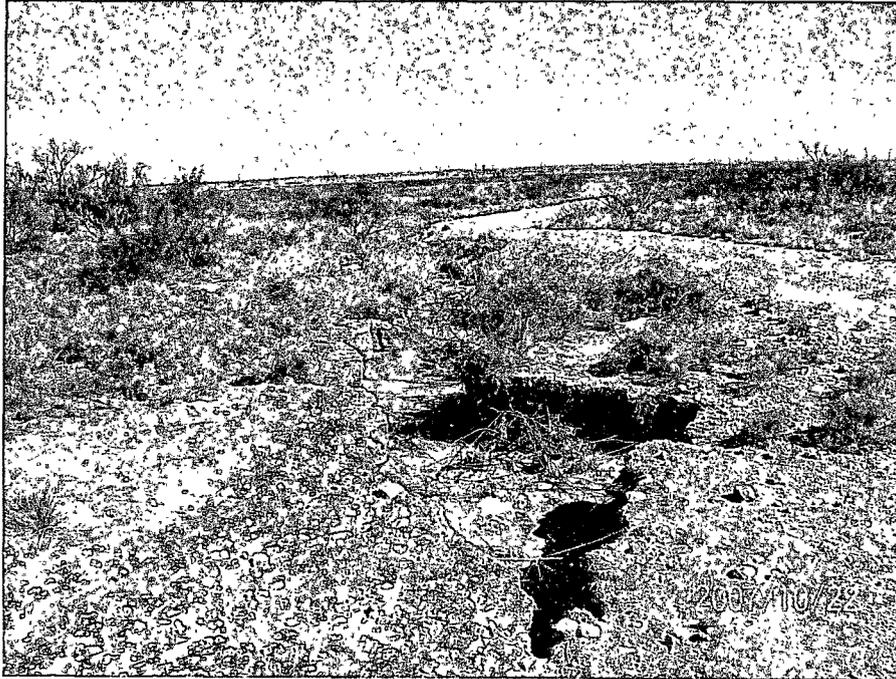
FACING EAST, IMMEDIATELY SOUTH OF THE XTO WELL LOCATION

BEFORE REMEDIATION

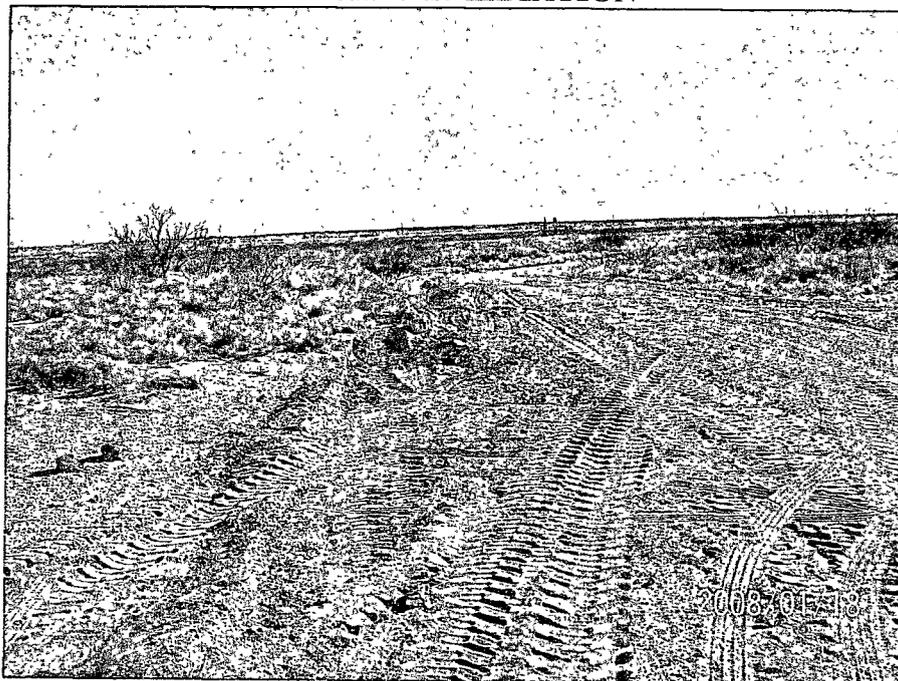
AFTER REMEDIATION

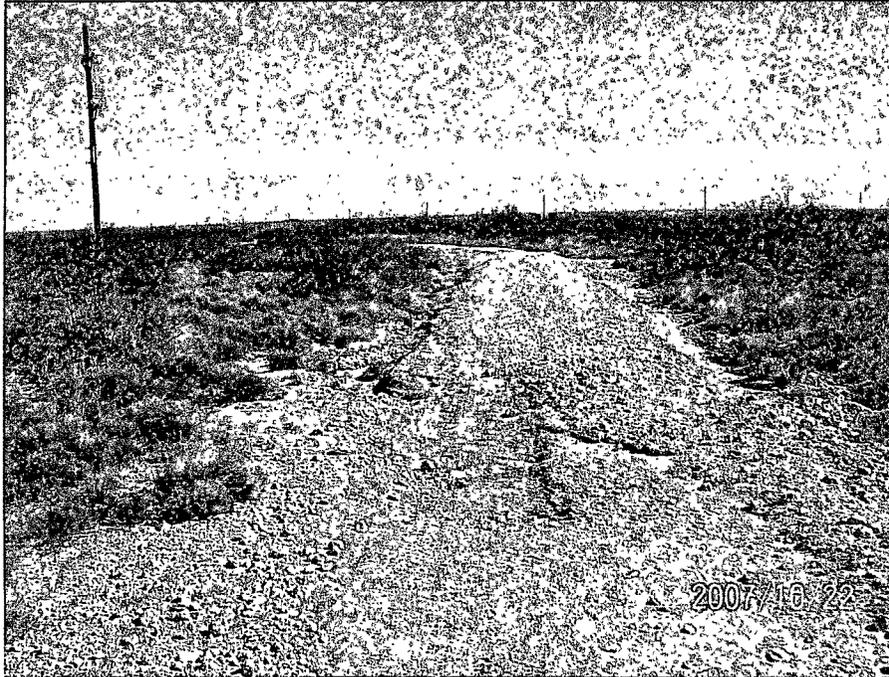
FACING EAST BETWEEN SOURCE AND XTO LOCATION

BEFORE REMEDIATION

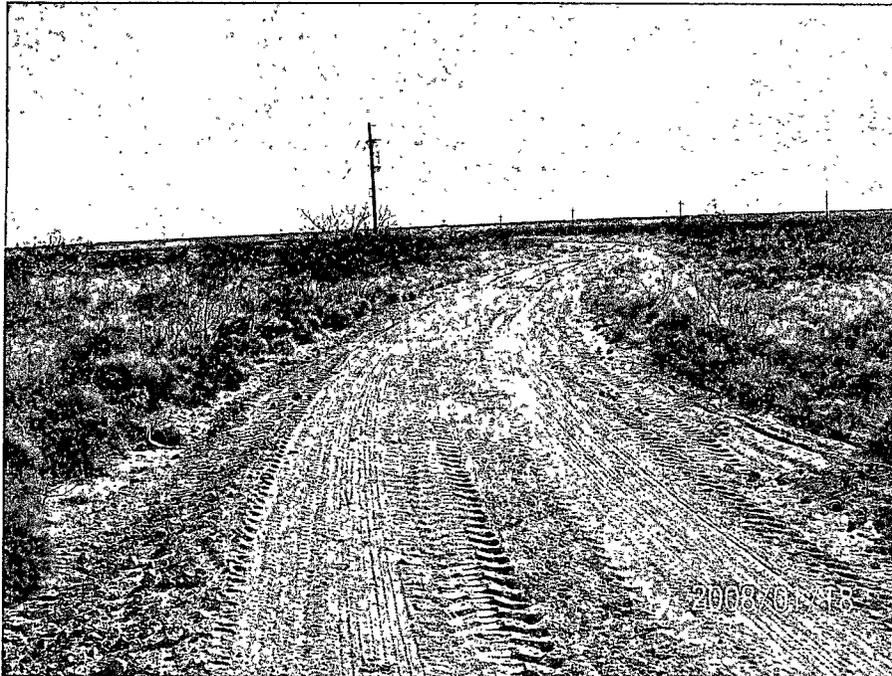
AFTER REMEDIATION

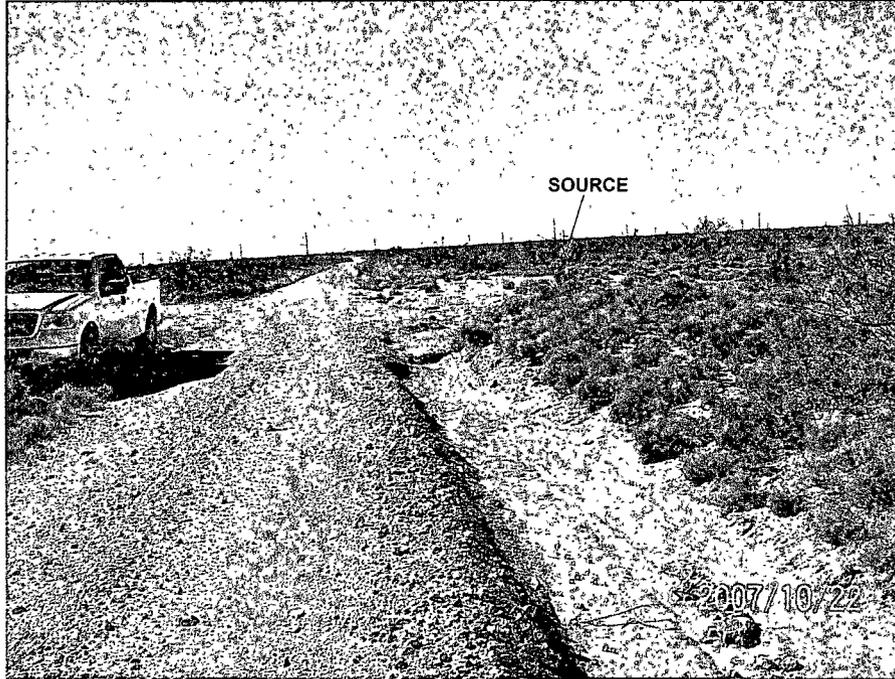
FACING WEST TOWARD SOURCE

BEFORE REMEDIATION

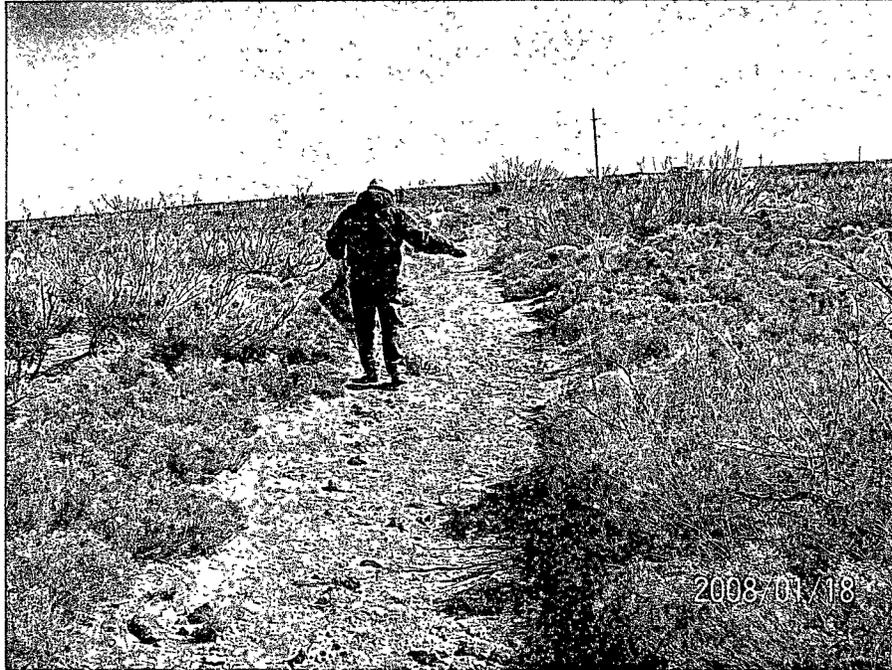
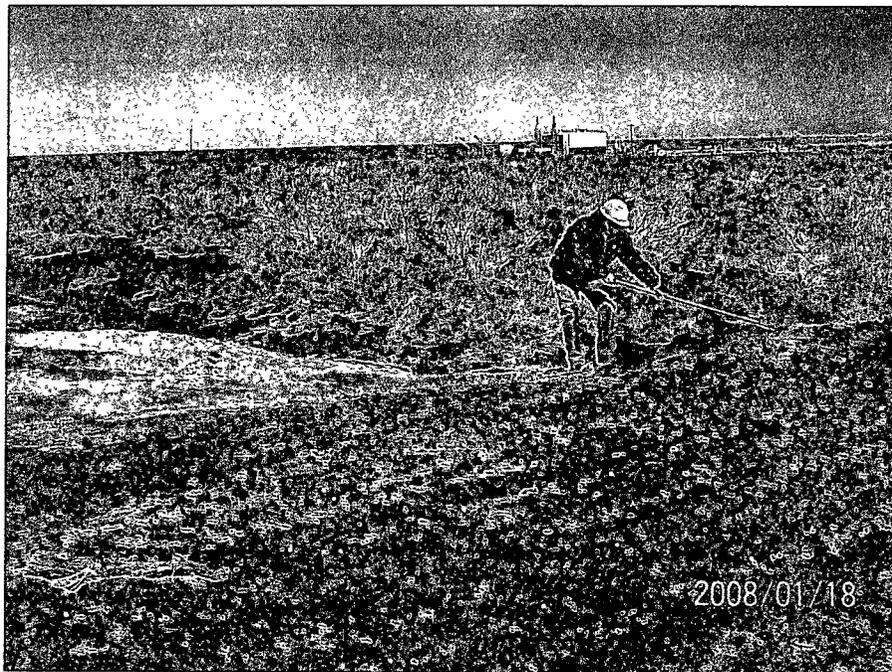
**SEEDING REMEDIATED AREA**
