RE: Phase II Remediation, Cockburn State "B" Well Site Pit, Lea County, New Mexico

Report on Phase II Remediation Activities at the Cockburn State "B" Well Site Pit, Lea County, New Mexico

June 30, 2008

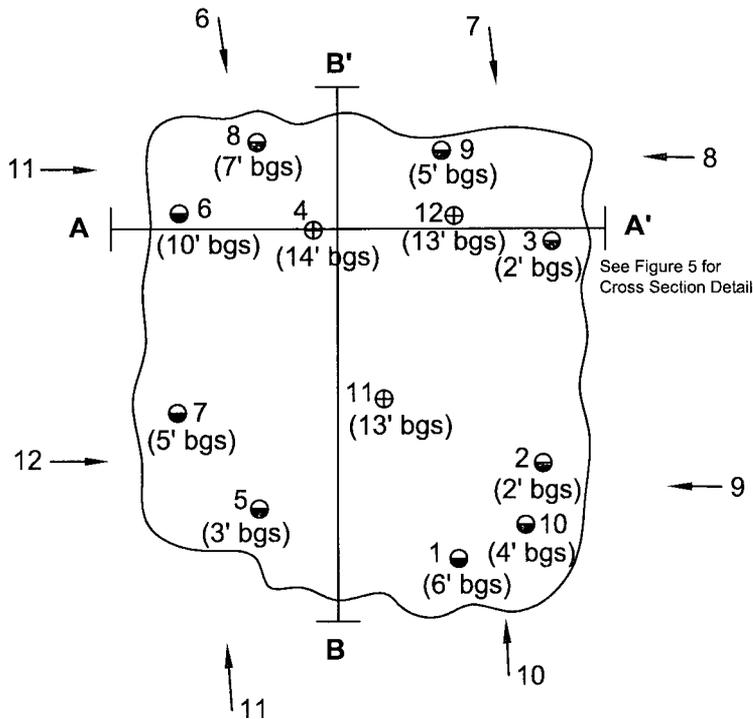
Figure 4
Excavation Detail / Sample & Photograph Locations

Legend	
	11 Photograph ID and Direction
	2 (10' bgs) Wall Sample ID and Depth (feet)
	4 (14' bgs) Excavation Bottom Sample ID and Depth (feet)

Notes:
 bgs = below ground surface
 Sample Dates: June 11 and 12, 2008

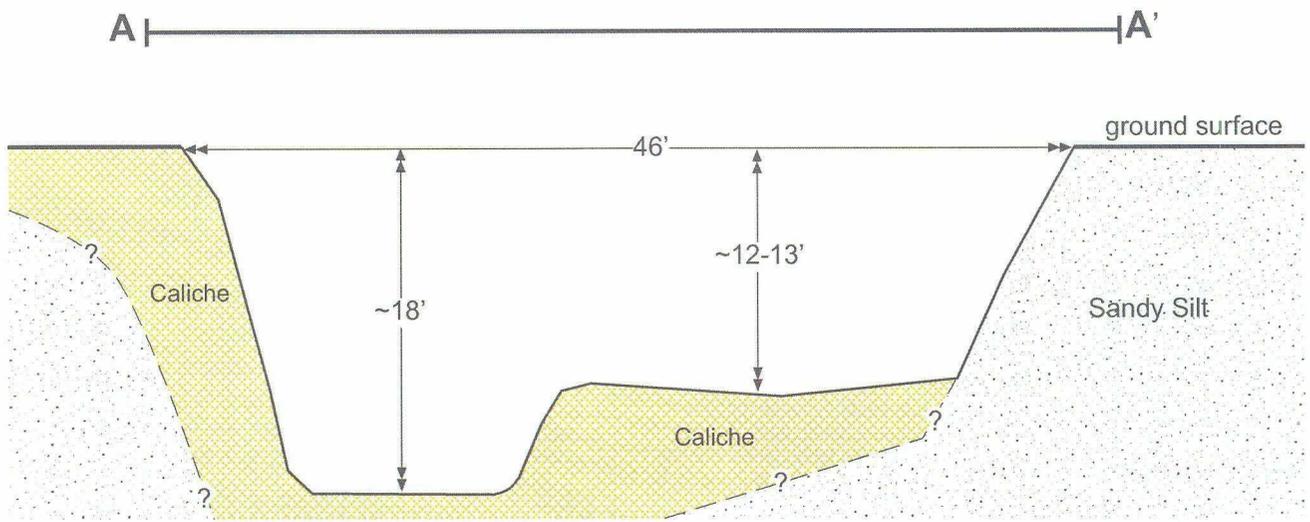
View Looking North
 Approx. Scale: 1" = 10'

See Appendix B, Photographic Log;
 photograph number 11.

Notes: Cross sections are of pit area after excavation.
 See Figure 4 for cross section lines.

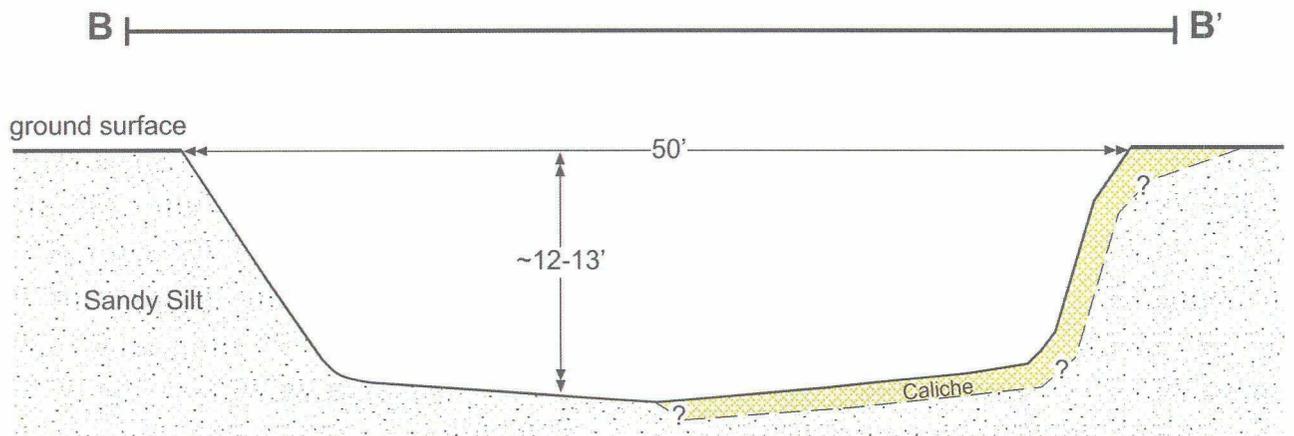
View Looking West
 Approx. Scale: 1" = 10'

See Appendix B, Photographic Log;
 photograph number 8.

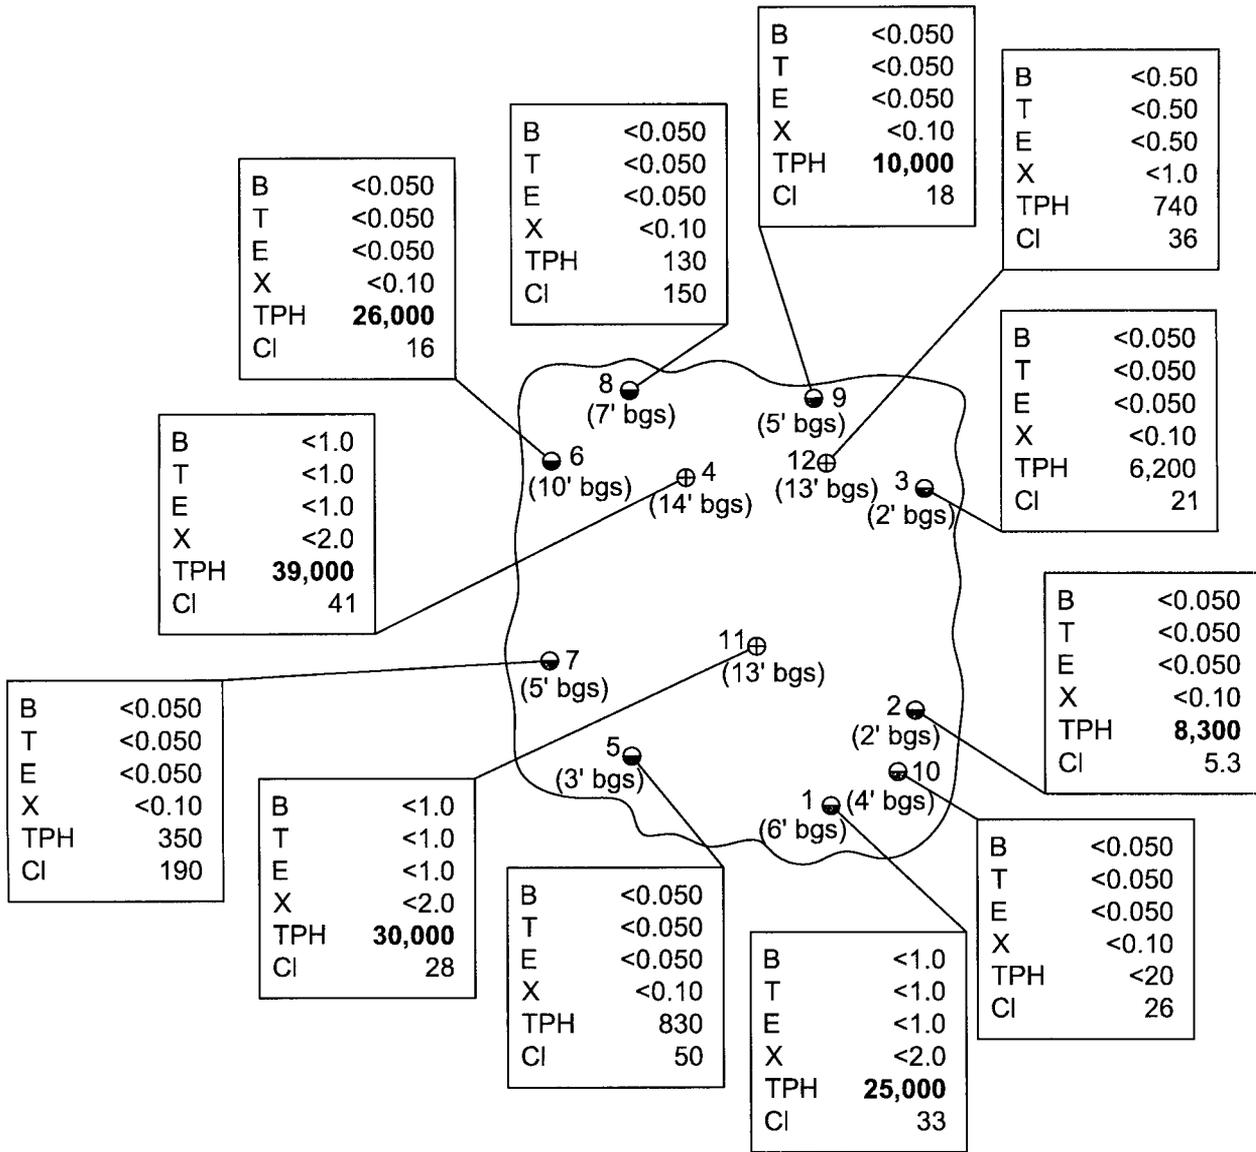
Figure 6
Sample Results

- Soil contamination extends beyond the excavation boundaries. TPH concentrations in excess of the cleanup standard of 2,500 mg/kg were found in seven out of twelve soil samples (Table 2). These seven samples were collected from the center of the south wall, the south side of the east wall, the north side of the east wall, the north side of the west wall, the east side of the north wall, the northwest side of the pit floor, and the center of the east side of the floor. However, it is likely that contamination on the floor of the pit is actually from material that sloughed in from the surrounding walls.

Notes:
 All concentrations shown are in milligrams/kilogram
 B = Benzene
 T = Toluene
 E = Ethylbenzene
 X = Xylenes
 TPH = Total Petroleum Hydrocarbons
 Cl = Chloride
 Sample Dates: June 11 and 12, 2008
 Results in **bold** indicate a concentration above Site cleanup standards

Based on the project findings, INTERA recommends that soil borings be advanced in all directions from the excavation in order to delineate the horizontal and vertical extent of TPH contamination at the Site. Once the extent of the contamination has been defined, a feasibility study should be performed that evaluates various technologies suitable for the remediation of the remaining contamination.

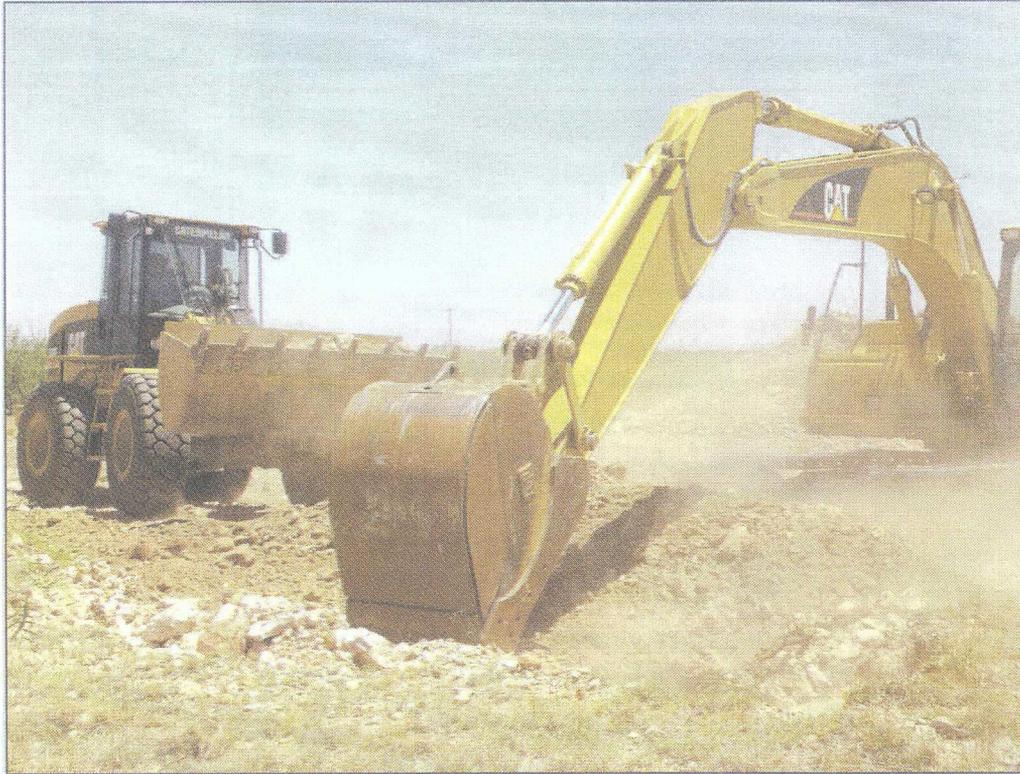
No. 1 – Beginning to excavate the overburden from the 2007 excavation.

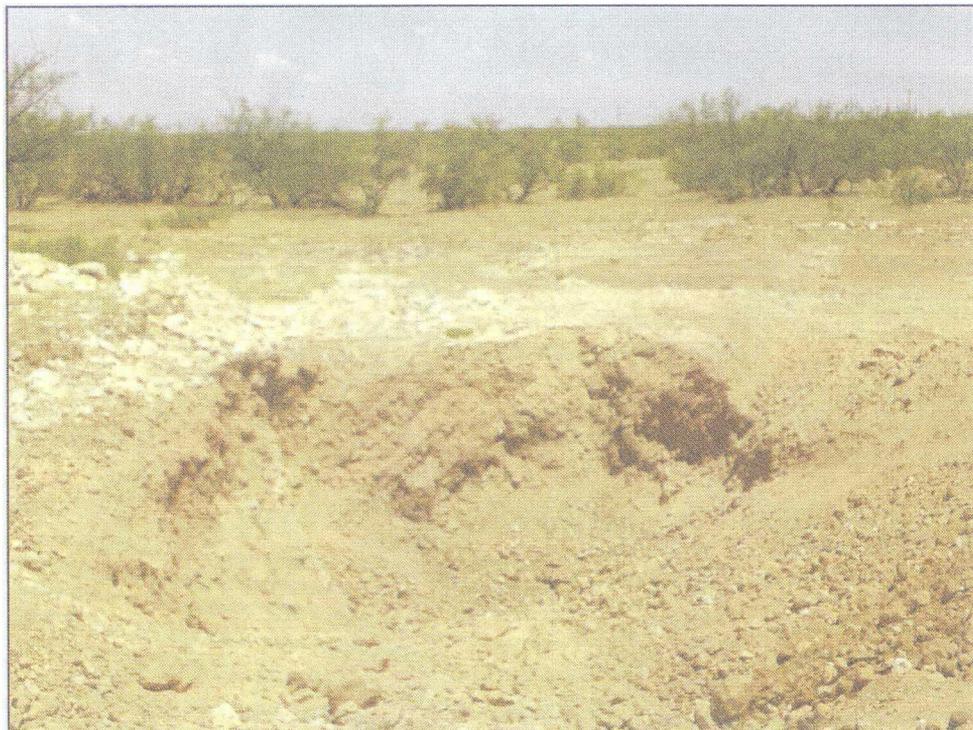
No. 2 – The view of the pit once the overburden was removed.

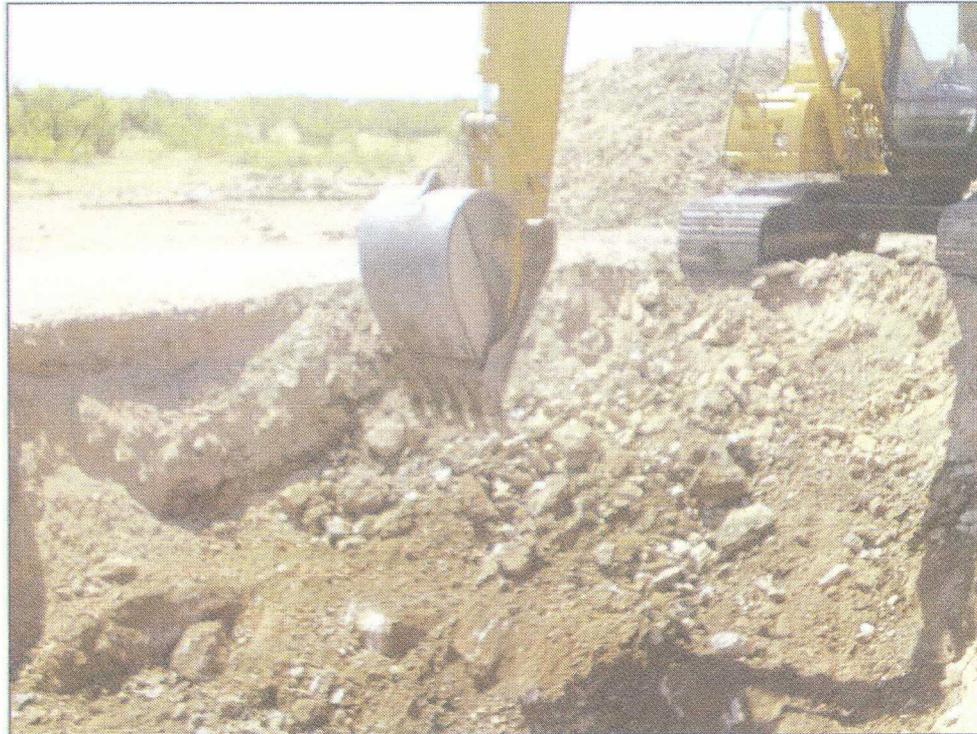
No. 3 – Beginning to excavate contaminated soil.

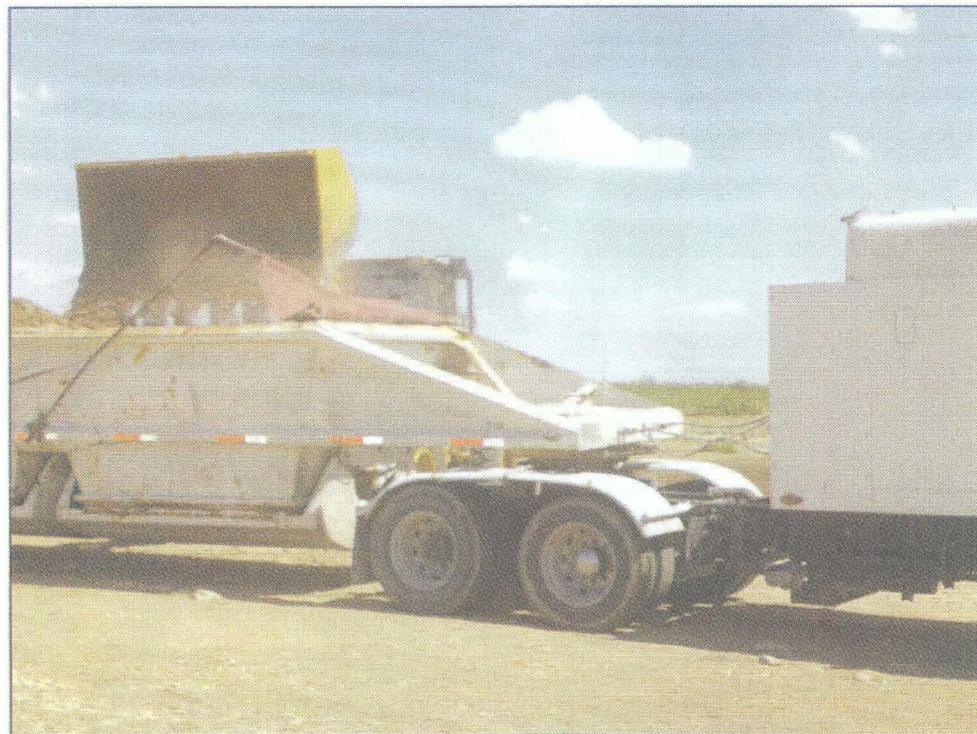
No. 4 – Loading a belly dump truck to haul the contaminated soil to the CRI facility.

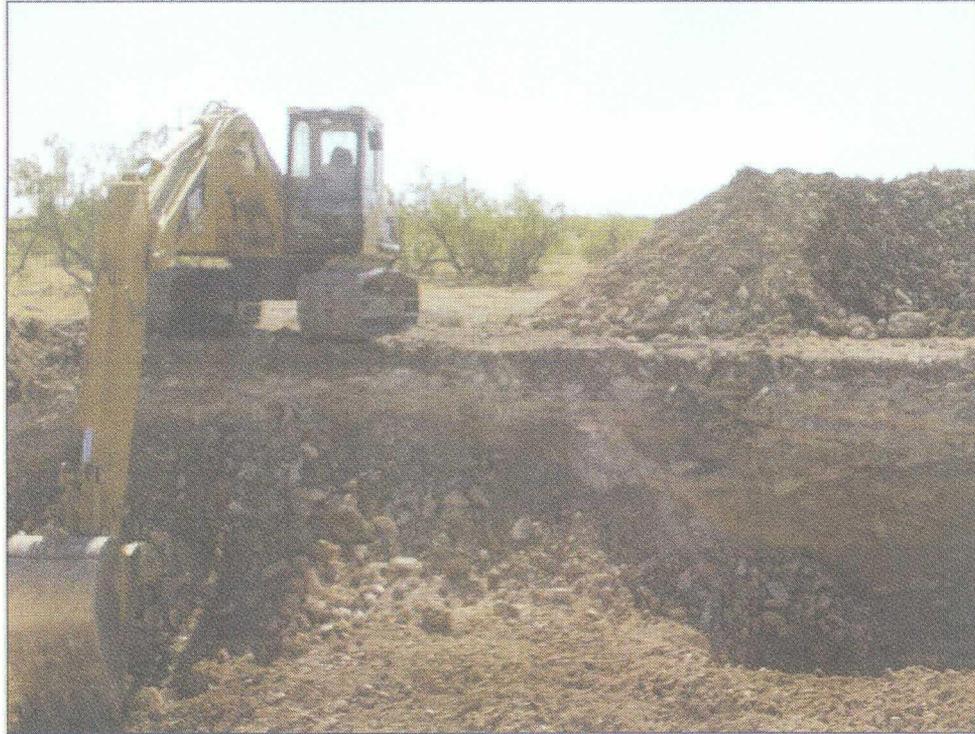
No. 5 – Nearing the end of the excavation.

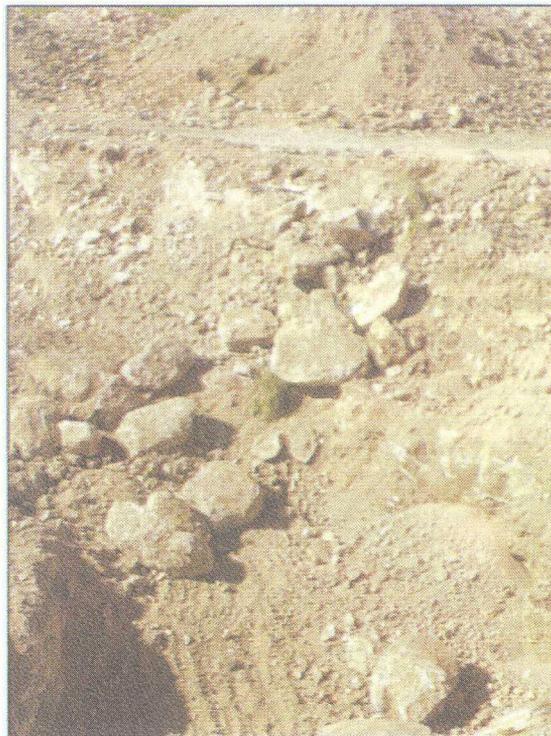
No. 6 – Looking south from the northwest corner to the southwest corner of the pit.

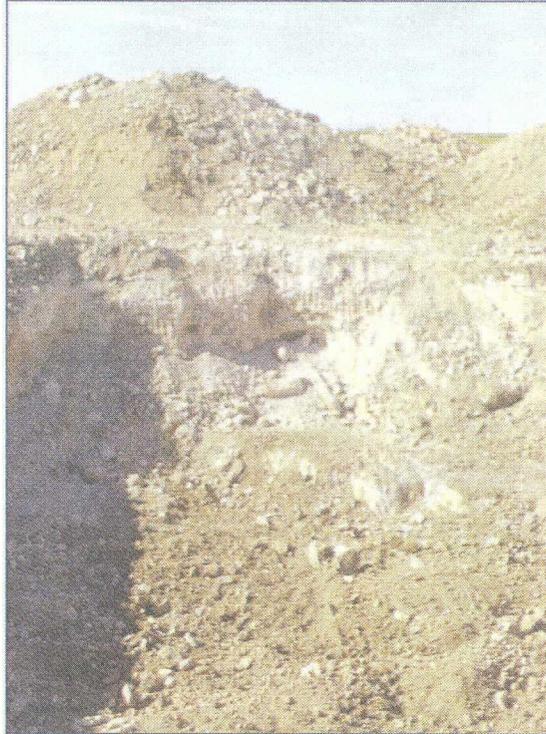
No. 7 – Looking south from the northeast corner to the southeast corner of the pit.

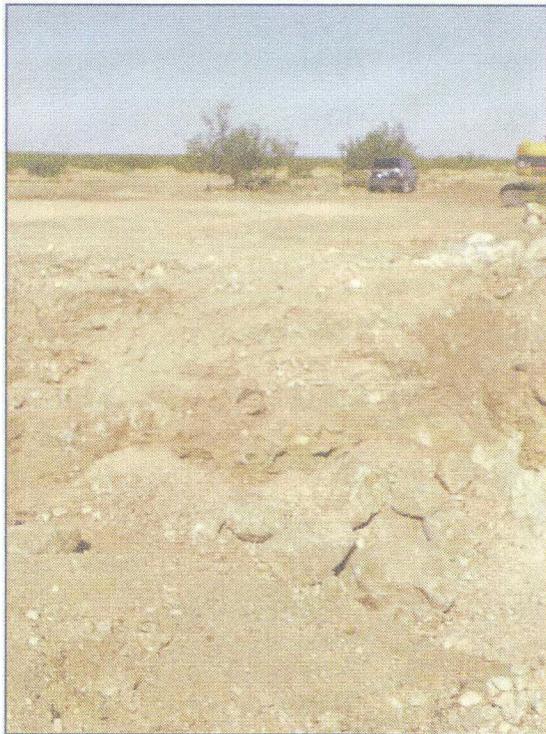
No. 8 – Looking west from the northeast corner to the northwest corner of the pit.

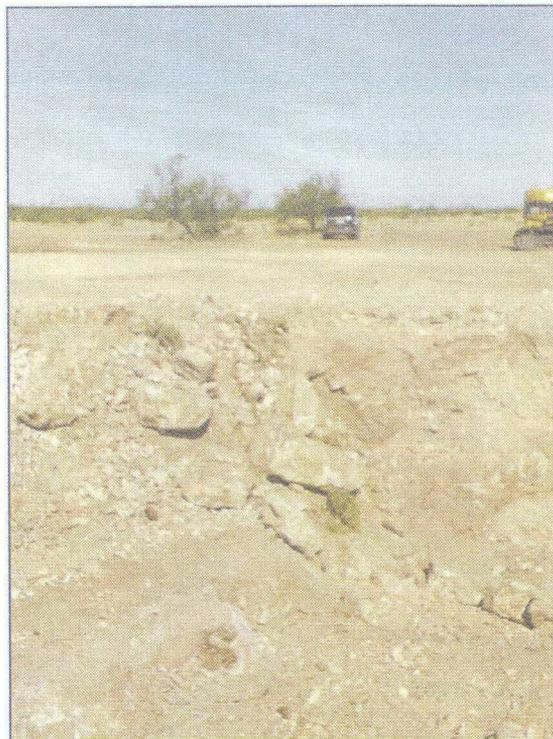
No. 9 – Looking west from the southeast corner to the southwest corner of the pit.

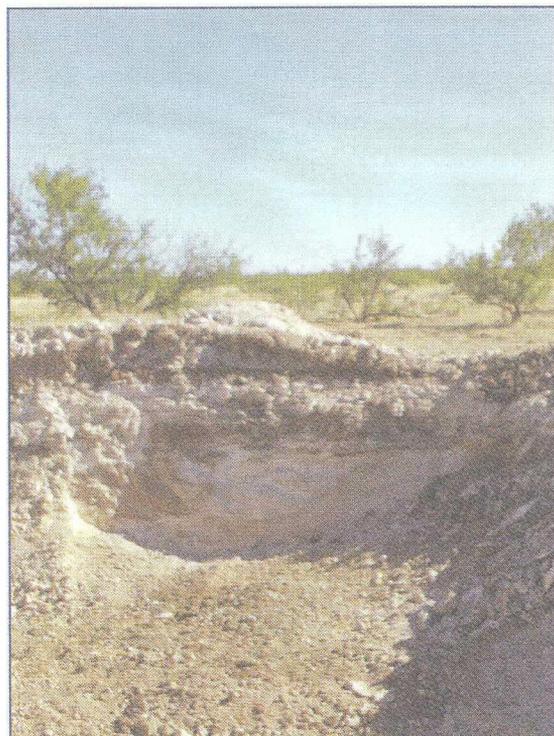
No. 10 – Looking north from the southeast corner to the northeast corner of the pit.

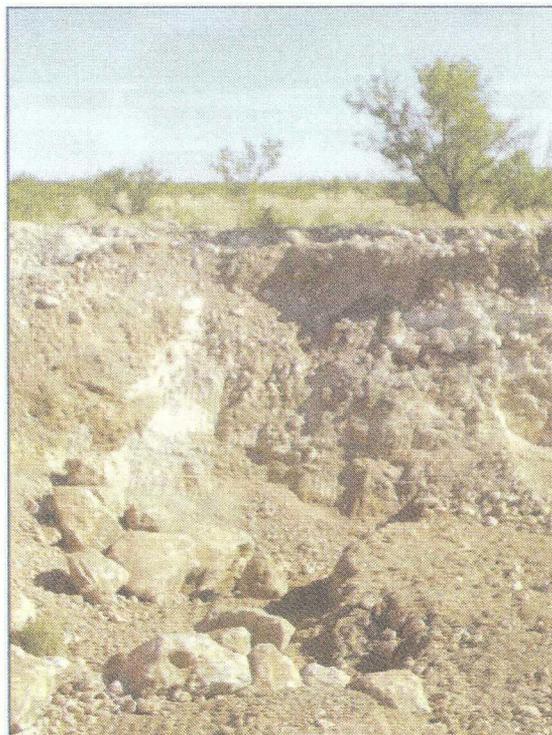
No. 11 – Looking north from the southwest corner to the northwest corner of the pit.

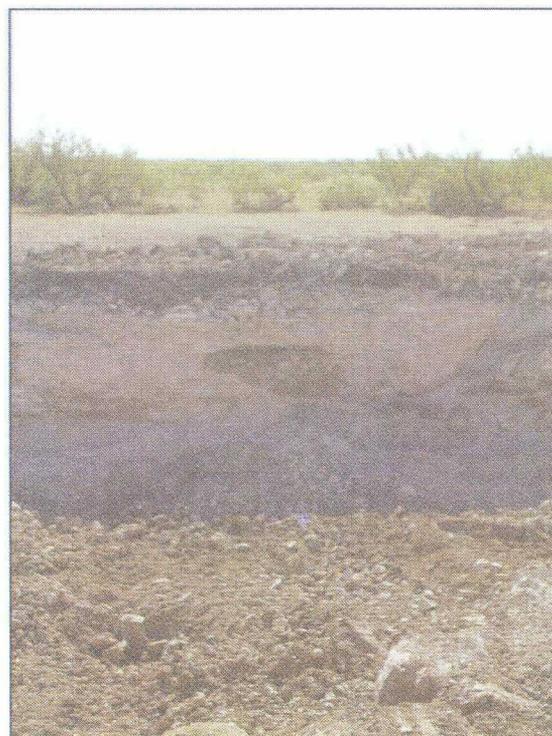
No. 12 – Looking east from the southwest corner to the southeast corner of the pit.

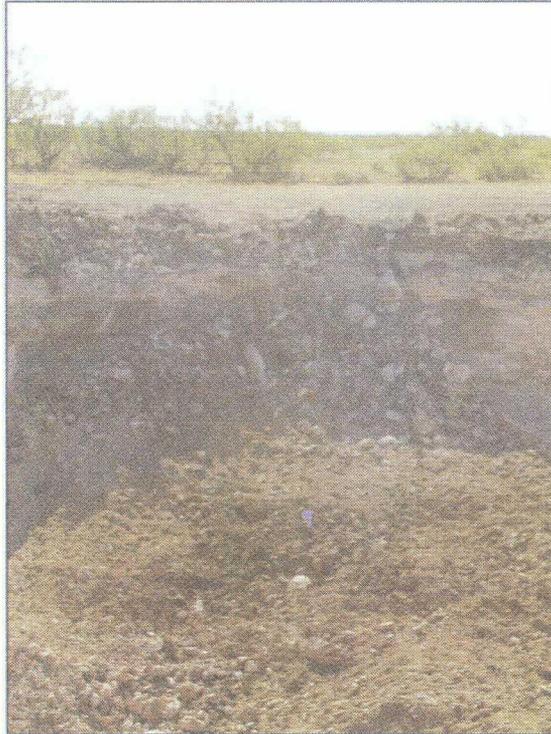
No. 13 – Looking east from the northwest corner to the northeast corner of the pit.

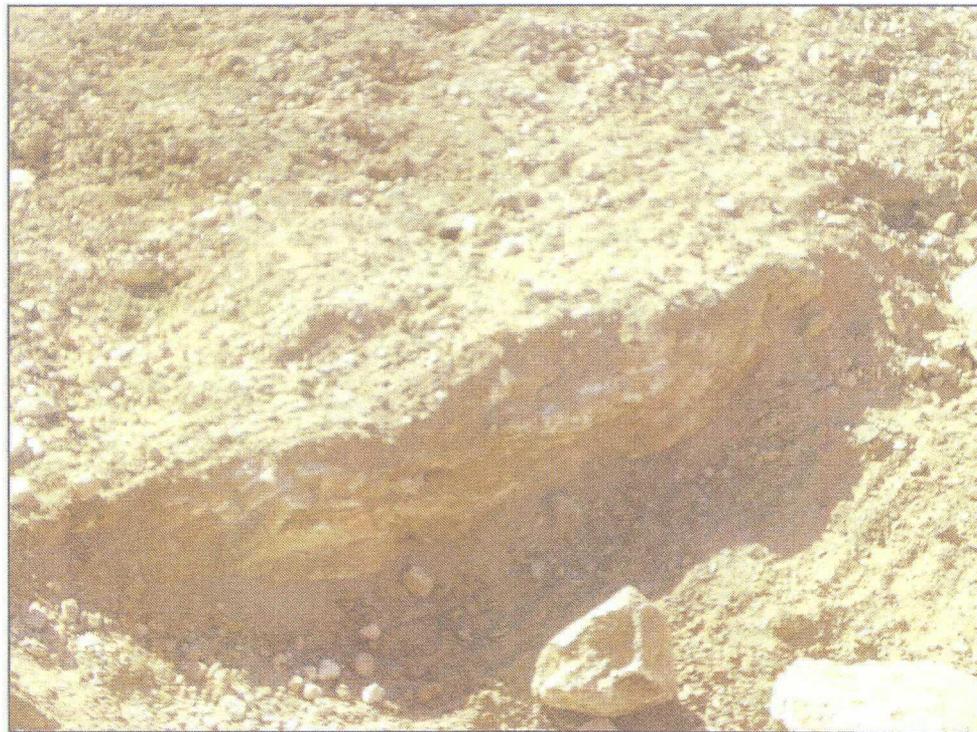
No. 14 – The caliche shelf at the bottom of the pit on the northwest side.

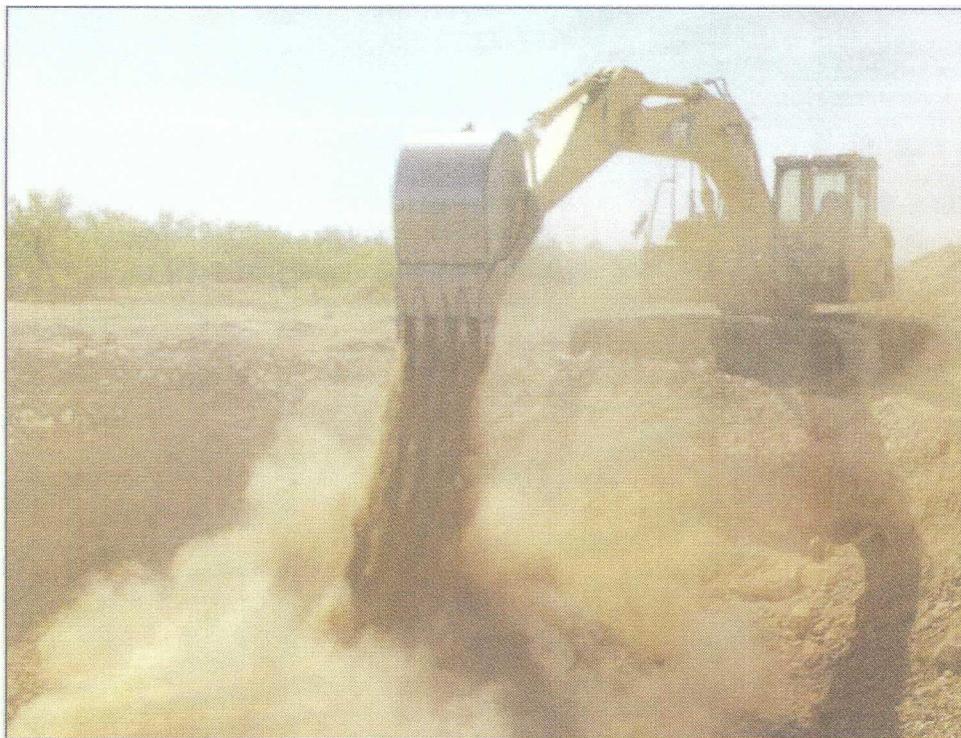
No. 15 – Beginning to backfill the pit.

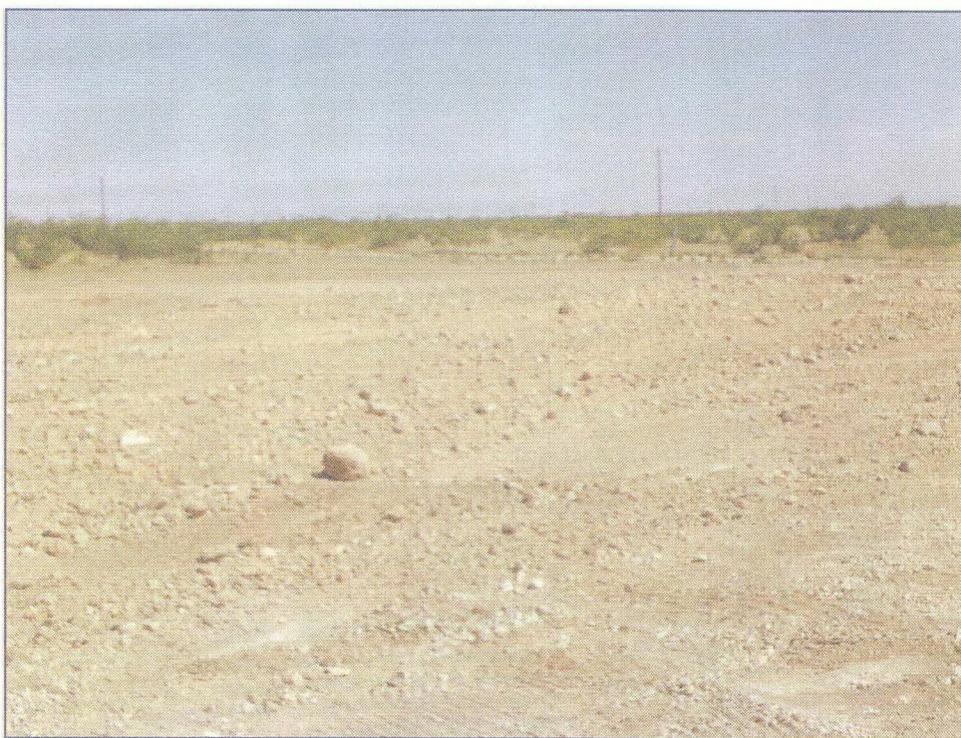
No. 16 – Looking south from the northern edge of the backfilled pit.

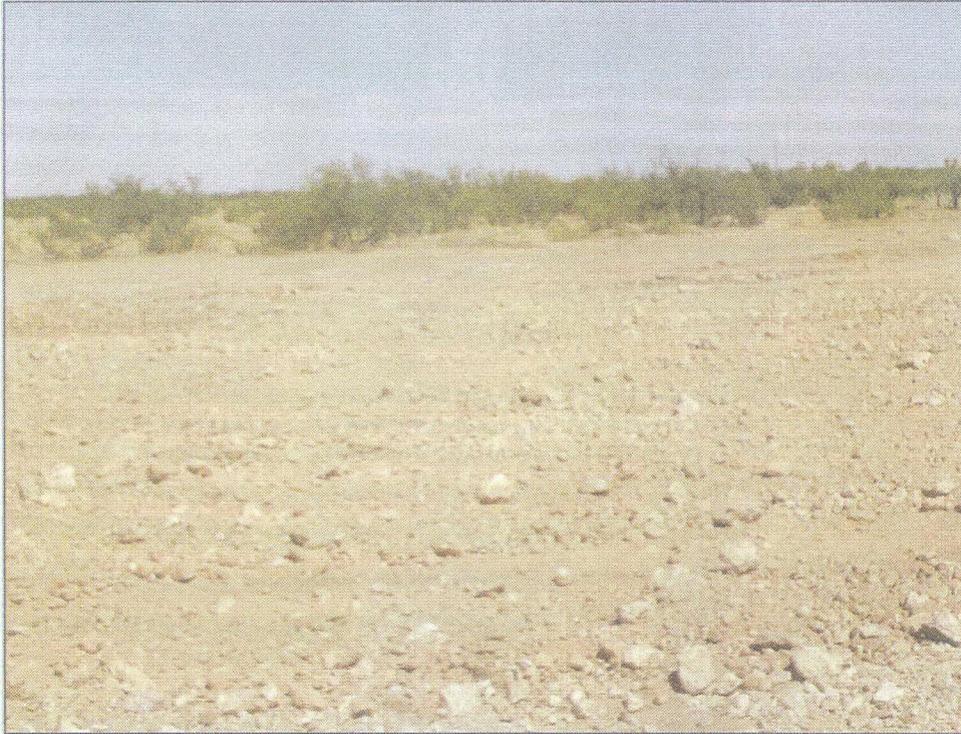
No. 17 – Looking east from the western edge of the backfilled pit

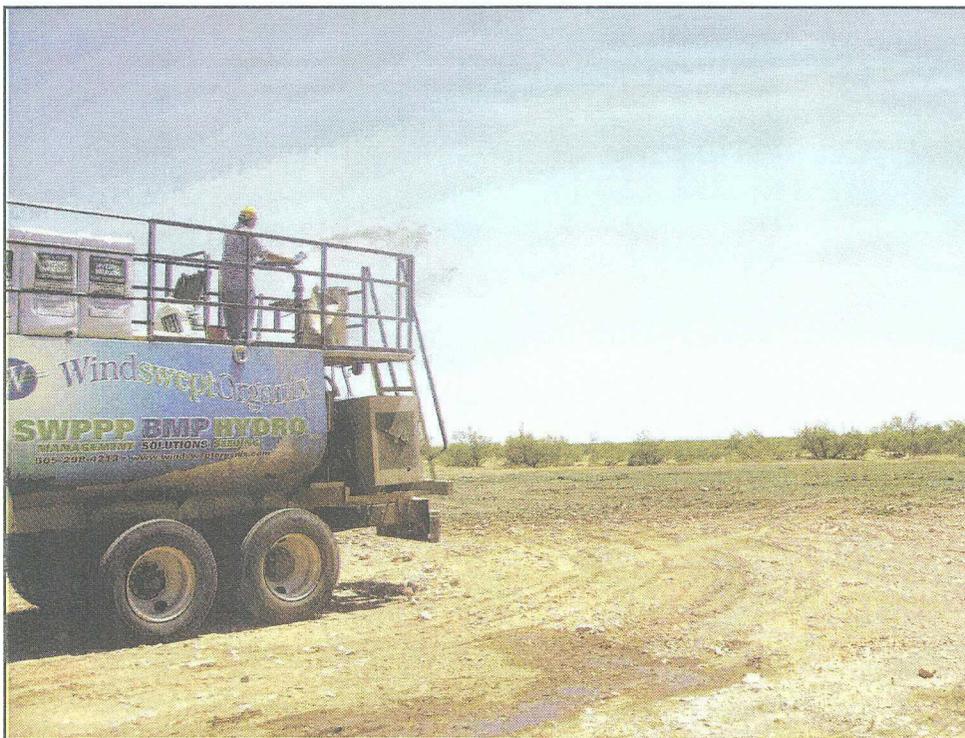
No. 18 – Beginning to hydroseed the Site.

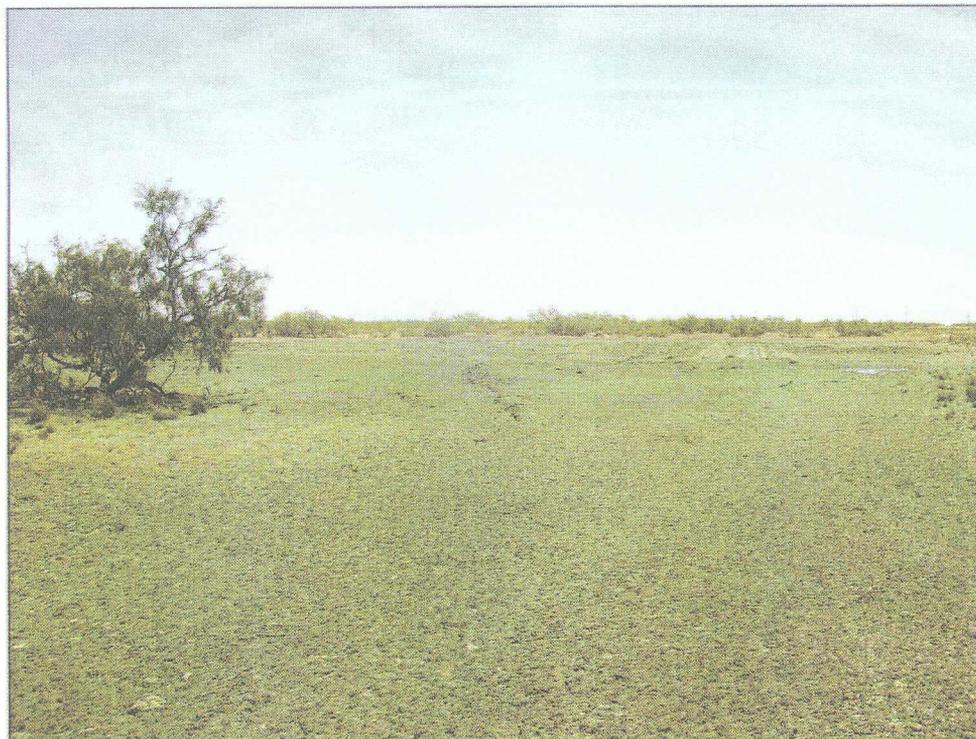
No. 19 – Looking south over the area covered in hydroseed.

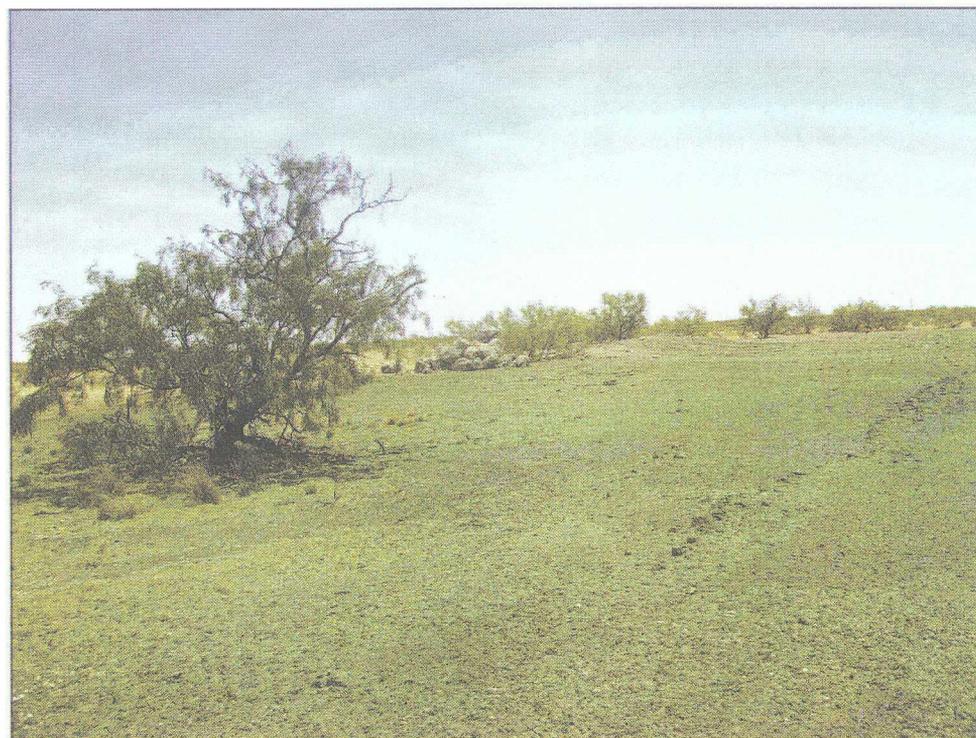
No. 20 – Looking east over the area covered in hydroseed.
