RE: Phase II Remediation, Millard Deck Estate Pit, Lea County, New Mexico

Report on Phase II Remediation Activities at the Millard Deck Estate Pit, Lea County, New Mexico

June 30, 2008

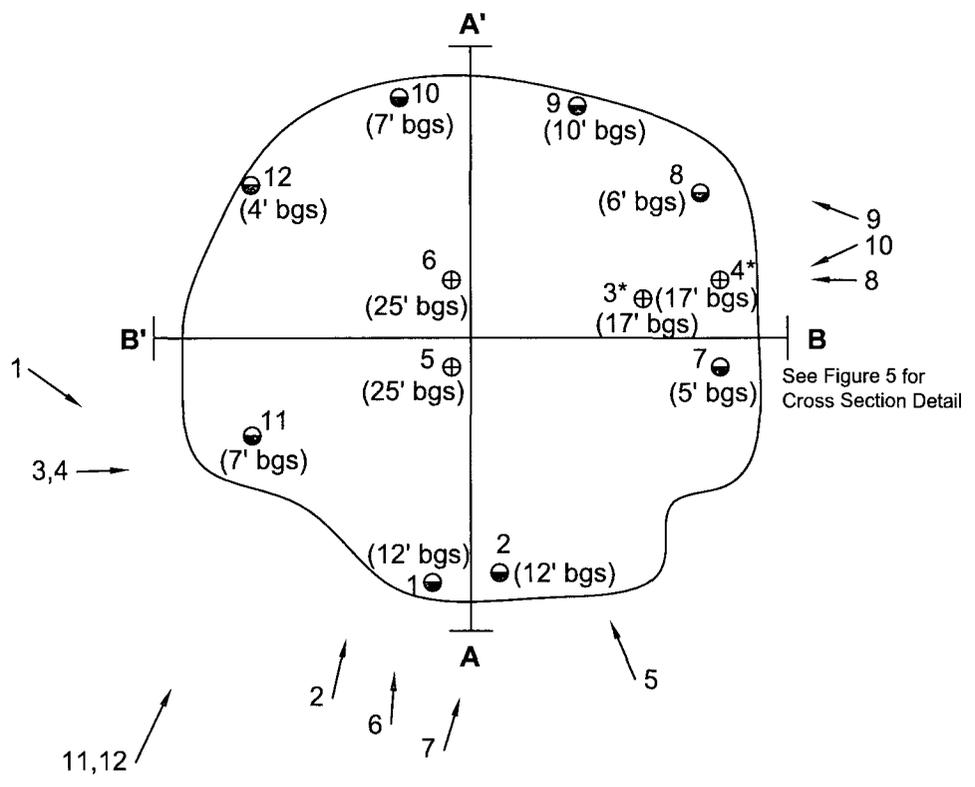
Figure 4
 Excavation Detail / Sample &
 Photograph Locations

Once the 1,400 cubic yards were removed, resulting pit dimensions were approximately 60 feet by 54 feet, and by 25 feet deep bgs (Figures 4 and 5). Contaminated soil was still present in the bottom of the excavation and along the excavation walls (visual/olfactory observation) after removal of the 1,400 cubic yards.

TPH using United States Environmental Protection Agency (EPA) Method 418.1; for chloride using EPA Method 9056A; and for benzene, toluene, ethylbenzene, and xylenes (BTEX) using EPA Method 8021B. Laboratory results are shown in Table 2 and Figure 6. The laboratory report is provided in Appendix D and soil sample locations are shown in Figure 4.

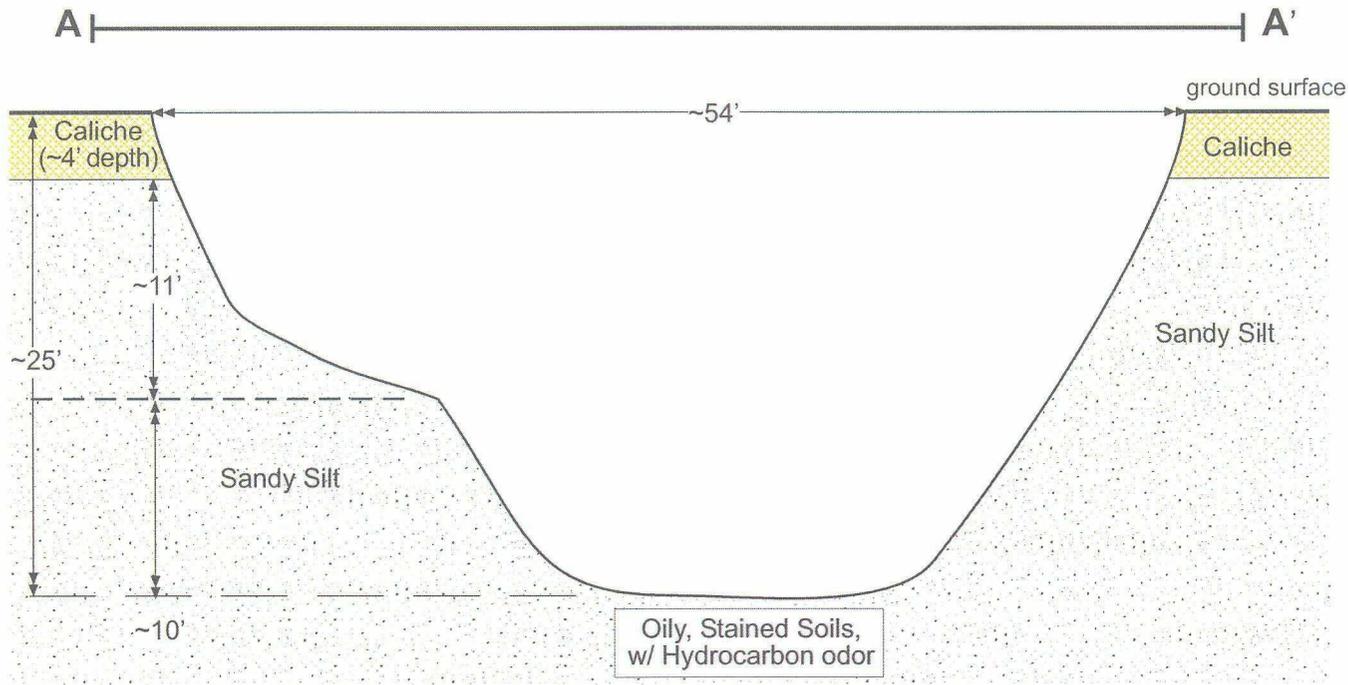
Figure 5
Schematic Cross Sections
for A-A' and B-B'

Approx. Scale: 1" = 10'
View Looking West

See Appendix B, Photographic Log;
photograph numbers 8, 9, & 10.

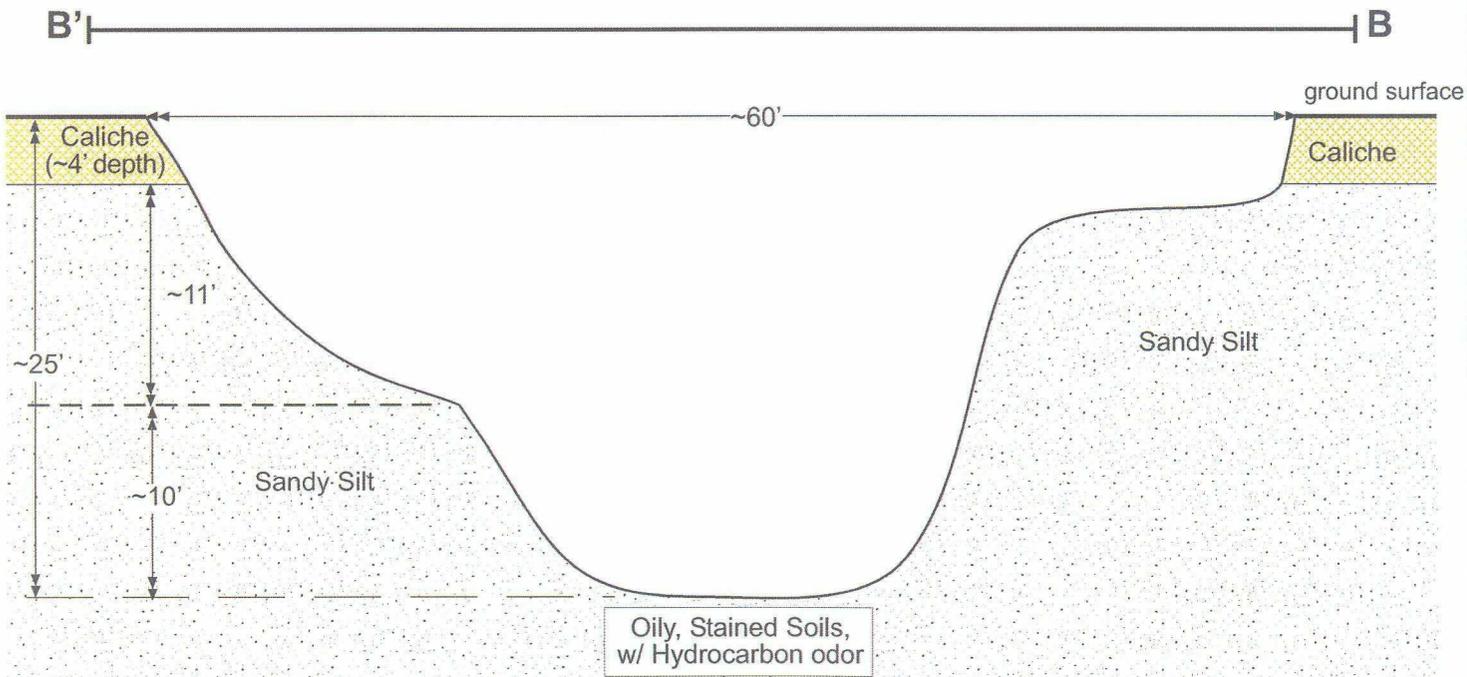
Approx. Scale: 1" = 10'
View Looking North

See Appendix B, Photographic Log;
photograph numbers 6 & 7.

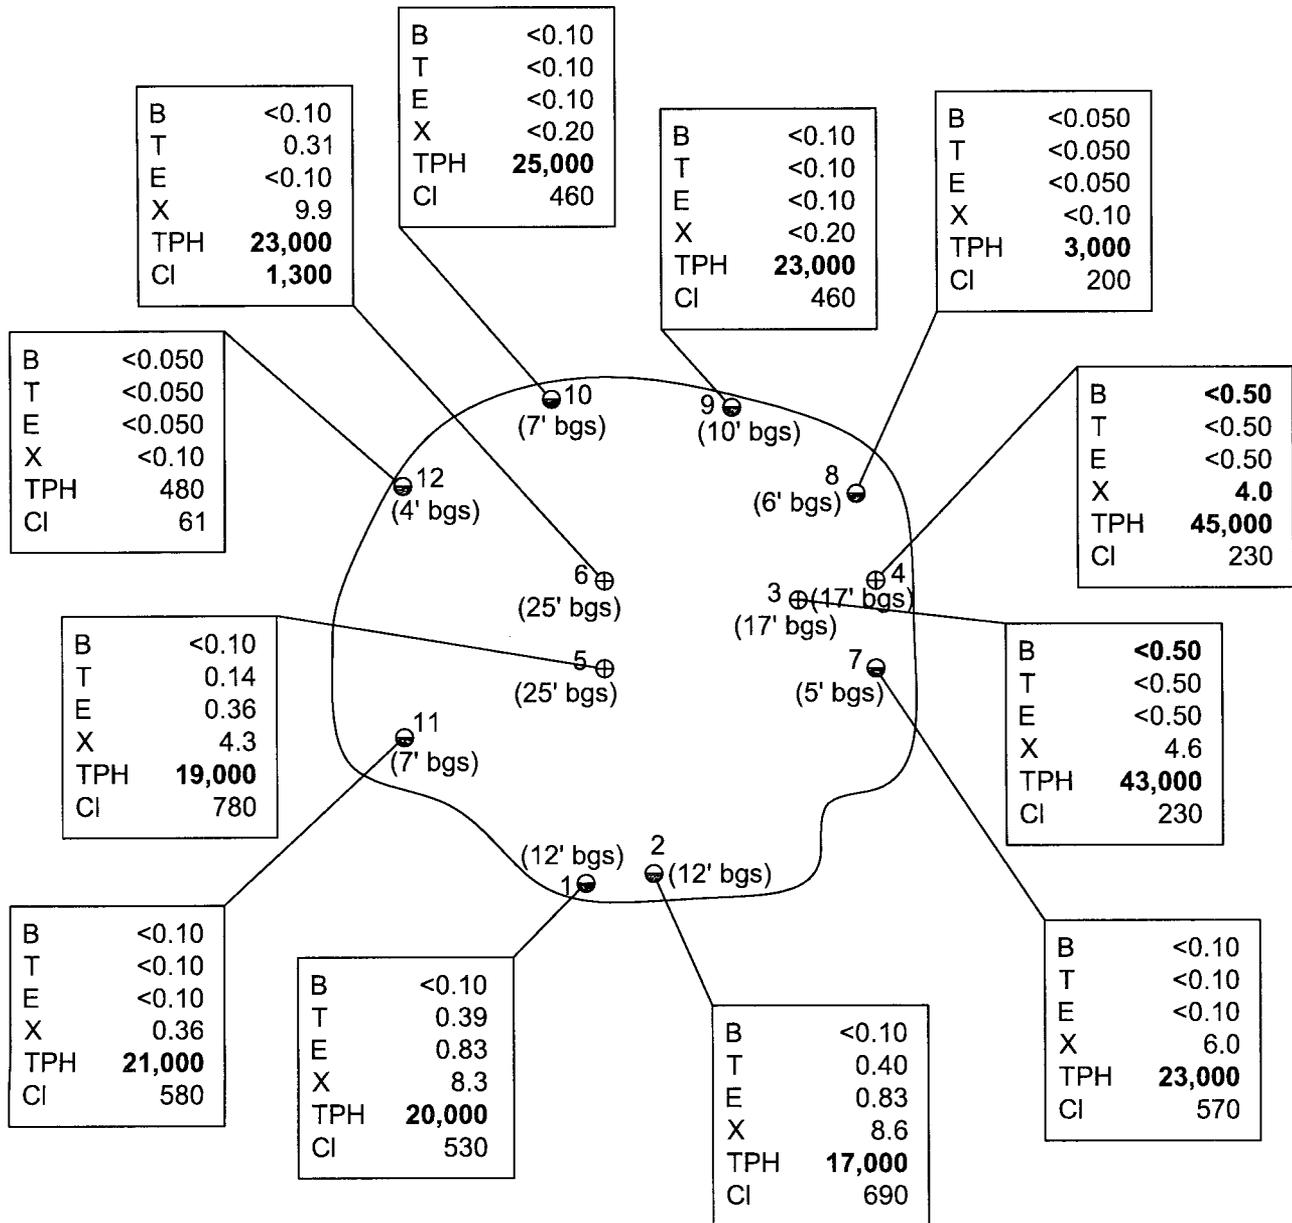
Figure 6
Sample Results
 Millard Deck Estate Pit - Lea Co., NM

The maximum laboratory TPH concentration in soil samples obtained from the excavation walls was 25,000 mg/kg in sample 10 (as shown on the north wall at 7 feet bgs in Figure 6). The maximum TPH concentration in soil samples obtained from the bottom of the excavation was 45,000 mg/kg in sample 4 taken at 17 feet bgs. Other than the 480 mg/kg soil TPH result obtained in sample 12 (as shown on the west wall at 4 feet bgs in Figure 6), only one other TPH soil sample (sample 8) was below 17,000 mg/kg. Of those twelve samples above or equal to 17,000 mg/kg, the average TPH value was 28,250 mg/kg.

Once the limits of the excavation were reached, confirmation soil samples were collected from four locations for in-field TPH analysis using PetroFLAG and for in-field chlorides analysis using a Hach[®] field kit. Confirmation soil sample results of field TPH analysis and field chloride analysis are discussed in Section 3.2 and are shown in Table 2. 14 grab soil samples were collected for laboratory analyses of BTEX, TPH, and chlorides (four of the 14 grab soil samples collected for laboratory analysis were additionally analyzed for field TPH using PetroFLAG and for field chlorides analysis using the Hach[®] field kit). The results of the laboratory analyses are discussed in Section 3.2 and are displayed in Table 2 and Figure 6.

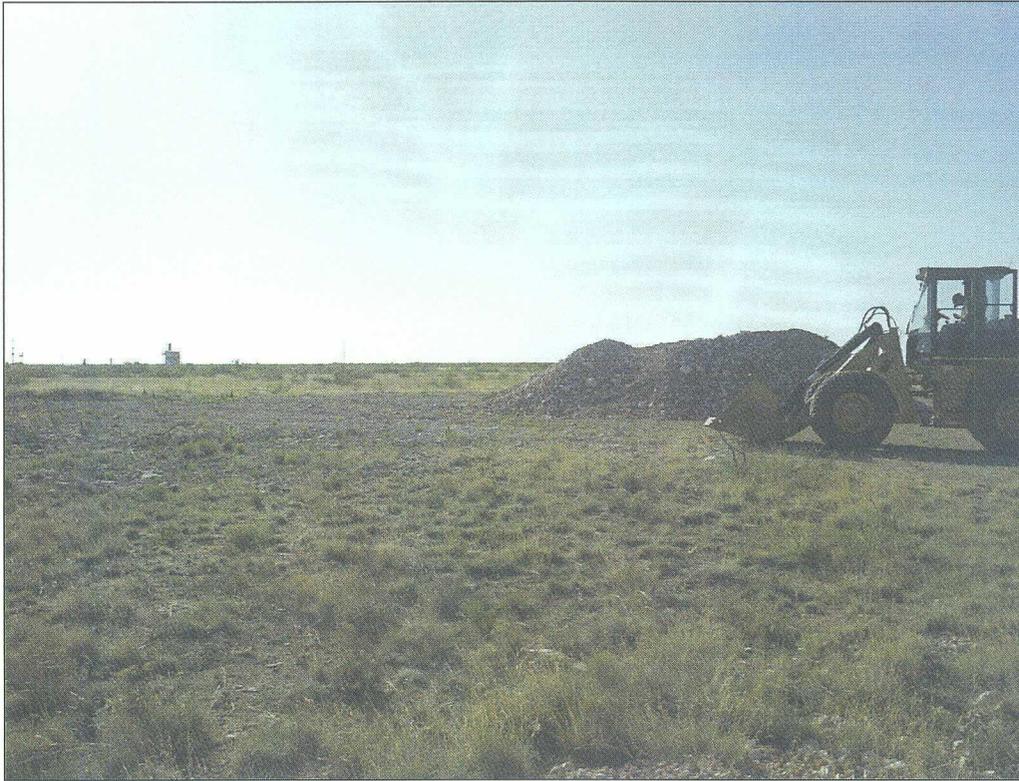
No. 1 – Site of June 2007 excavation upon arrival on June 10, 2008; the remaining fill from June 2007 is visible in the background. View is to the southeast.

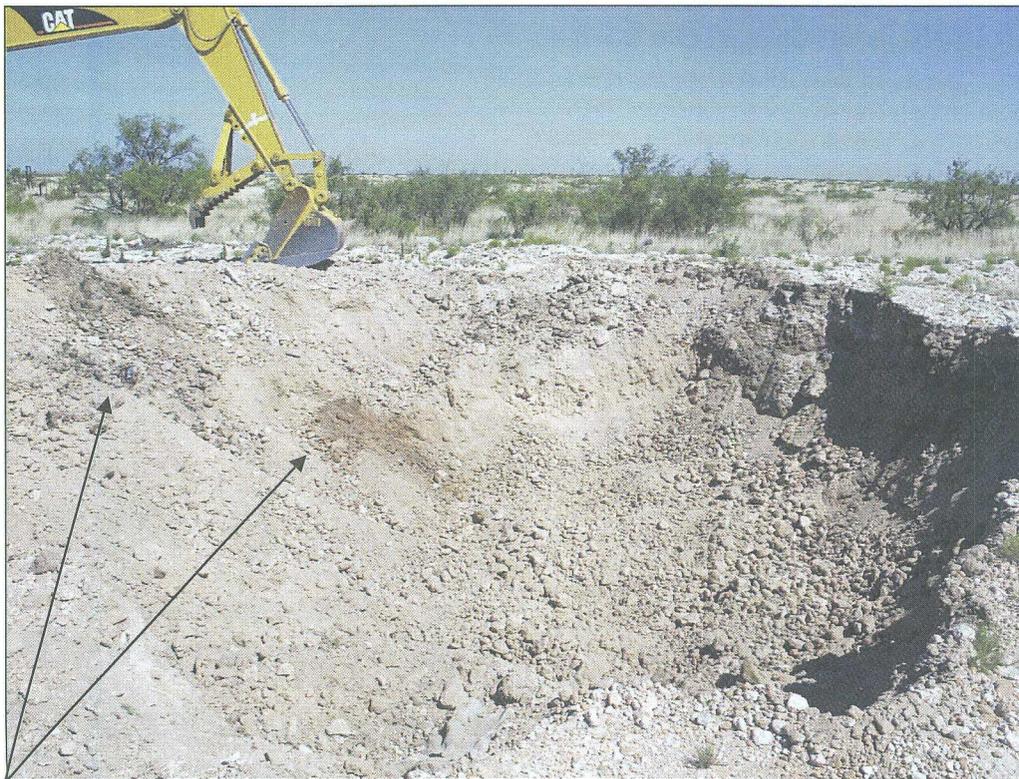
No. 2 – View to the north after reaching the end-point of the June 2007 excavation. Staining is visible along the north wall.

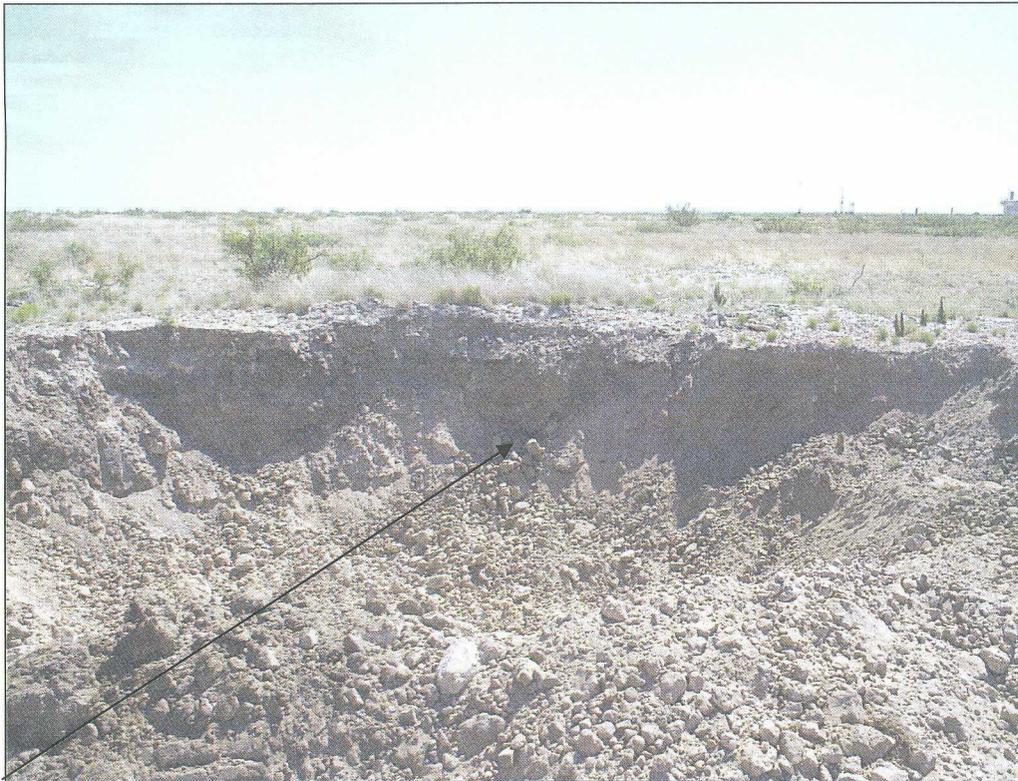
No. 3 – View to the east after reaching the end-point of the June 2007 excavation. Staining is visible along the east wall.

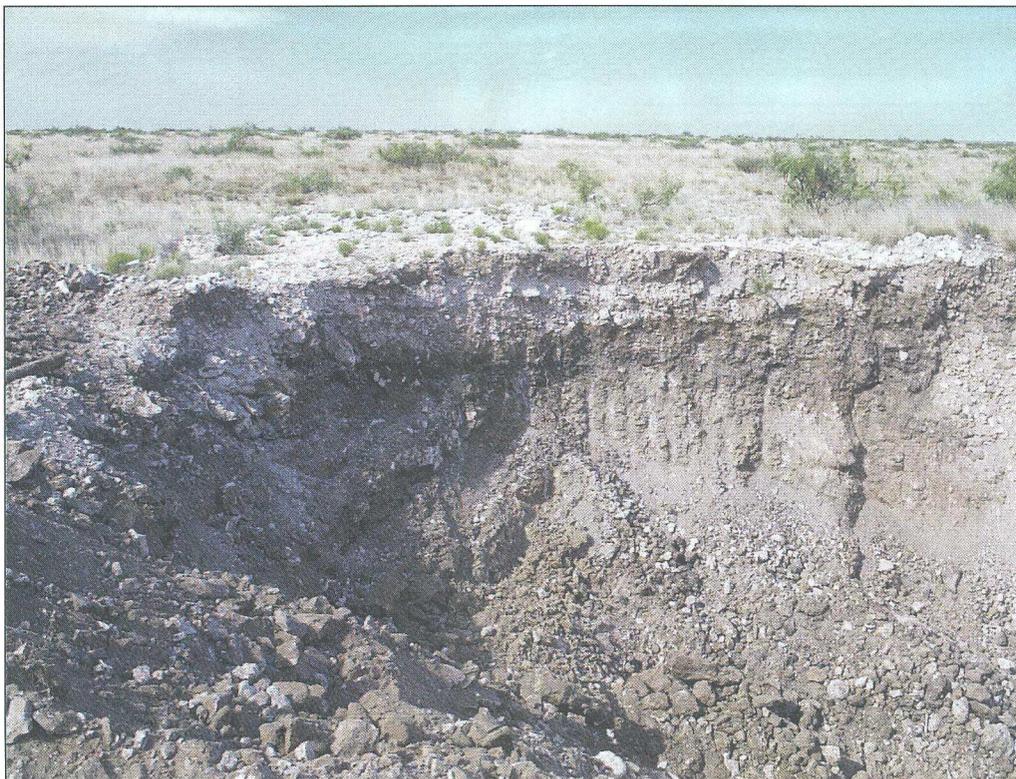
No. 4 – View to the east approximately 6 ½ hours after photograph No. 3 was taken, showing further extent of contamination.

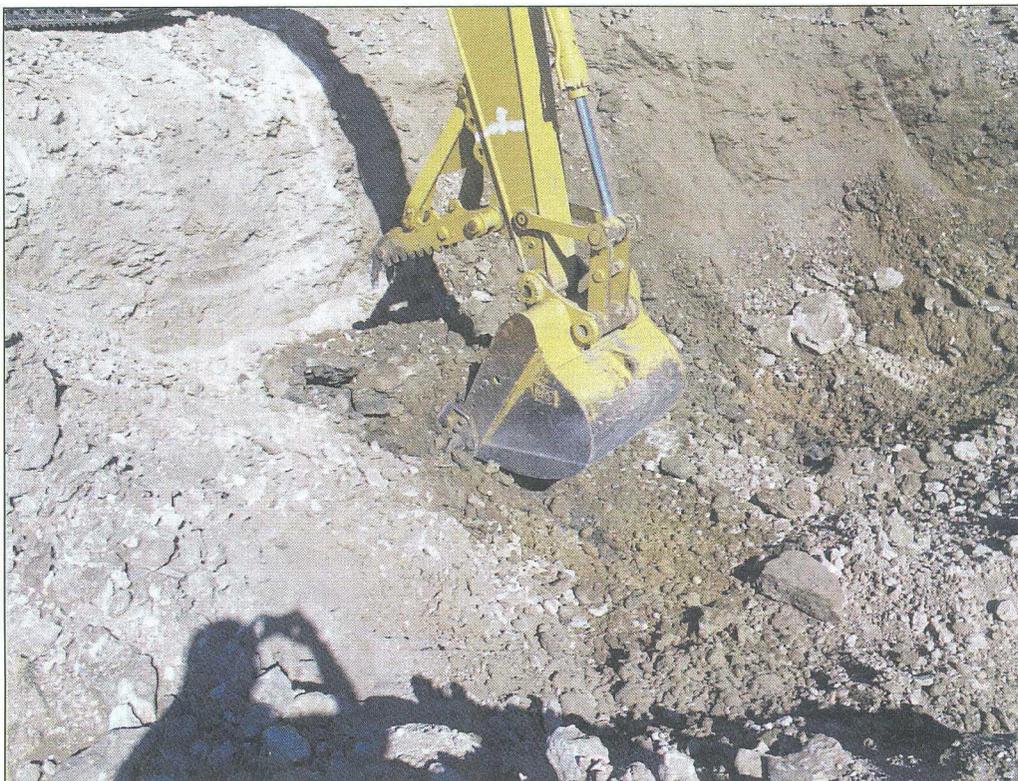
No 5 – View of the bottom of the excavation at 9 a.m. on June 11, 2008. A white/grey caliche layer is visible to the left of the photograph, while brown, sandy silt can be seen at the pit bottom.

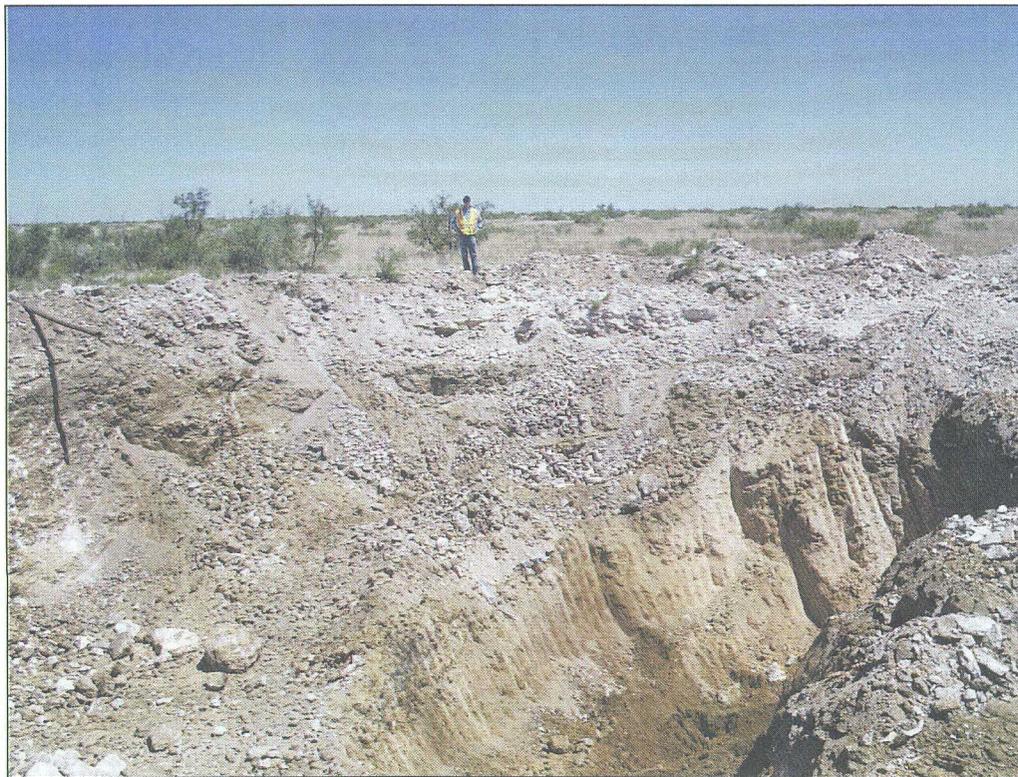
No. 6 – View to the north of the excavation after 1,400 cubic yards of contaminated soil had been removed off-site; photograph 1 of 2 (see Figure 5).

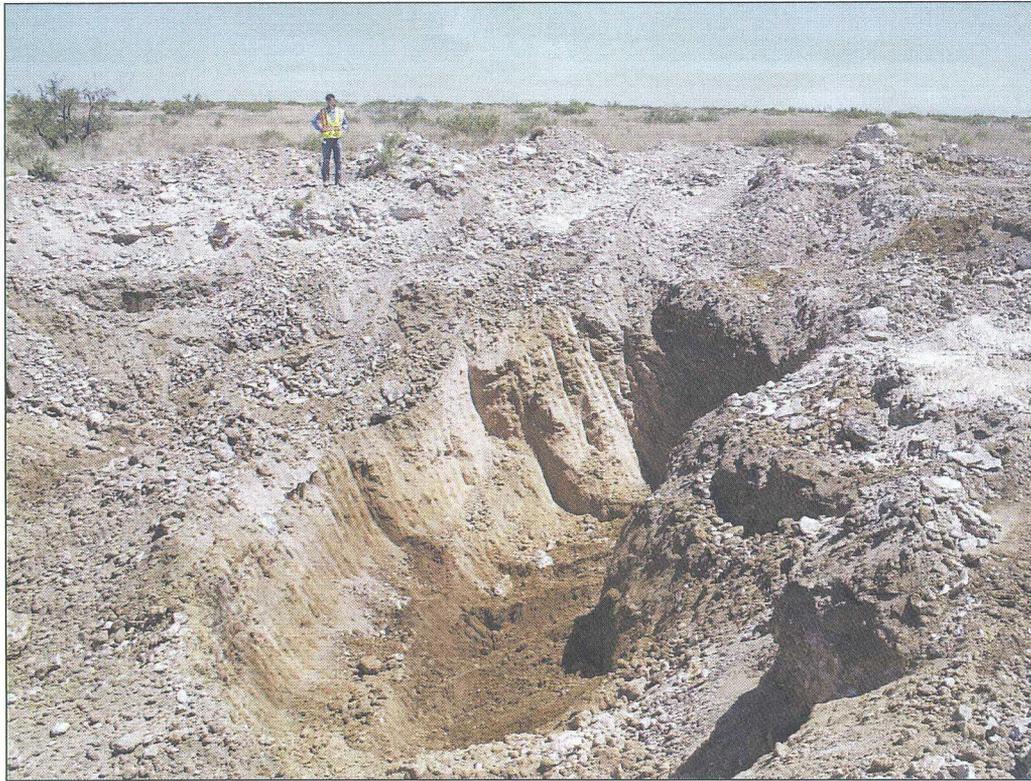
No. 7 – View to the north, northeast of the excavation after 1,400 cubic yards of contaminated soil had been removed off-site; photograph 2 of 2 (see Figure 5).

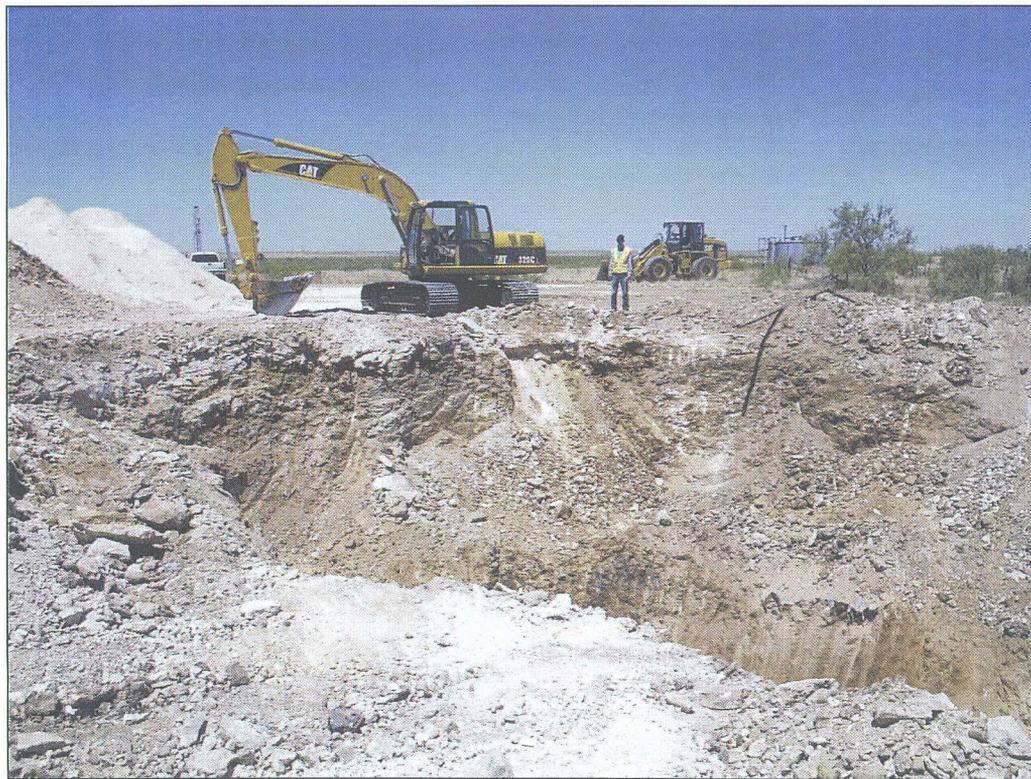
No. 8 – View to the west of the excavation after 1,400 cubic yards of contaminated soil had been removed off-site; photograph 1 of 3 (see Figure 5).

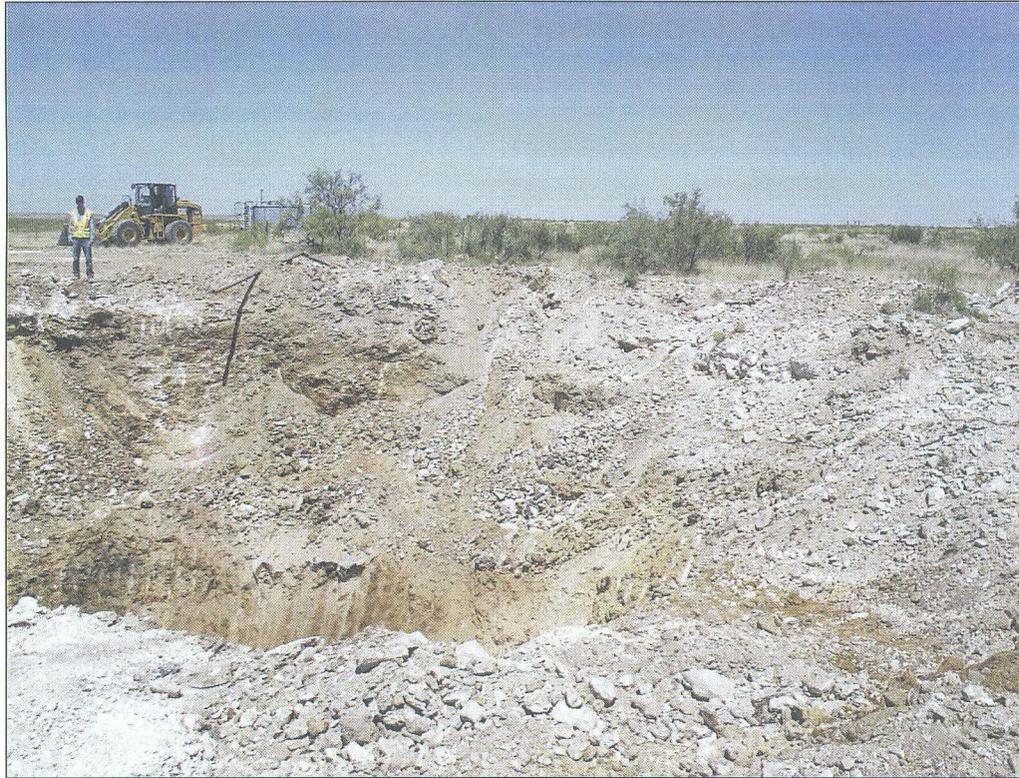
No. 9 – View to the northwest of the excavation after 1,400 cubic yards of contaminated soil had been removed off-site; photograph 2 of 3 (see Figure 5).

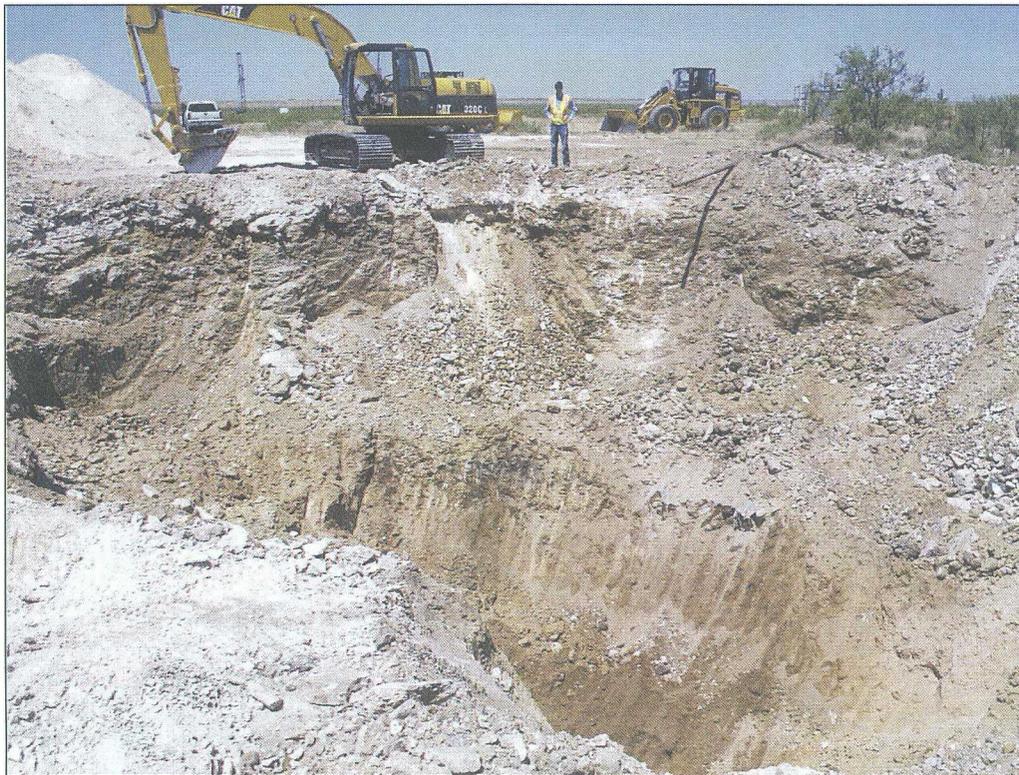
No. 10 – View to the west, southwest of the excavation after 1,400 cubic yards of contaminated soil had been removed off-site; photograph 3 of 3 (see Figure 5).

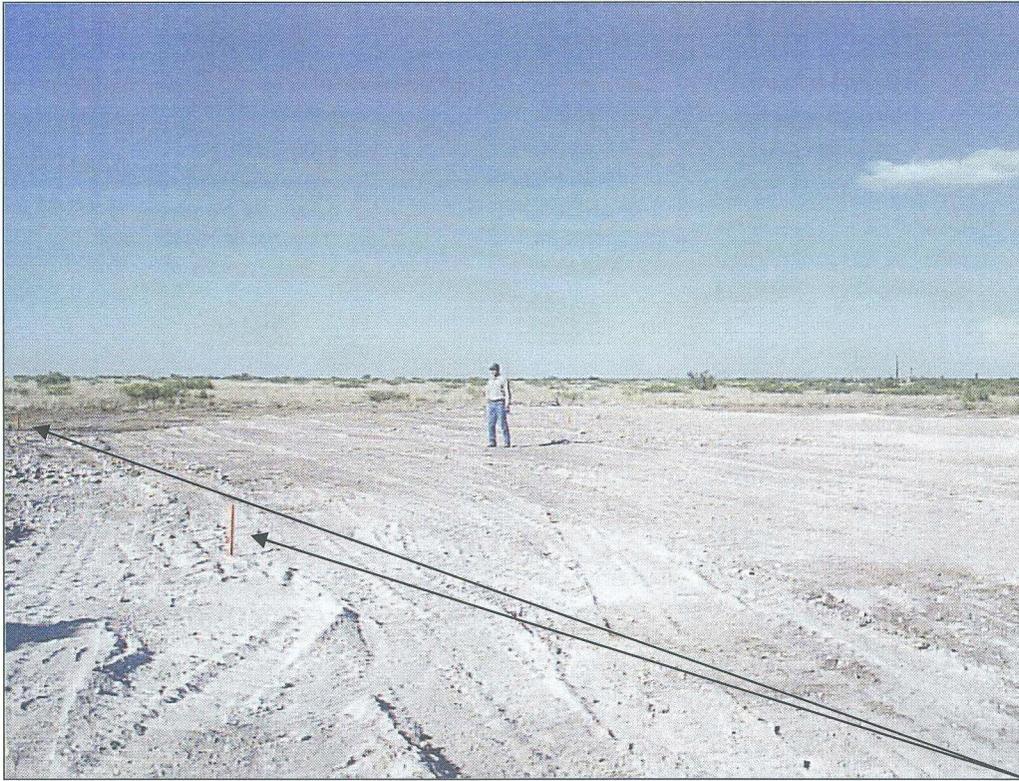
No. 11 – View to the north, northeast looking at the backfilled excavation. Visible to the north are stakes placed at the corners of the excavation to aid reseeding operations.

Backfilling activities took place on June 13, 2008. The backfilling was performed by a track-hoe and a front-end loader, and the backfill material was emplaced in two-foot lifts. In order to fill the deepest area of the excavation, a ramp was created with the track-hoe and fill was placed in the area. Once placed, the track-hoe was used to roll-over this area to achieve compaction. This method was performed within the majority of the excavation except for the area from which the original ramp was created. However, the process of moving the track-hoe along this ramp during the initial fill activities did cause appreciable compaction to occur in this area. As backfill operations continued, both the front-end loader and track-hoe were utilized to compact the fill material to grade (Appendix B, Photograph No. 11).

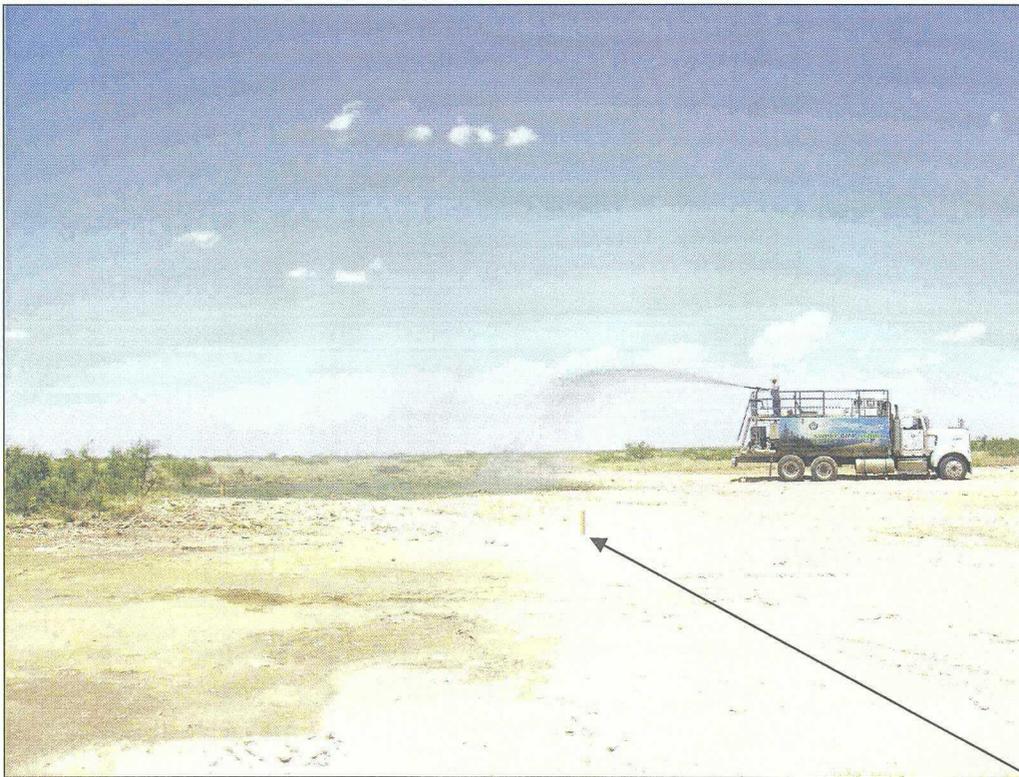
No. 12 – View to the north, northeast looking at the backfilled excavation and the start of reseeding operations. The stakes from Photograph No. 11 are visible in the foreground.
